Citywide
Facility Condition Assessment

Report of
Facility Condition Assessment

For
City of Manhattan Beach
Live Oak Park
1902 Valley Drive, Manhattan Beach, CA

*September 4, 2013
(Rev A)*

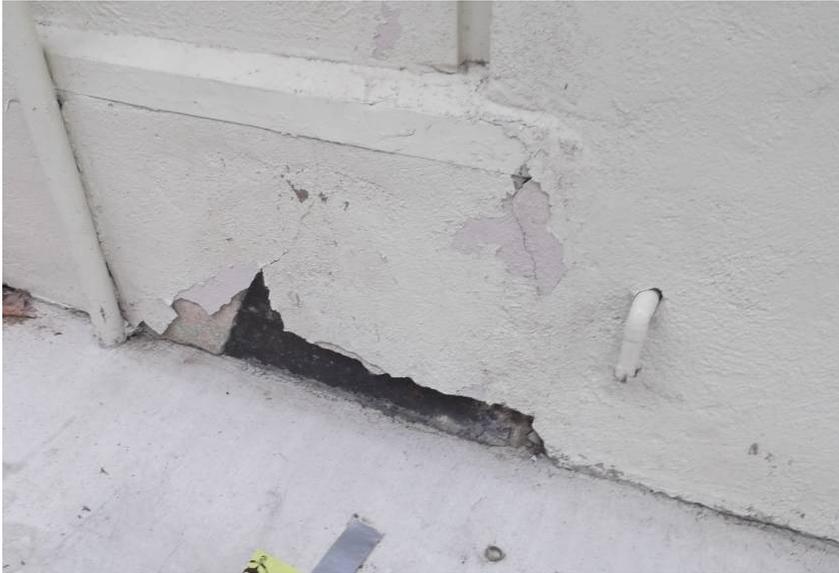
Photograph No. 4

View of an area of damaged stucco on the west facade.

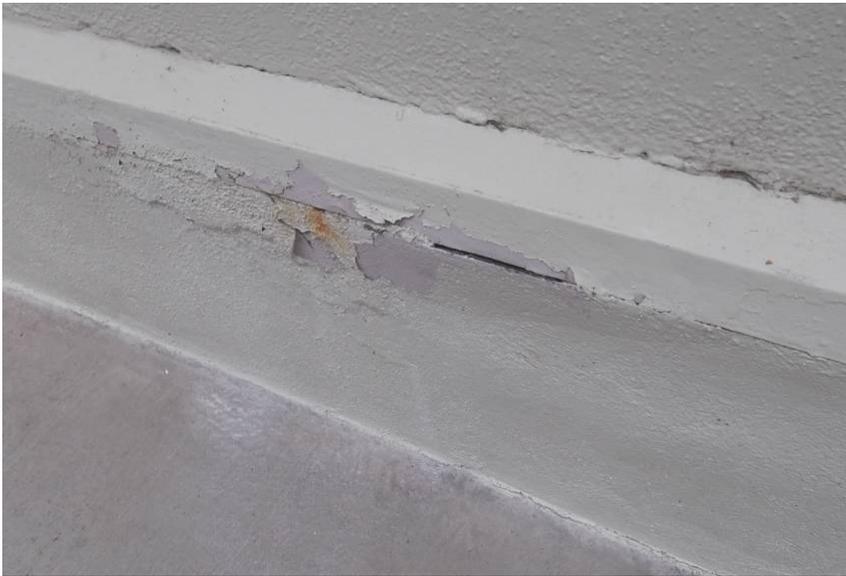
Photograph No. 5

View of peeling paint and deteriorated stucco on the west facade.

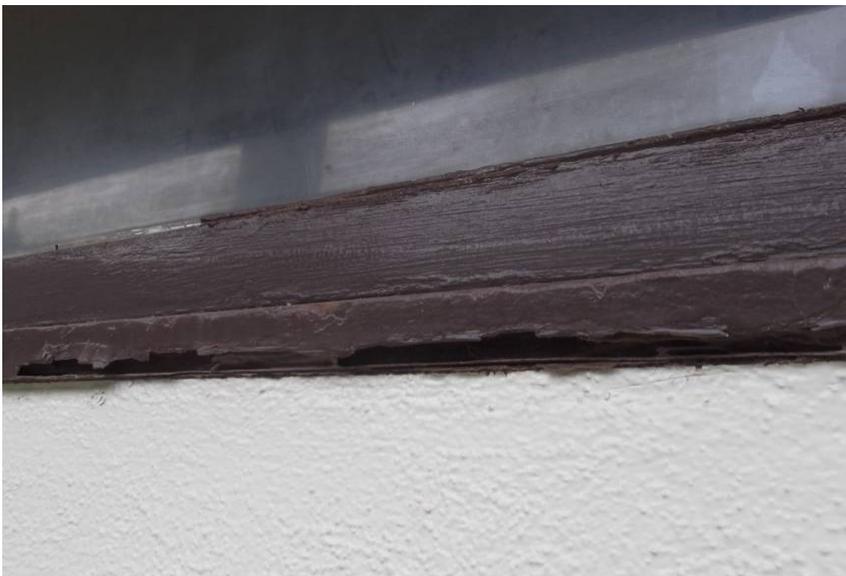
Photograph No. 6

The flat roof structural construction appeared to be in good condition. There was some minor damage to the trim (reference Photograph 6 in Appendix B). We do not anticipate any expenditure during the cost study period which relates to replacement of the roof structure.

View of deteriorated wood trim on the east façade.

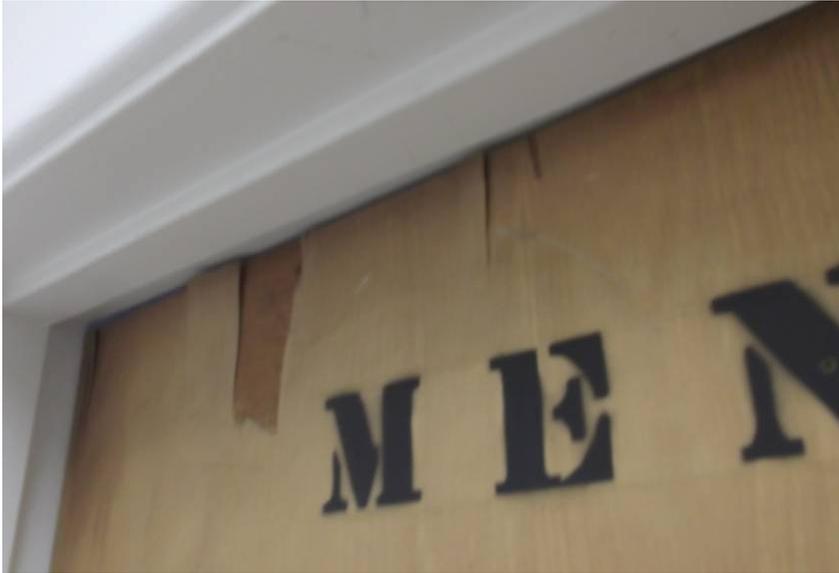
Photograph Nos. 10

Detail view of a deteriorated interior door.

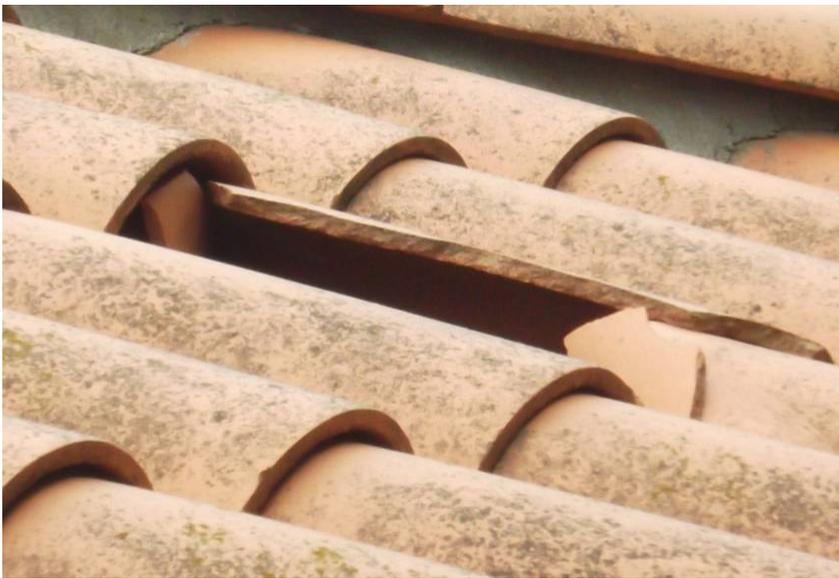
Photograph No. 23

Detail view damaged clay tiles.

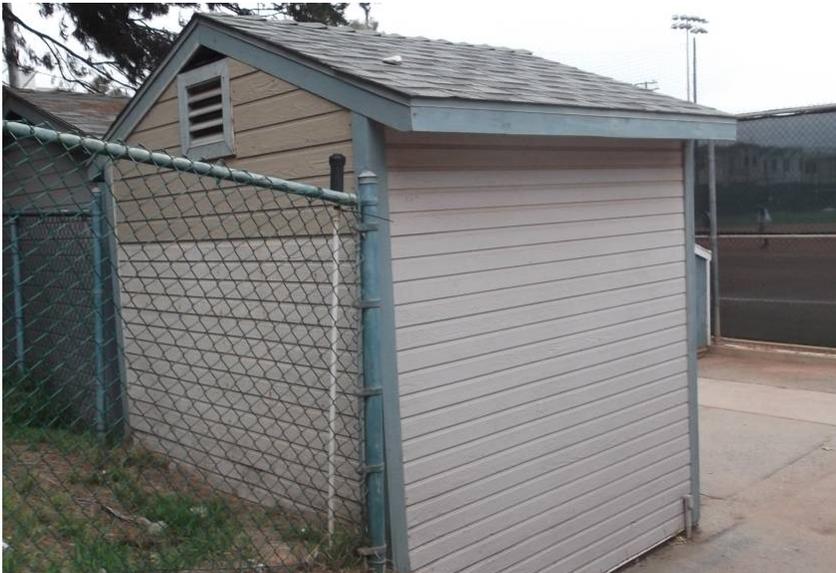
Photograph No. 36

Detail view exterior wall siding damage on the east façade of the building.

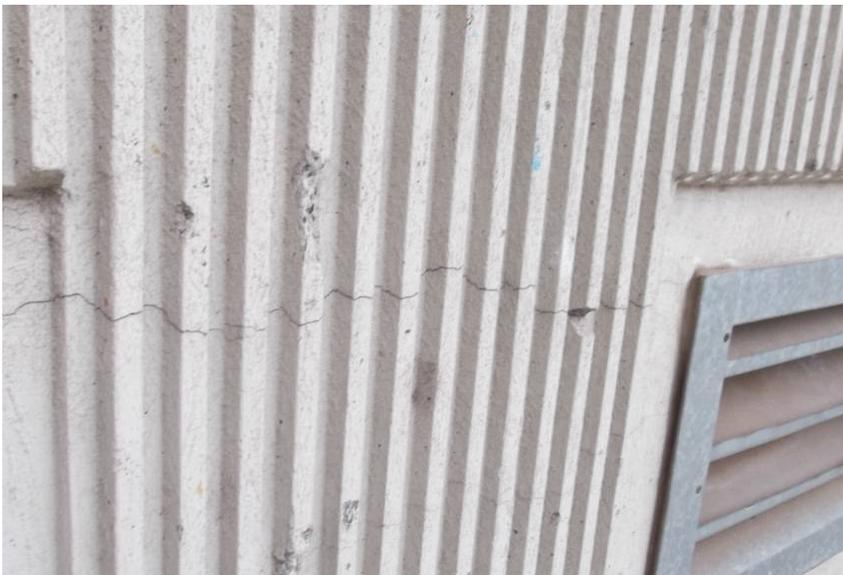
Photograph No. 41

Detail view of cracking and spalling in the precast concrete facade.

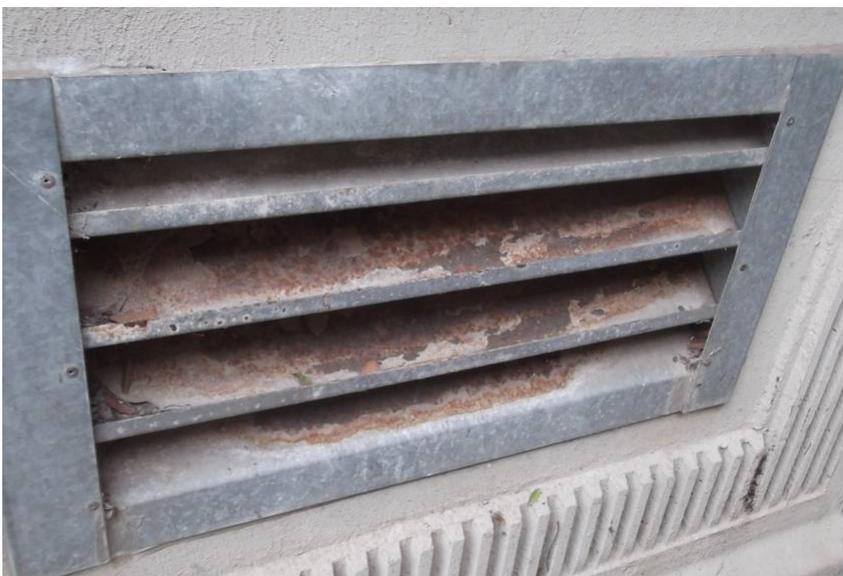
Photograph No. 42

View of the ventilation louver with surface corrosion.

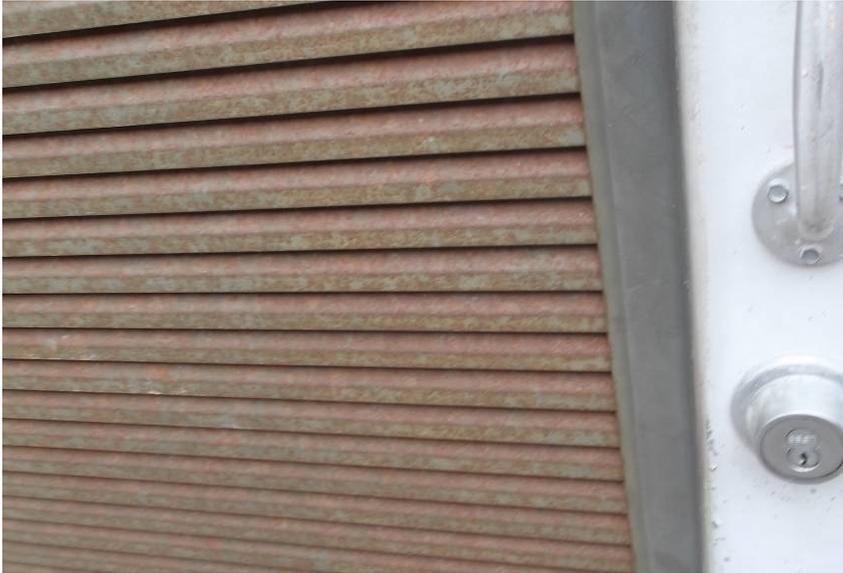
Photograph No. 43

View of the louvered entrance doors with surface corrosion.

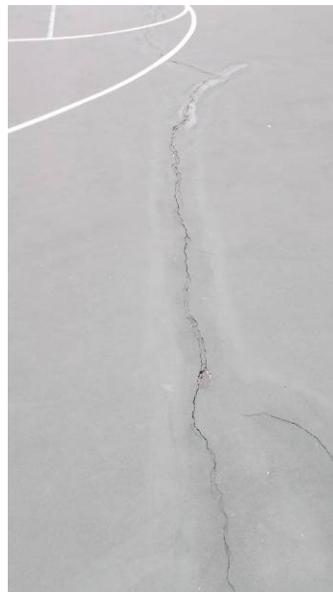
Photograph No. 60

View of the cracking in the surface of the basketball courts.

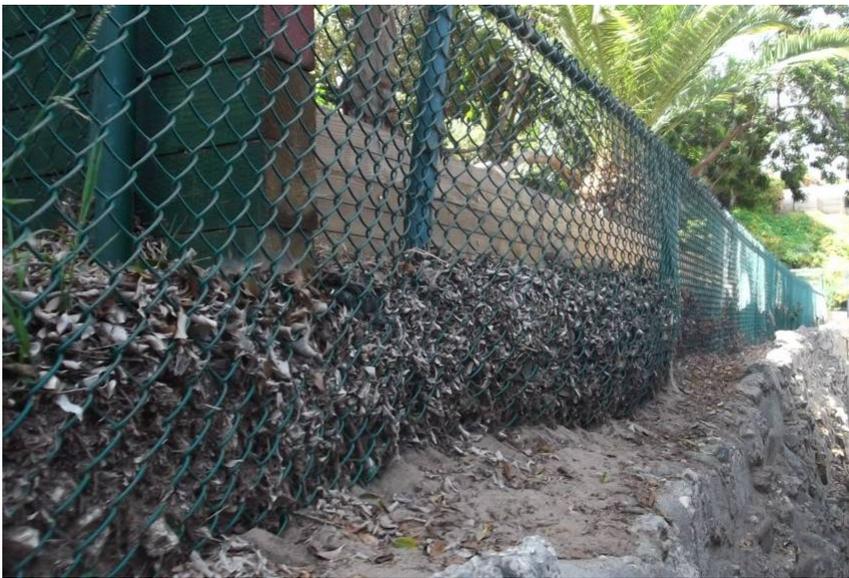
Photograph No. 62

View of the damaged fencing along the west side of the park.

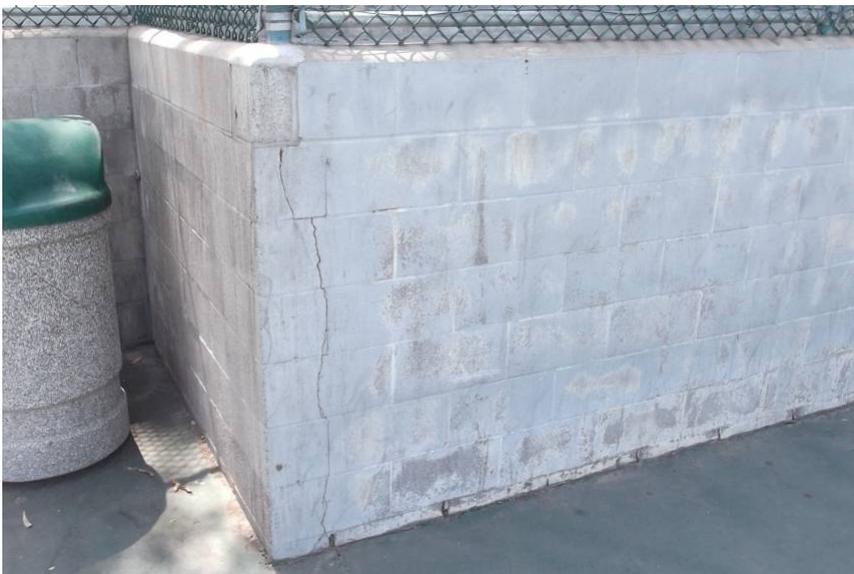
Photograph No. 63

View of the retaining walls with vertical cracking.

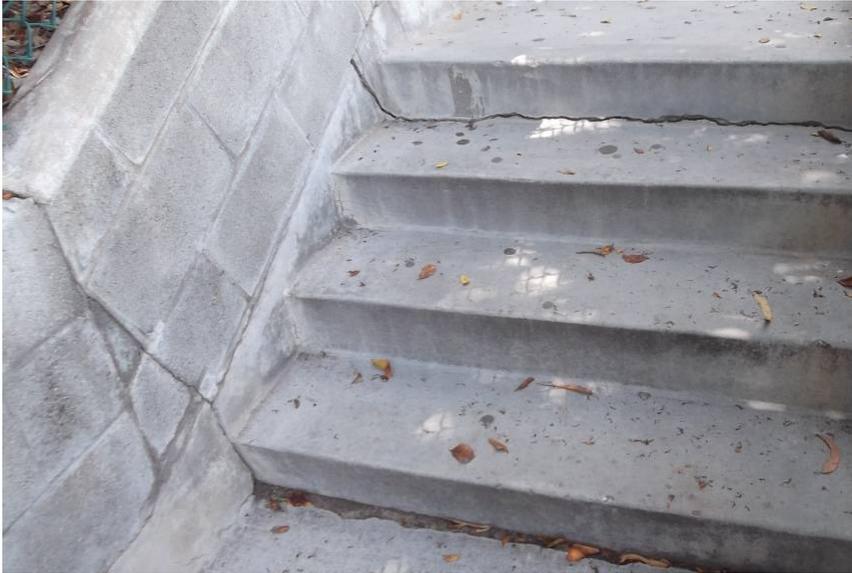
Photograph No. 64

View of the cracking in the concrete steps and walkway at the west side of the park.

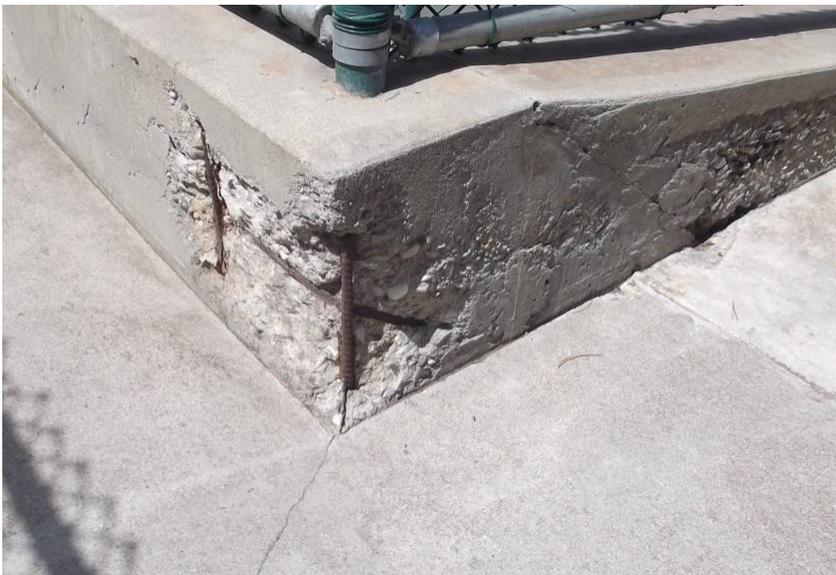
Photograph No. 65

View of the spalling concrete in the walkway at the west side of the park.

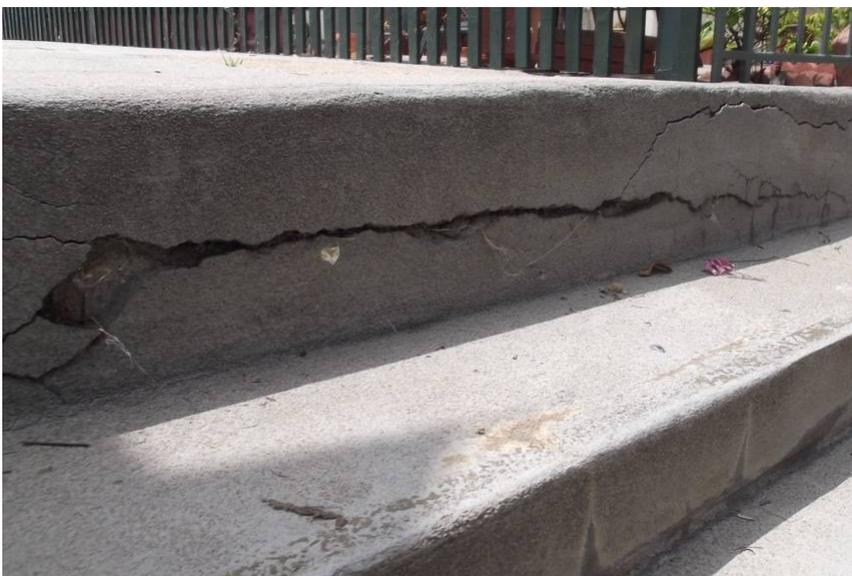
Photograph No. 66

View of cracking in the concrete steps at the west side of the park.
