Citywide
Facility Condition Assessment

Report of
Facility Condition Assessment

For
City of Manhattan Beach
Joslyn Community Center
1601 North Valley Drive, Manhattan Beach, CA

*August 23, 2013
(Rev A)*

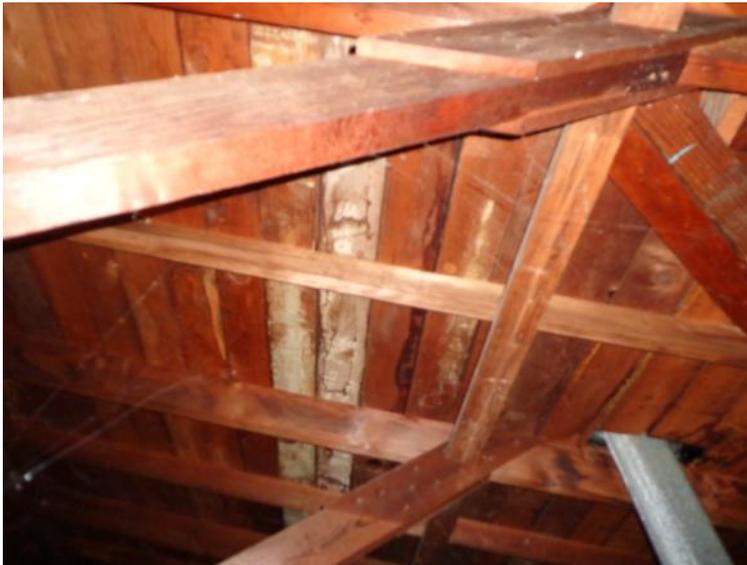
Photograph No. 5

The pitched roof construction at the Scout House building appeared to be in poor condition. Evidence of past repairs and rafter replacement was observed in the attic space. We observed rot and deterioration at many of the exposed wood framing members including the exposed rafter ends at the front and rear elevations, the 4" x 8" header and the 4" x 4" posts at the front porch (reference Photographs 6 and 7 in Appendix B). To maintain the structural integrity of the building we recommend that the wood roof framing system be assessed in more detail to establish the degree of the deterioration. This will require removal of the ceiling systems at various locations to expose the wood framing for further inspection. It is likely that the damage will be far more extensive than can currently be observed. We have also included an allowance for any repairs required following the structural evaluation. Additionally, the attic space is not insulated which causes temperature fluctuation, increased rate of deterioration to the framing system as well as difficulty in obtaining comfortable interior temperatures. Therefore we recommend the installation of insulation in the attic. A feasibility study is recommended "Repair v Replace" to determine the cost benefit of one over the other – this has not been included in this study.

View of the Scout House roof framing.

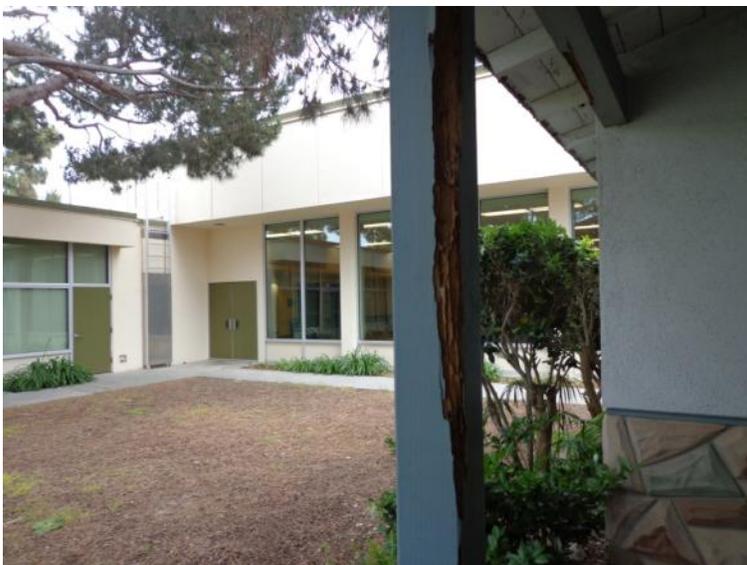
Photograph No. 6

The timber columns are in poor condition. They columns are affected by termites and do not have a secure contact with their concrete pads. They should be replaced early in the study period, and treated to limit further attack. A further investigation into termite damage should be explored, as in the roof sections.

View of a rotted column at the Scout House porch..

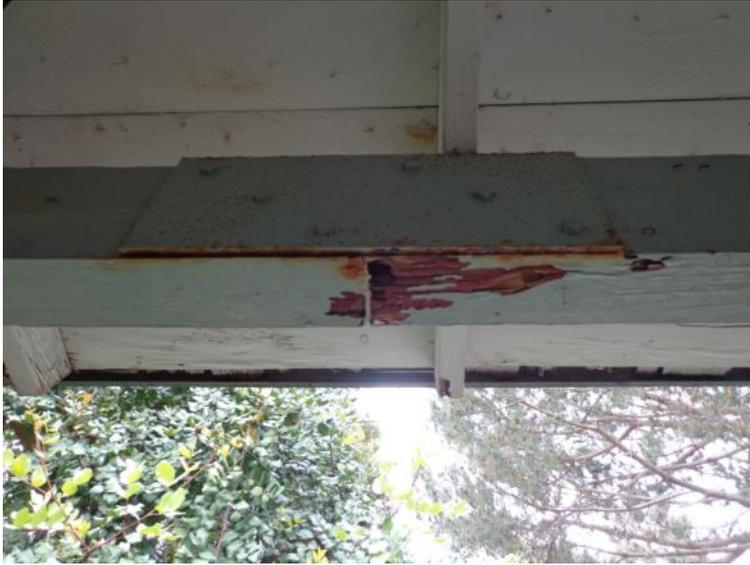
Photograph No. 7

View of the rotted porch header.

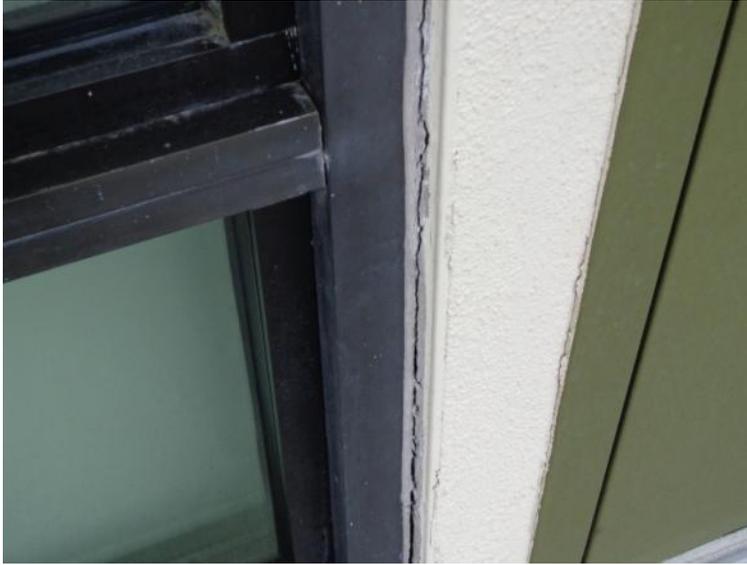
Photograph No. 13

View of the typical condition of the sealants at the community center.

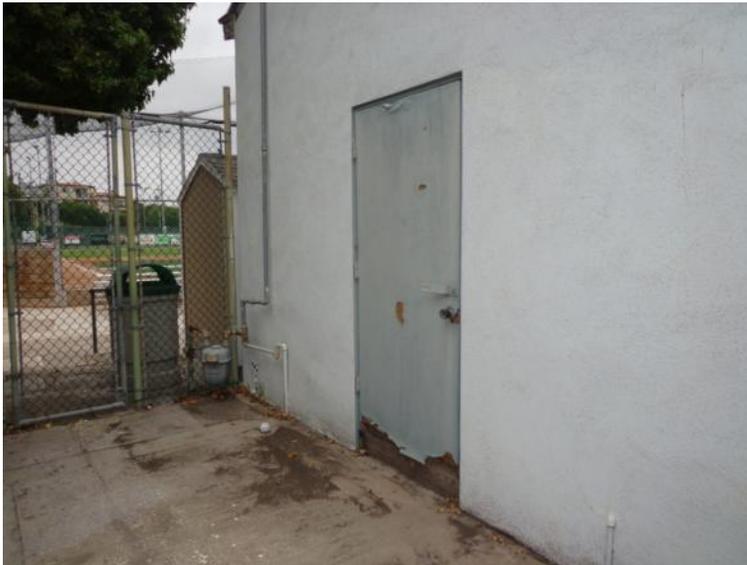
Photograph No. 14

View of the damage observed at the Scout House rear doors.

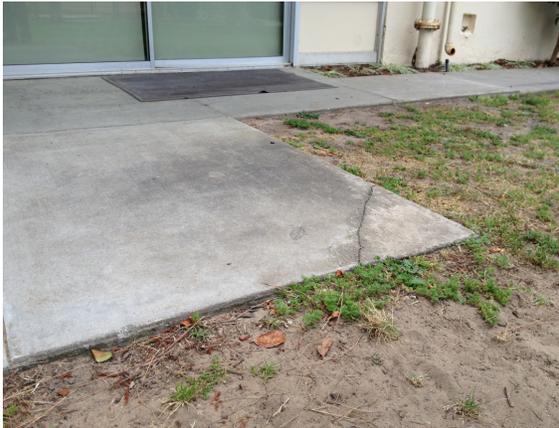
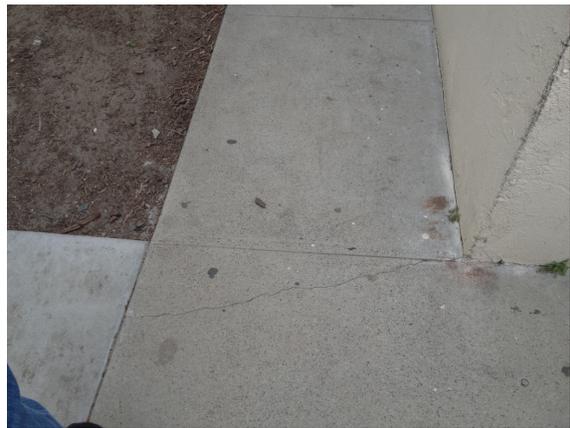
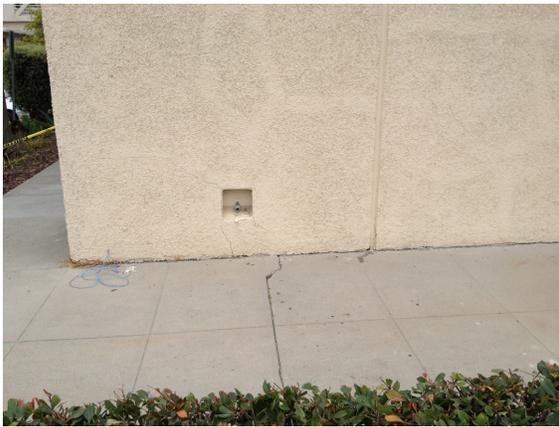
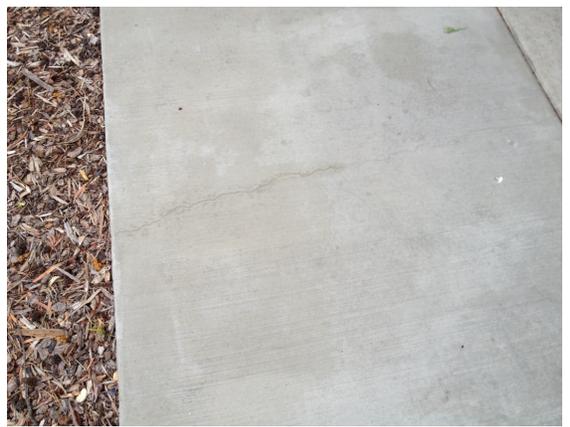
Figure 8: Cracked Exterior Slab on Grade

Cracking was noted in the exterior slab on grade. The extent of the cracking varies from minor to moderate, and is an indication of soil and foundation movement, but poses no direct impact on the existing structure's life safety capacity

Element No.	Building Element	Recommendation	Qty	Unit	Rate	Cost	Year	Priority Code
A1031	Standard Slab on Grade	Undertake crack repairs within slab	30	LF	\$30	\$900*	2014	3
Total Anticipated Expenditure for A Substructure						\$900
