Citywide
Facility Condition Assessment

Report of
Facility Condition Assessment

For
City of Manhattan Beach
Sand Dune Park Office and Restrooms
3800 Bell Avenue, Manhattan Beach, CA

*September 4, 2013
(Rev A)*

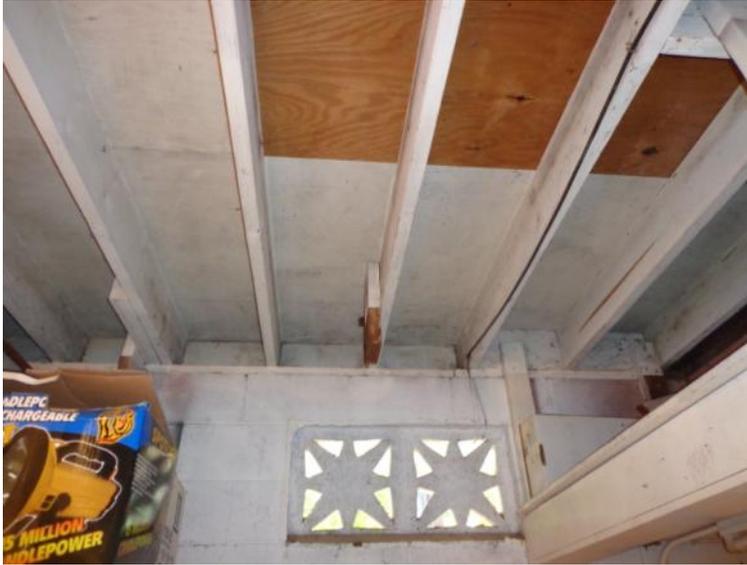
Photograph No. 1

The flat roof construction at the building appeared to be in fair condition. There were no visible signs of failure noted. However, we observed localized rot at the wood ceiling joists in the men's room. We understand that a number of the wood joists have been damaged and therefore we recommend that they are replaced at the time of the roof covering replacement to maintain the structural integrity of the roof.

View of the roof framing system and vent.

| Element No. | Building Element | Recommendation | Qty | Unit | Rate | Cost | Year | Priority Code |
|---|---|---|---|---|---|---|---|---|
| B1020 | Roof Construction | Repair or replace the 2" x 8" wood joists | 1 | LS | \$4,000 | \$4,000 | 2016 | 3 |

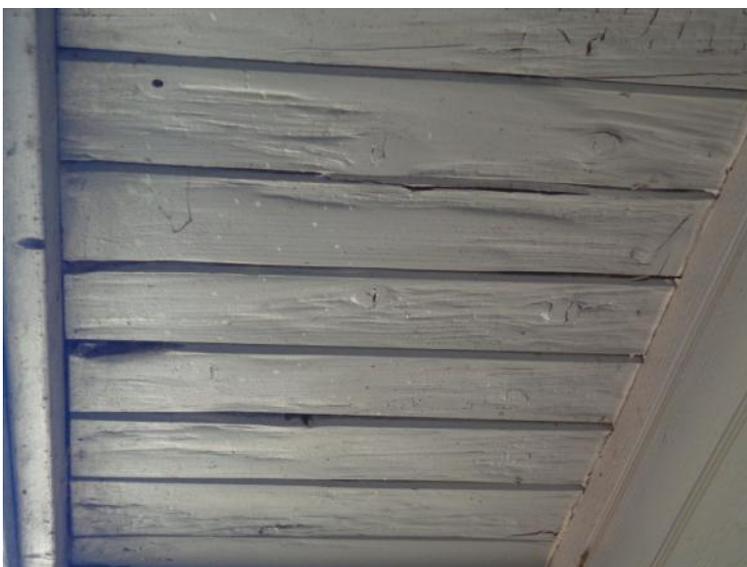
Photograph No. 6

The exterior wall systems at the building appeared to be in fair condition with generally no major signs of deterioration, water ingress or general failure noted. However, we observed several locations where the wood fascia and soffit materials have deteriorated, predominantly at the office section of the building (reference Photographs 6 and 7 in Appendix B). The exterior painted walls do not appear to have been recently painted and therefore based on the typical EUL of 4 years for exterior paint at these buildings, as well as current observed conditions, wood trim repair or replacement and exterior re-painting will be necessary near-term in the study period to maintain the appearance and protect the exterior walls.

View of deterioration observed at the soffit.

| Element No. | Building Element | Recommendation | Qty | Unit | Rate | Cost | Year | Priority Code |
|---|---|---|---|---|---|---|---|---|
| B2011 | Exterior Wall Construction | Repair or replace wood trim materials | 100 | SF | \$35.00 | \$3,500 | 2013 | 2 |

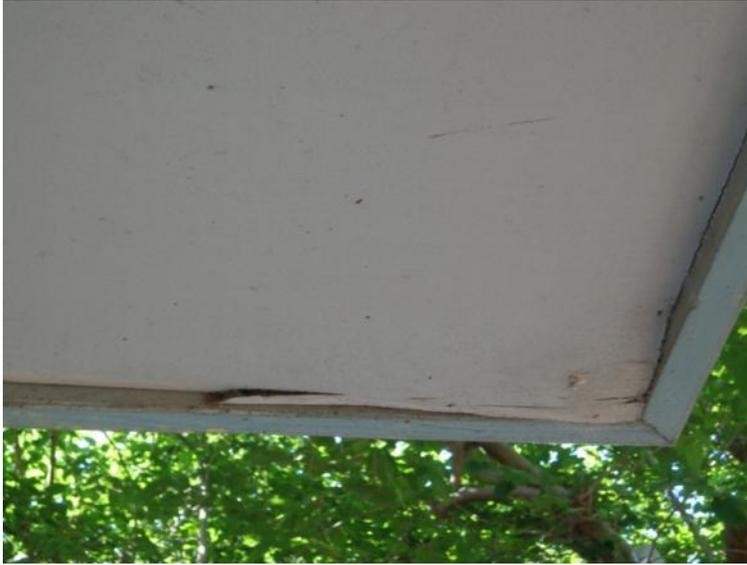
Photograph No. 7

Additional view of deterioration observed at the soffit.

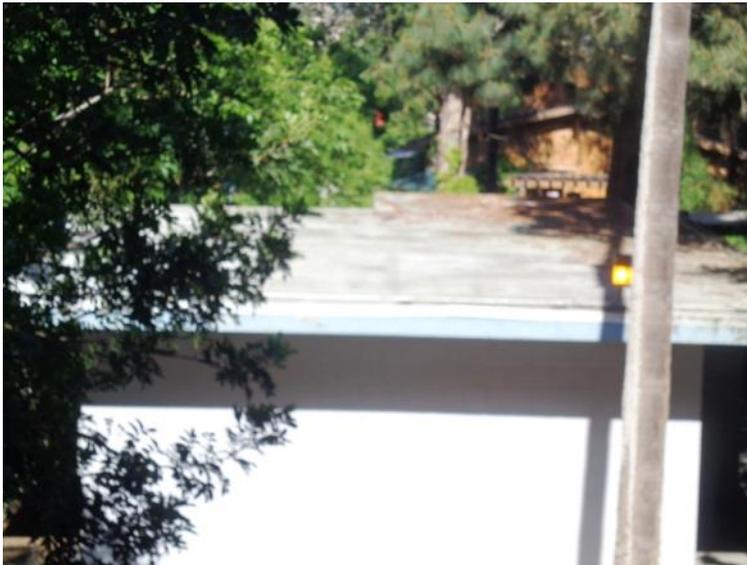
Photograph No. 8

The BUR areas appeared to be in fair overall condition. This type of roof covering has a typical EUL of 15 to 20-years and based on observed conditions and roof material ages we anticipate that the low-sloped roof would usually last beyond the study period. However, we have brought forward replacement of the roof covering so that the damaged joists can be replaced.

View of the low slope roof.

| Element No. | Building Element | Recommendation | Qty | Unit | Rate | Cost | Year | Priority Code |
|---|---|---|---|---|---|---|---|---|
| B3011 | Roof Finishes | Replace BUR roof covering | 681 | SF | \$15.00 | \$10,215 | 2016 | 3 |

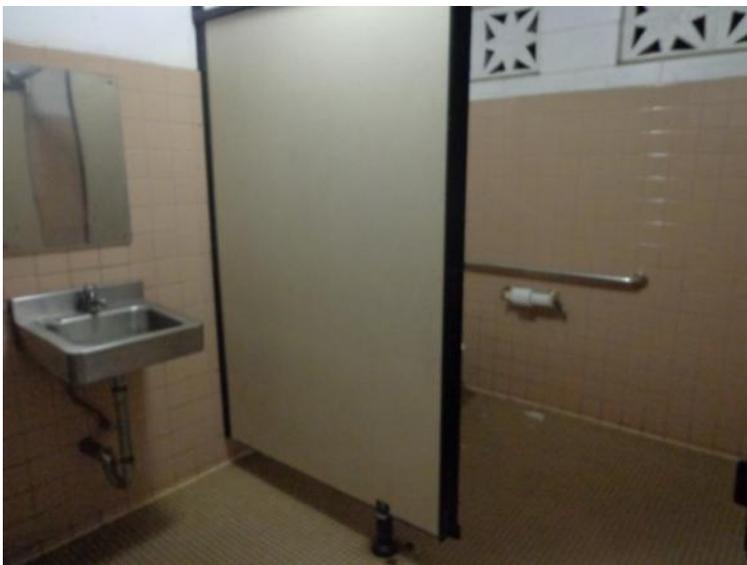
Photograph No. 9

The toilet partitions and doors all appeared to be in fair condition. There were no deficiencies found in relation to the wall structures. The partitions are suitable for the current use. There are ADA compliant stalls installed at each of the restrooms.

View of a toilet partition.

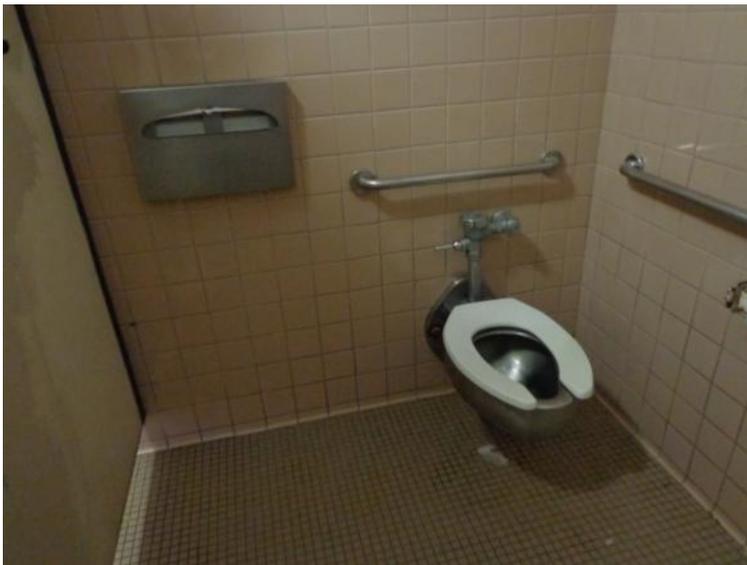
Photograph No. 11

The ceramic tile flooring appeared to be in fair condition throughout the building. The typical EUL for ceramic tile floor coverings is 30 years and therefore with an age of more than 48 years, late-term replacement is recommended. The concrete floors appeared to be in fair condition and should remain serviceable throughout the study period.

The building contained floor mounted stainless steel tank-less water closets with manual flush valves within the men's and women's restrooms (reference Photograph 11 in Appendix B).

The water closets and flush valves appeared to be in good condition. The water closets flushed properly and did not have damage. The water closets appear to be ADA compliant; however they are not low flow water saving compliant, and will remain serviceable beyond the study period.

View of a floor mounted water closet and ceramic tile flooring.

| Element No. | Building Element | Recommendation | Qty | Unit | Rate | Cost | Year | Priority Code |
|---|---|--|---|---|---|---|---|---|
| C3024 | Flooring | Replace ceramic tile floor covering | 190 | SF | \$18.00 | \$3,420 | 2020 | 3 |

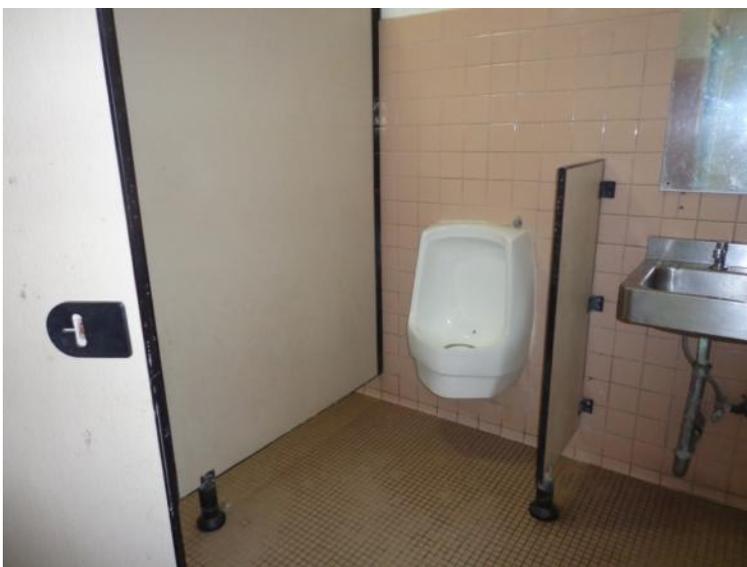
Photograph No. 12

The urinal appeared to be in good condition. The urinals operated properly and did not have any cracks in the china. The urinal appears to be ADA compliant; however they are not low flow water saving compliant, and will remain serviceable beyond the study period.

View of the waterless urinal.

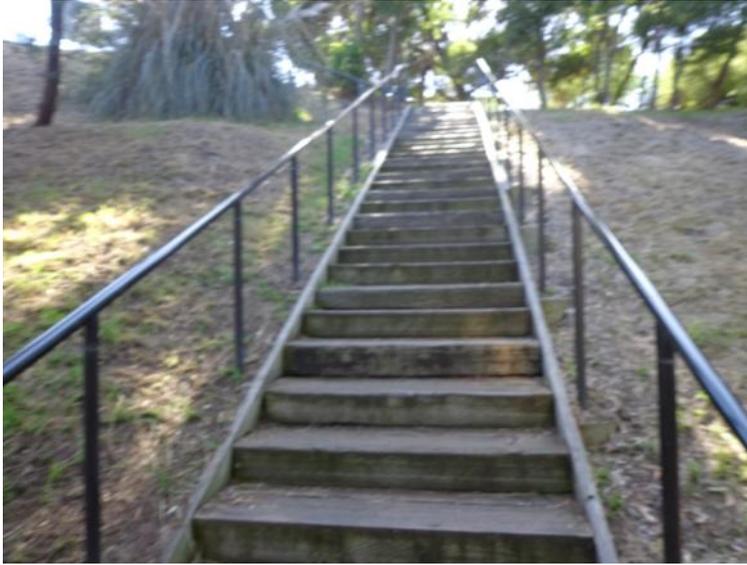
Photograph No. 16

View of a typical wood stairway and metal railing.

Replace wood stairwell
-

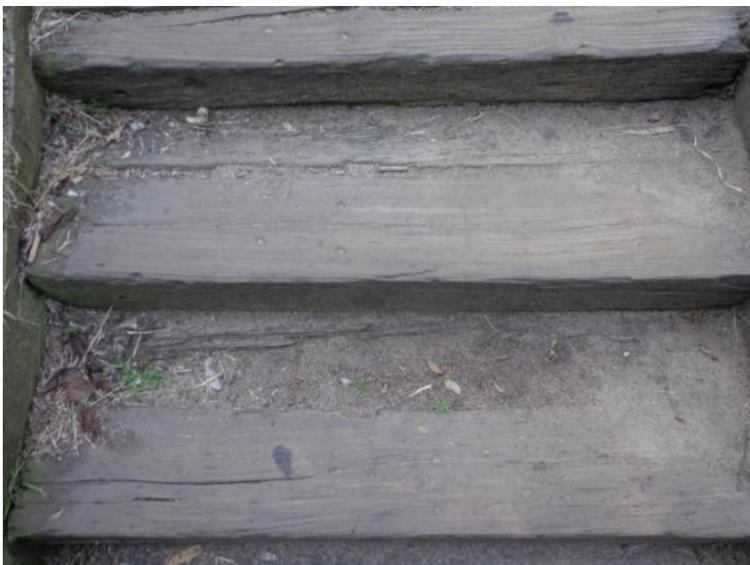
Photograph No. 24

View of the typical deterioration at the wood steps.

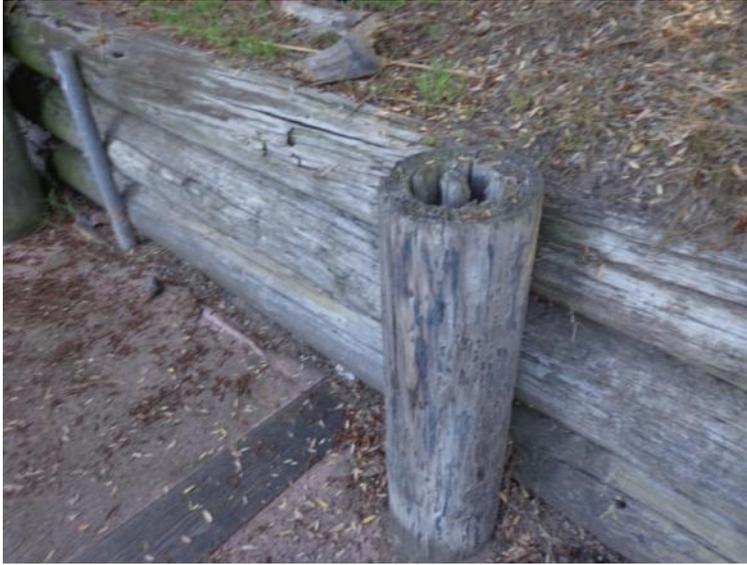
Photograph No. 25

View of the deterioration observed at the wood retaining walls.

Repair damaged wood retaining wall

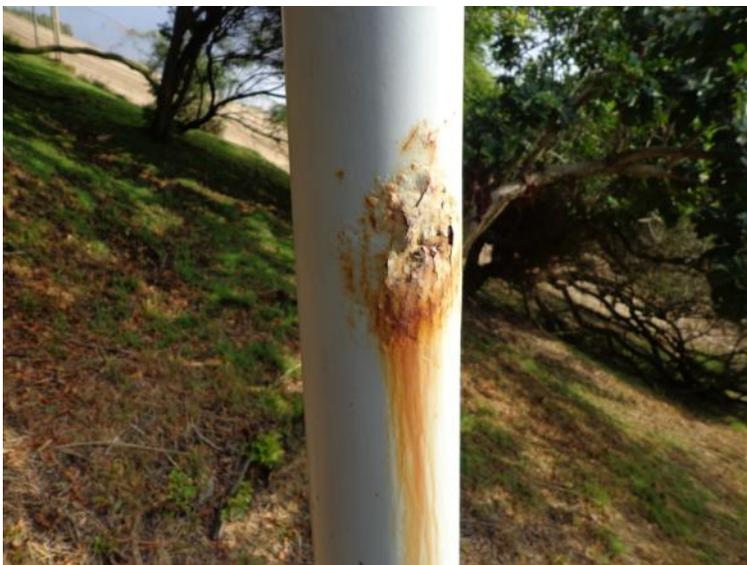
Photograph No. 27

View of typical rust at the pole mounted lights.
