Citywide  
Facility Condition Assessment

Report of  
Facility Condition Assessment

For  
City of Manhattan Beach  
Manhattan Village Soccer Field  
1300 Parkview Avenue, Manhattan Beach, CA

*September 4, 2013  
(Rev A)*

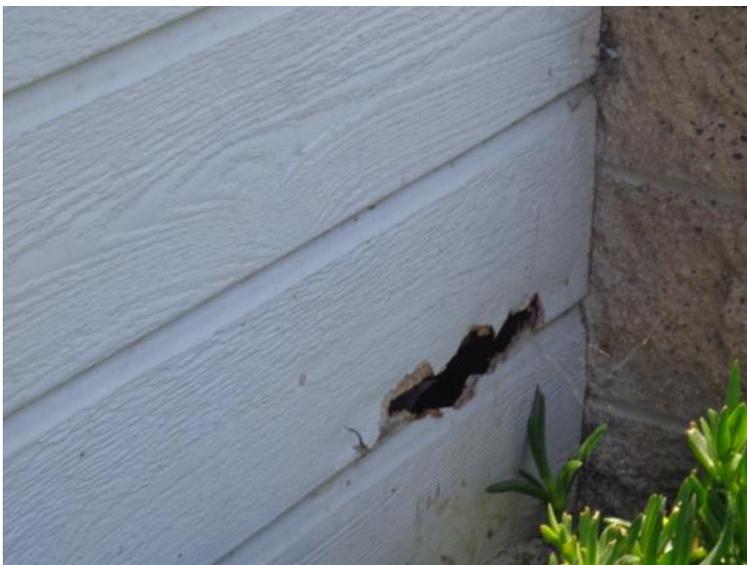
**Photograph No. 6**

The exterior wall systems at the building appeared to be in fair condition. However, we observed holes in the siding and overall deterioration to the painted siding and trim surfaces (reference Photograph 6 in Appendix B). The exterior painted surfaces appear to not have been recently painted and therefore based on the EUL of 4 years for exterior paint at this building, as well as current observed conditions, we recommend near-term repair of the siding and repainting near-term in the study period to maintain the appearance and protect the exterior walls.

View of the damage to the storage shed siding,

Element No.	Building Element	Recommendation	Qty	Unit	Rate	Cost	Year	Priority Code
B2011	Exterior Wall Construction	Repair exterior siding	25	SF	\$30.00	\$750	2013	3
B2011	Exterior Wall Construction	Repaint exterior wall surfaces, windows and doors	375	SF	\$3.25	\$1,219	2013	5
B2011	Exterior Wall Construction	Repaint exterior wall surfaces, windows and doors	375	SF	\$3.25	\$1,219	2017	5
B2011	Exterior Wall Construction	Repaint exterior wall surfaces, windows and doors	375	SF	\$3.25	\$1,219	2021	5
Total Anticipated Expenditure for B Shell						\$4,406

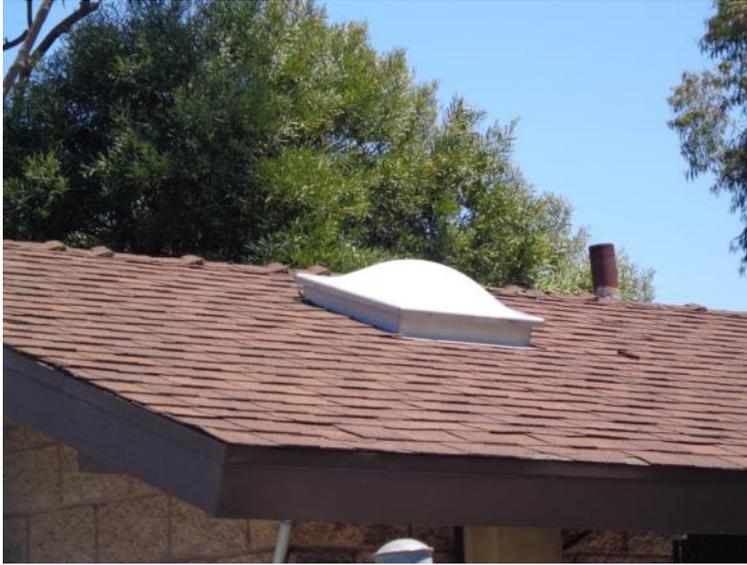
**Photograph No. 7**

The steep-sloped roof areas at the Restrooms and Storage Shed contained architectural style asphalt shingles with mineral surface granules (reference Photographs 7 and 8 in Appendix B). We understand that roofs were installed in circa 1991.

The pitched roof area appeared to be in fair to good overall condition. These types of roof covering have a typical EUL of 20 to 25-years and based on observed conditions and roof material ages we anticipate that the roof will require mid-term replacement. We are unaware or could not visually see any possible areas of water ingress.

The skylights appeared to be in fair condition and should remain serviceable throughout the study period. We recommend that they are inspected when the roofing system is replaced.

View of pitched roof and a skylight at the restroom..

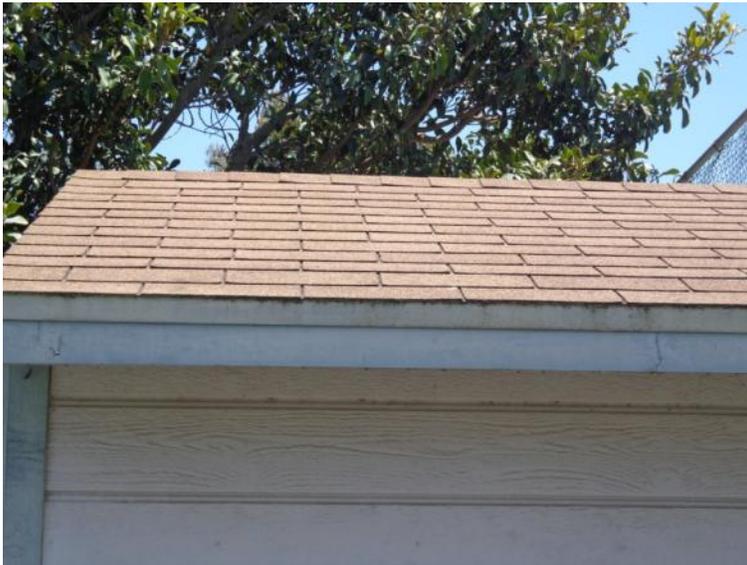
**Photograph No. 8**

The pitched roof area appeared to be in fair to good overall condition. These types of roof covering have a typical EUL of 20 to 25-years and based on observed conditions and roof material ages we anticipate that the roof will require mid-term replacement. However, the cost for this work will fall below the threshold of \$500 and therefore it has not been included within this cost study.

View of the storage shed roof.

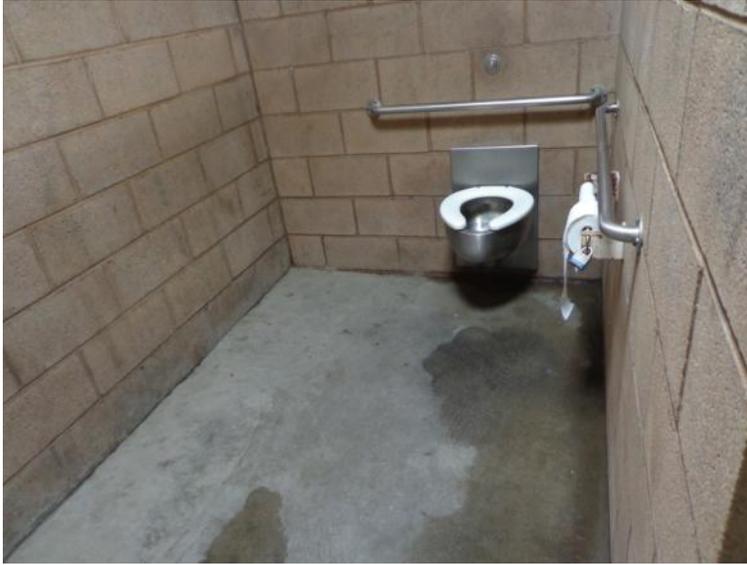
**Photograph No. 10**

The building contained floor mounted stainless steel tank-less water closets with manual flush valves within the men's and women's restrooms (reference Photograph 10 in Appendix B).

View of a water closet.

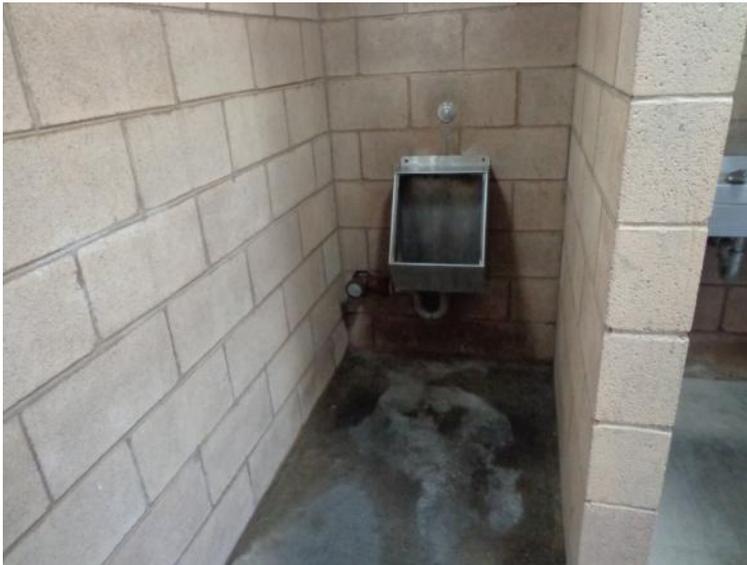
**Photograph No. 11**

The building contained stainless steel urinals with manual flush valves within the men's restroom (reference Photograph 11 in Appendix B).

View of a men's room urinal.

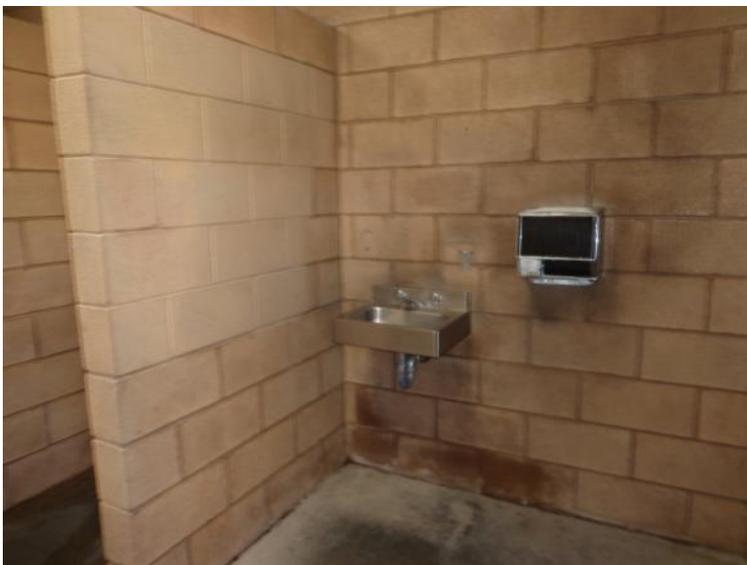
**Photograph No. 12**

The building contained wall mounted stainless steel lavatories (reference Photograph 12 in Appendix B). The lavatories generally consisted of single-handle lever type, non-metering faucets. Water is supplied via copper pipe work and drained through cast iron pipe work and fittings.

View of a typical lavatory.

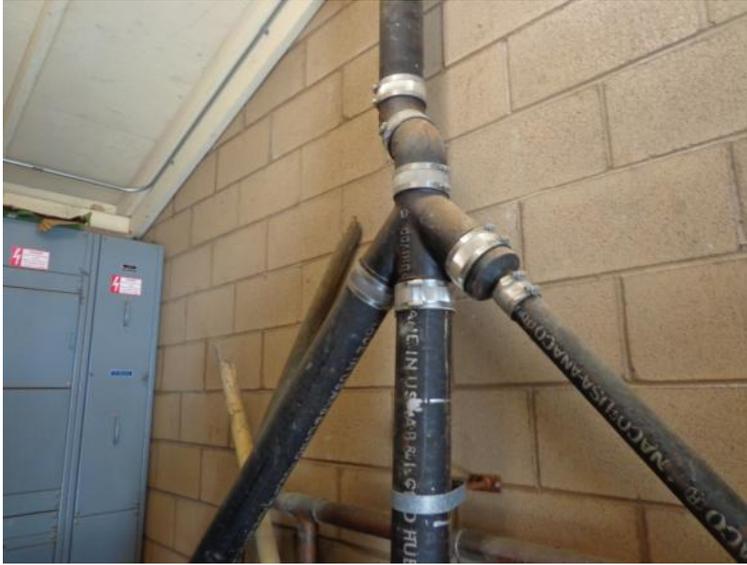
Photograph No. 13

Waste piping observed at the building consisted of 2" to 3" diameter cast iron (reference Photograph 13 in Appendix B).

View of the sanitary waste piping.
