Citywide  
Facility Condition Assessment

Report of  
Facility Condition Assessment

For  
City of Manhattan Beach  
Marine Avenue Sports Complex  
1600 Marine Avenue, Manhattan Beach, CA

*September 4, 2013  
(Rev A)*

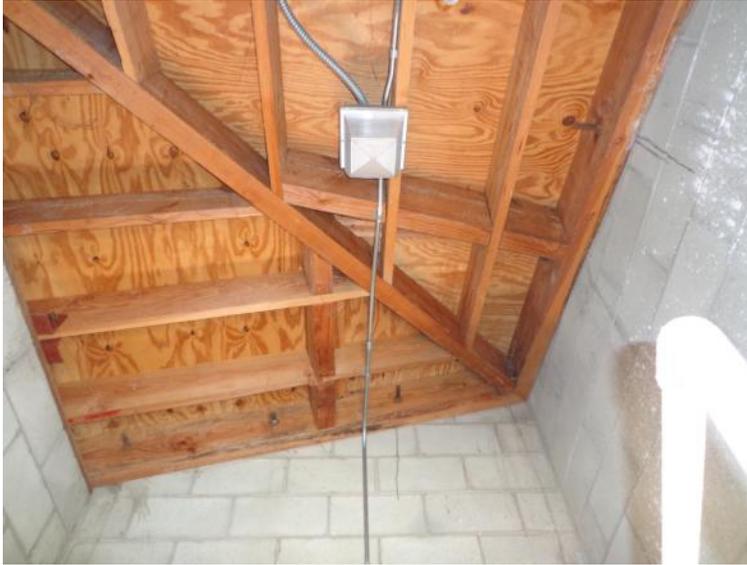
**Photograph No. 1**

View of the storage building roof framing.

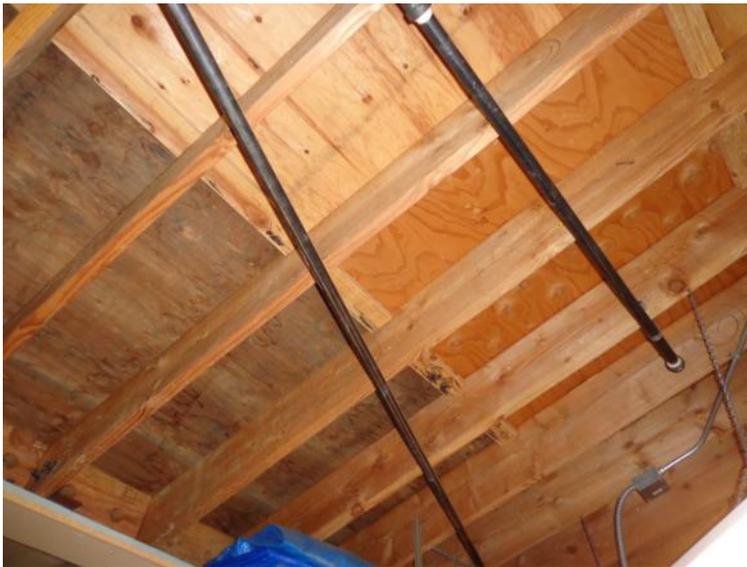
**Photograph No. 2**

The unfinished roof framing and sheathing appeared to be in fair to good condition. We anticipate that they will not need repairs during the cost study period.

View of the Score Booth roof framing.

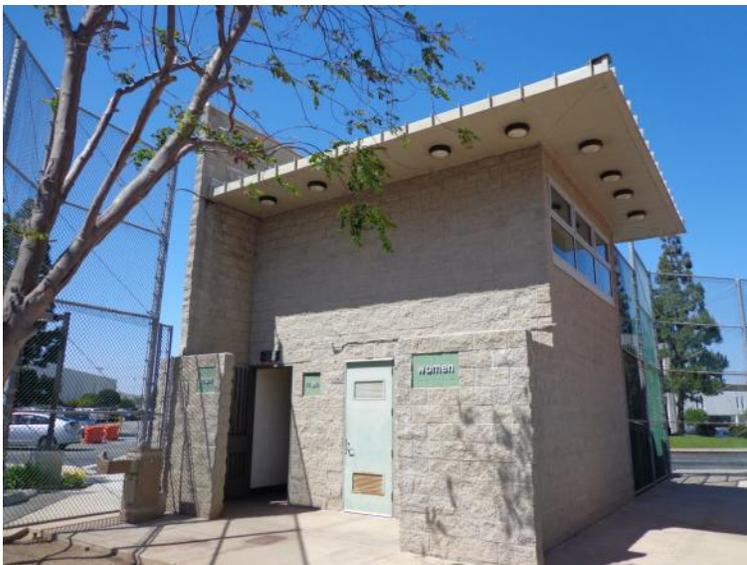
**Photograph No. 3**

The exterior wall systems at all of the buildings appeared to be in good condition with generally no major signs of deterioration, water ingress or general failure noted. The exterior painted surfaces do not appear to have been painted recently painted and therefore based on the EUL of 4 years for these buildings exterior paint, as well as current observed conditions, re-painting will be necessary near-term in the study period to maintain the appearance and protect the exterior walls, doors, etc.

View of the typical exterior walls.

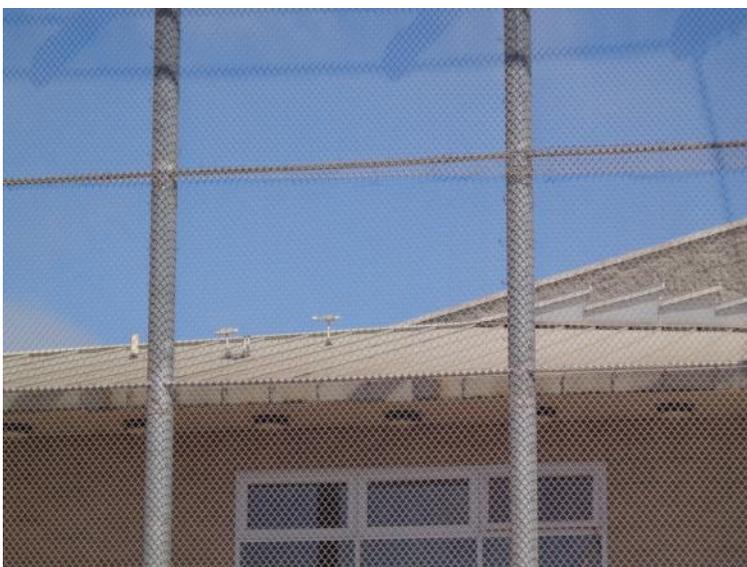
**Photograph No. 6**

The pitch roof areas appeared to be in fair to good overall condition. These types of roof covering have a typical EUL of 30-years and based on observed conditions and roof material ages we anticipate that the roofs at all buildings will not require replacement and will remain serviceable beyond the study period. We are unaware or could not visually see any possible areas of water ingress.

View of the metal roofing system.

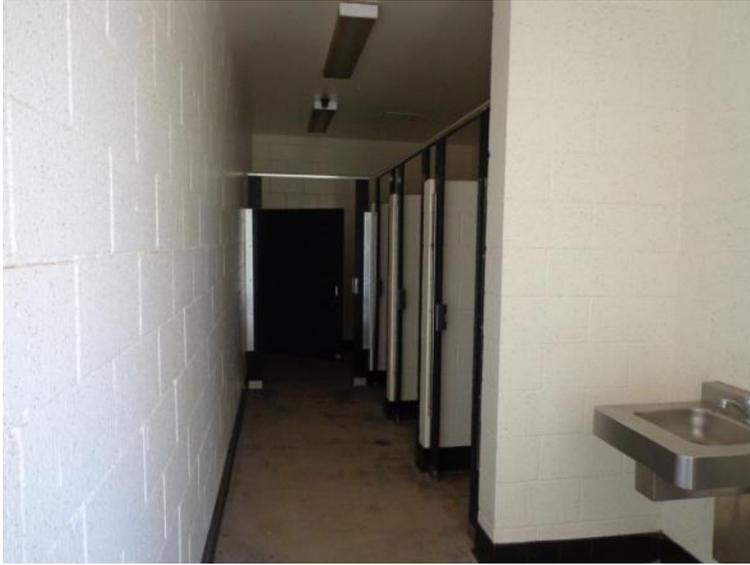
**Photograph No. 7**

The interior fixed partitions all appeared to be in fair to good condition. There were no deficiencies found in relation to the wall structures. The fixed partitions are suitable for the current use.

View of interior partitions.

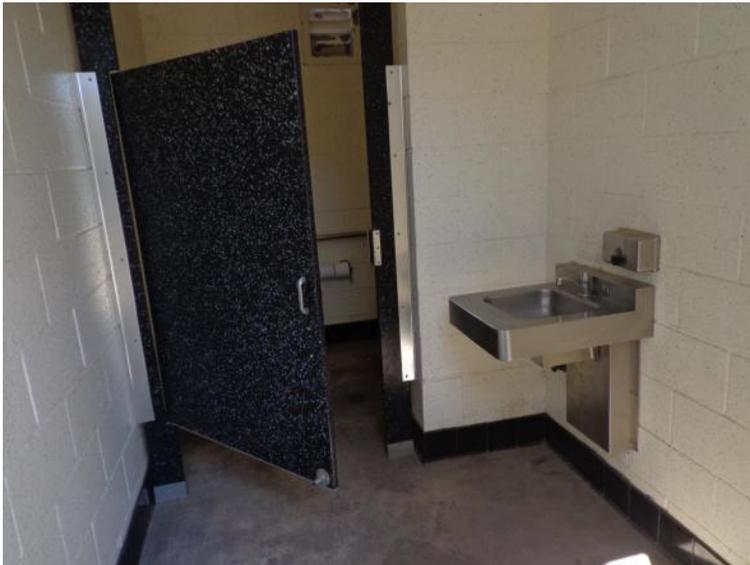
**Photograph No. 8**

The toilet partitions all appeared to be in fair to good condition. There were no deficiencies found in relation to the partition structures. The toilet partitions are suitable for the current use.

View of a typical toilet partition.

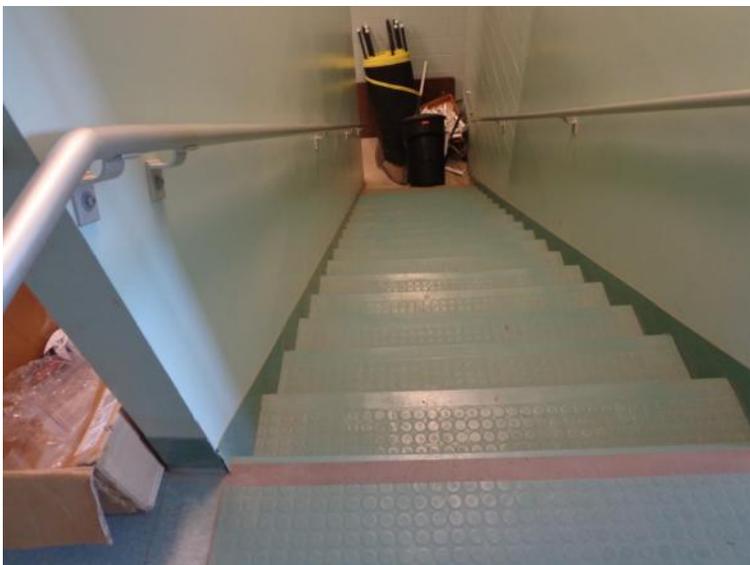
**Photograph No. 9**

The stairway appeared to be in a good condition with no issues reported or identified. We do not anticipate any actions in association with the stairway during the study period.

View of the interior stairway.
