CAPITAL IMPROVEMENT AND  
PROTECTION PROGRAM

CITY OF MANHATTAN  
BEACH PARKING  
STRUCTURES  
LOTS 2, 3 & 4

Prepared for:  
CITY OF MANHATTAN BEACH  
PROJECT NO. 37-8377.00

SEPTEMBER 2013

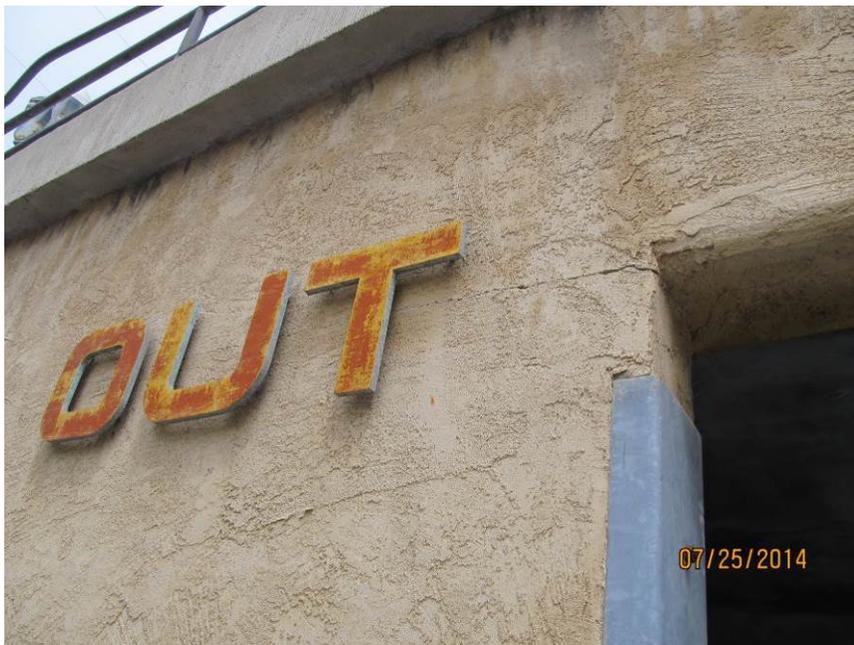
Photo 4

Faded signage and surrounding cracks in stucco outside of lower level entry.

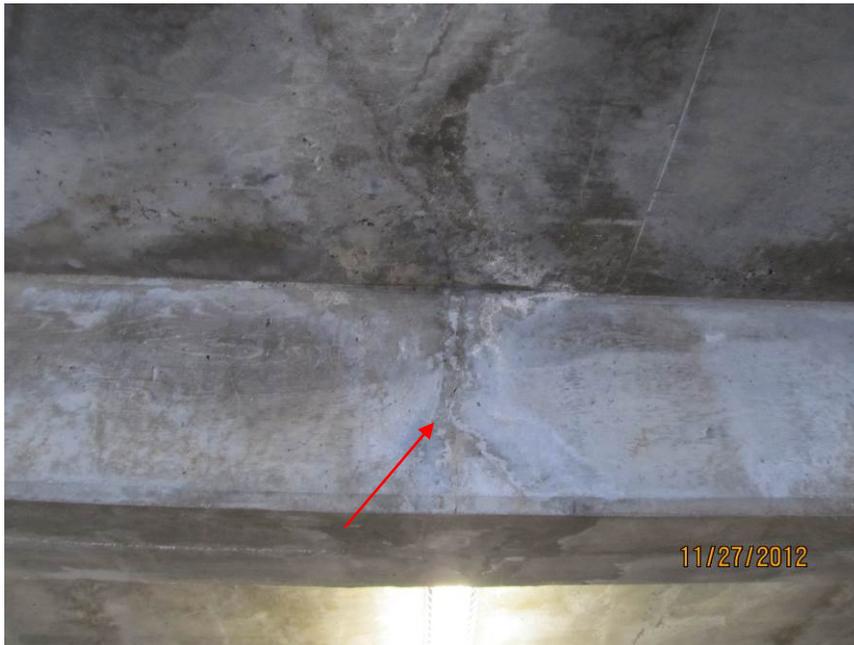
Photo 11

Cracking and efflorescence in the ceiling and beam.

- Inject epoxy in large cracks identified in ceiling, beams and walls to prevent deterioration from infiltrating water and maintain structural integrity.

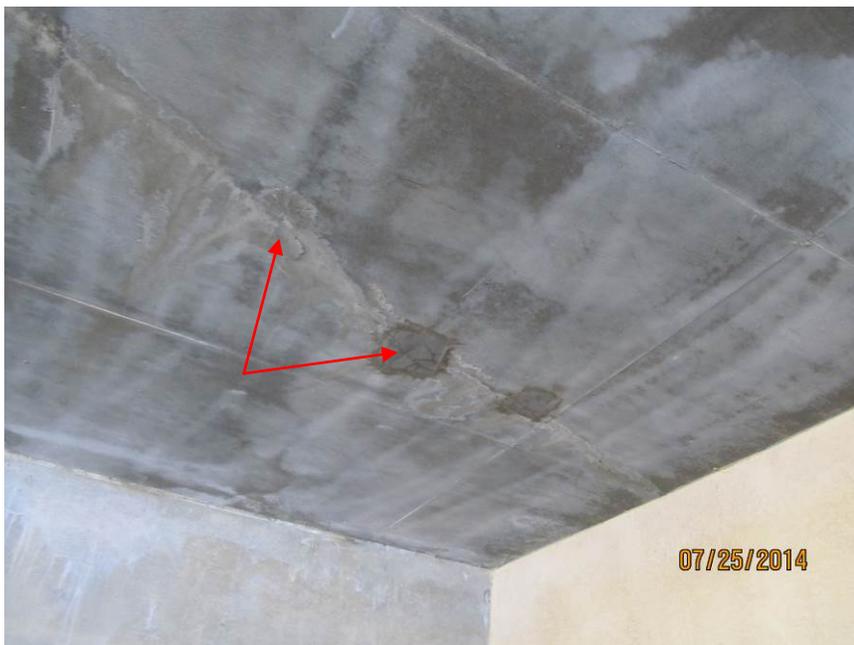
Photo 12

Cracking and previous patchwork seen in the ceiling.

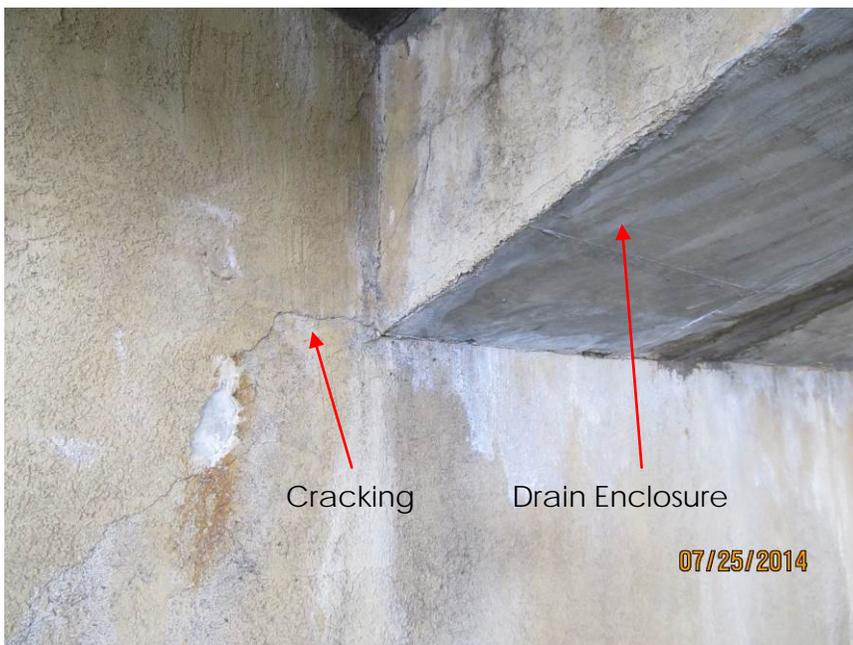
Photo 14

Cracking seen extending from concrete drain enclosure. Signs of active leakage can also be seen.

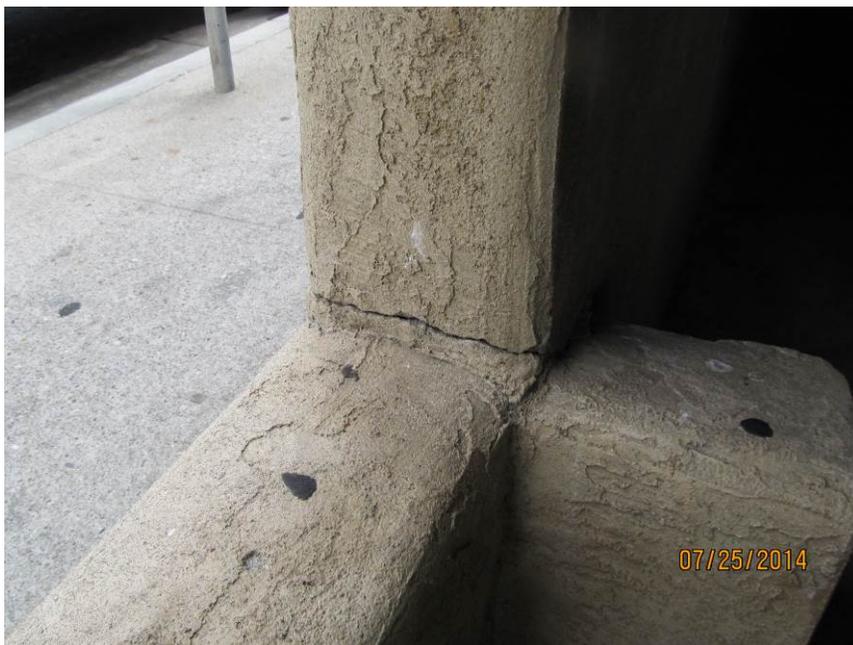
Photo 16

Cracking seen in the skim coat near a cold joint.

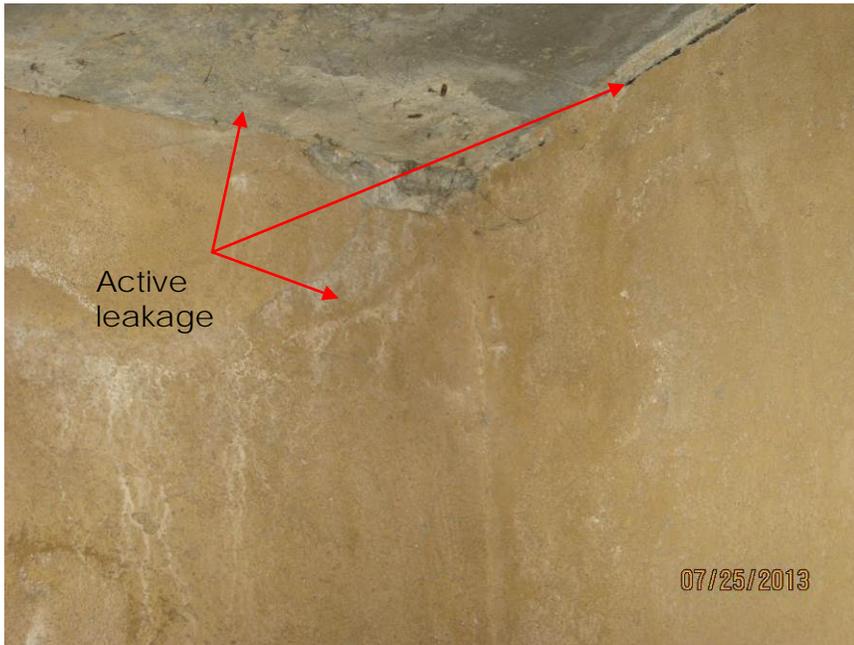
Photo 21

Active leakage seen at the joint between the walls and ceiling.

- Inject chemical grout at the joint between the walls and slab to reduce the possibility of water infiltration through the joint.
- Repair the large spall identified in the top tread of the cast-in-place concrete stairs.

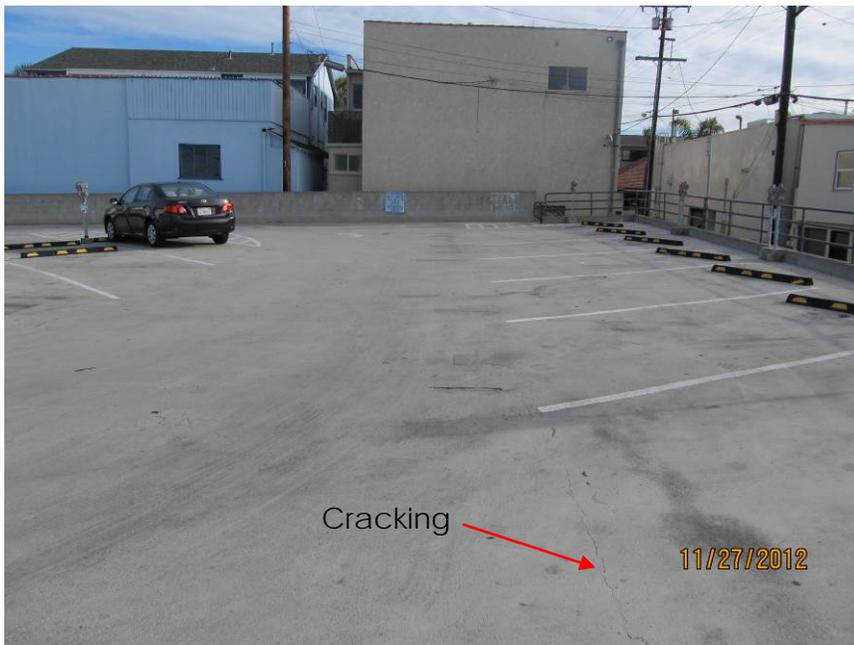
Photo 22

Typical drive aisle on the upper level. Cracking can be seen in the floor.

- Rout and seal typical floor cracks and install cove sealants at cold joints to prevent ingress of water and other environmental contaminants.
- Apply a new urethane traffic topping on the floor of the upper level.

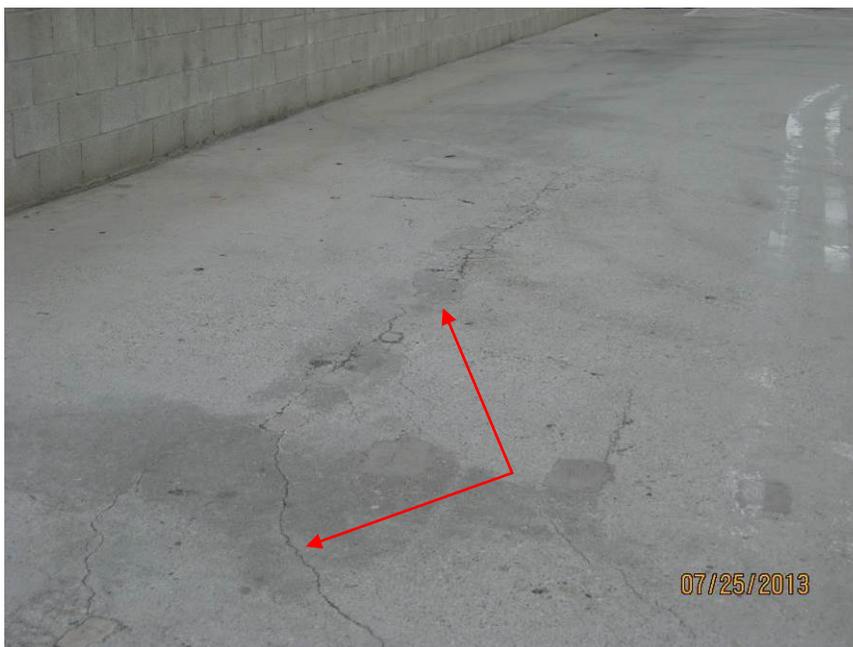
Photo 24

Large cracks seen in the elevated deck.

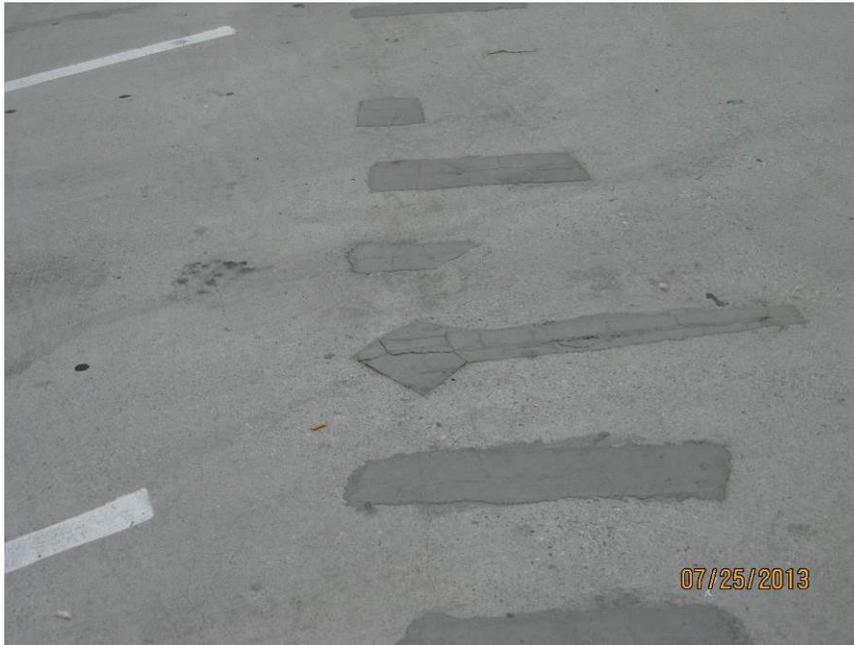
Photo 25

Typical pattern of prior spall patches over once exposed PT tendons.

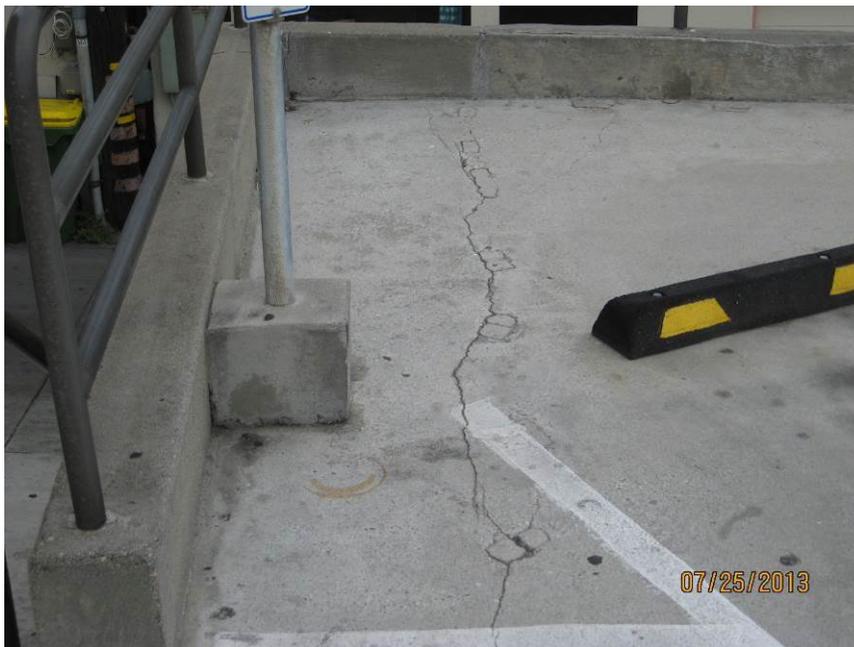
Photo 26

Large crack and patches likely from previous seismic retrofit work in upper level.

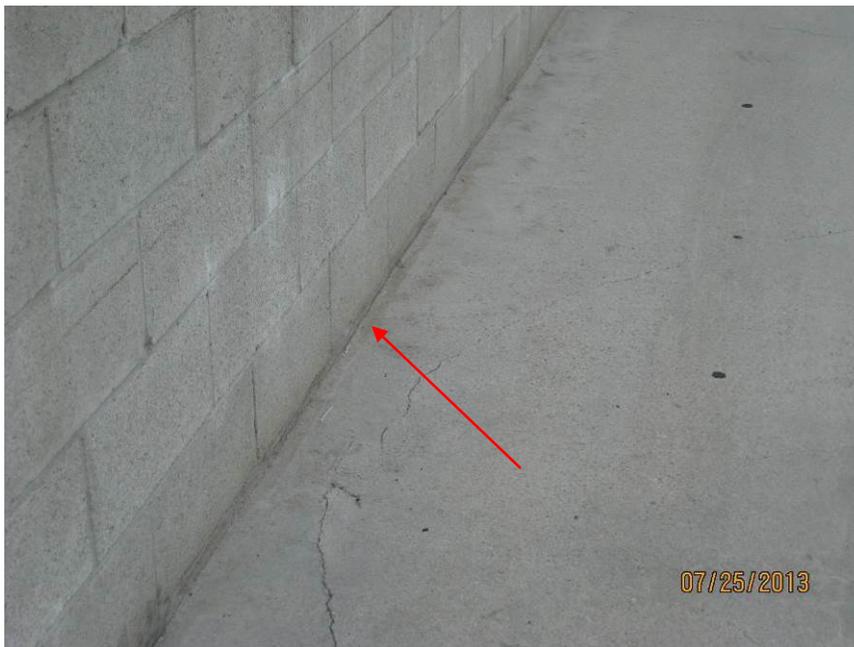
Photo 28

Unsealed cove joint.

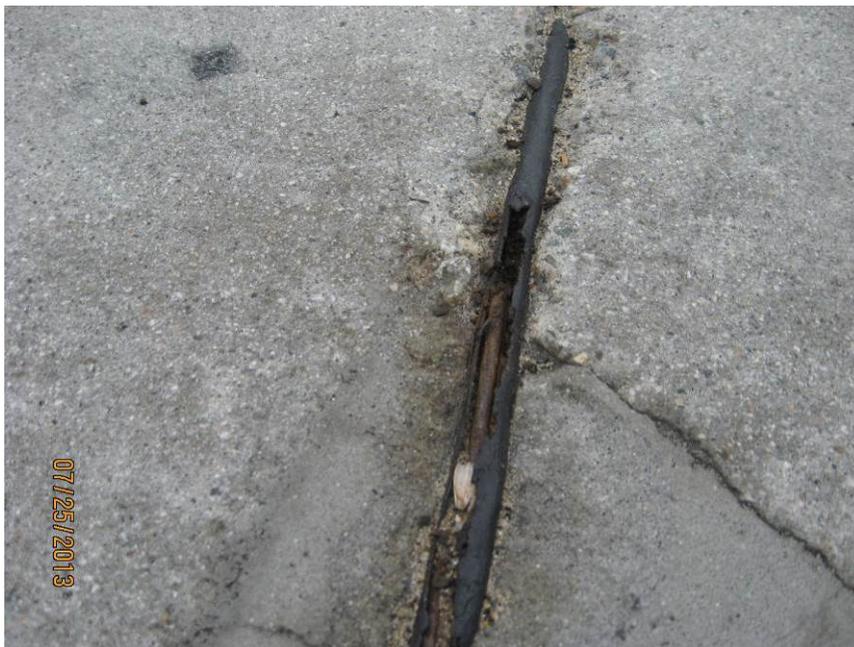
Photo 30

Close-up of exposed PT strand showing signs of corrosion.

- Repair concrete spalls, delaminations and failed patchwork identified on the floor and ceilings of the supported slab and slab soffit.
- Replace de-stressed PT tendons that have been exposed on top of the upper level. Functional PT tendons that are uncovered during the partial or full-depth concrete repair work should be protected with new sheathing to mitigate deterioration.

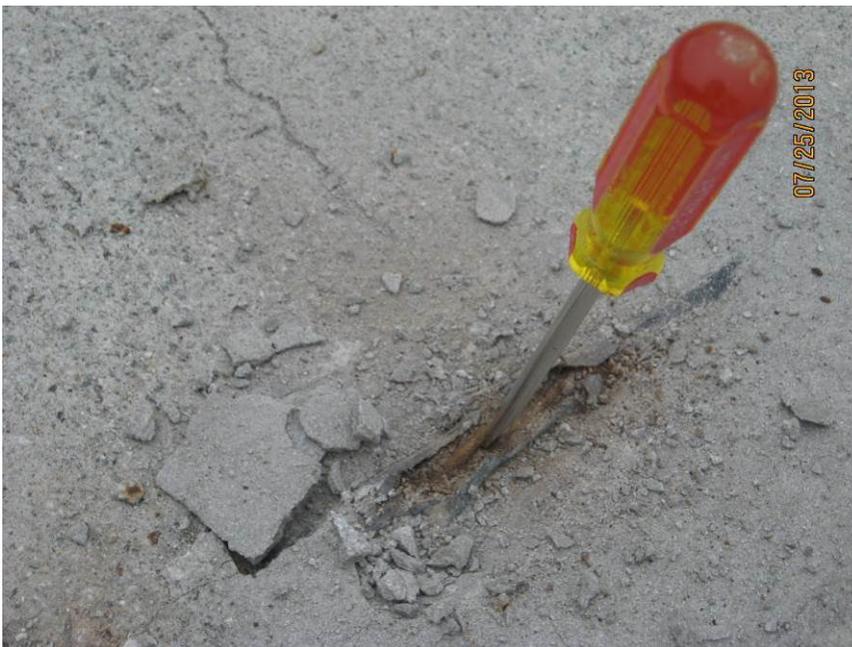
Photo 32

The "screwdriver method" was utilized to determine that the PT tendon has been de-stressed.

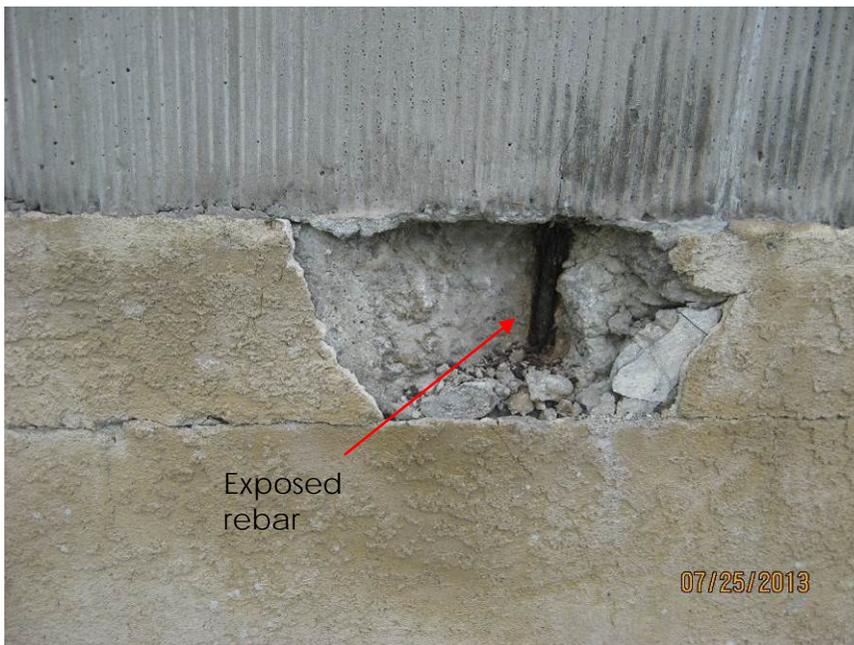
Photo 34

Concrete spall on an exterior wall, exposing underlying reinforcement.

- Repair spalls in the concrete walls and repair damaged stucco where necessary.
- Repair concrete as necessary in conjunction with routine maintenance performed in 2019 and 2023.

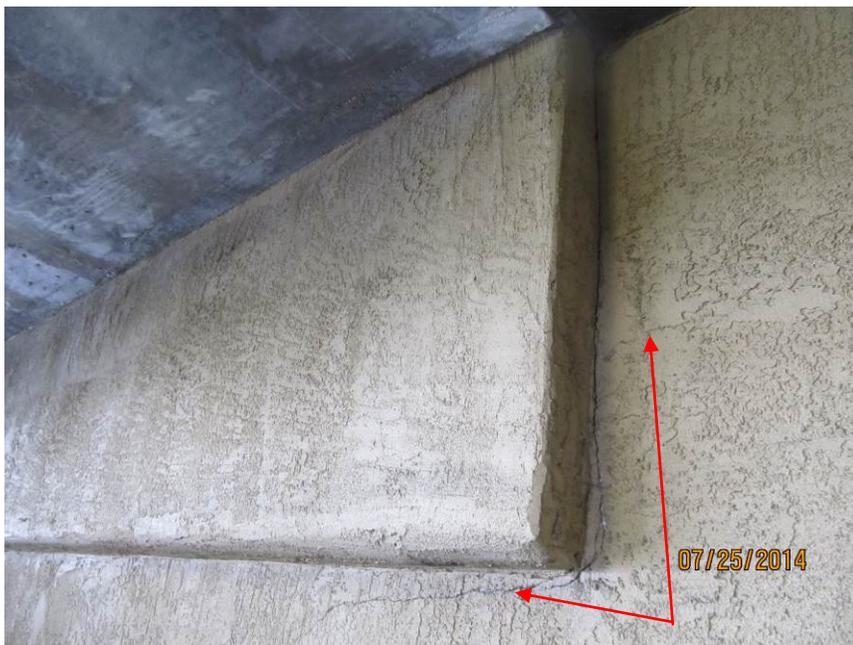
Photo 36

Cracking seen in a wall around a beam.

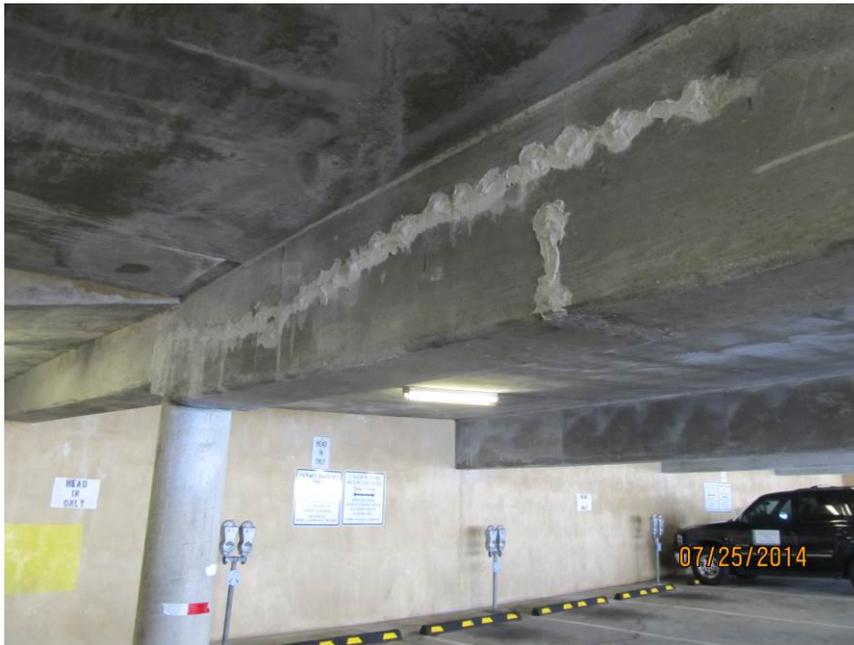
Photo 37

Previously repaired beam crack using epoxy injection.

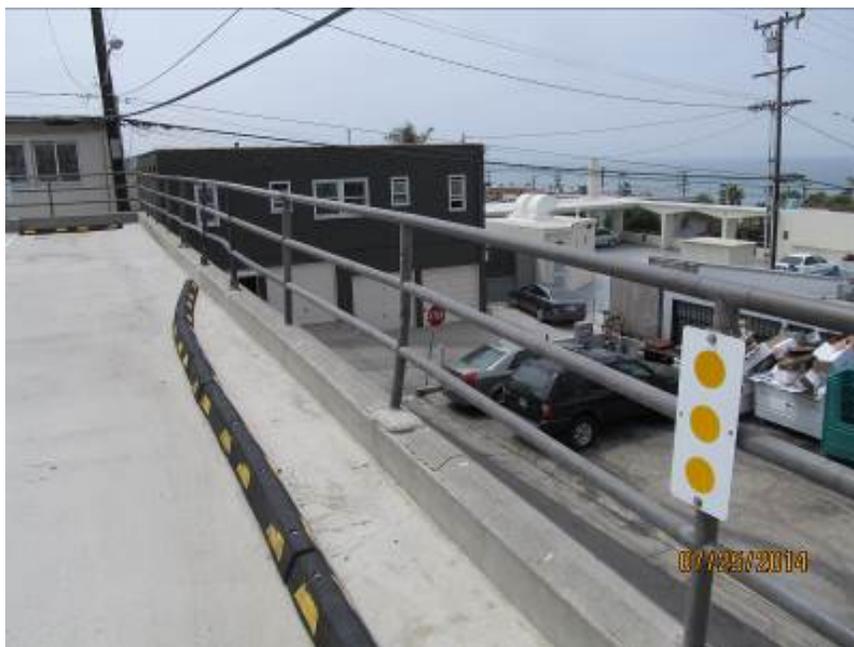
Photo 38

The existing vehicular barriers in this structure do not appear to meet current code requirements for maximum spacing and load resistance. This could pose a potential hazard to the users of this structure. While the existing barriers may be grandfathered in under the current code, we recommend the City take a proactive approach and install a new vehicular barrier system that would replace the existing system and meet current code.

Typical barrier rail on the perimeter of the upper level.

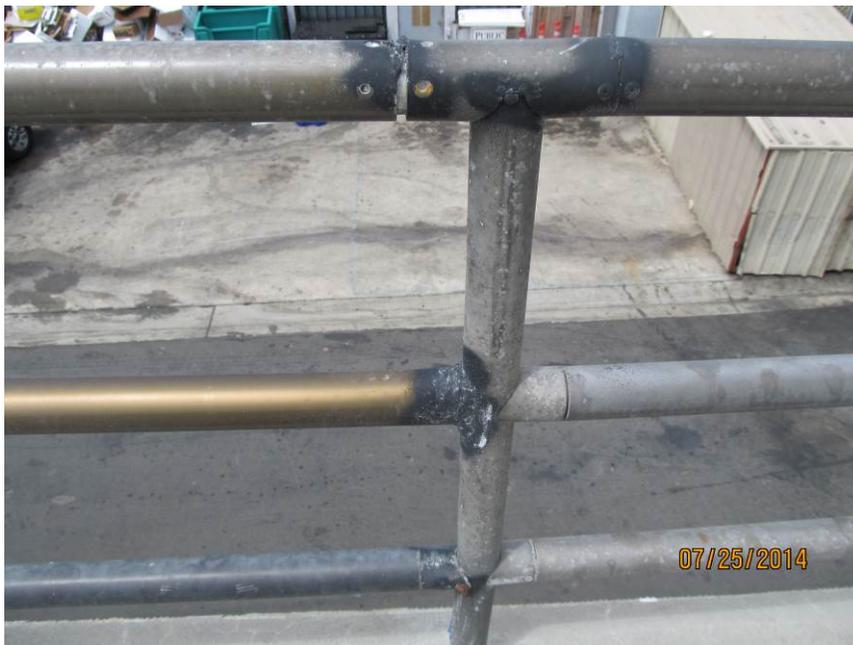
Photo 42

Previous repair work on barrier railing showing signs of deterioration.

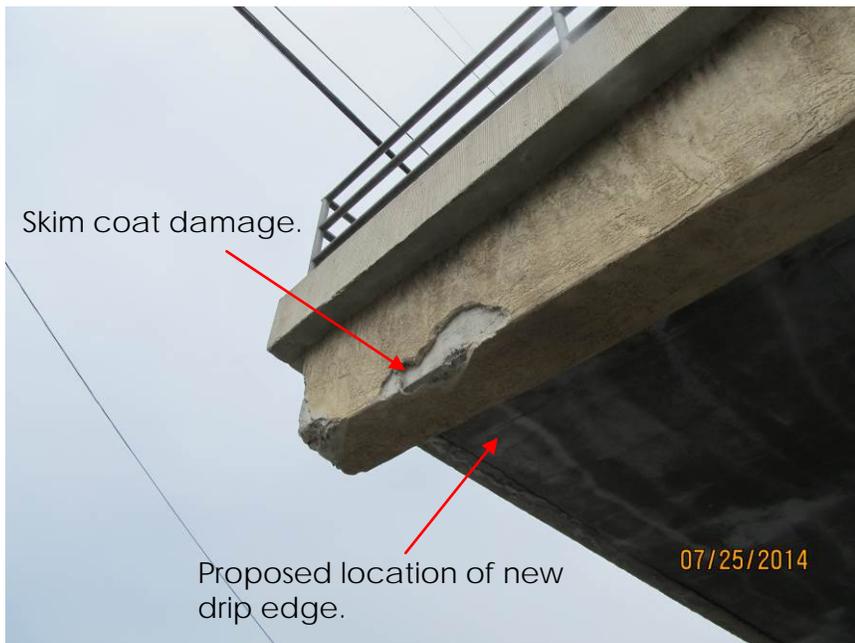
Photo 46

Damaged skim coat, perhaps due to vehicle impact.

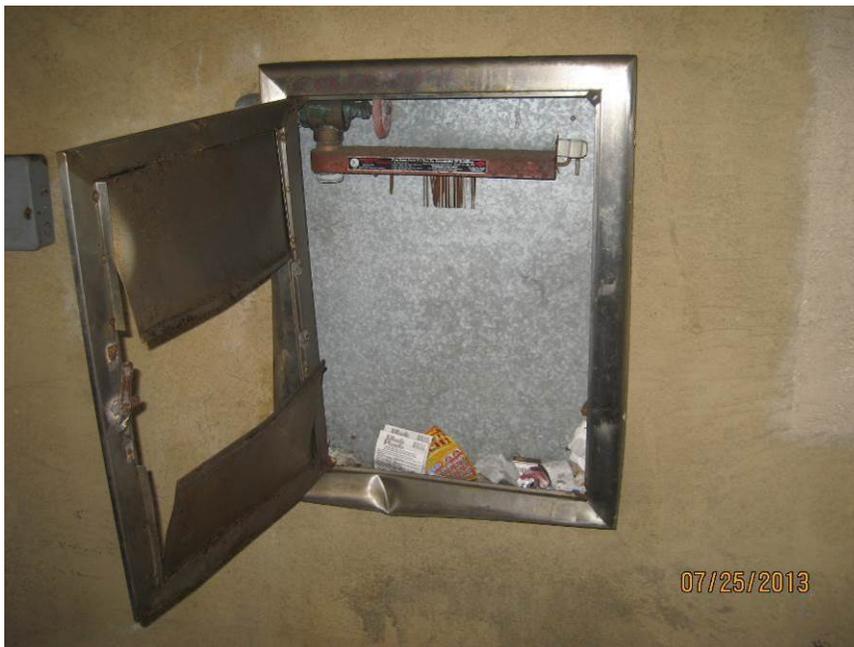
Photo 48

Damaged fire hose cabinet with missing fire hose and non-functioning standpipe.

- Repair identified non-working light fixtures.
- Clean the existing floor drain.
- Repair identified cracking in the masonry wall.
- Install a concrete cap along the top of the masonry wall on the east side of the structure to prevent water from collecting.
- Repair the stucco skim coat at de-bonded areas.
- Clean staining from walls and repaint to improve the aesthetics of the facility.
- Repaint traffic markings to eliminate conflicts that exist with old striping.
- Replace existing signage at the south entry into the lower level.
- Remove unused and non-functional fire hose cabinet, as it is not required by code.

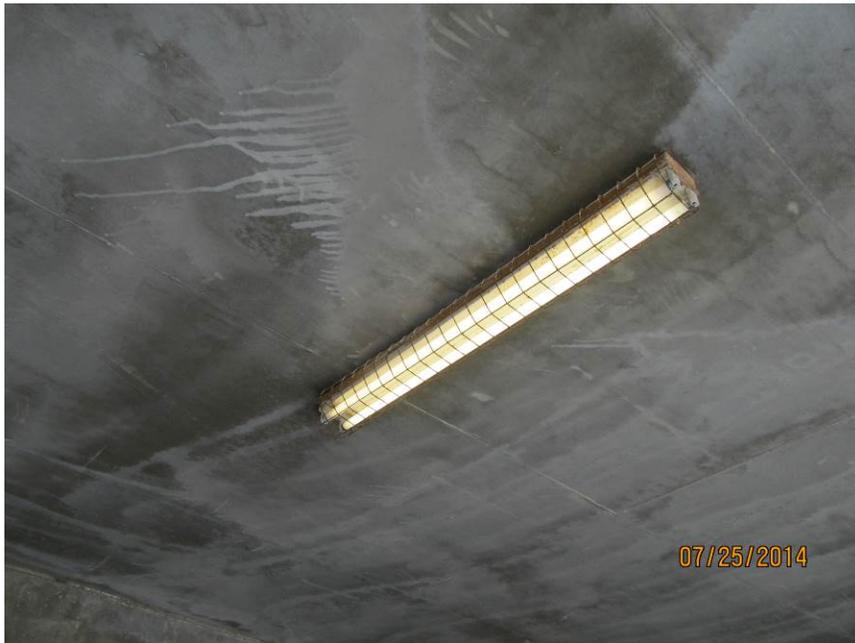
Photo 54

Lighting in the parking structure is provided by fluorescent T5 light fixtures, with embedded conduit. Light level measurements were not part of the scope of this project. A number of light bulbs at select locations were not functional. Corrosion damage was noted on the lighting fixtures at select locations.

A typical T5 florescent light fixture with a metal cage cover; many fixtures such as this one were showing signs of corrosion.

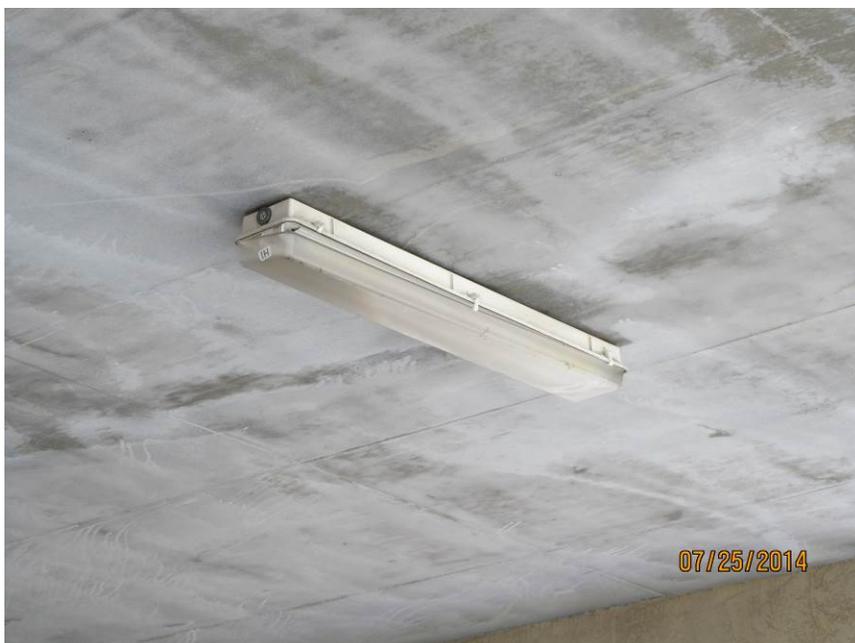
Photo 55

A typical florescent light fixture with an acrylic lens; many fixtures such as this one were showing signs of corrosion.

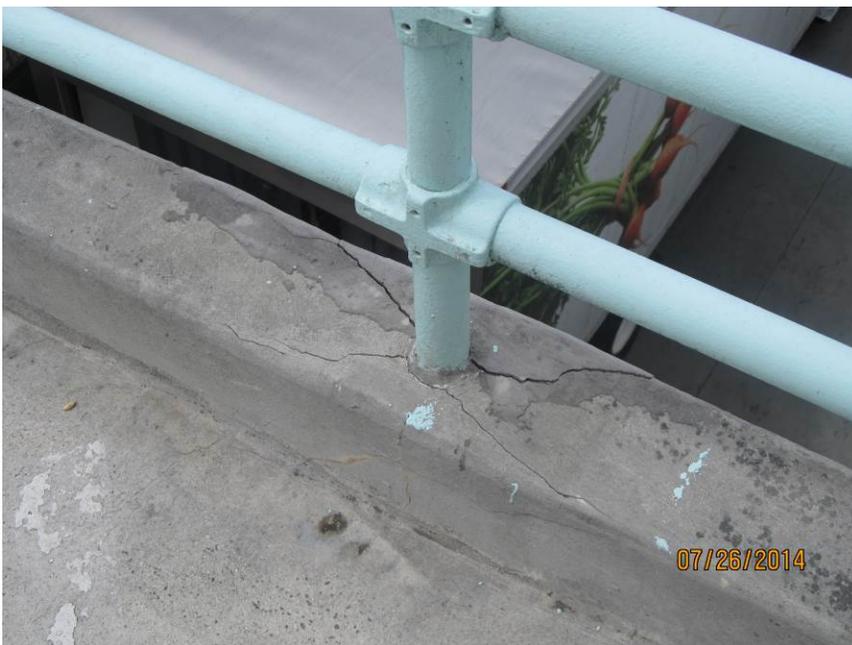
Photo 16

Typical spalled concrete at the anchor of a barrier rail.

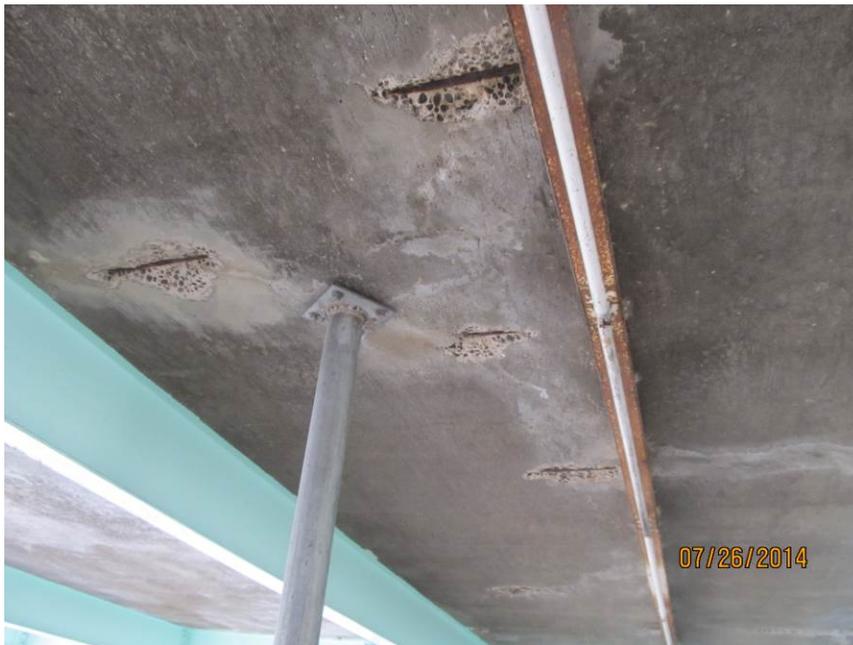
Photo 19

Typical spalling with exposed reinforcement seen in the ceiling. A corroded light fixture can also be seen.

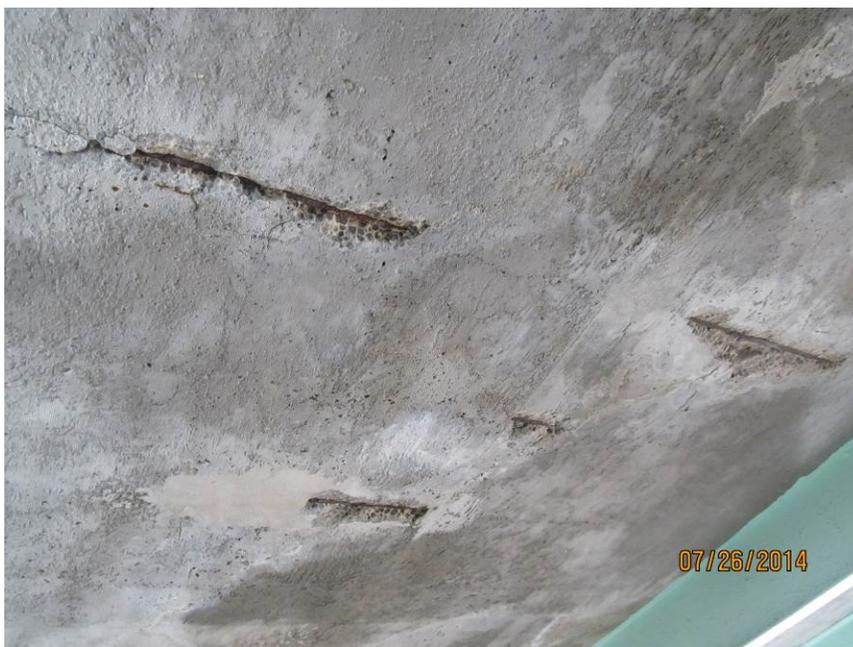
Photo 20

Typical spalling with exposed reinforcement seen in the ceiling.

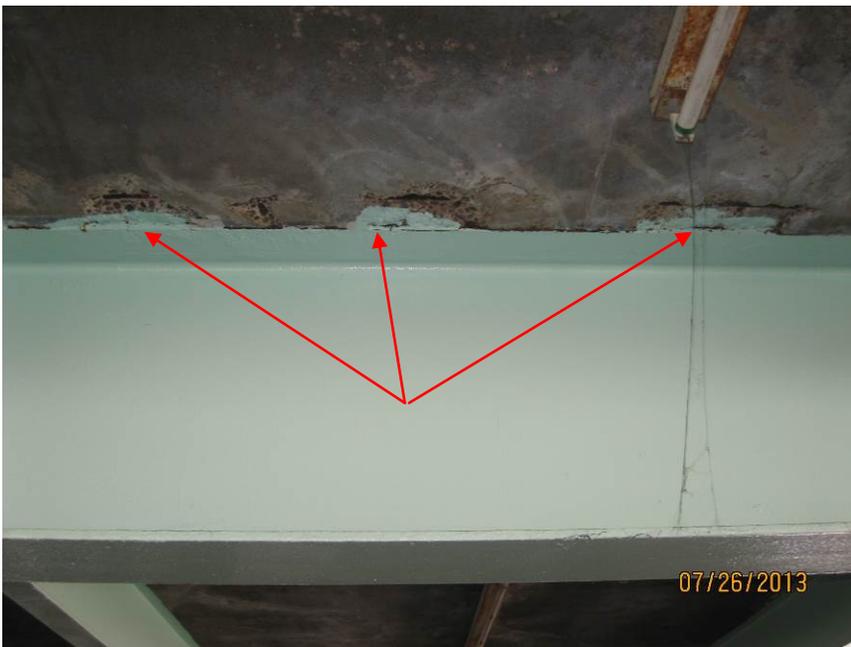
Photo 26

Delaminated and spalled concrete seen initiating from the interface between the slab and the top of beam, particularly at the location of shear studs.

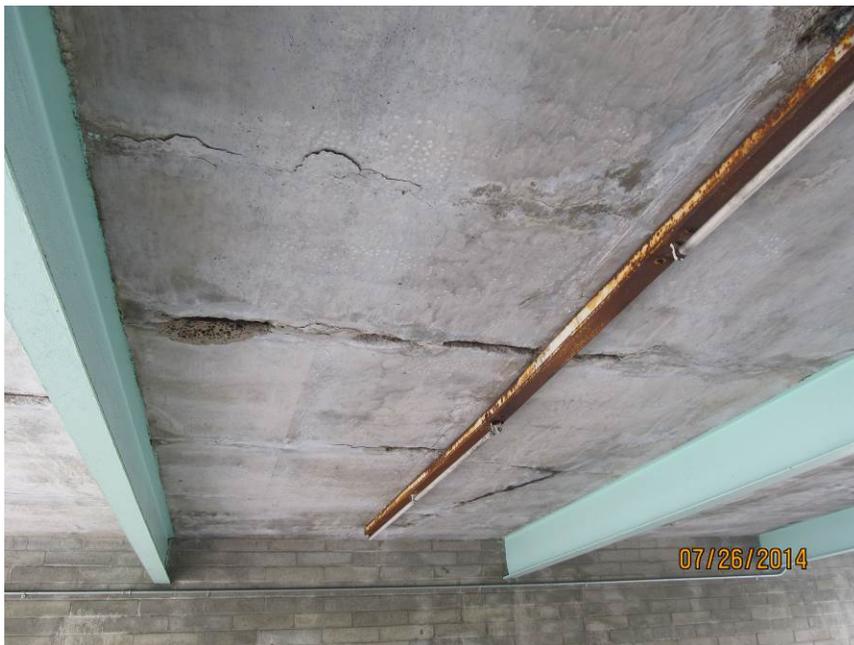
Photo 28

Typical spalling and delaminated concrete in the ceiling. A missing bulb in a nearby light fixture can also be seen.

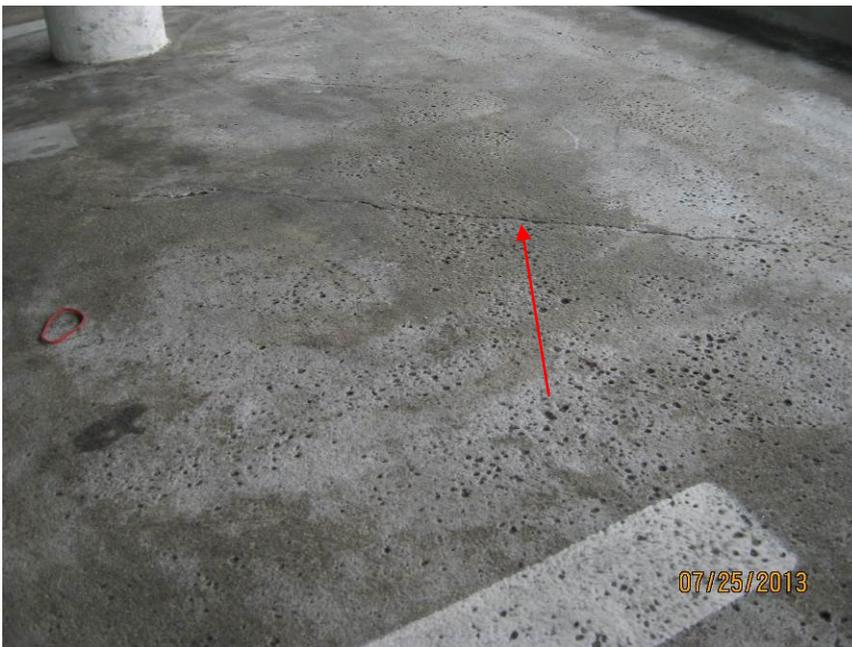
Photo 30

Typical floor crack on second level.

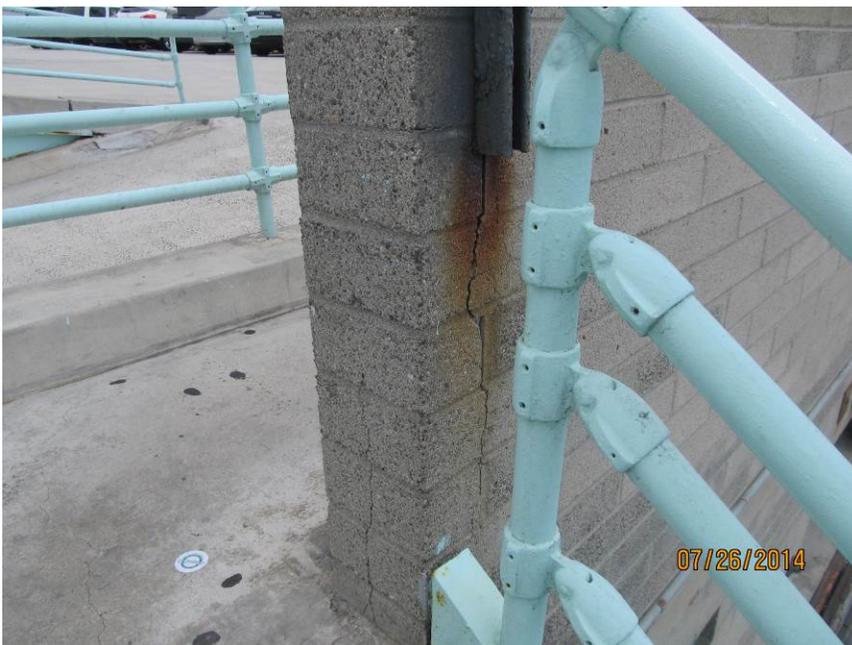
Photo 32

Large crack in a masonry shear wall on the west side of the structure.

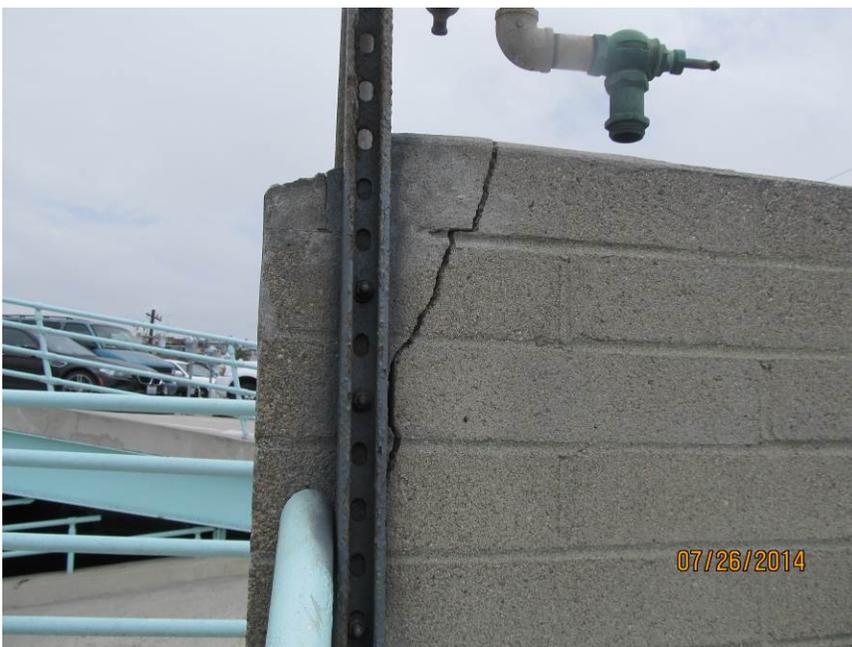
Photo 34

Large crack in a masonry shear wall on the west side of the structure.

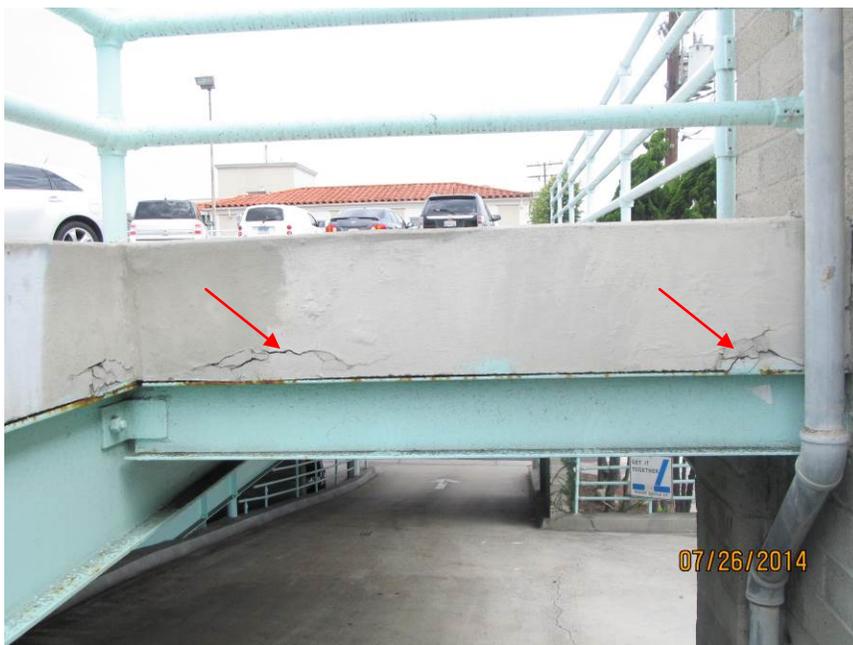
Photo 40

Spalls in curb at shear stud locations.

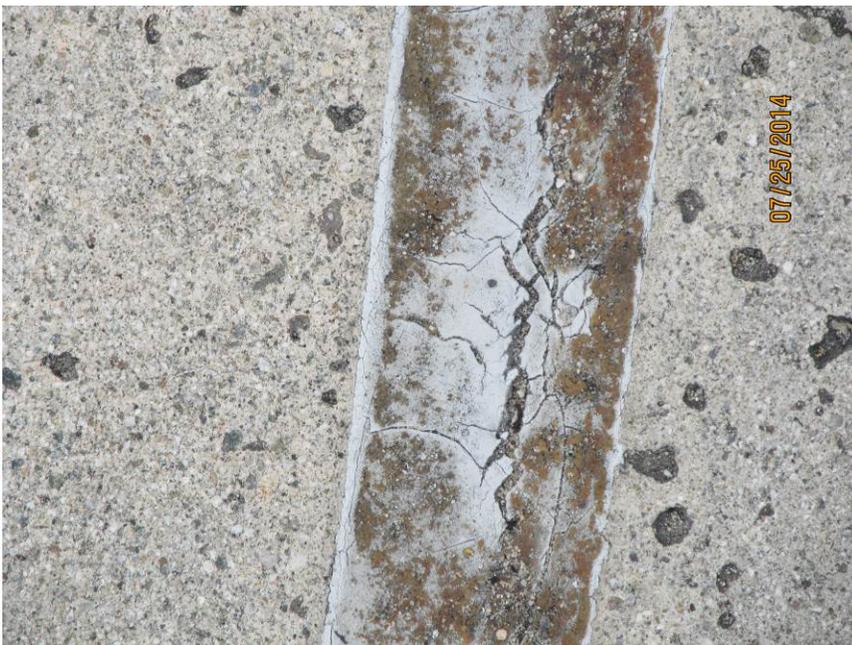
Photo 46

Close up of the deteriorated control joint sealant.

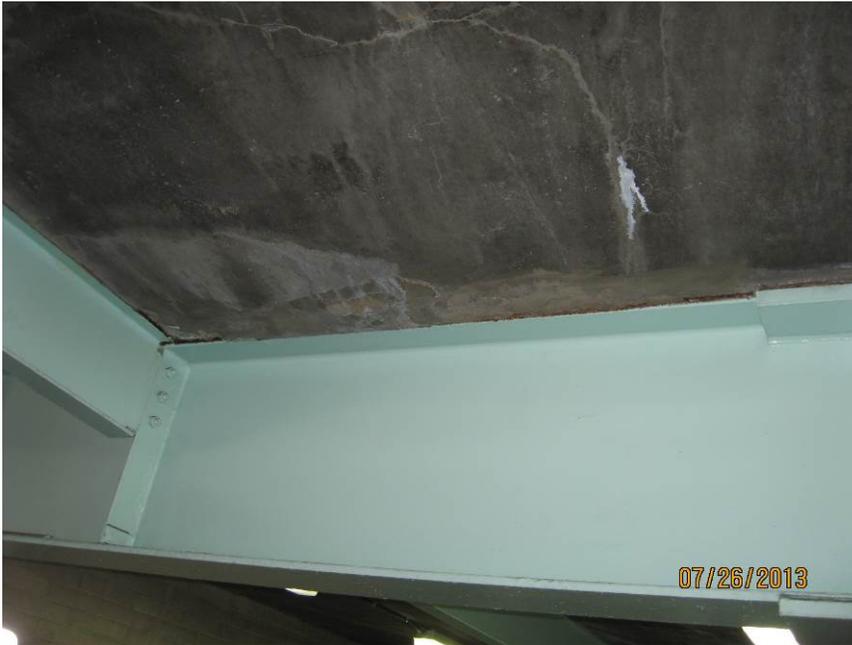
Photo 47

Efflorescence in the second level ceiling, a sign of active leakage through the slab.

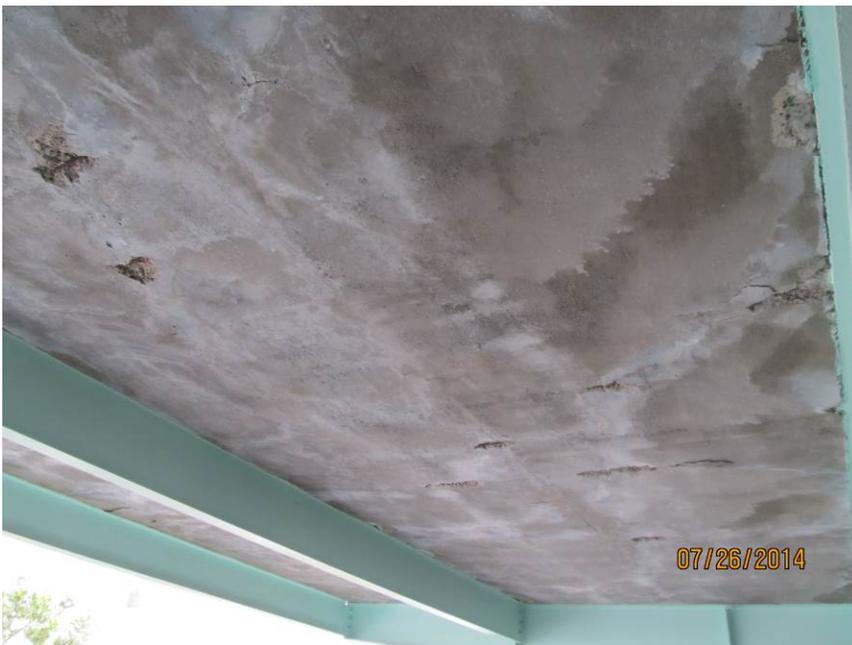
Photo 48

Efflorescence in the second level ceiling, a sign of active leakage through the slab.

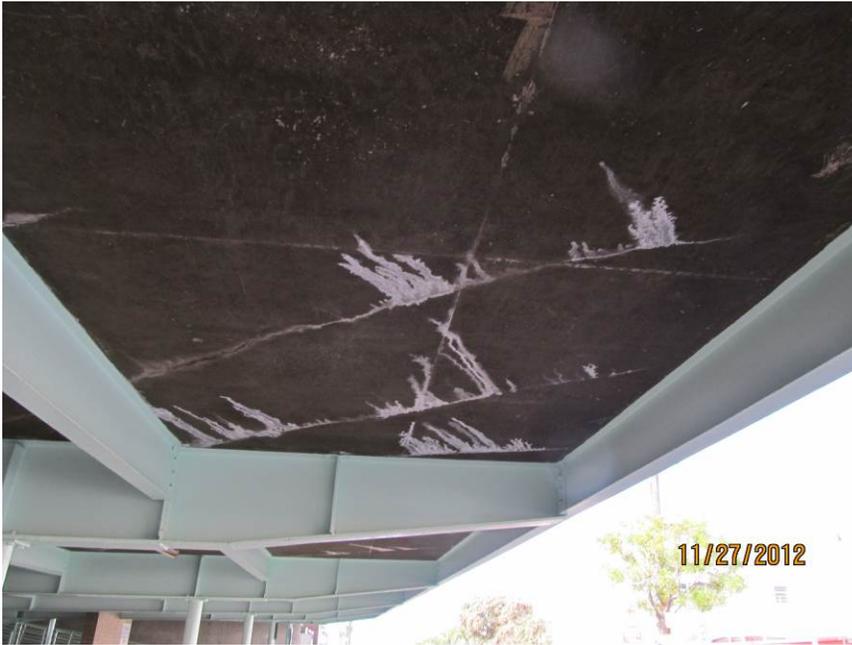
Photo 51

Efflorescence in the second level ceiling, a sign of active leakage through the slab.

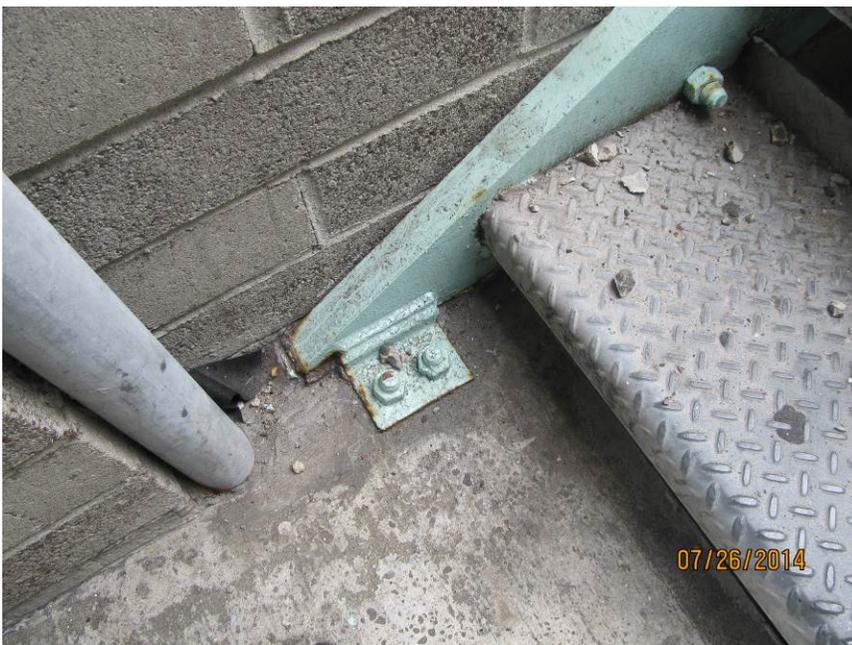
Photo 58

Deteriorating steel stair connection plate.

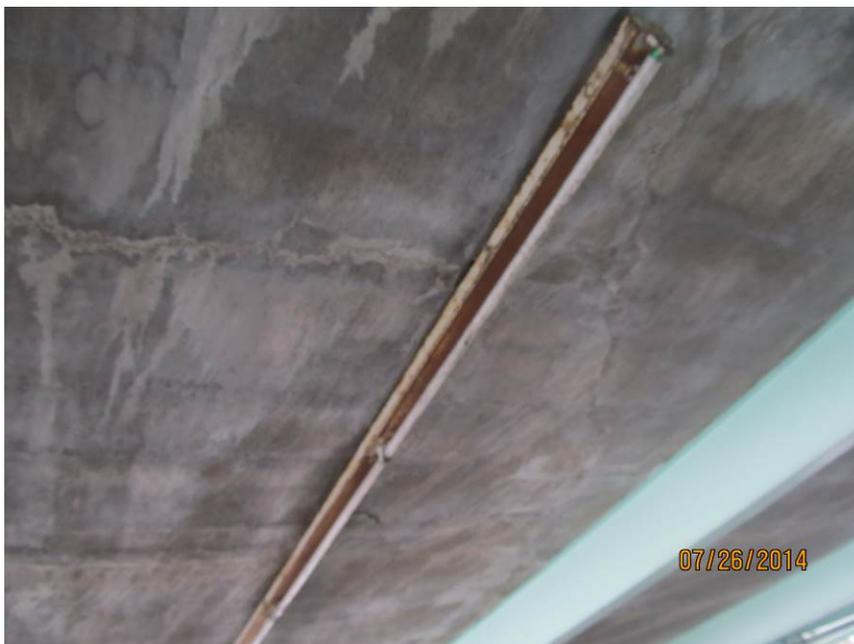
Photo 60

Corroded lighting fixture.

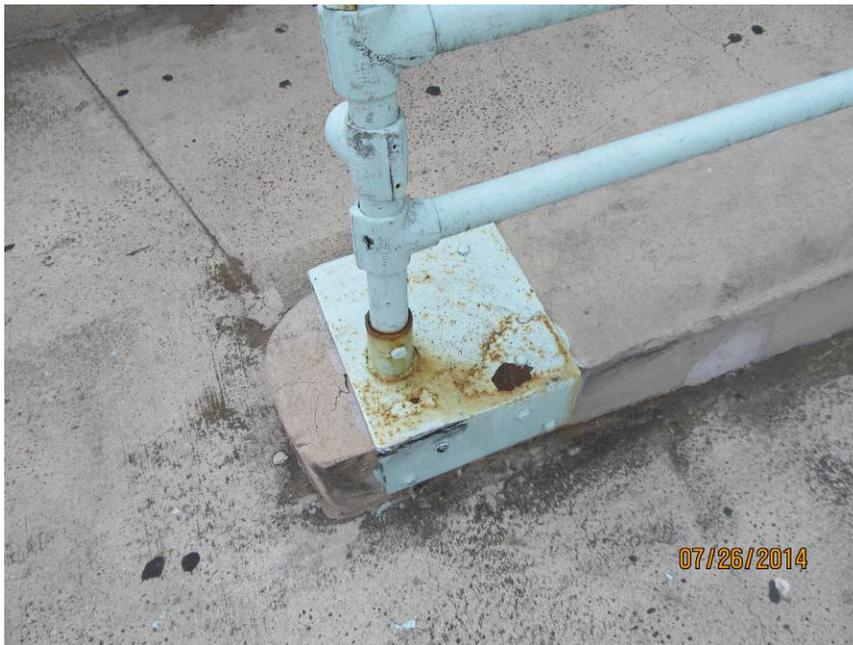
Photo 67

Corroded anchor plate at base of railing.

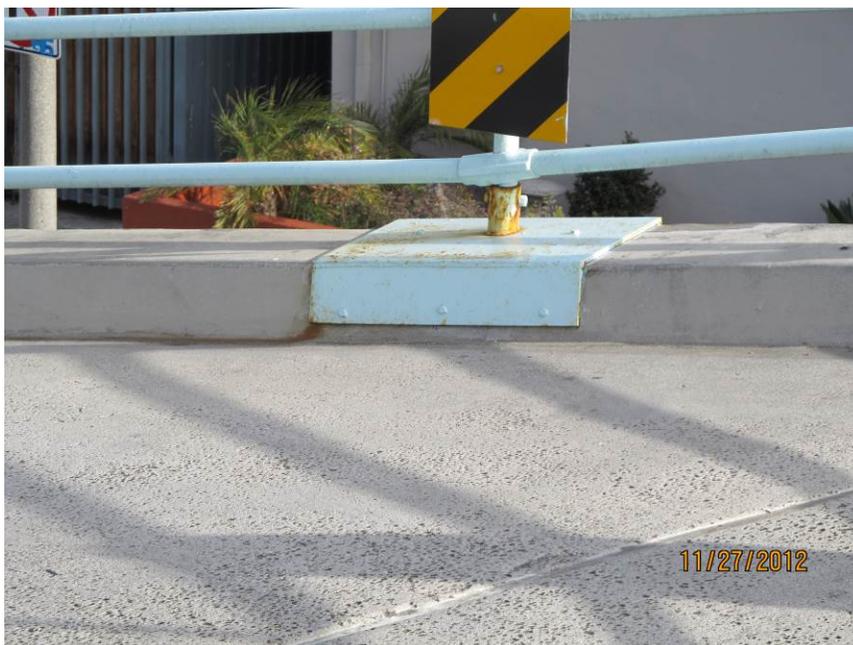
Photo 68

Corroded anchor plate at base of railing.
