CAPITAL IMPROVEMENT AND  
PROTECTION PROGRAM

CITY OF MANHATTAN  
BEACH PARKING  
STRUCTURES  
LOTS 2, 3 & 4

Prepared for:  
CITY OF MANHATTAN BEACH  
PROJECT NO. 37-8377.00

SEPTEMBER 2013

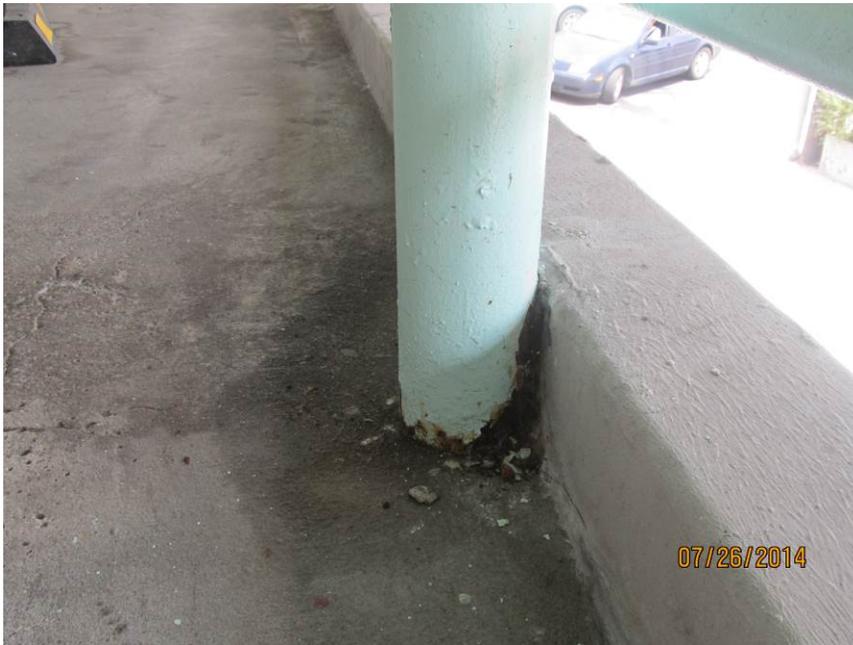
Photo 69

Corroded base of a perimeter steel pipe column showing early signs section loss.

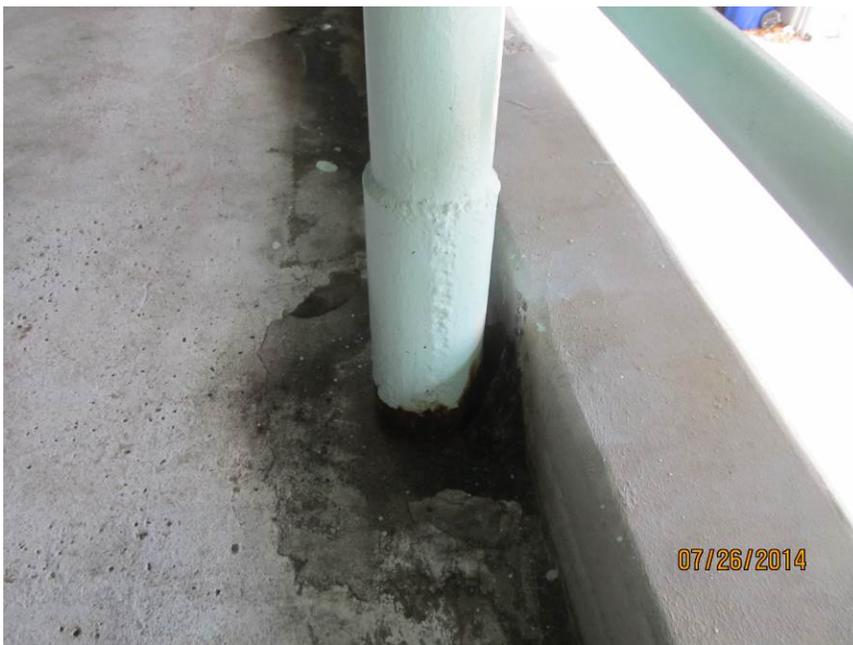
Photo 70

Steel jacket previously installed at base of steel pipe column.

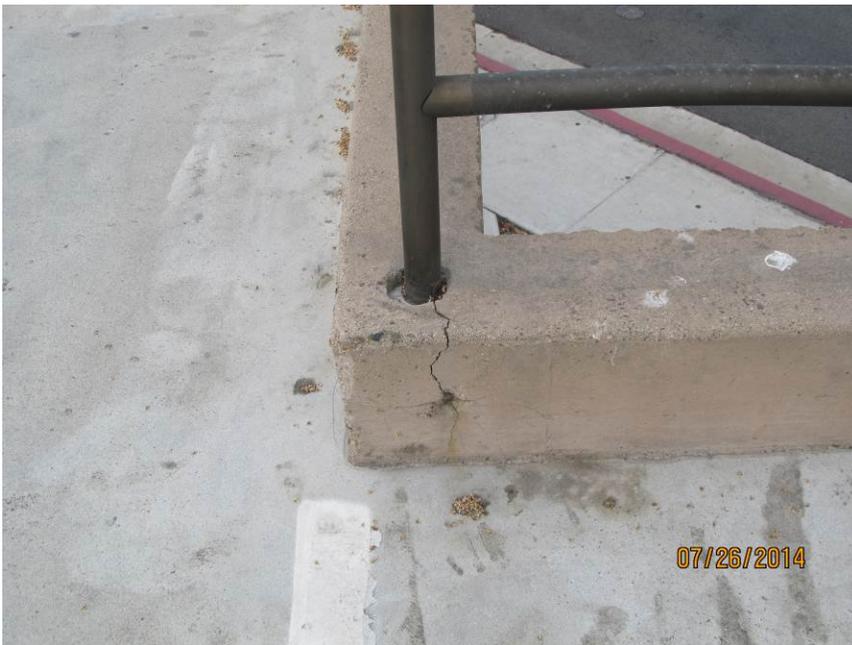
Photo 12

Cracking in concrete curb at rail mount location.

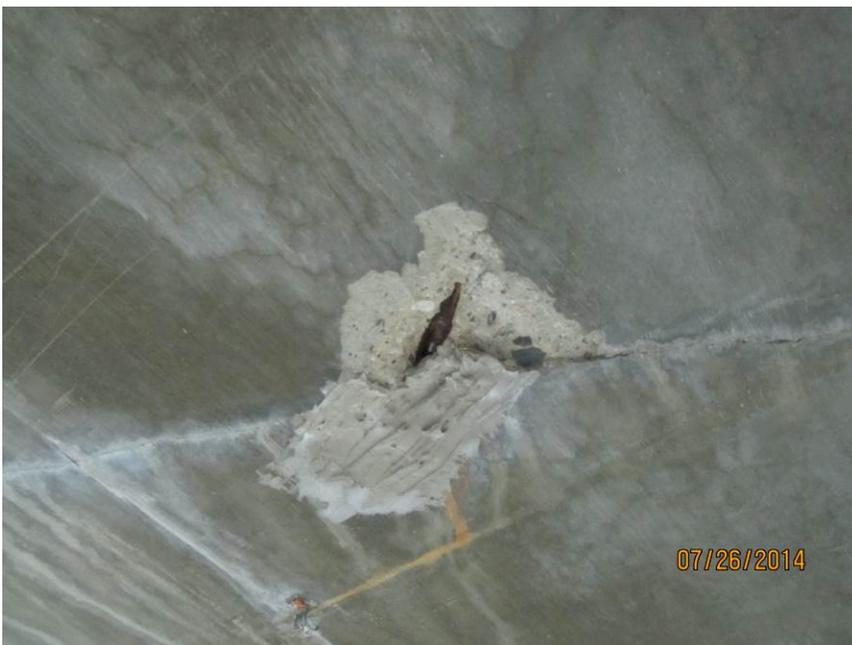
Photo 16

Spalled concrete in ceiling, which has exposed embedded reinforcement.

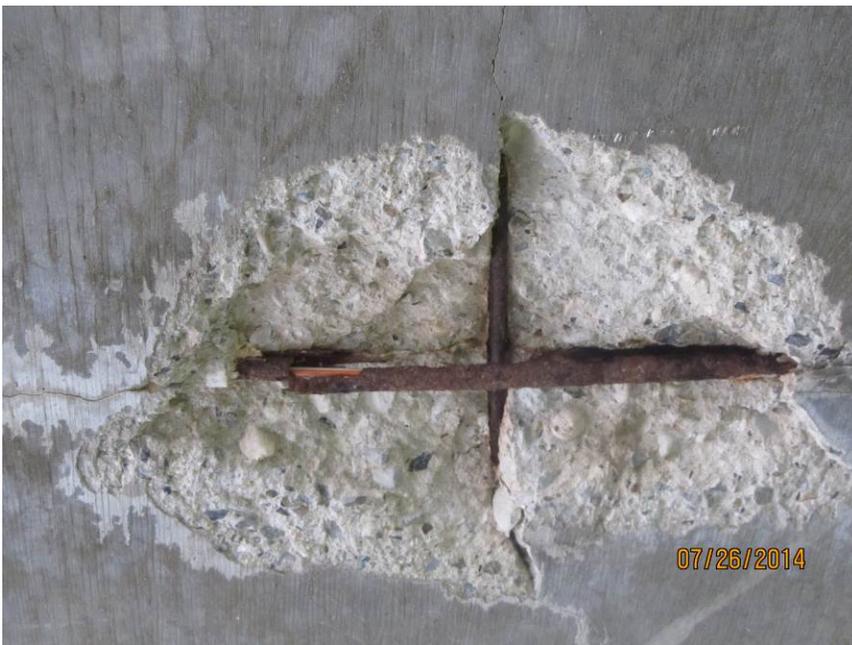
Photo 18

Exposed and deteriorated conduit due to spalled concrete in the ceiling.

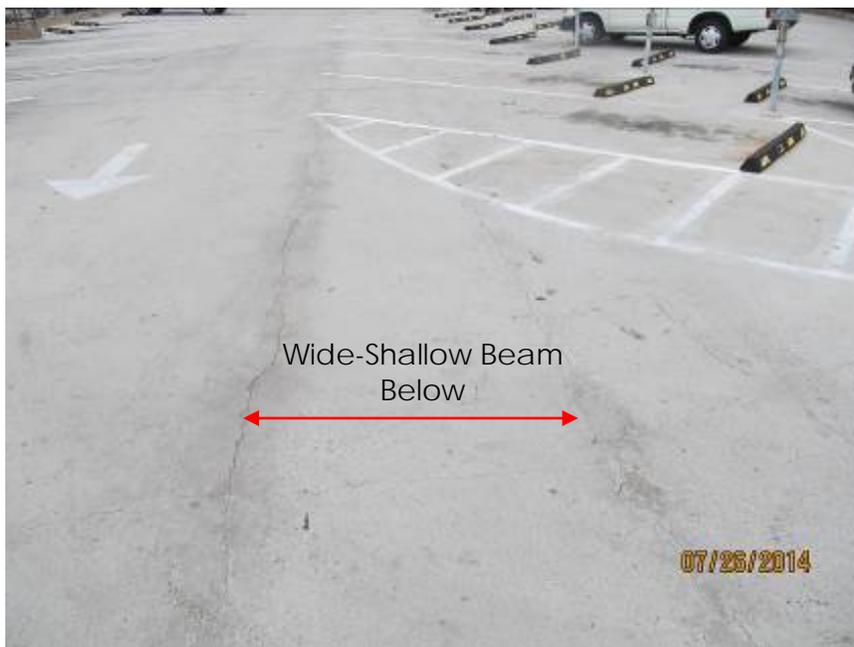
Photo 20

Large floor cracks running parallel to beams below.

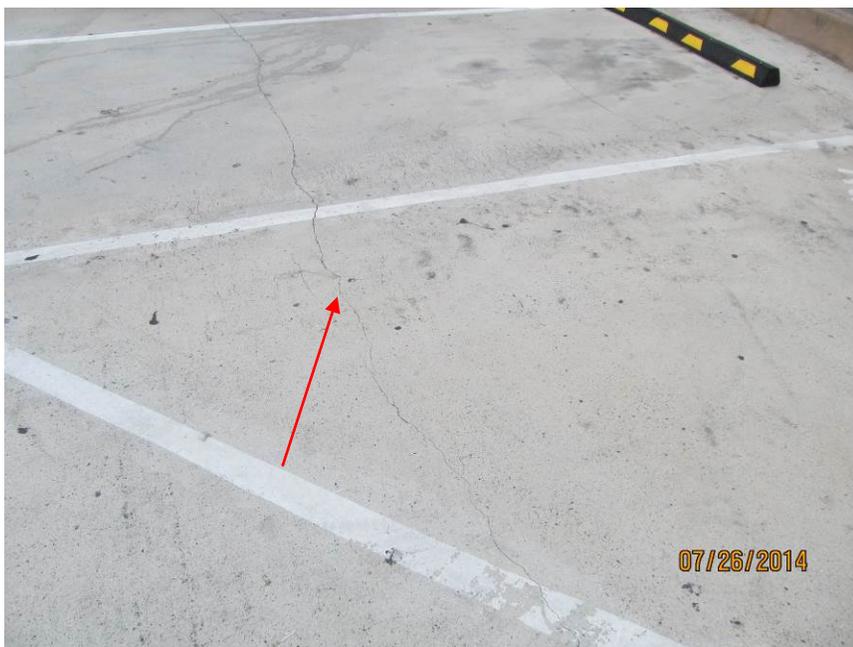
Photo 22

Typical floor cracks on the upper level.

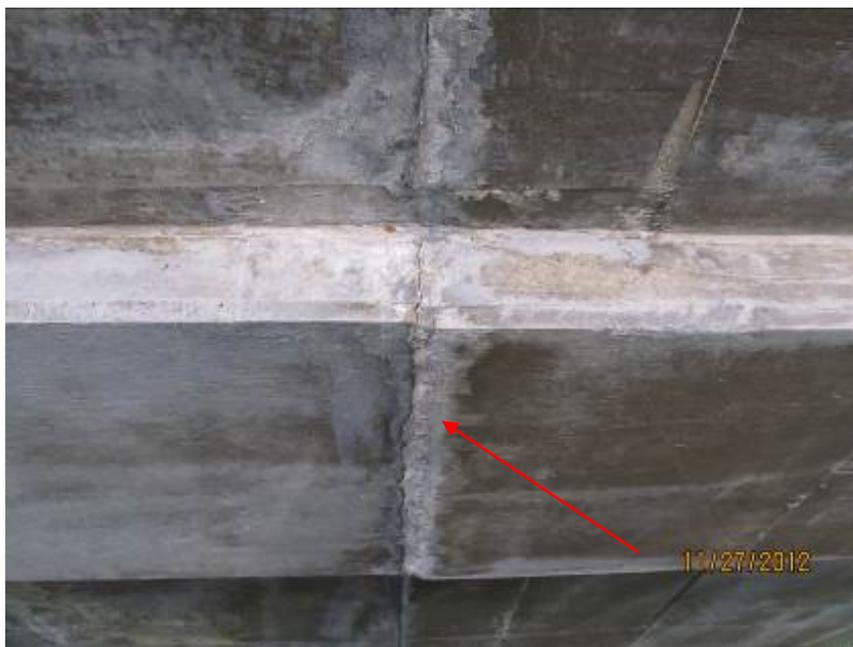
Photo 24

Large crack seen in a drop panel.

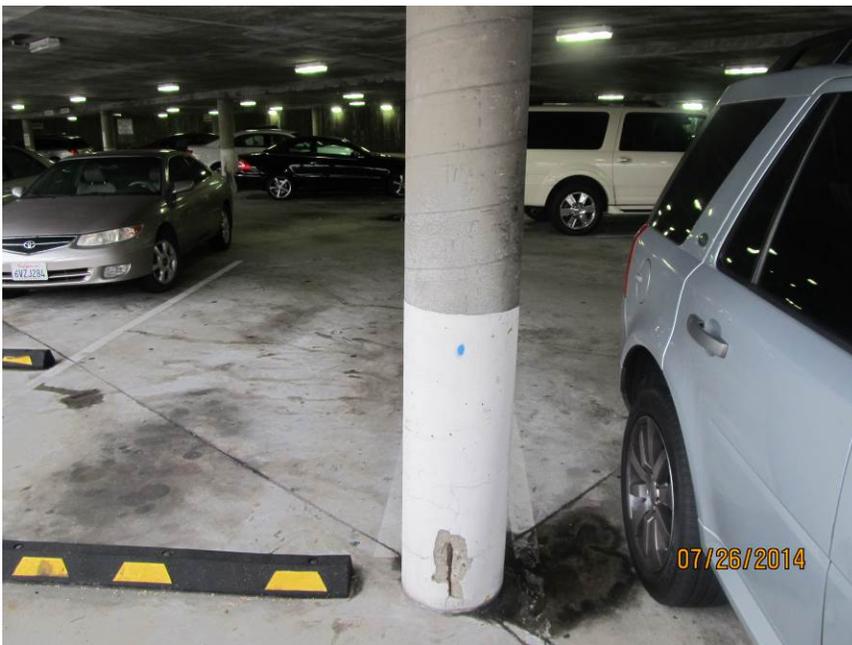
Photo 26

Spalling at the base of a column.

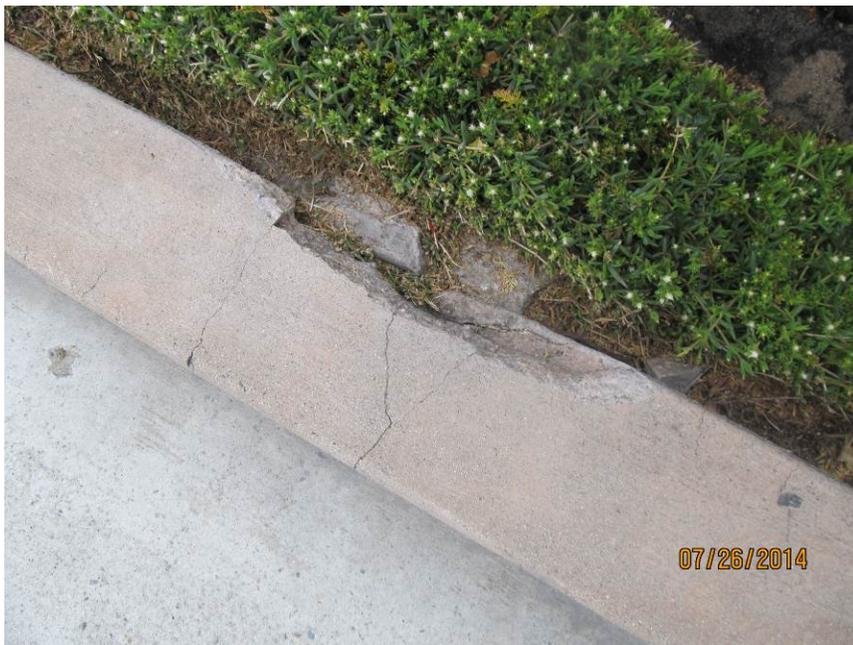
Photo 30

Damage in concrete curb adjacent to a planter.

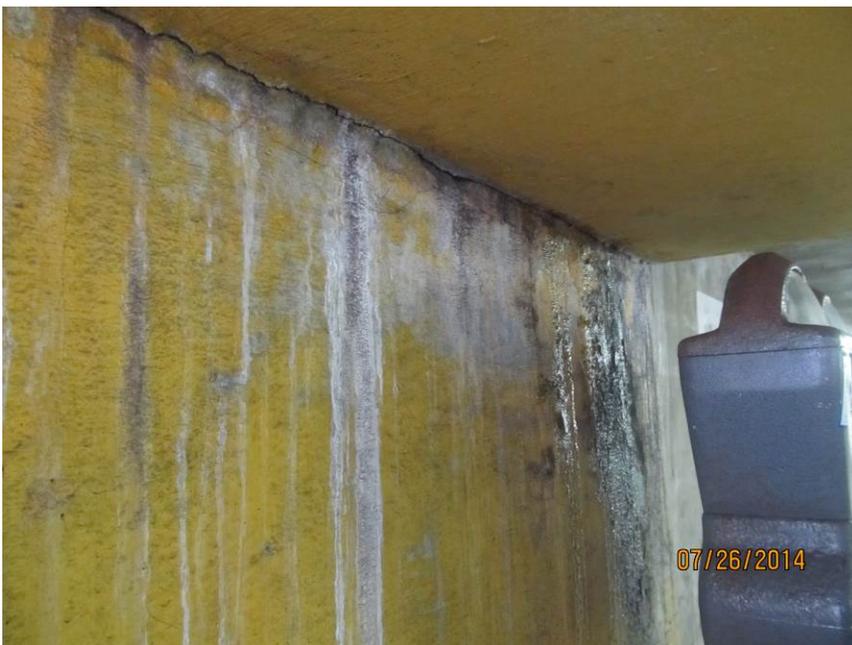
Photo 32

Concrete drain enclosure exhibiting signs of active leakage.

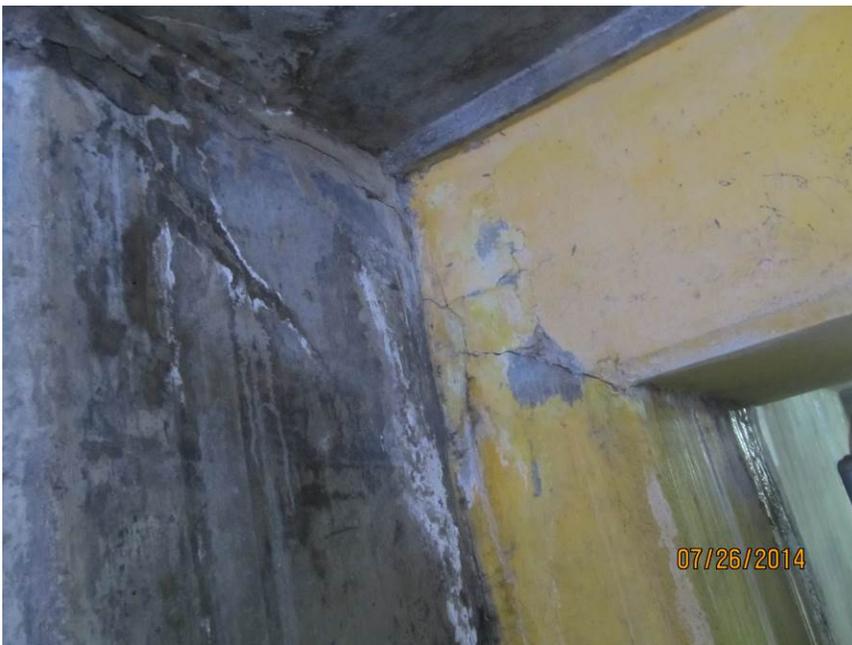
Photo 34

Extensive cracking and active leakage in the concrete drain enclosure.

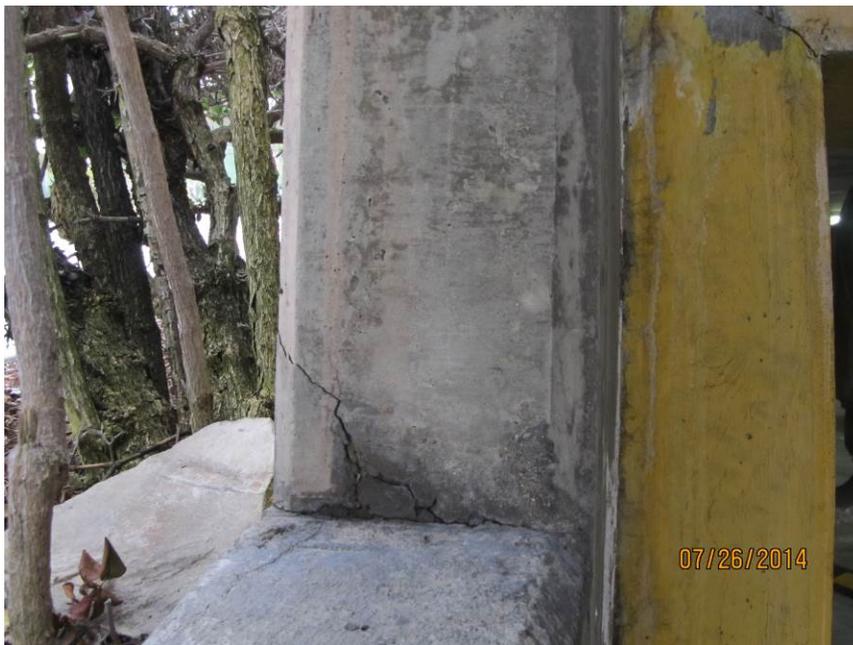
Photo 36

Cracking in the concrete wall near the drain enclosure.

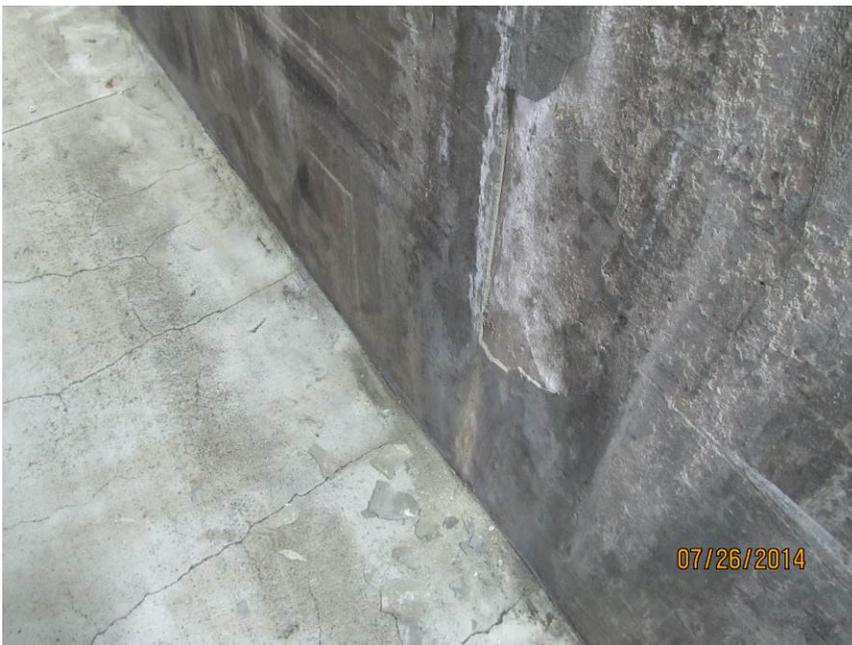
Photo 40

Damaged concrete due to moisture infiltration through the retaining wall.

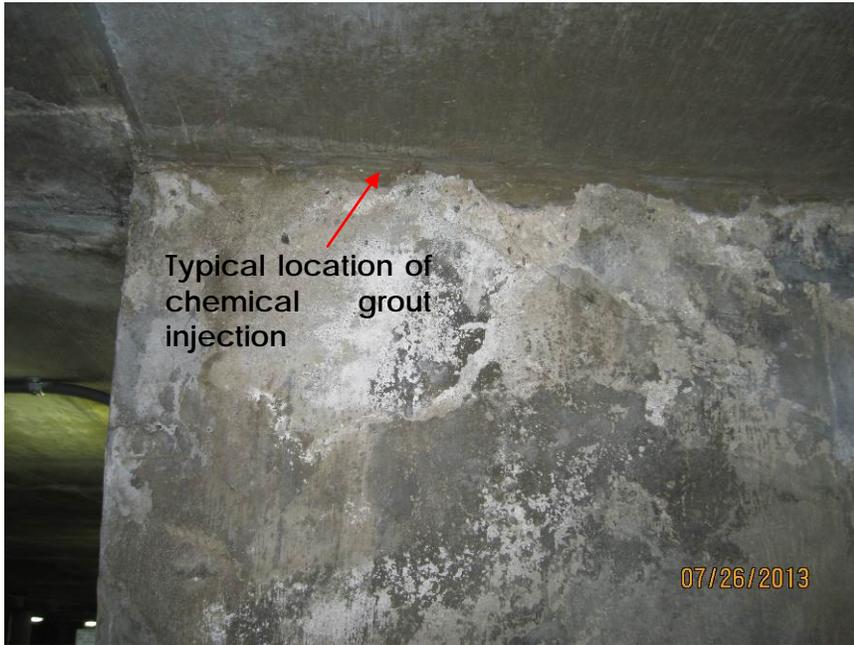
Photo 41

Damaged skim coat due to moisture infiltration through the retaining wall.

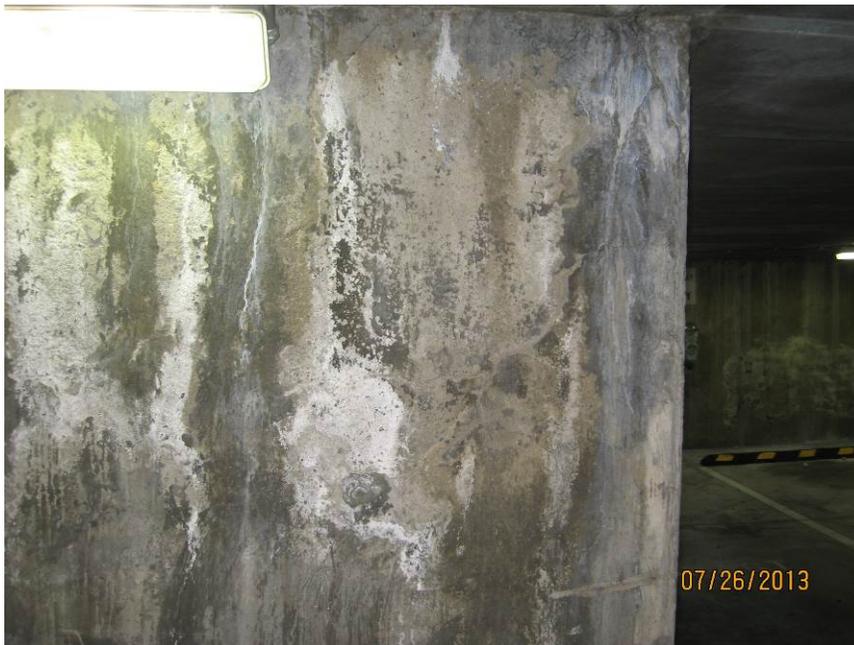
Photo 42

Damaged skim coat due to moisture infiltration through the retaining wall.

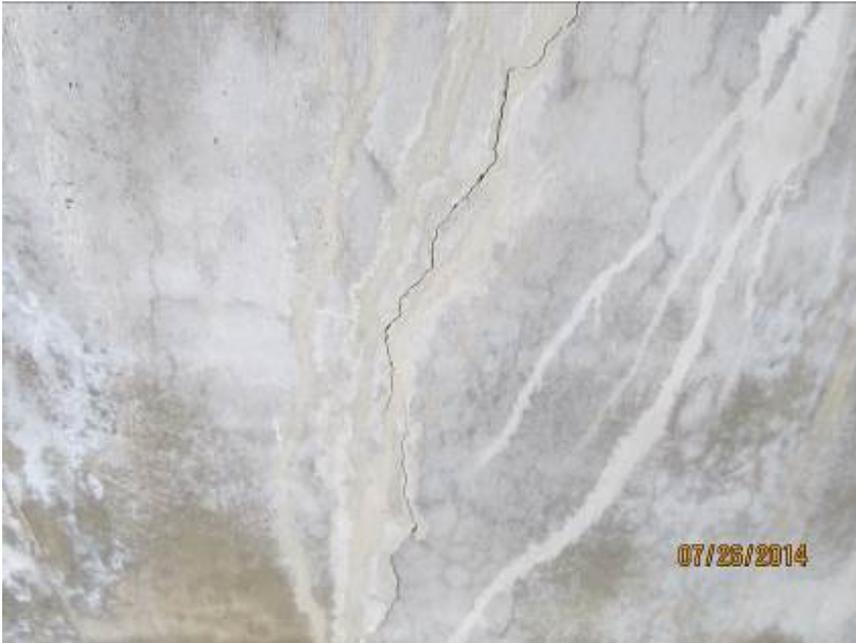
Photo 43

Signs of active leakage through a crack in the ceiling.

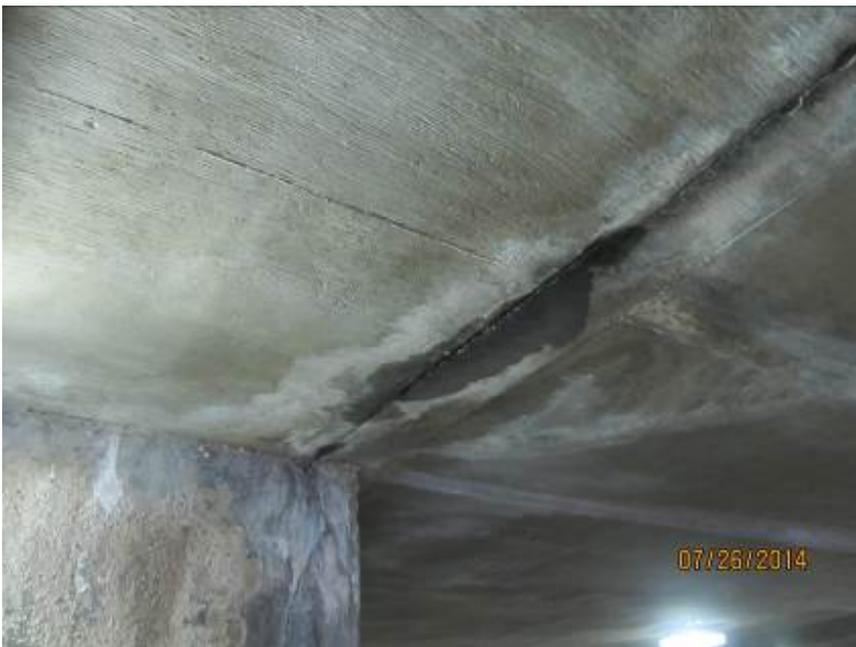
Photo 44

Active leakage below the location of the construction joint.

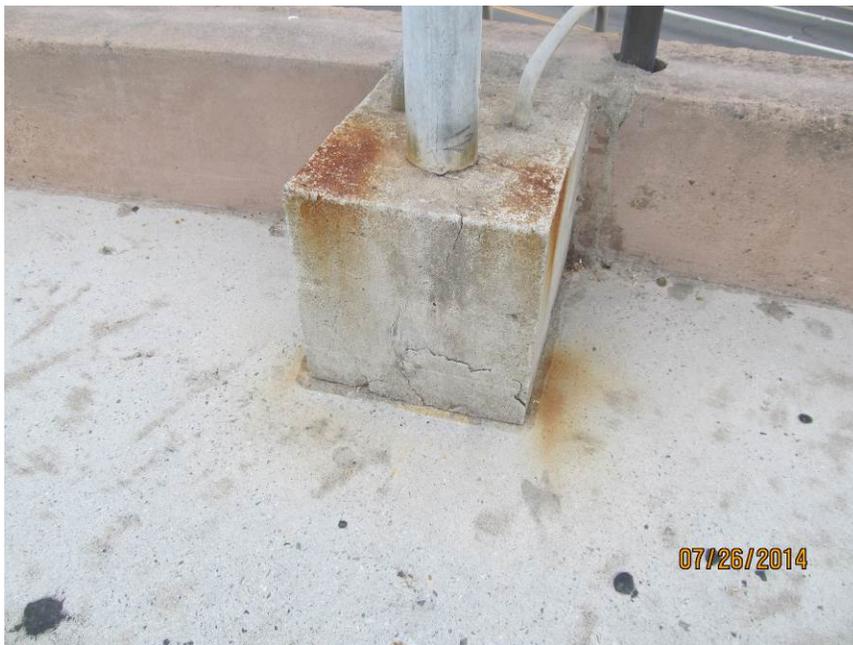
Photo 54

Delaminated concrete at base of upper level parking meter.

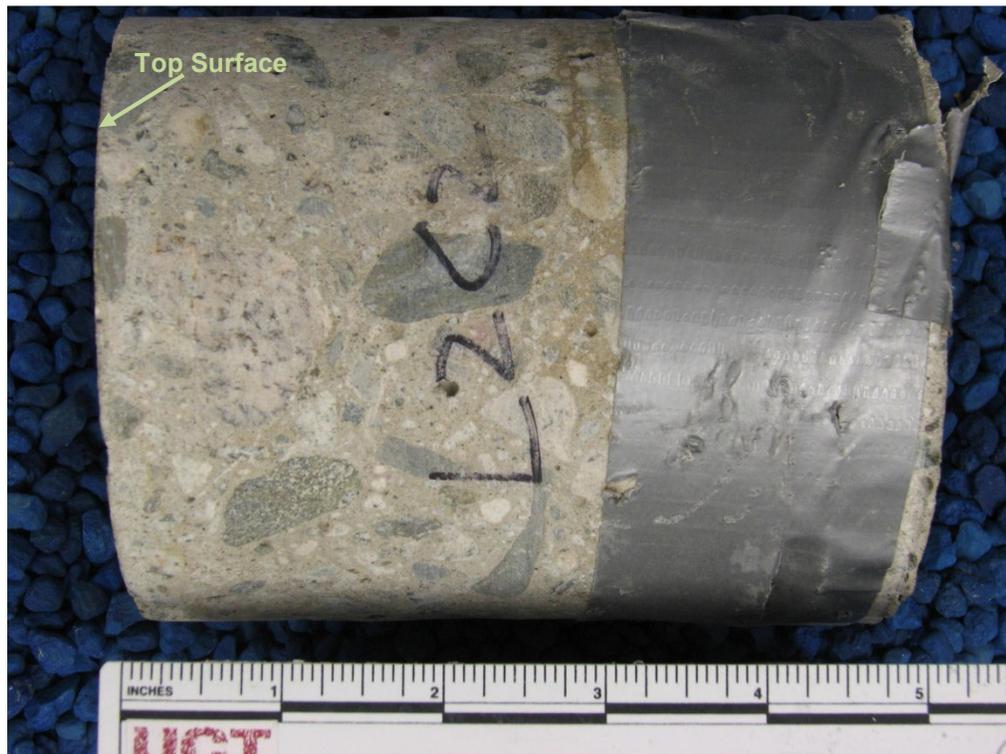
The core sample is 4.2" in diameter and approximately 5.1" long; full slab thickness. The paste of the top of this core sample is worn; originally a broom-finished surface exhibits exposed sand grains. The bottom of the core is a formed surface showing deterioration (1" depth delamination). Consolidation of the concrete is good with no evidence of segregation.

**Figure 1 – Core Sample L2C2, as received for examination. The top surface of the core sample is to the left.**

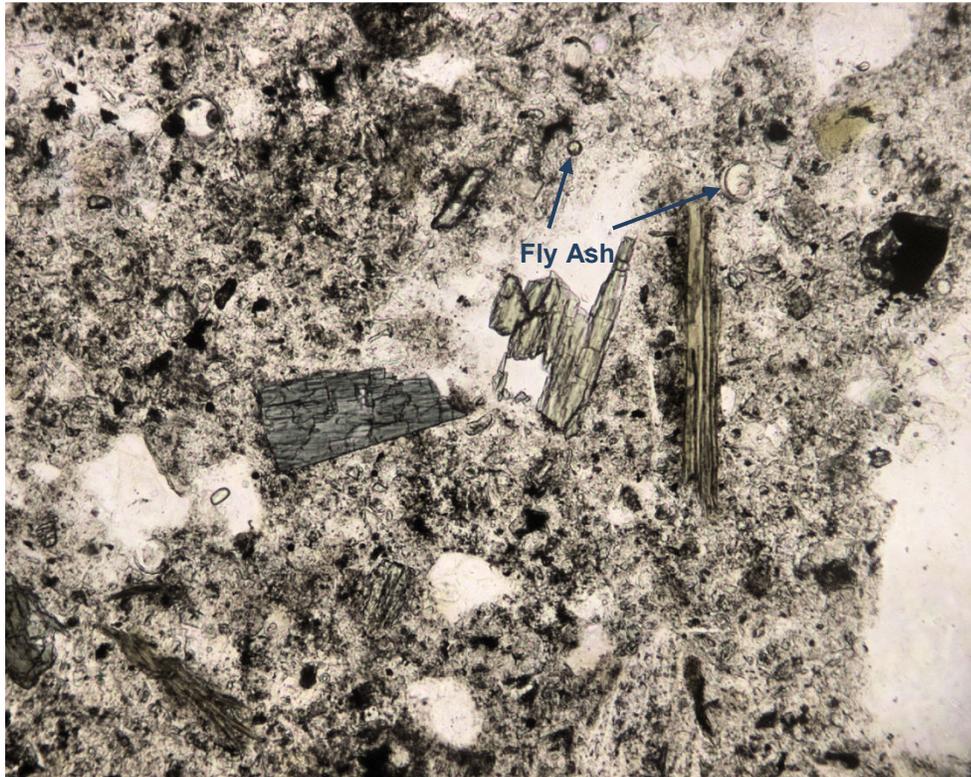
The water-cementitious materials (cement plus fly ash) ratio is estimated at **0.55 ± 0.05**.

Figure 3 – Thin-section photomicrograph taken in plane-polarized light showing the cementitious-paste microstructure in Core Sample L2C2. Concrete paste contains residual cement and fly ash spheres. 100X magnification.

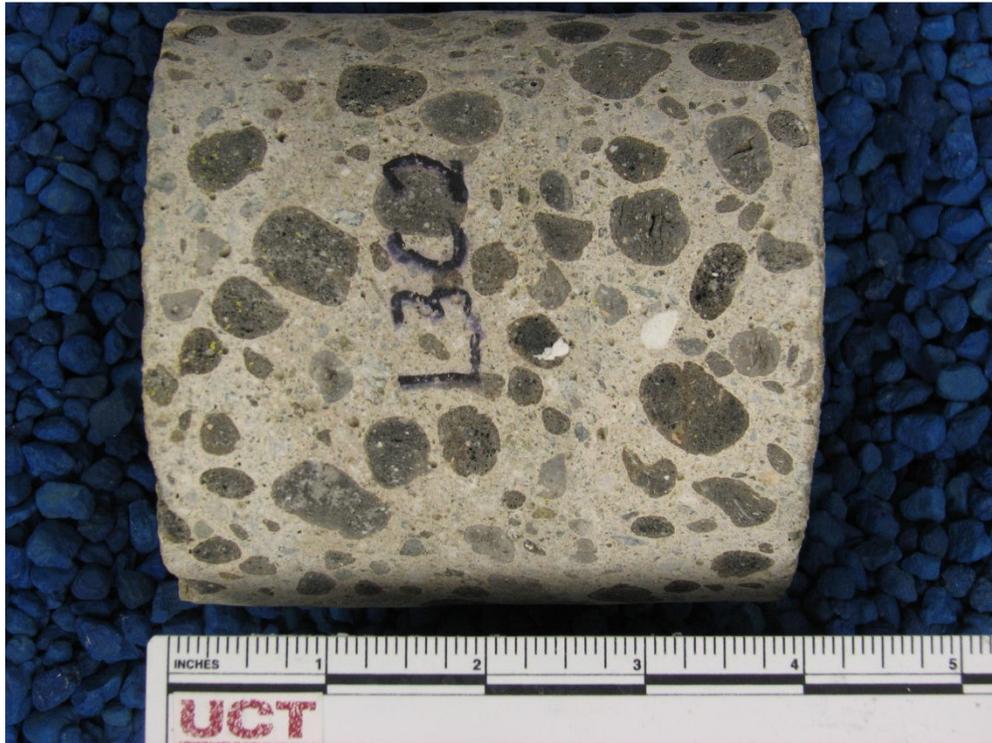
The core sample is 4.2" in diameter and approximately 4.2" long; full slab thickness. The top surface of the core sample is worn with exposed aggregates; the original surface appears to have been broom finished. The bottom of the core is a formed surface. Consolidation of the concrete is good with no signs of segregation.

**Figure 5 – Core Sample L3C2, as received for examination. Lightweight coarse aggregates (dark rocks) are generally spherical and rounded. The top surface of the core is to the left.**

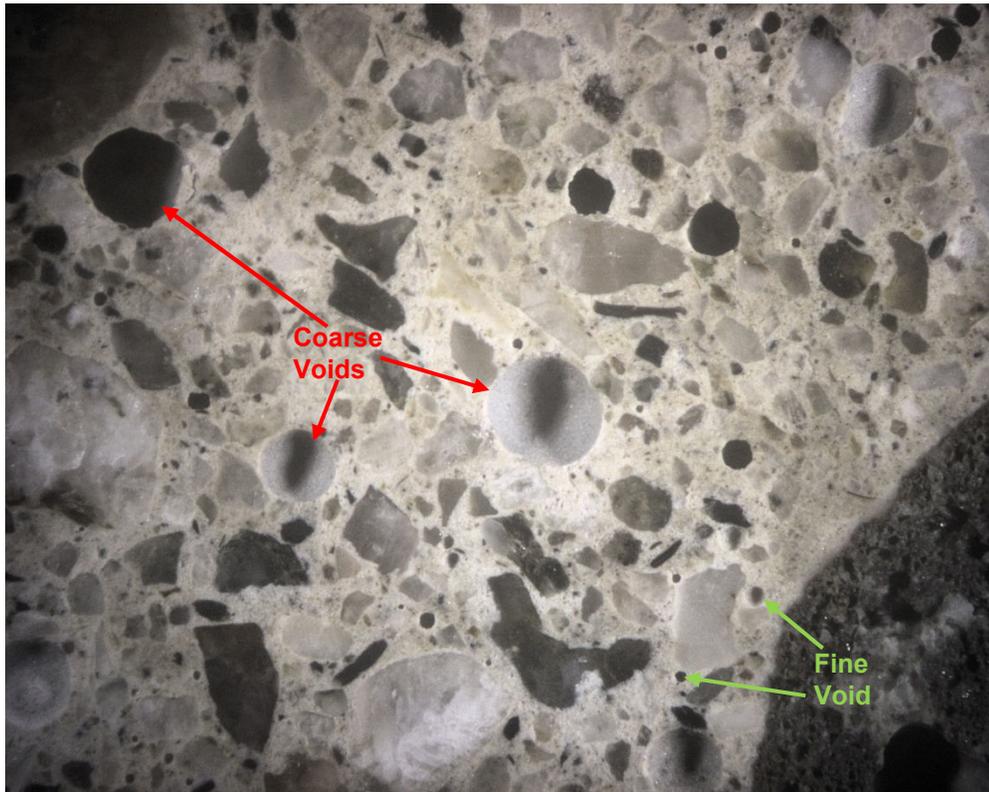
The concrete is improperly air-entrained. Air content is estimated at **3-5%**. Air-void distribution is non-uniform and coarse; occasional small, spherical voids are observed.

Figure 6 – Photomicrograph showing the air-void system in Core Sample L3C2. The air-void system is comprised of coarse air voids and some small, spherical voids. Length of view is approximately 0.35".

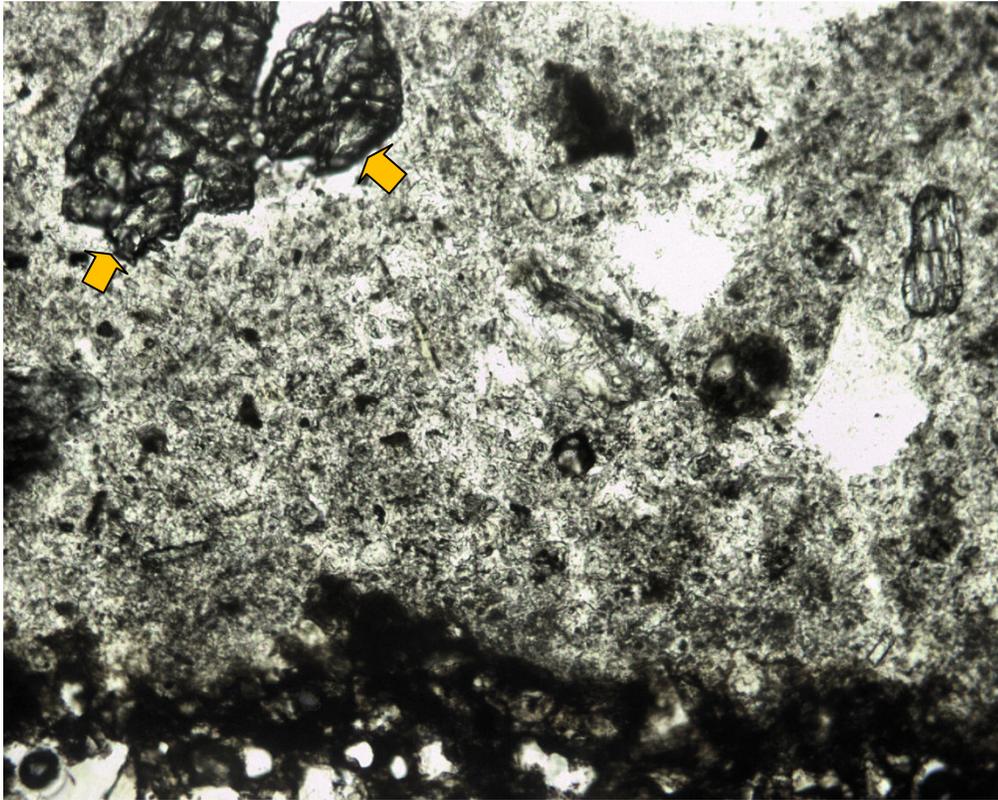
The water-cementitious materials (cement plus fly ash) ratio is estimated at around 0.50.

Figure 7 – Thin-section photomicrograph taken in plane-polarized light showing the cement-paste microstructure in Core Sample L3C2. Concrete is predominately residual portland cement particles; note two coarse cement grains (arrows). Fly ash spheres are rare to infrequently. 100X magnification.
