Citywide
Facility Condition Assessment

Report of
Facility Condition Assessment

For
City of Manhattan Beach
City Hall
1400 Highland Avenue, Manhattan Beach, CA

*August 23, 2013
(Rev A)*

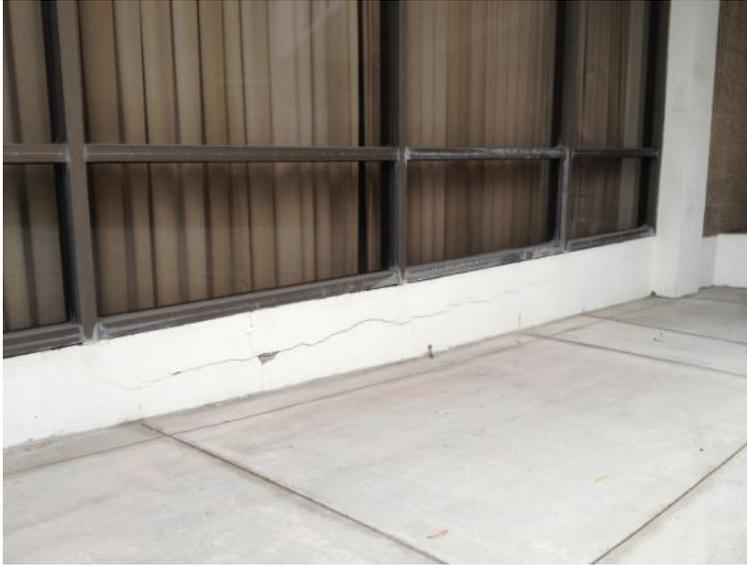
Photograph No. 1

The floor structure appeared to be in good condition therefore we assume that the reinforced concrete foundations are also in good condition. However, we observed localized areas of minor cracking in the lower level concrete walls. It was also noted in the concrete buttress walls and in the stem wall adjacent to the basement level entrance on the west side of the building (reference Photograph 1 in Appendix B). We recommend budgeting for repairs of the cracking in the near-term to prevent further damage. Further details of these issues can be reviewed in Appendix F.

View of the cracks in the stem wall.

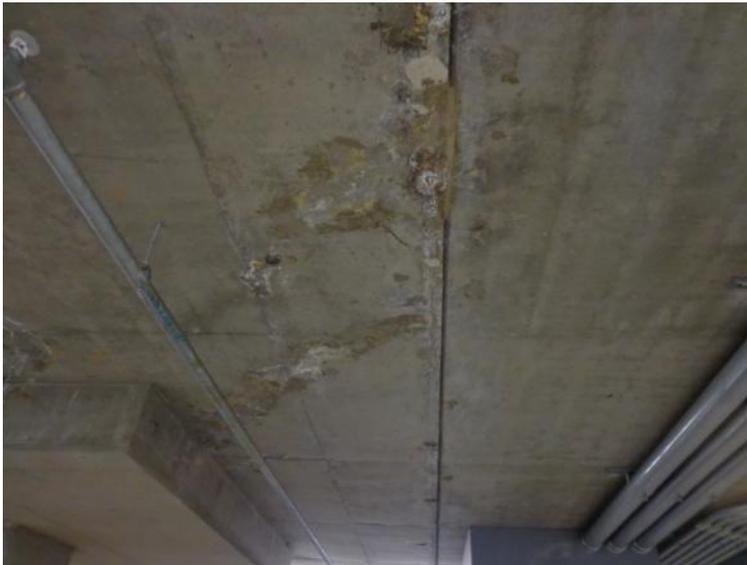
Photograph No. 5

Extensive water intrusion damage was noted at the upper level deck of the garage (reference Photographs 5 and 6 in Appendix B). Evidence of water infiltration is indicated by the efflorescence at the underside of the deck, particularly adjacent to the expansion joints. It was reported to Faithful+Gould that a series of urethane injections were performed in an attempt to eliminate the water infiltration which did not eliminate the infiltration issue. The primary source of the water infiltration appears to be the numerous landscape planters along the upper level of the garage. Additionally, the exposed surface of the deck exhibited alligator cracking throughout contributing to the water damages. Prolonged exposure to water can potentially deteriorate the reinforcing steel bars in the concrete and cause long term structural performance and safety concerns. Therefore, we recommend repair of the upper level deck including replacement of the waterproofing membrane.

View of the water infiltration at the garage.

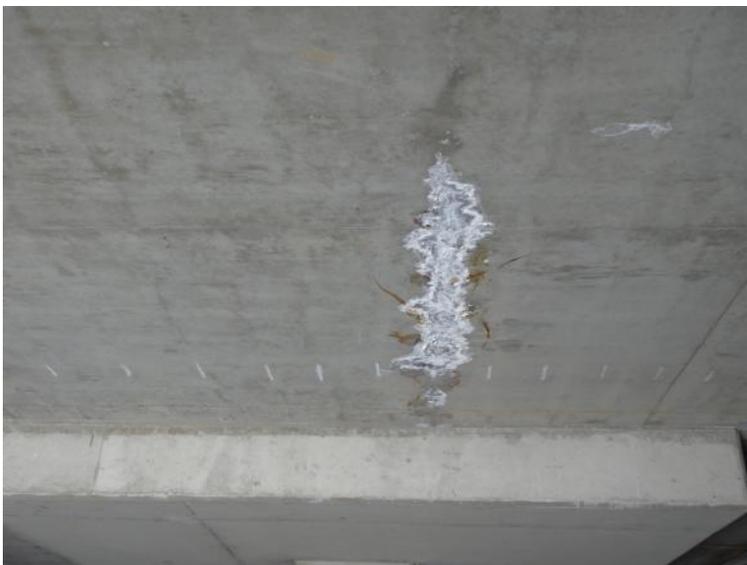
Photograph No. 6

Additional view of the water infiltration at the garage.

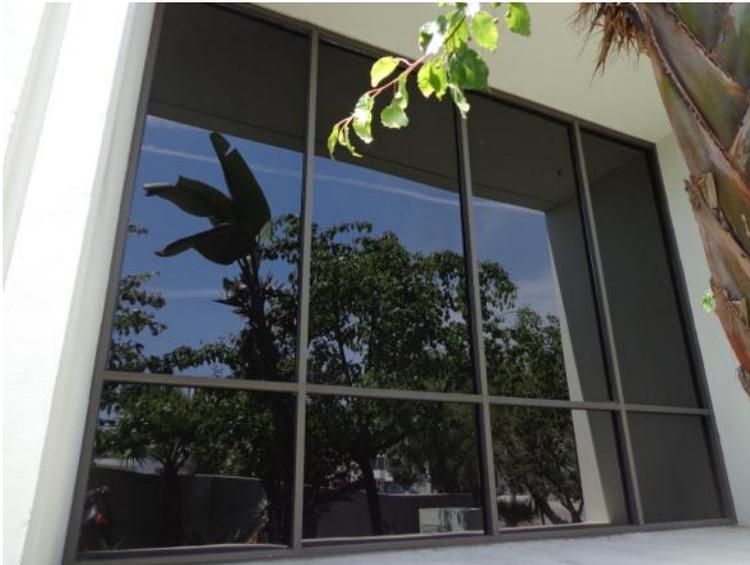
Photograph No. 8

All windows at the building are single glazed units. The windows consist of fixed and awning type units set in bronze anodized aluminum frames (reference Photograph 8 in Appendix B). The windows are fitted with vertical blinds at the interior. Information regarding window finishes can be found in section E2013.

View of the automatic entrance doors at the north elevation.

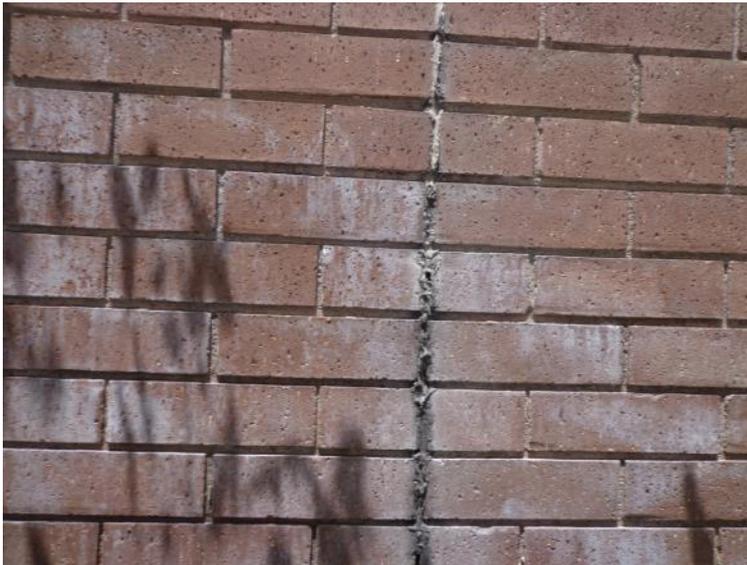
Photograph No. 11

The exterior wall systems at the building appeared to be in poor to fair overall condition with generally no major signs of deterioration, water ingress or general failure noted. However, efflorescence and minor mortar deterioration was observed at the lower level CMU walls (reference Photograph 11 in Appendix B). It appears that the damage was caused by the frequent use of the below grade irrigation system. We recommend near-term cleaning and re-pointing of the affected areas. The exterior painted surfaces were reportedly last painted a few years ago and therefore based on the typical EUL of four-years for exterior paint, as well as current observed conditions, re-painting will be necessary near-term in the study period to maintain the appearance and protect the exterior walls.

View of the efflorescence at the masonry walls.

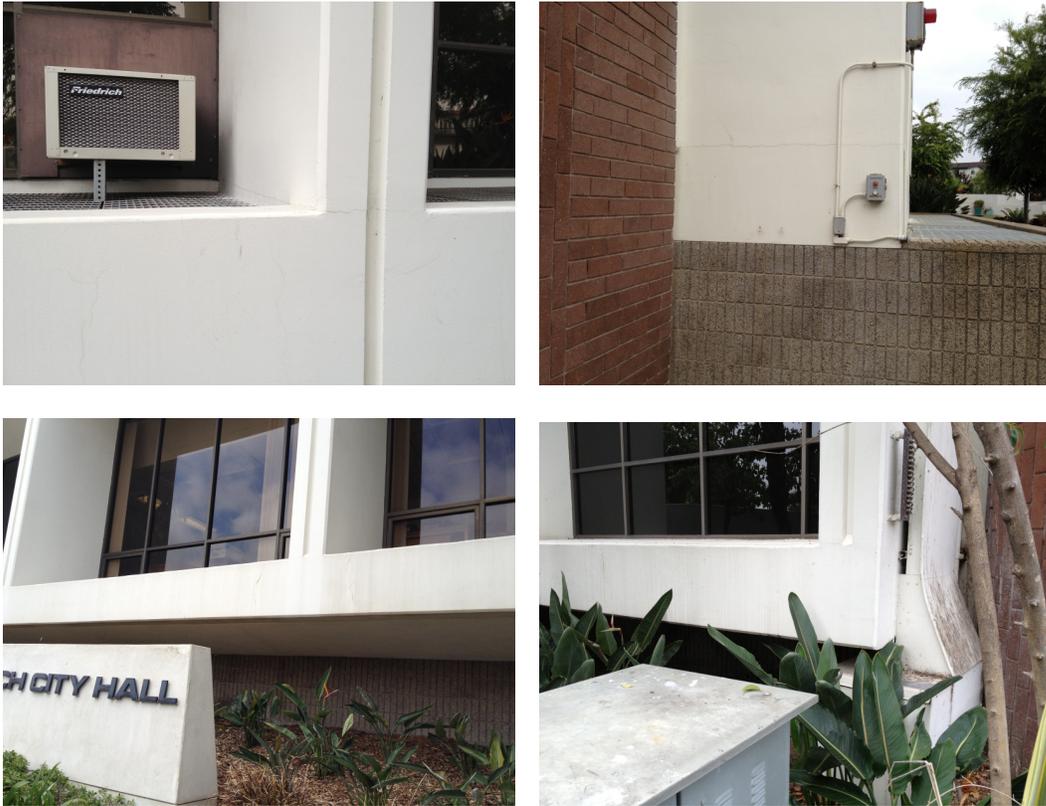
Figure 6: Concrete Cracking in Buttress Walls

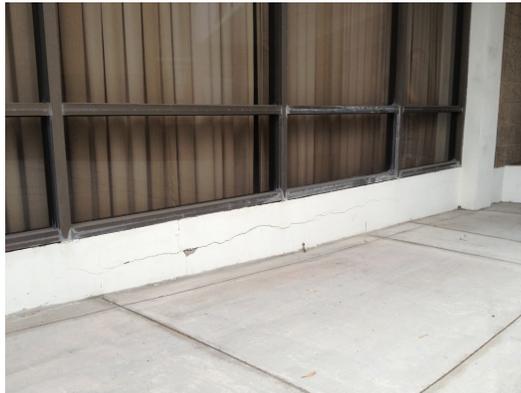
Figure 7: Concrete Cracking in Entrance Stem Wall

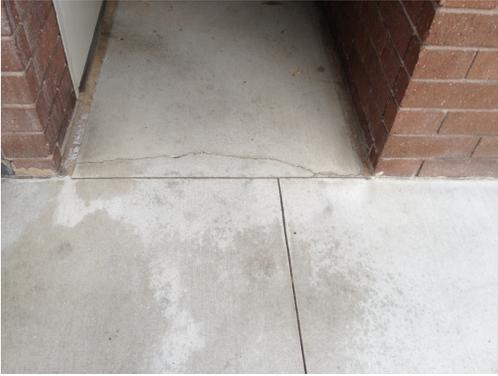
The cast-in-place concrete slab at the building appeared to be in good condition. However minor cracking was observed at first level slab on grade at the side exit. Due to the quantity of the cracks and the minimal cost to repair, repairs will fall below the threshold of \$500 and therefore would usually not be included in this study, although in this instance it has been included as they can be undertaken at the same time as the subterranean parking garage repairs.

Figure 8: Cracked Slab on Grade

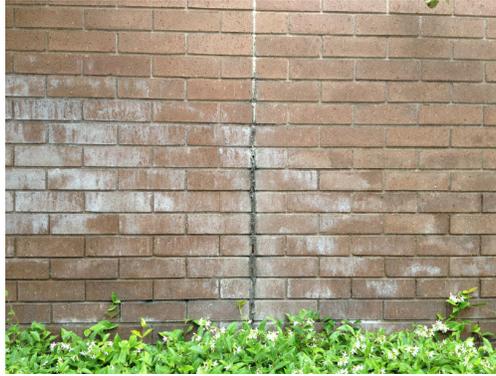
Figure 9: Efflorescence

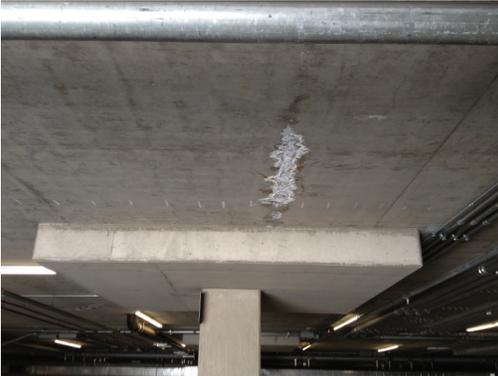
Although not part of the City Hall Building, the adjacent subterranean parking garage needs to have the water intrusion in the slabs and cracking in the slabs and retaining walls addressed within the short term (1-3 years) time frame. The estimated cost for such repair is summarized in the following table:

Figure 10: Water Intrusion Damage in Adjacent Garage

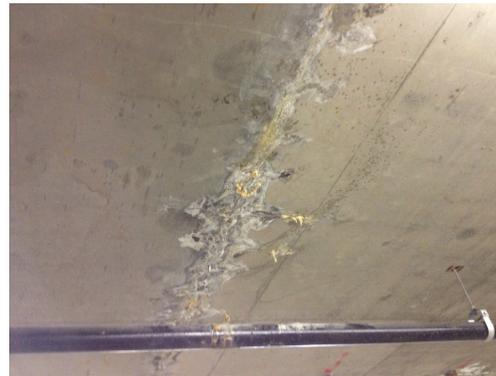
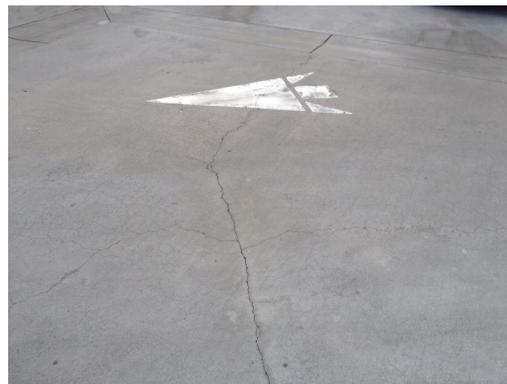
The concrete slab on grade at the subterranean parking garage also contains minor cracking which we recommend repair with patching using cement based mortar or suitable epoxy materials.

Figure 11: Garage Slab Cracking

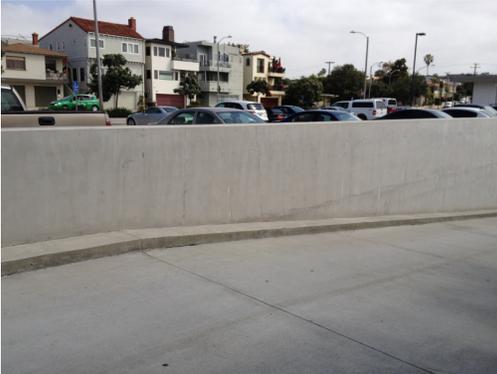
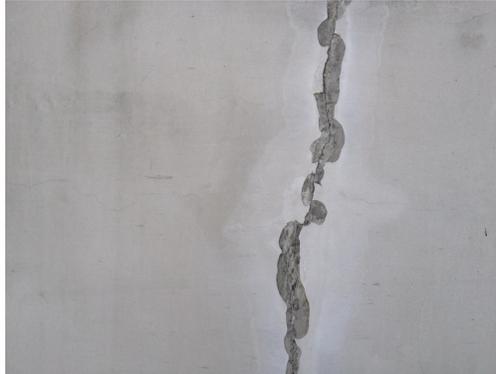
Figure 12: Cracking in Garage Retaining Wall
