Citywide  
Facility Condition Assessment

Report of  
Facility Condition Assessment

For  
City of Manhattan Beach  
City Hall Annex  
421 15th Street, Manhattan Beach, CA

*August 23, 2013  
(Rev A)*

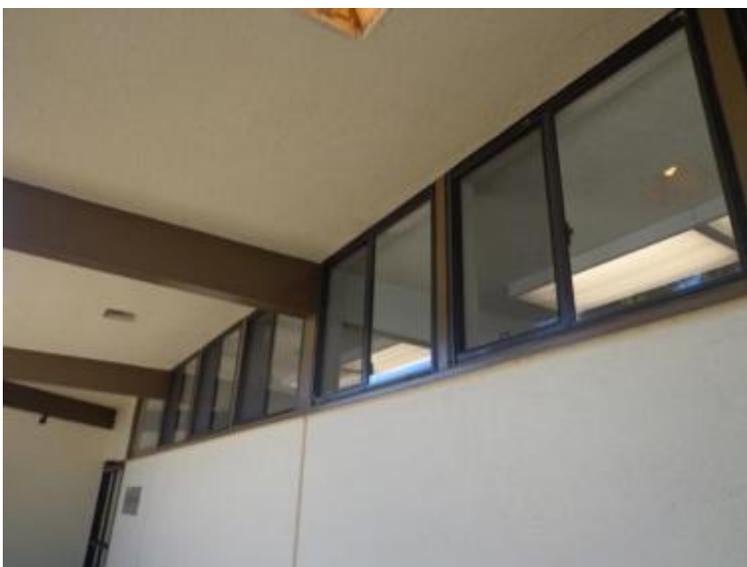
**Photograph No. 6**

The exterior window units appeared to be in fair condition, they are single pane and even though they are aged, there were no major deficiencies observed in the windows. However they are approaching the end of their useful life and some of the screens are inoperable, and we have recommended their mid-term replacement to operable insulated units for energy efficiency and improve thermal resistance.

View of the sliding aluminum windows.

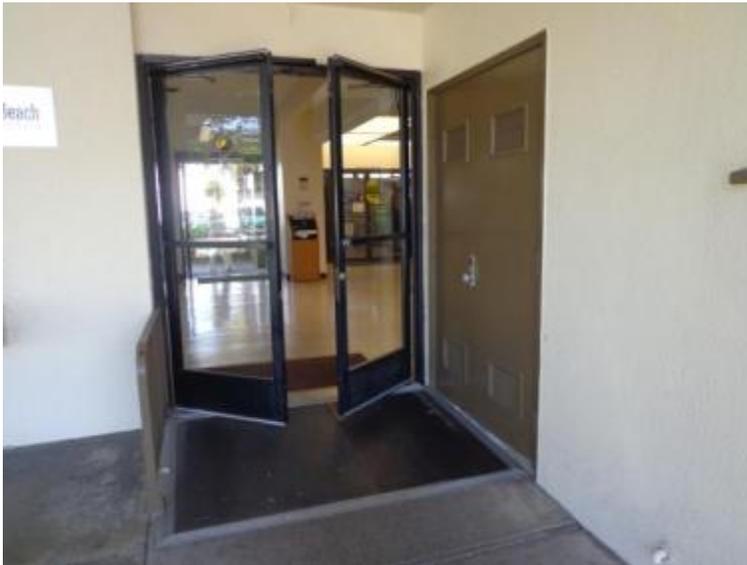
**Photograph No. 8**

The exterior doors appeared to be in good condition. The doors are approximately ten-years of age and therefore replacement will not be required during the study period. We understand that there are safety issues with the automatic entrance doors and should be replaced early in the study period.

View of the automatic entrance doors at the north elevation.

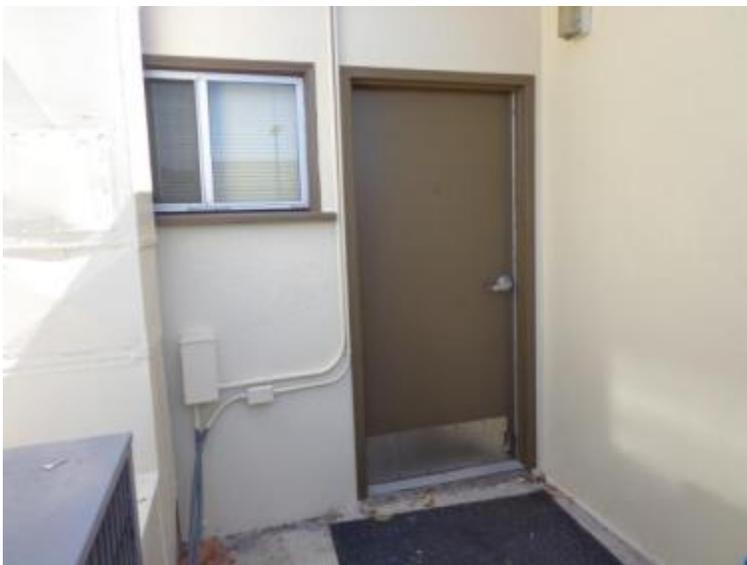
**Photograph No. 9**

The metal doors appeared to be in fair condition and there were no observed issues. In general the operation of the doors was satisfactory and operated without any difficulty. However the west door with the Post Office is in poor condition and should be replaced. Re-painting concurrent with the building exterior will be necessary to maintain the doors.

View of the meatl exit door at the east elevation.

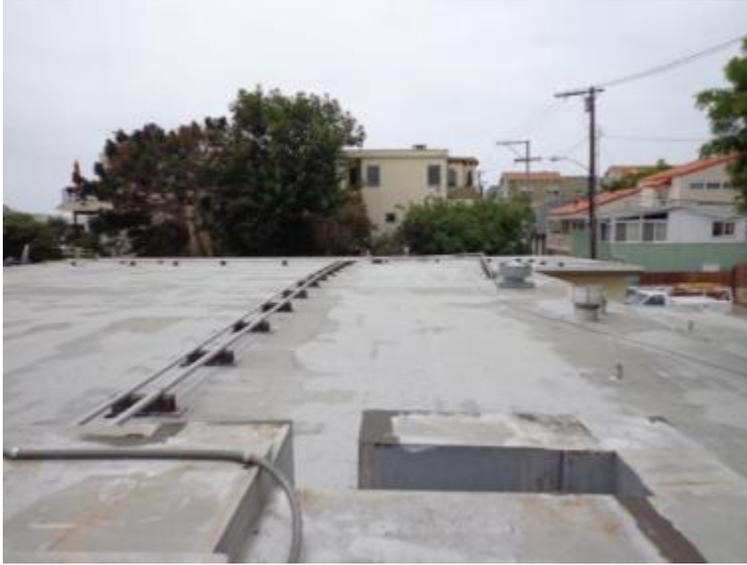
**Photograph No. 10**

The two low-sloped roof areas contained asphaltic Built-Up Roof (BUR) with a mineral cap sheet surface with loose granules applied to the surface (reference Photographs 10 through 12 in Appendix B). The roof coverings are approximately five-years of age. Roof drainage gutters and downspouts are provided at the rear service door and above the two main entrances. The remaining roof areas drain via edge drainage along the perimeter of the roof. Table B30-1 provides a summary of the roof coverings:

The BUR roof areas appeared to be in fair to good overall condition. This type of roof covering has a typical EUL of 15 to 20-years and based on observed conditions and roof material ages we anticipate that both Roofs 1 and 2 will last beyond the study period without replacement necessary. We are unaware or could not visually see any possible areas of water ingress.

View of the main BUR roofing system.

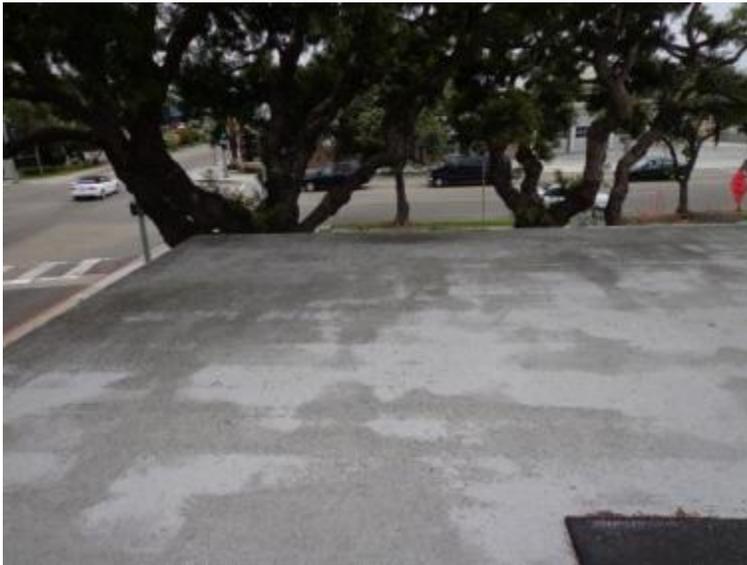
**Photograph No. 11**

Additional view of the main BUR roofing system.

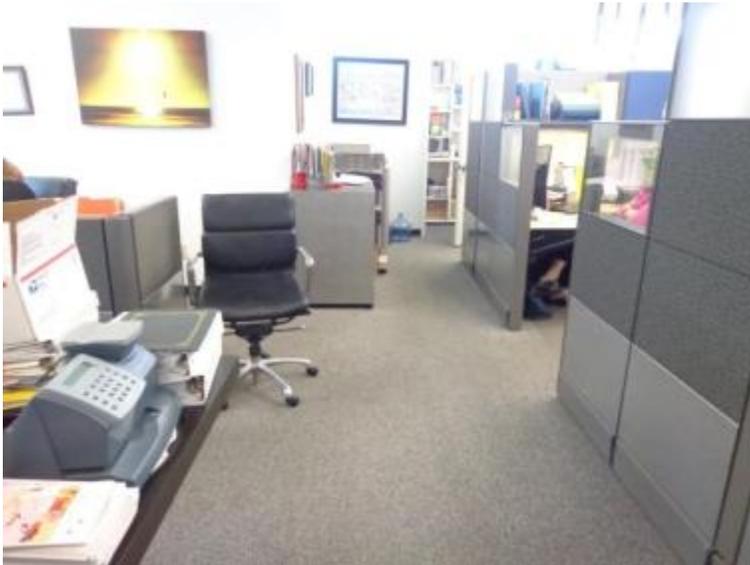
**Photograph No. 14**

The sheet carpet floor coverings appeared to be in fair condition. The typical EUL of carpet sheet is ten-years and therefore we have recommended for its replacement near-term in the study period (reference Photographs 14 and 18 in Appendix B).

Additional view of the typical interior finishes.

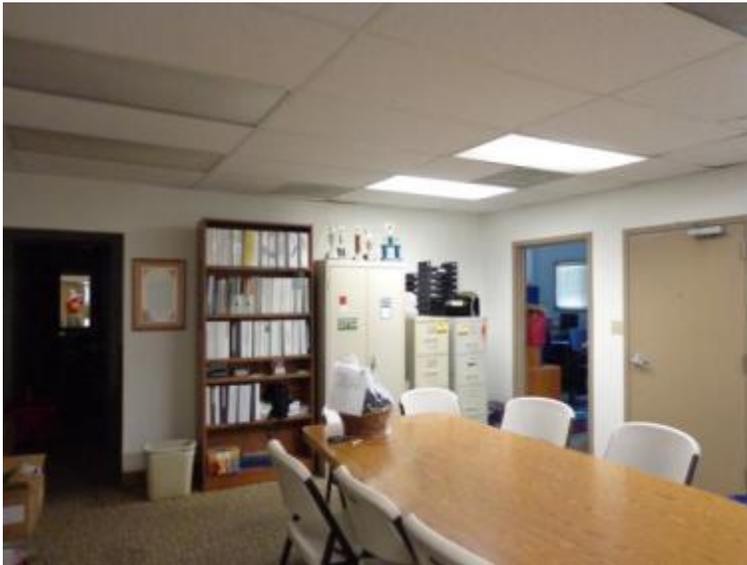
**Photograph No. 17**

The Dial a Ride offices contained 2' x 4' suspended acoustical tiled ceilings within a white enameled exposed grid system (reference Photograph 17 in Appendix B). The system is supported with wires from the underside of the roof construction above. The ceiling panels are generally 5/8" thick mineral board in fissured pattern. The ceiling system incorporated lighting and air-handling components.

The suspended acoustical ceiling systems appeared to be in fair to good condition. We do not anticipate a requirement for replacement during the study period.

View of the suspended ceiling in the Dial a Ride offices.

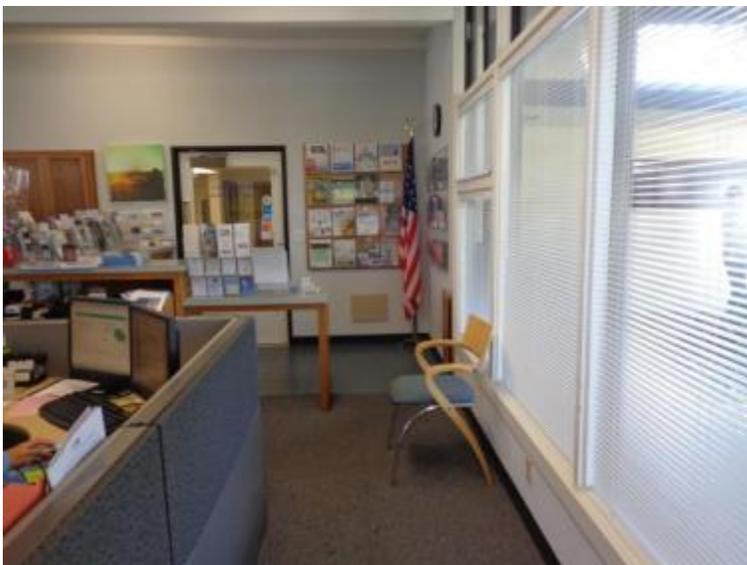
**Photograph No. 18**

View of carpet floor coverings in the Chamber of Commerce office.

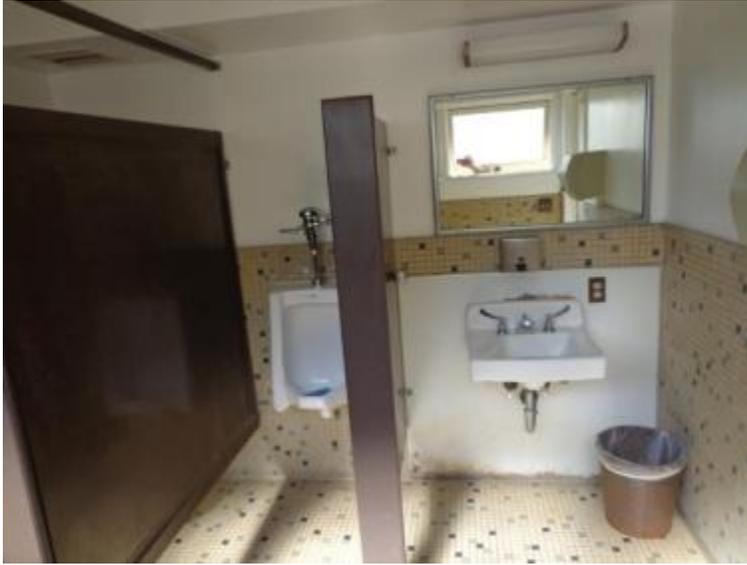
**Photograph No. 19**

The urinal and flush valve appeared to be in fair condition. The urinals flushed properly and did not have any cracks in the china. However the urinal is not currently ADA compliant. Therefore, we recommend replacement with of the current urinal with a waterless or low-flow ADA compliant urinal during the study period.

View of the urinal and one of the wall hung lavatories.

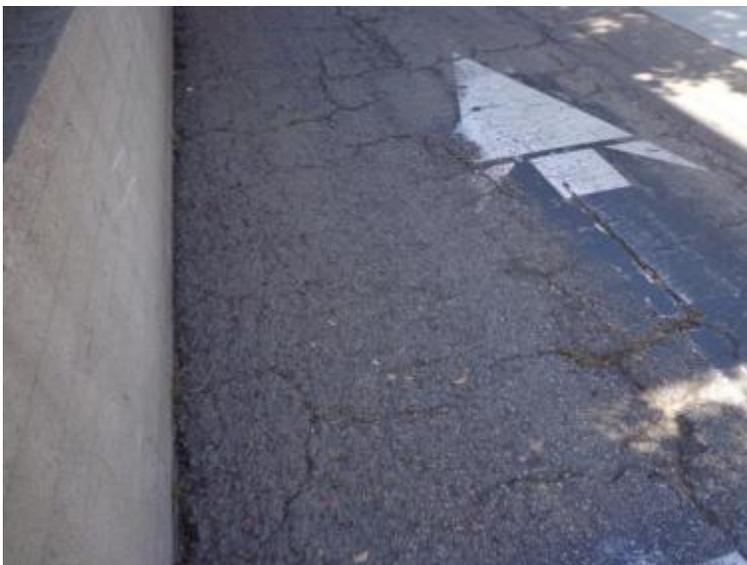
**Photograph No. 30**

View of the condition of the alley pavement.
