Citywide
Facility Condition Assessment

Report of
Facility Condition Assessment

For
City of Manhattan Beach
Creative Arts Center
1560 Manhattan Beach Boulevard, Manhattan Beach, CA

*August 23, 2013
(Rev A)*

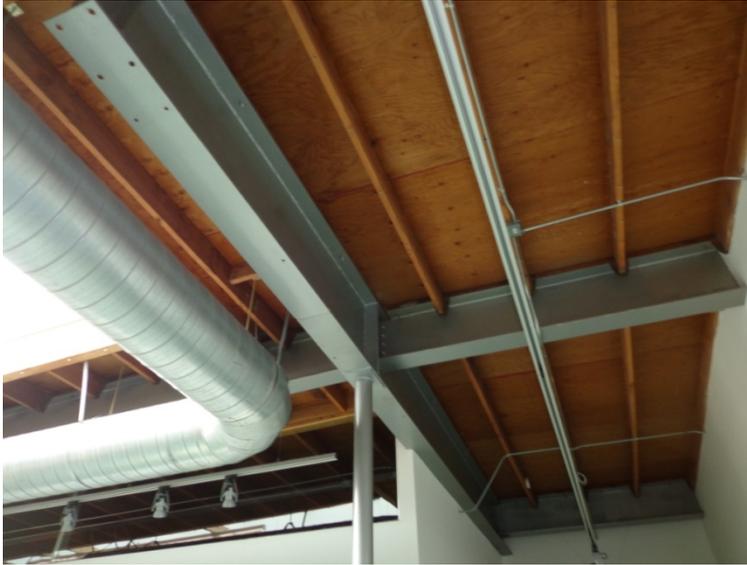
Photograph No. 1

The flat roof construction at the building appeared to be in good condition. There were no visible signs of failure noted. We do not anticipate any expenditure during the cost study period which relates to replacement of the roof structure.

View of the roof framing system.

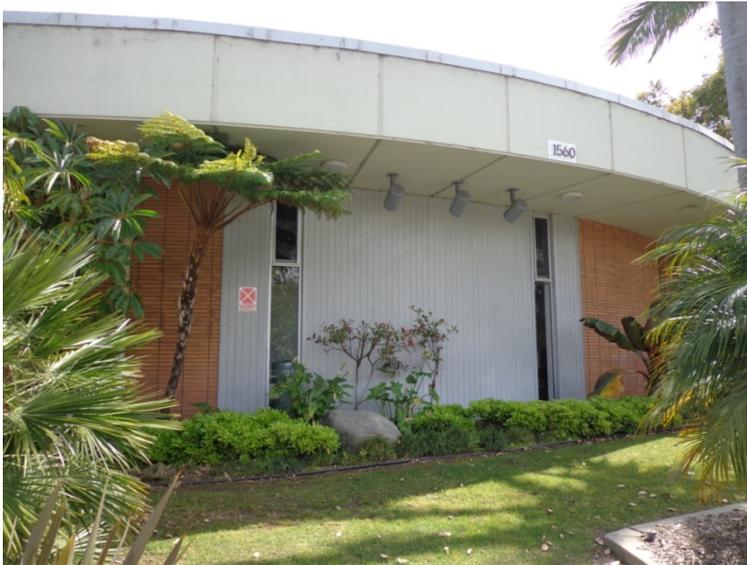
Photograph No. 2

The exterior window units appeared to be in fair condition. They were installed in circa 2000 and there were no major deficiencies observed. We do not anticipate any actions for their replacement as they will last beyond the study period, however consideration should be made for their replacement to insulated units for energy efficiency and improve thermal resistance.

View of finishes and windows at the front elevation.

The caulking at the perimeter of the window units was generally in fair to good condition. We recommend that the caulking at the window perimeters is replaced near-term in the study period concurrent with exterior painting.

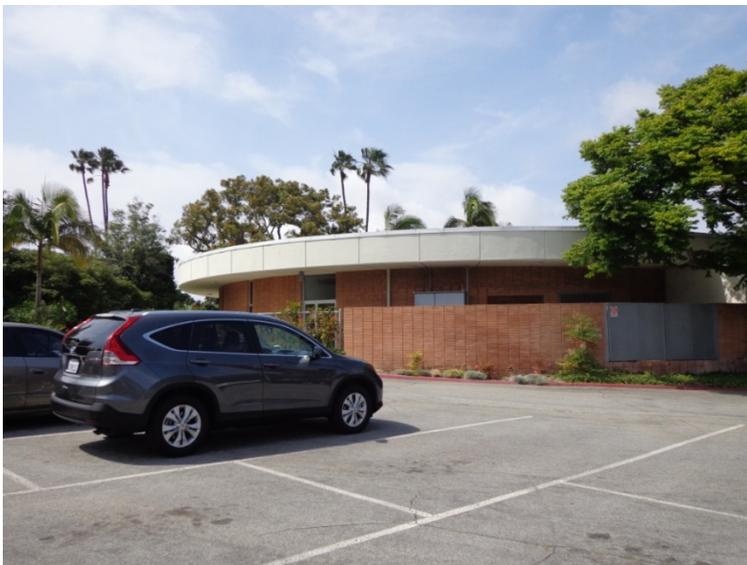
Photograph No. 3

The exterior wall systems at the building appeared to be in fair to good condition with generally no major signs of deterioration, water ingress or general failure noted. The exterior painted surfaces were reportedly last painted in circa 2009 and therefore based on the typical EUL of 4 years for exterior paint, as well as current observed conditions, re-painting will be necessary near-term in the study period and at future 4 year intervals to maintain the appearance and protect the exterior walls.

View of the rear elevation and finishes.

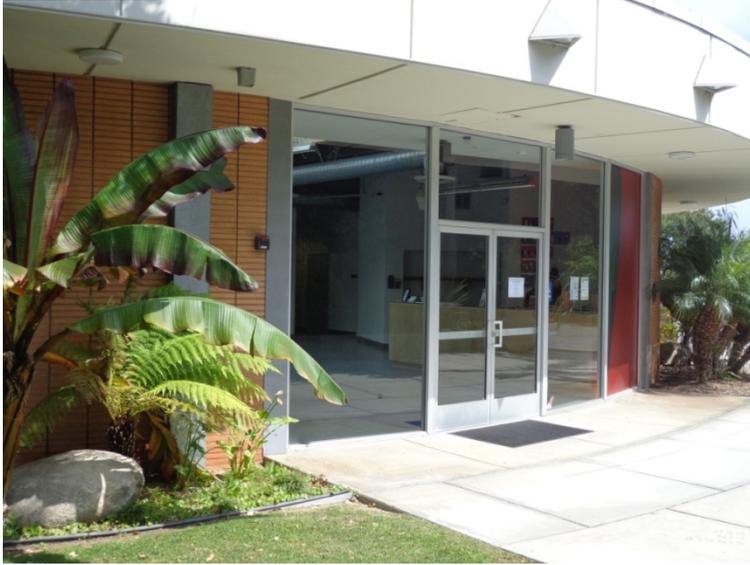
Photograph No. 4

The storefront systems appeared to be in good condition. We do not anticipate any replacement during the study period. Perimeter sealant replacement is included with the windows above.

View of the storefront system at the main entrance.

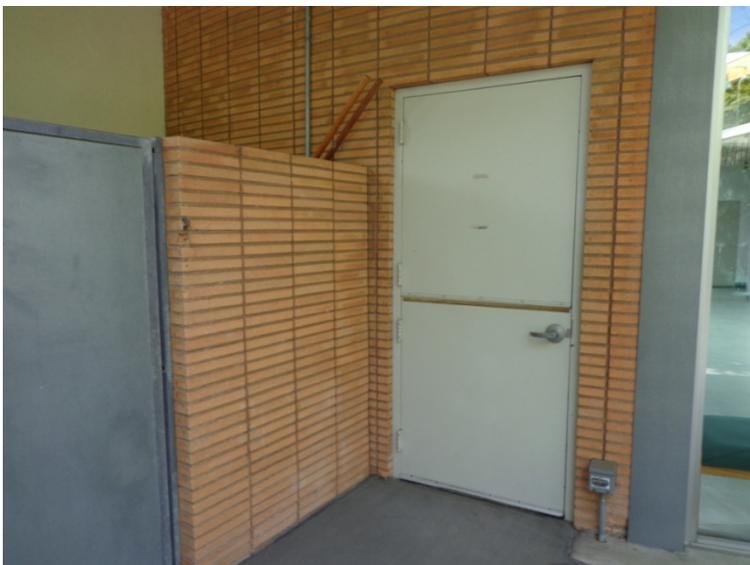
Photograph No. 6

The metal doors appeared to be in fair condition and there were no observed issues. In general the operation of the doors was satisfactory and operated without any difficulty. Re-painting concurrent with the building exterior will be necessary to maintain the doors.

View of a metal service door.

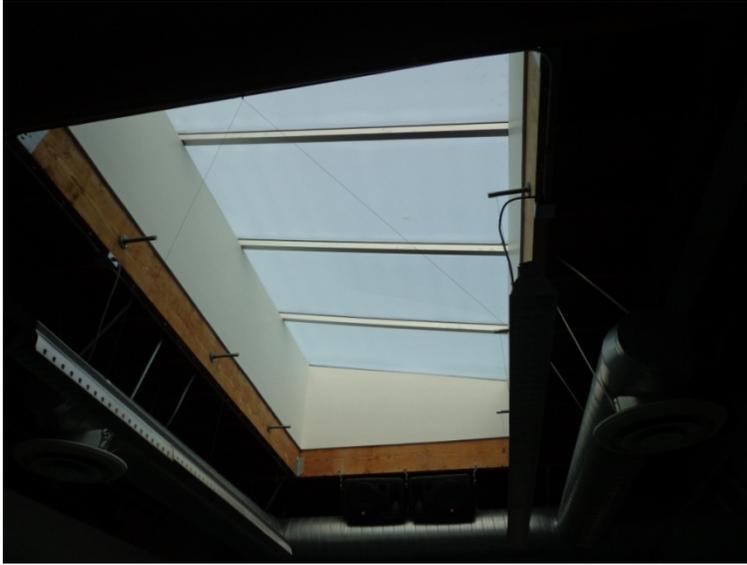
Photograph No. 7

The skylights were replaced in circa 2000 during the building renovation. Skylights of this type have a typical EUL of 30 years and based on observed conditions and an age of 13 years we anticipate that both of the skylights will last beyond the study period without replacement necessary. We did not see any areas of water ingress.

View of one of the two skylights.

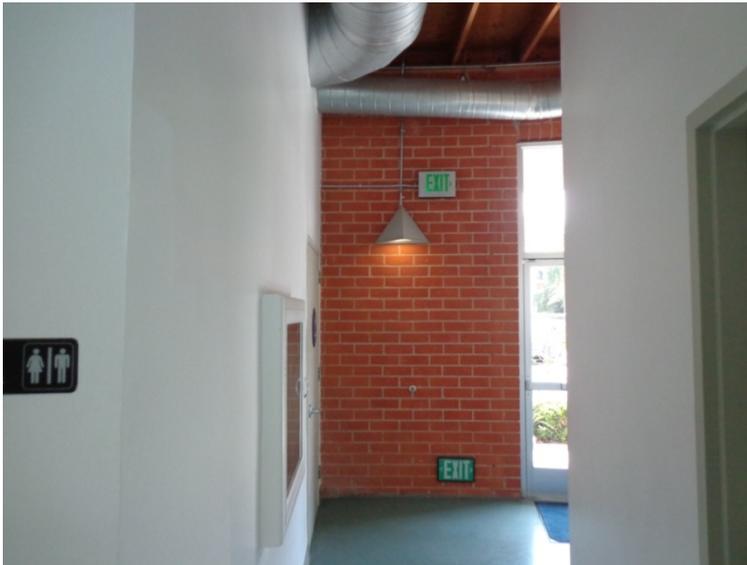
Photograph No. 8

The interior fixed partitions all appeared to be in fair to good condition. There were no deficiencies found in relation to the wall structures. The fixed partitions are suitable for the current use.

View of the typical interior partitions.

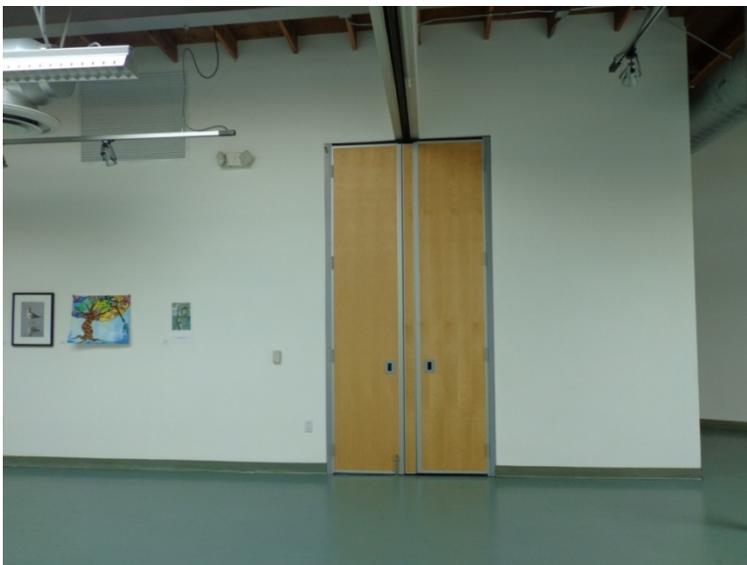
Photograph No. 9

The retractable partitions appeared to be in good condition and are suitable for the current use.

View of the closet containing the retractable partition.

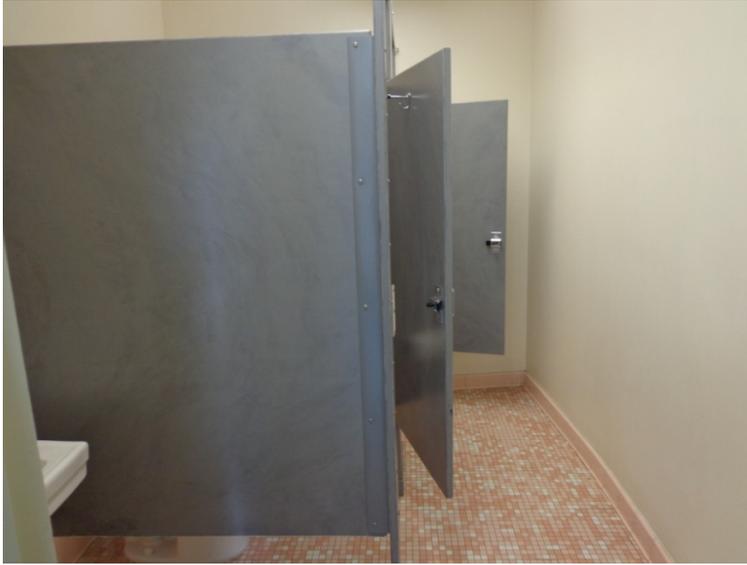
Photograph No. 10

The men's and women's restrooms have faux slate acrylic partitions mounted on stainless steel frames (reference Photograph 10 in Appendix B).

The toilet partitions appeared to be in good condition and are suitable for the current use.

View of the typical toilet partitions.

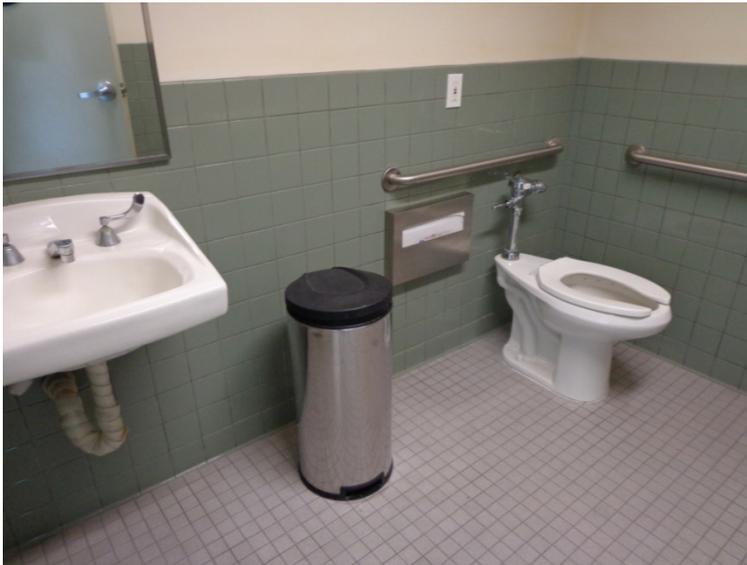
Photograph No. 11

The ceramic tiled walls within the restrooms appeared to be in fair to good condition. The typical EUL for ceramic tile wall coverings is 30-years and therefore with an age of 13-years, replacement should not be required.

View of the restroom finishes.
