Citywide
Facility Condition Assessment

Report of
Facility Condition Assessment

For
City of Manhattan Beach
Marine Avenue Park
1625 Marine Avenue, Manhattan Beach, CA

September 4, 2013
(Rev A)

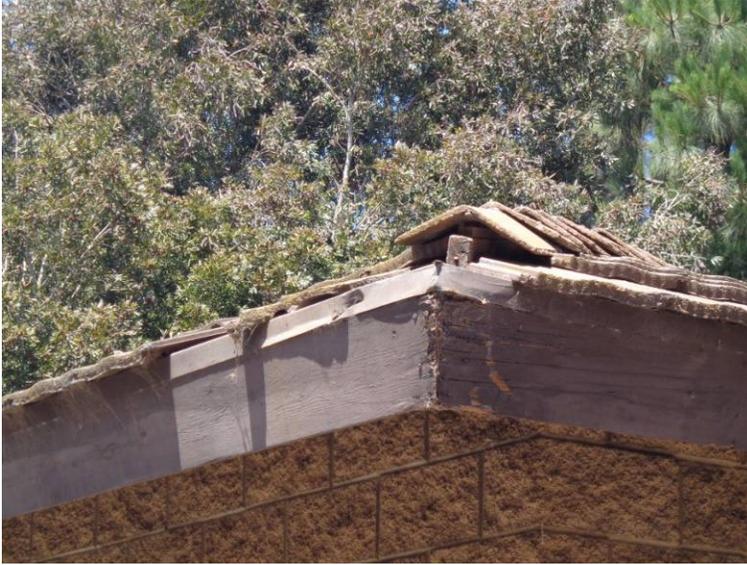
Photograph No. 12

The CMU walls and the wood trim materials appeared to be in fair condition. There were localized areas of damaged wood soffit and fascia observed at the building (reference Photograph 12 in Appendix B). This extends into the roof structure. We recommend near-term repair of the damaged trim materials. The painted surfaces were reportedly painted in 2010 and therefore based on the EUL of 4 years for exterior paint for this building, re-painting will be necessary near-term in the study period to maintain the appearance and protect the exterior components.

View of the typical damage observed at the Community Building trim.
