Citywide  
Facility Condition Assessment

Report of  
Facility Condition Assessment

For  
City of Manhattan Beach  
Fire Station #2  
1400 Manhattan Beach Boulevard, Manhattan Beach, CA

*August 23, 2013  
(Rev A)*

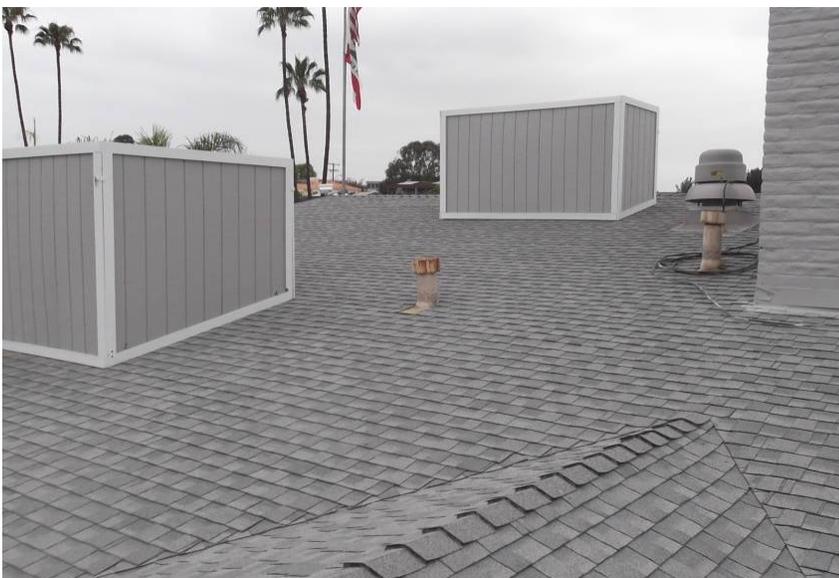
**Photograph No. 6**

Roof 1, on the Station House, contains a covering of granular-surfaced, multi-tab asphalt-fiberglass shingles (reference Photograph 6 in Appendix B), including over the apparatus bays, sleeping quarters and hose tower. Rooftop mechanical equipment is enclosed by panels of painted wood siding attached to metal and wood framing. Storm water typically drains to the roof edge, with aluminum gutters provided over some entrances, draining to grade and into an underground stormwater system.

The asphalt-fiberglass shingle roof coverings appeared to be in good condition, with no evidence of leaks or water ingress. Minor issues noted include initial weathering/aging of the shingles and the need for all metal flashing surfaces to be painted for protection from corrosion. Based on the typical EUL of 20 to 25 years for roofing such as this, we do not anticipate replacement will be necessary in the study period. We recommend the equipment enclosure panels be painted at the time of building exterior repainting.

View of the roof and equipment enclosures

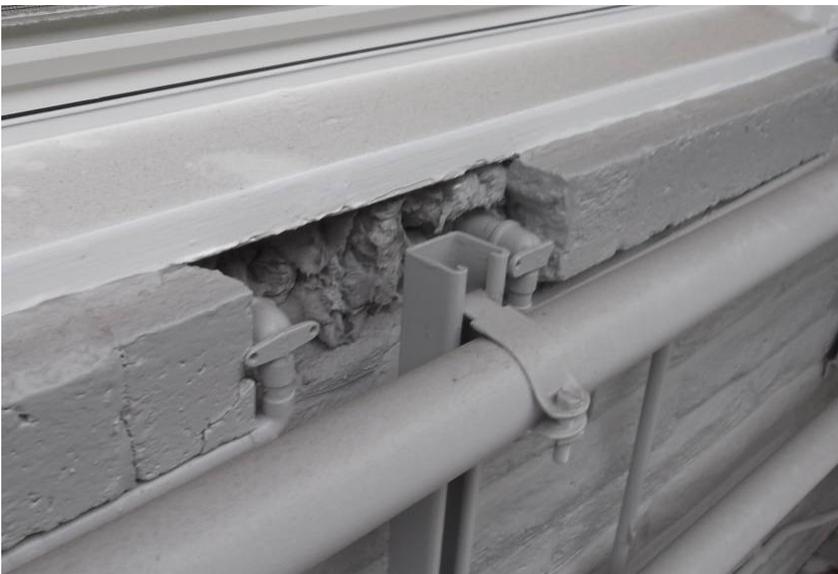
**Photograph No. 9**

The exterior wall systems at each of the buildings appeared to be in good condition, with no major indications of deterioration, water ingress or general failure noted. Localized areas of damaged brick, at locations of electrical component installation, were noted at the Station House (reference Photograph 9 in Appendix B). The exteriors of the Station House and Gymnasium appear to have been recently painted, but based on an EUL of 4 years for exterior paint for this building, we recommend budgeting for repainting in the near-term. In conjunction with the repainting, we recommend repairs be made to the exterior sealants as needed.

View of masonry damage caused by electrical installation at the south side of the building.

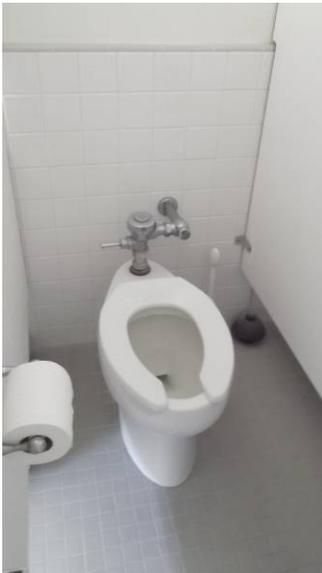
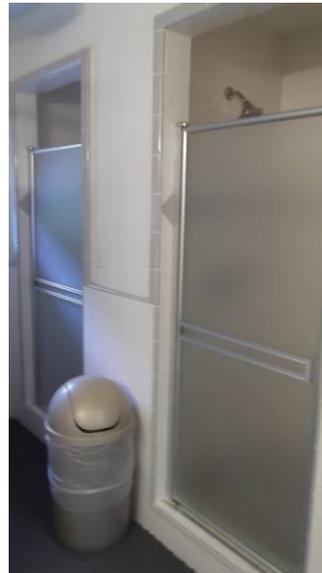
**Photograph Nos. 14 & 15**

View of the showers and restroom fixtures

We have recommended a full upgrade / renovation of the restrooms during the study period which will include full replacement of the fixtures and a major floor plan modification.

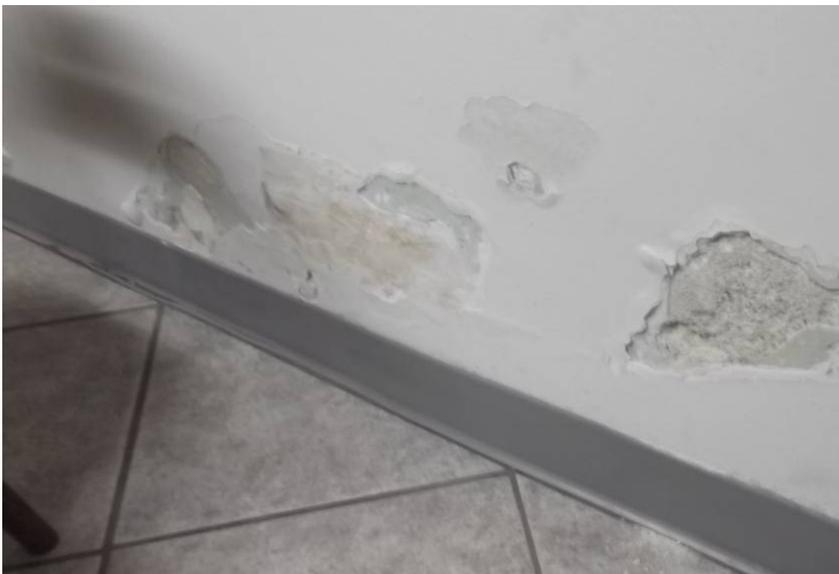
**Photograph No. 16**

View of water damaged plaster in the dining room, adjacent to the shower stalls.

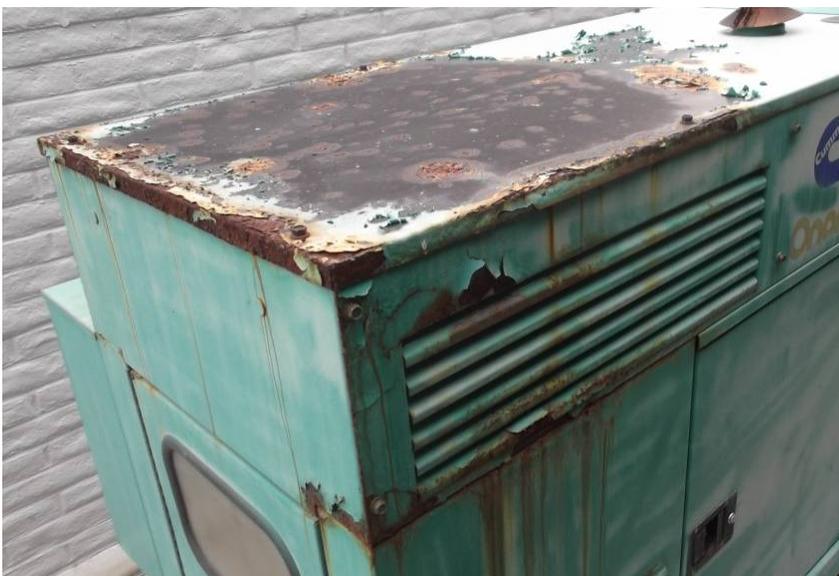
**Photograph No. 30**

View of the peeling paint and corrosion on the generator housing.

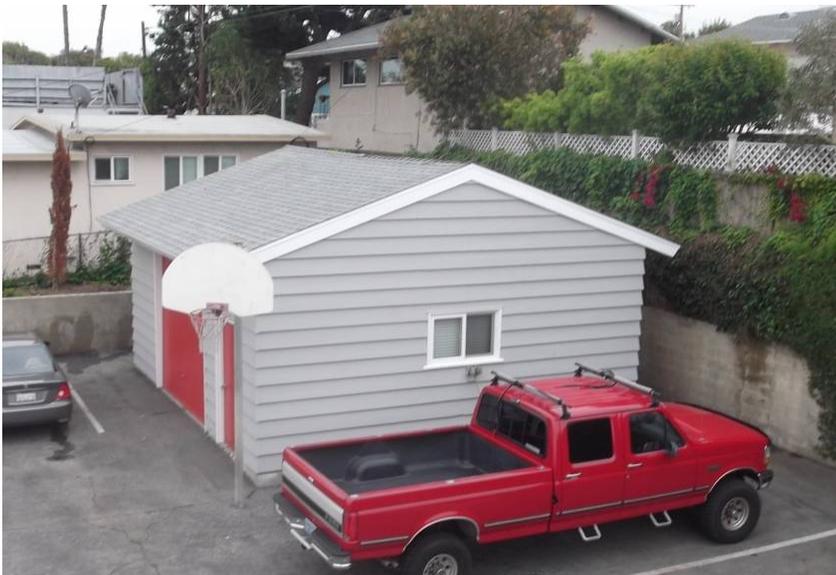
**Photograph No. 32**

Roof 2, on the Gymnasium, also contains a covering of granular-surfaced, multi-tab asphalt-fiberglass shingles (reference Photograph 32 in Appendix B). Storm water typically drains to the roof edge.

View of the building's roofing.

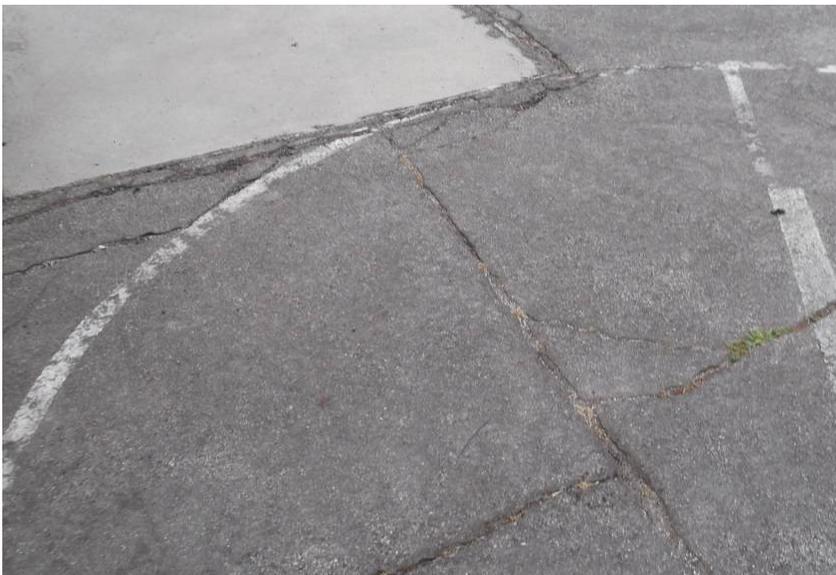
**Photograph No. 38**

View of asphalt pavement deterioration.

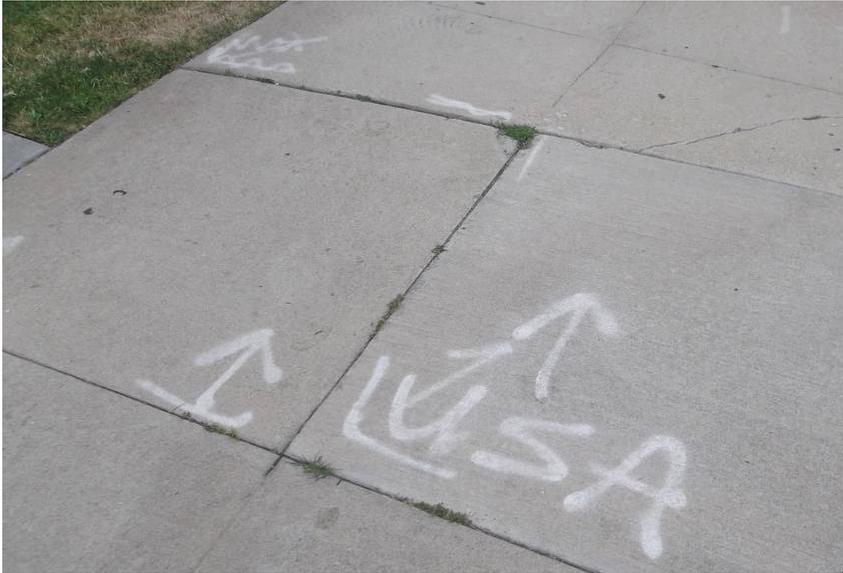
**Photograph No. 40**

View sidewalk sections with cracking and slight settlement along the south side of the site.

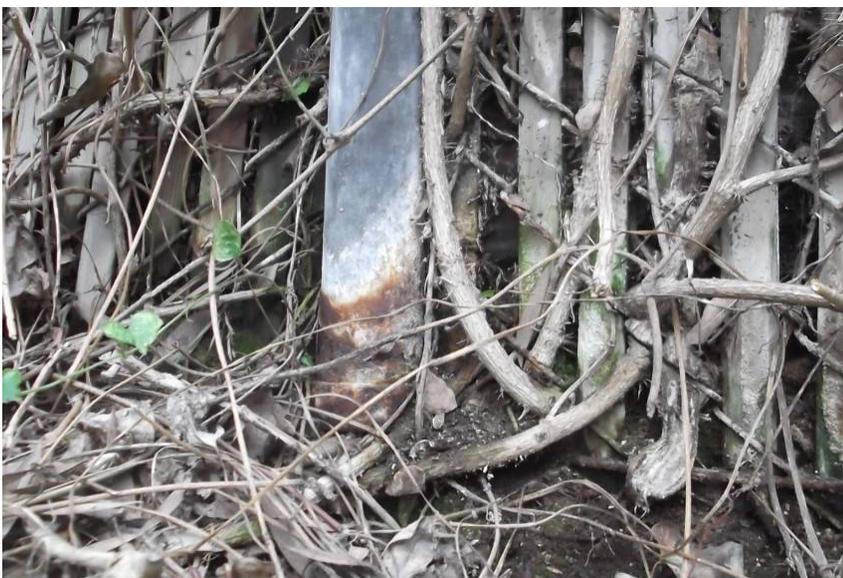
**Photograph No. 42**

View of corrosion in the chain-link fencing along the south side of the site.

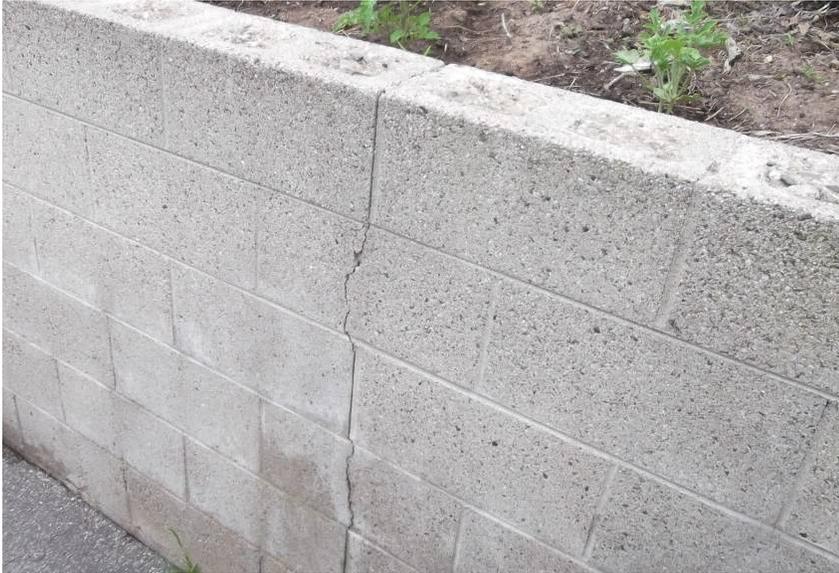
**Photograph No. 43**

View vertical cracking in the retaining wall along the east side of the site.
