Citywide
Facility Condition Assessment

Report of
Facility Condition Assessment

For
City of Manhattan Beach
Polliwog Park
1601 Manhattan Beach Boulevard, Manhattan Beach, CA

*September 4, 2013
(Rev A)*

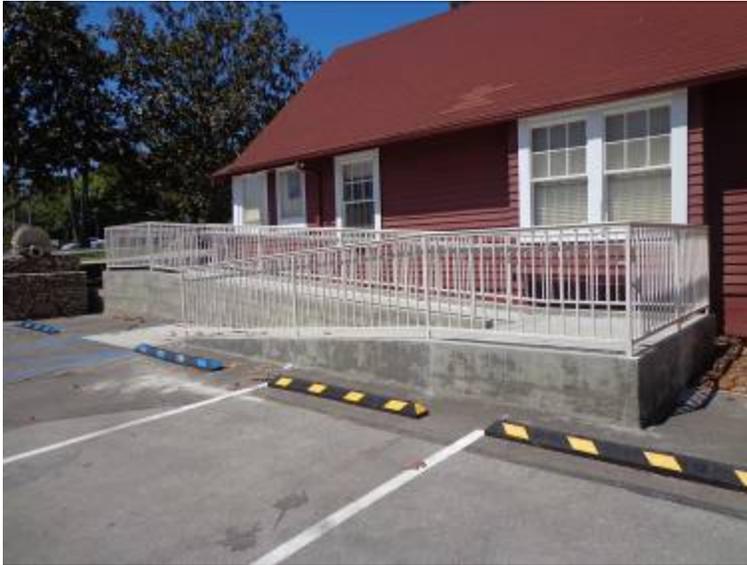
Photograph No. 1

The ramp appeared to be in good condition. We do not anticipate any actions for its replacement during the study period.

View of the concrete ramp at the Historic House.

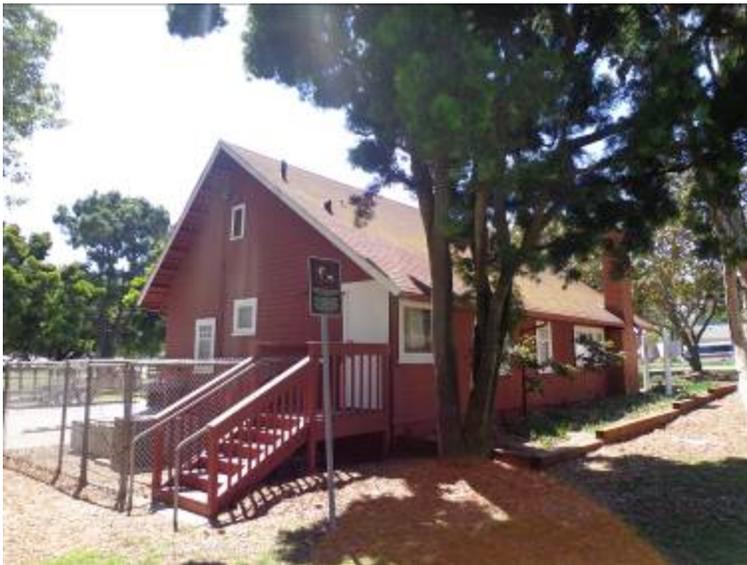
Photograph No. 2

The wood stairway construction appeared to be in good condition. We do not anticipate any actions for its replacement during the study period.

View of the exterior stairway at the Historic House.

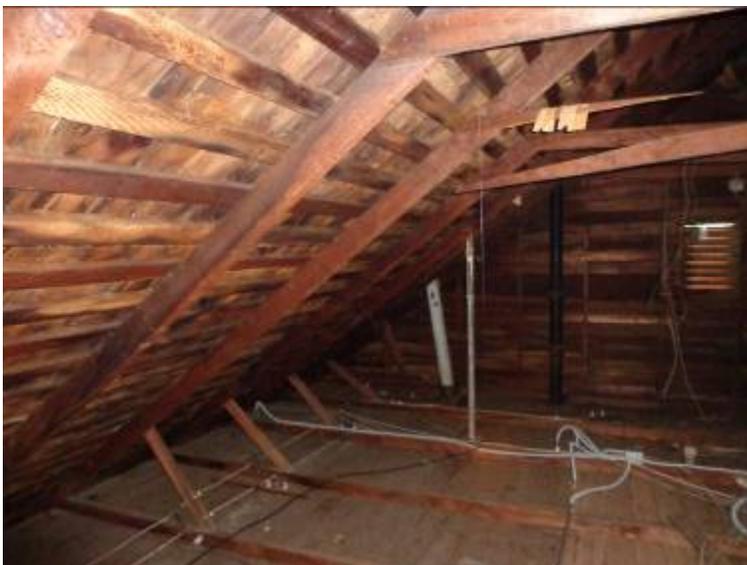
Photograph No. 3

The pitched roof construction at the building appeared to be in fair to good condition. There were no visible signs of failure noted. We do not anticipate any expenditure during the cost study period which relates to replacement of the structure.

View of the roof framing at the Historic House.

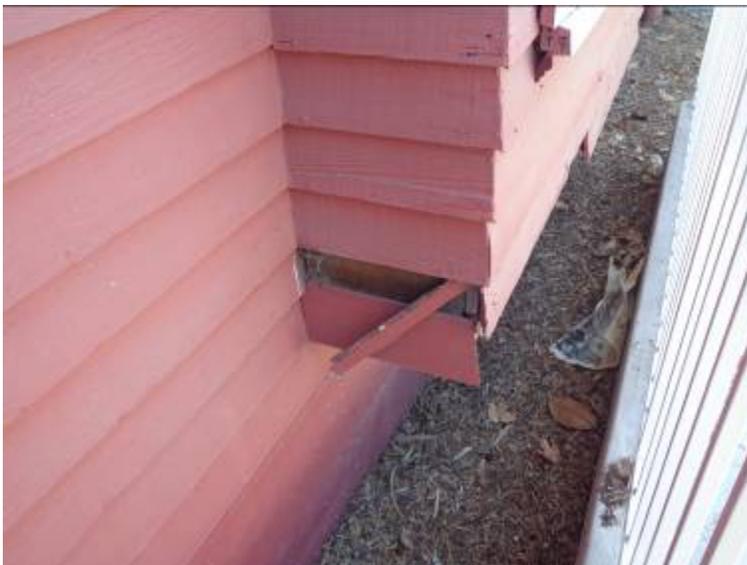
Photograph No. 12

View of the typical damage observed at the house clapboards.

B Shell: Repair exterior wood clapboards at an estimated cost of \$4,500 in year 2013
-

- ✚ Repair exterior clapboards

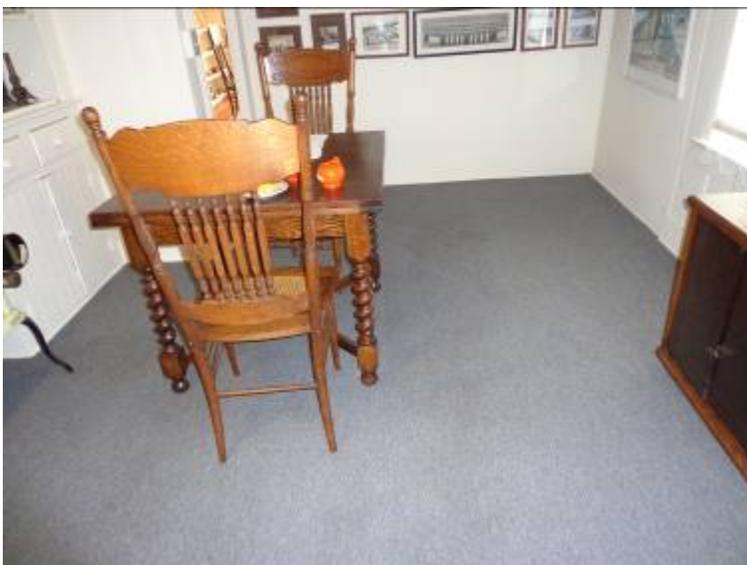
Photograph No. 18

View of the carpet floor coverings.

C Interiors: Replace sheet carpet floor covering at an estimated cost of \$3,149 in year 2015

- ✚ Replace carpet

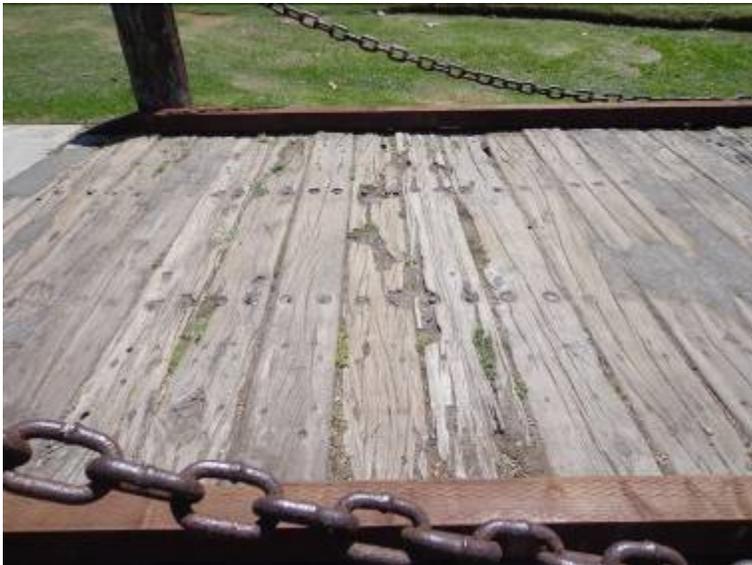
Photograph No. 36

View of the deteriorated bridge deck.

- + G Building Sitework: Replace the pedestrian bridge deck at an estimated cost of \$12,500 in year 2013
- + G Building Sitework: Replace the playground mats at an estimated cost of \$52,500 in years 2014 and 2019
- + G Building Sitework: Replace light fixtures at an estimated cost of \$108,800 in year 2013

+ Replace pedestrian bridge deck
