Citywide
Facility Condition Assessment

Report of
Facility Condition Assessment

For
City of Manhattan Beach
Public Safety Building and Fire Station No. 1
400-420 15th Street, Manhattan Beach, CA

*September 4, 2013
(Rev A)*

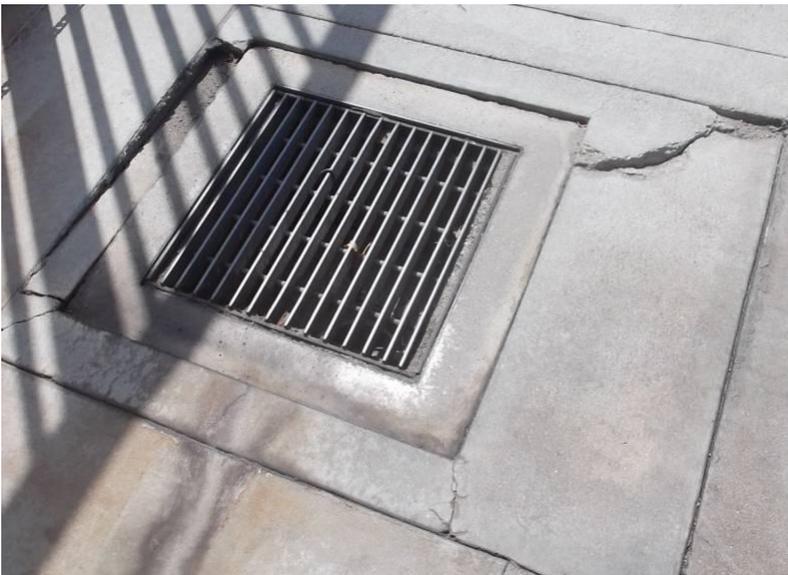
Photograph 15

View of storm water inlet, with concrete cracking

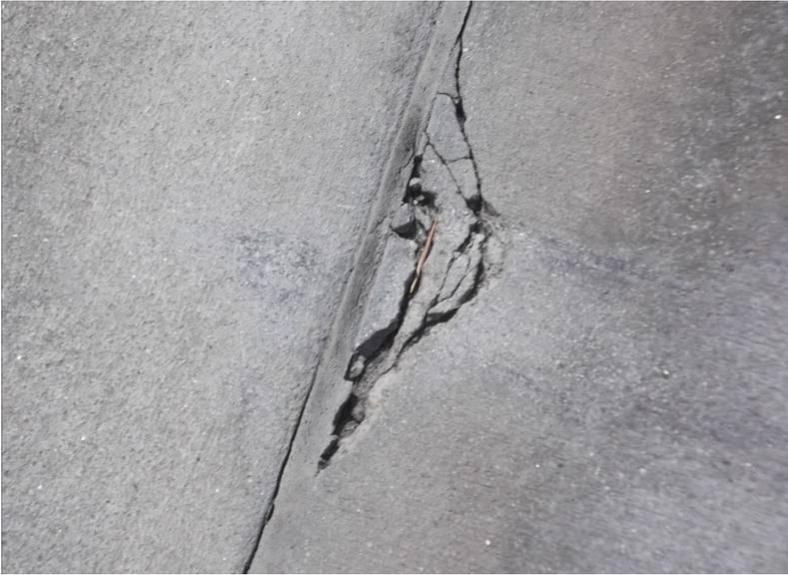
Photograph 16

The cast-in-place concrete slabs-on-grade appeared to be in good condition. Minor cracking was observed in various locations of the parking garage, but the quantity of the cracking was minimal and the cost for repairs falls below the threshold of \$500. Therefore, we have not been included such costs within the expenditure forecast.

Detail of cracking in the surface parking deck

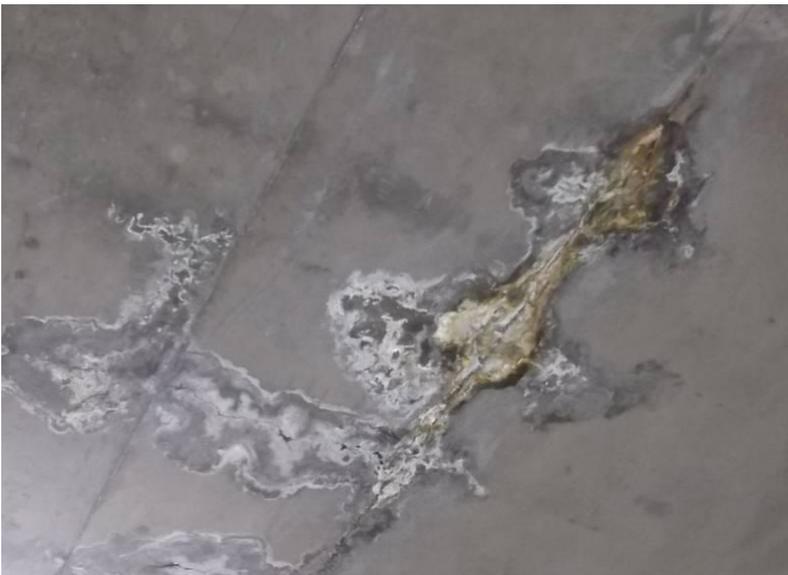
The elevated floors' construction is in good condition, with no indications of structural insufficiency observed or reported to us. However, there were signs of limited water infiltration through the first floor's concrete deck, observed on the underside of the deck in the parking garage (reference Photograph 18 in Appendix B). The infiltration has occurred from the surface parking deck areas, primarily around deck penetrations for drains. These conditions should be monitored during the period of study and if conditions worsen, repairs to the seals at the penetrations should be completed as part of operational maintenance. We do not anticipate expenditure during the cost study period relating to significant repair or replacement of the upper floor construction.

View of the underside of the surface parking deck, with water infiltration staining

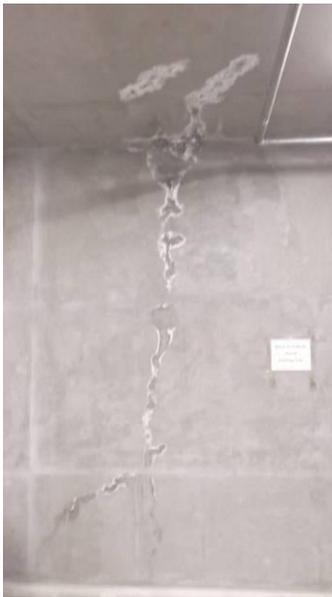
Photograph. 19

The observable portions of the building foundations (in the basement) appeared to be in good condition, with no indication of significant structural deficiency observed. We assume that the hidden reinforced concrete supports are also in good condition. Hairline cracking, efflorescence indicating minor water infiltration, was noted in several locations in the parking garage (reference Photograph 19 in Appendix B) and is reported to be an ongoing issue. These conditions should be monitored during the period of study.

View of the basement foundation wall with water infiltration staining

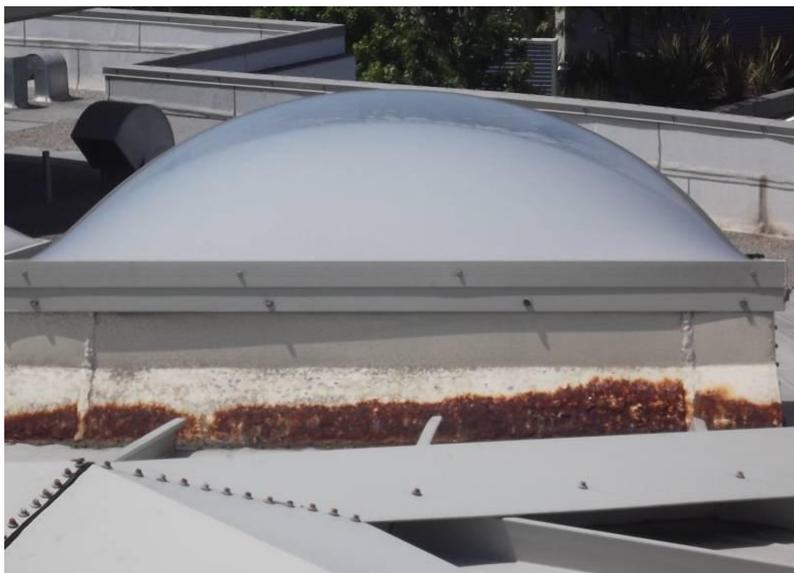
Photograph 24

Detail view of corrosion in the skylight curbing at the fire station

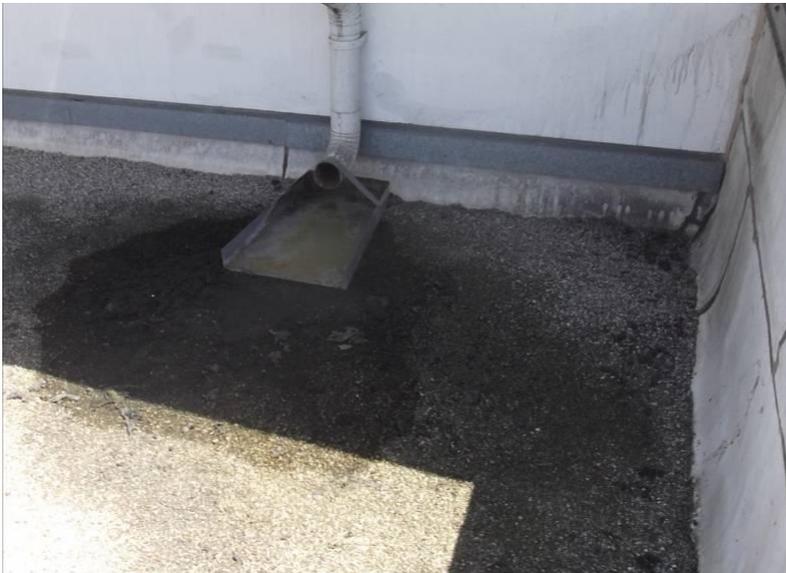
Photograph 26

Detail view of staining on the roofing, an indication of regular ponding water

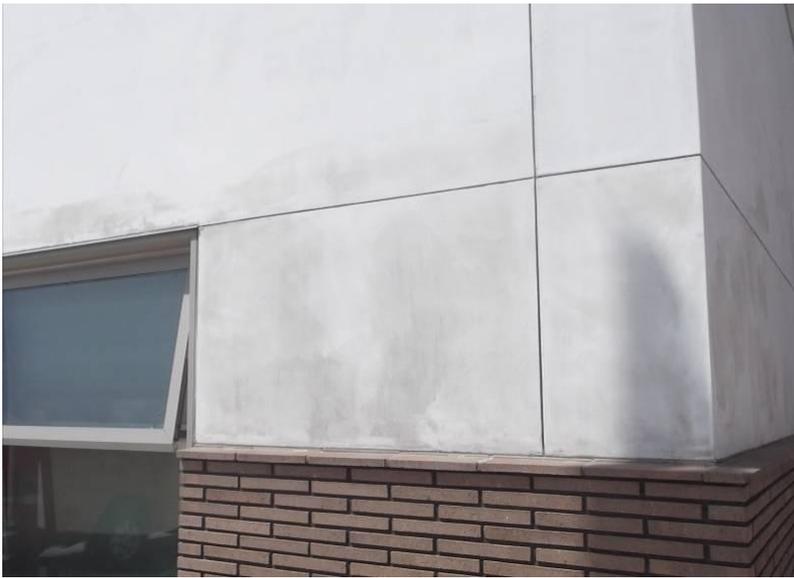
Photograph 28

The exterior wall systems of the building appeared to be in good overall condition, with no significant signs of deterioration, water ingress or general failure noted. However, surface cracking in the stucco plaster and areas of staining/discoloration were noted on most façades (reference Photographs 28 and 29 in Appendix B). The exterior painted surfaces were reportedly last painted in 2011 and, based on the EUL of 4-years for exterior paint at this building, as well as current observed conditions, minor plaster repairs and re-painting will be necessary in the near-term in the study period to maintain the appearance and protect the exterior walls.

Detail view of staining/markings on the stucco cladding

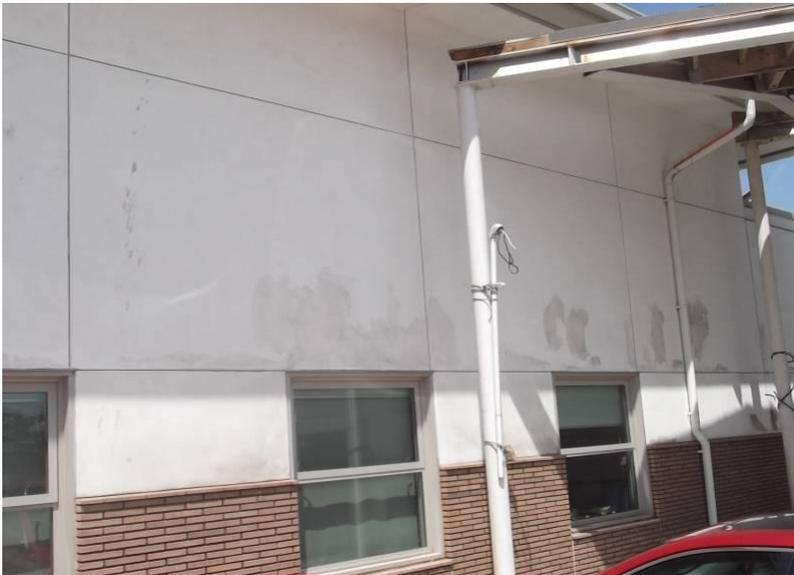
Photograph 29

Detail view of staining/markings on the stucco cladding

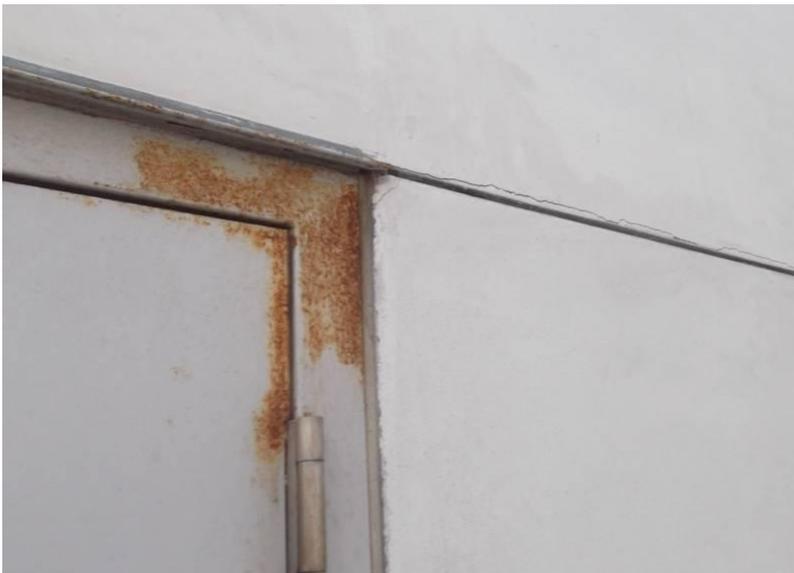
The exterior doors appeared to be in good condition, although corrosion was noted, exacerbated as a result of the marine environment (reference Photograph 30 in Appendix B). Also, the entrance doorways are difficult to operate therefore we recommend the installation of a suitable automatic door opening device for disabled use and also the refinishing of the door surfaces at regular intervals in the study period.

Detail view of corrosion on a metal door and frame

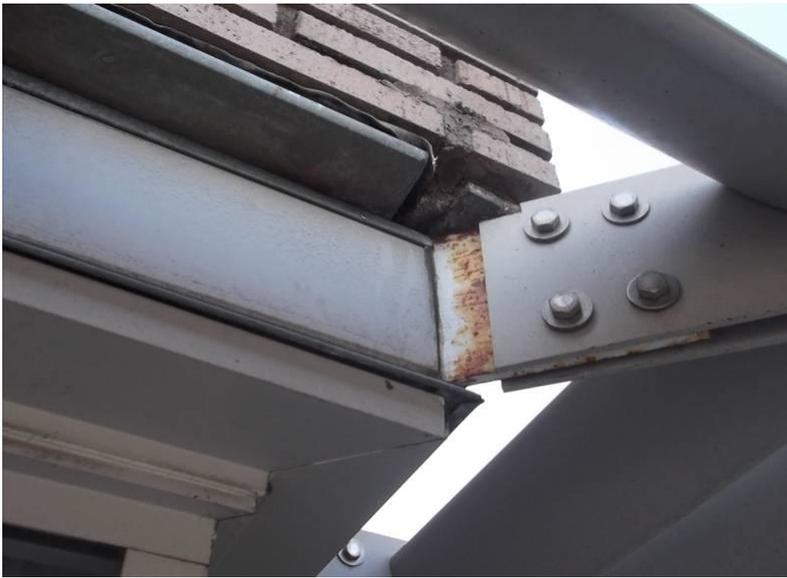
The canopies were in good condition, but initial corrosion was noted to be forming on the steel supports and the adjacent shelf-angles over the window openings (reference Photograph 31 in Appendix B). We recommend the metals be cleaned and repainted at the time of other exterior painting.

Detail view of corrosion on sun screen framing
