Citywide
Facility Condition Assessment

Report of
Facility Condition Assessment

For
City of Manhattan Beach
Manhattan Heights Park
1600 Manhattan Beach Boulevard, Manhattan Beach, CA

*September 4, 2013
(Rev A)*

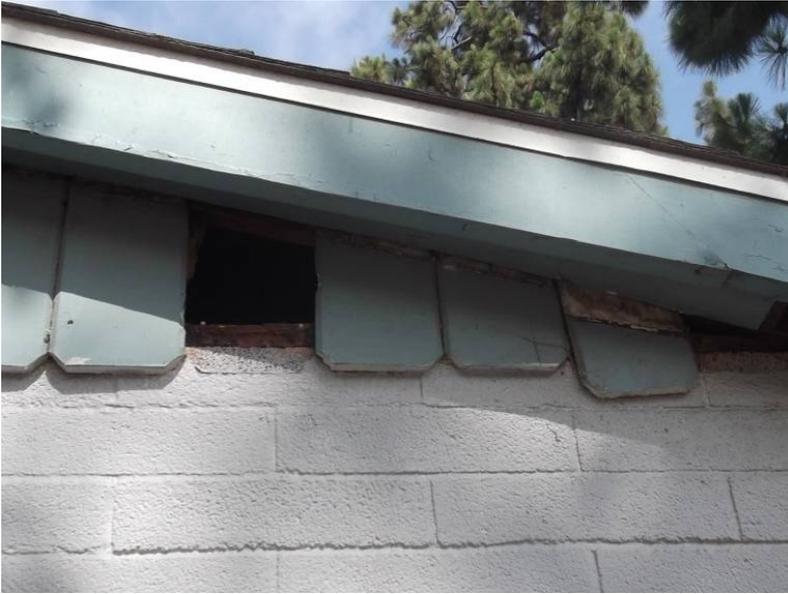
Photograph 10

The buildings' painted concrete masonry walls are in fair condition, with locations of cracking, chipped and spalled masonry and faded painted surfaces. The wood fascia and soffits of both buildings, the siding at the gable ends and on the cupola of Building 6 and Restrooms are deteriorated, with water damage and missing sections. Screening walls at each end of Building 6 and Restrooms, at the restroom entrances, have deteriorated plywood siding with faded paint. We recommend completion of fascia, soffit, siding and screening wall repairs to address the locations of deterioration, as well as repainting of the facades in the near term. Based on an EUL of 4 years, we recommend repainting of the early in the study period.

View of the deteriorated soffit of Building 6 and Restrooms

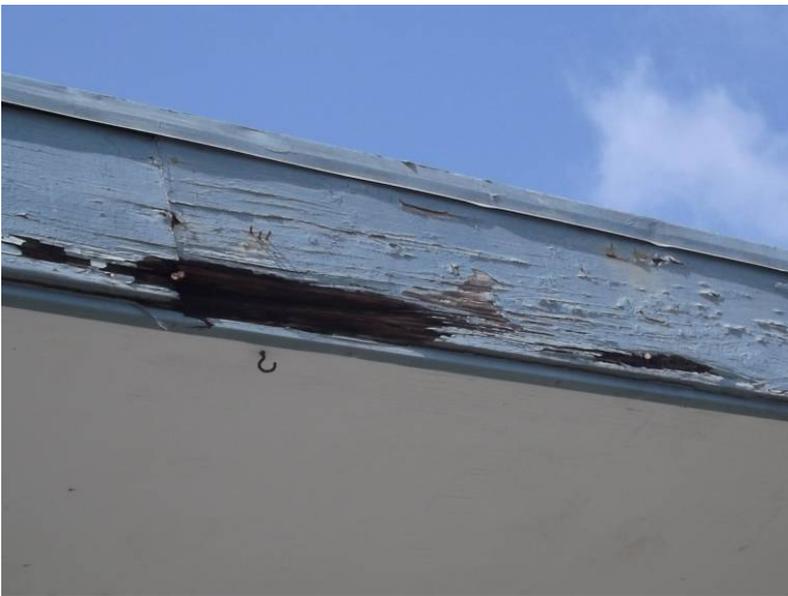
Photograph 17

View of deterioration in the fascia of Building 7

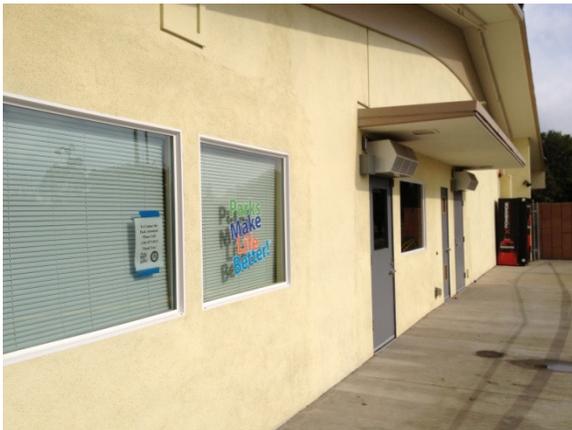
Figure 7: Patched Cracks in Stucco

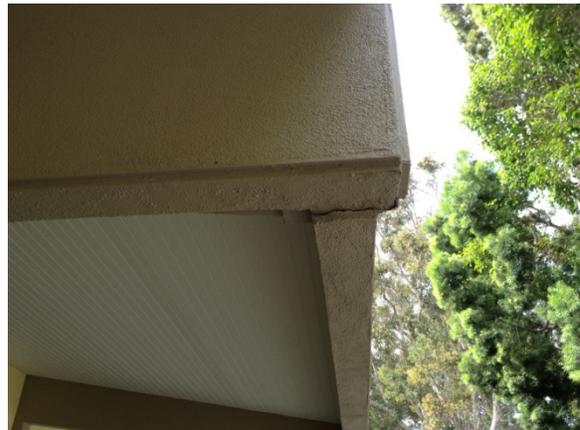
Figure 8: Crack between Roof Framing

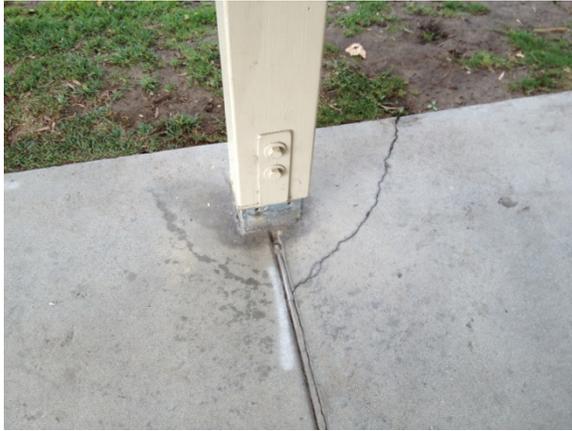
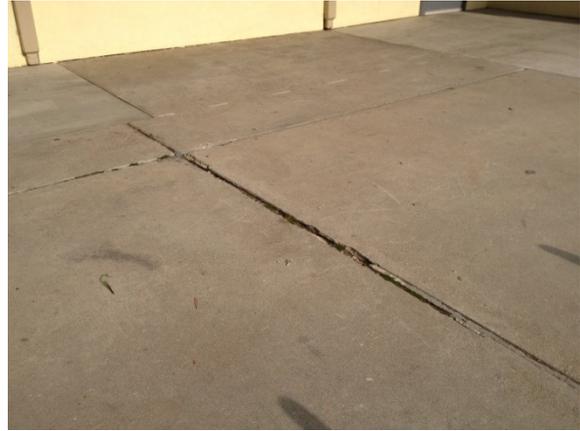
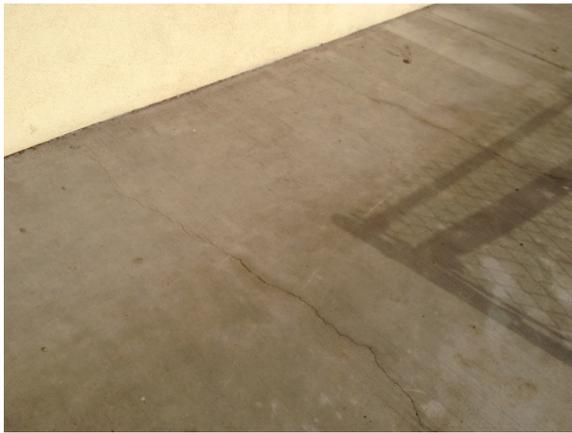
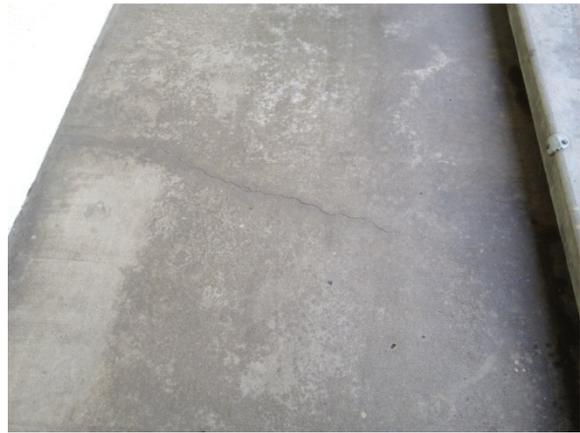
The cast-in-place concrete slabs at each of the buildings appeared to be generally in good condition. We do not anticipate any expenditure during the cost study period, which relates to their replacement. However the Community Center was observed to have minor cracking present in various locations. This has been detailed in the structural report in Appendix E. The necessary repair expenditure has been included in the study period.

Figure 9: Cracks and Heaving/Settlement in Slab on Grade

Element No.	Building Element	Recommendation	Qty	Unit	Rate	Cost	Year	Priority Code
A1031	Standard Slab on Grade	Undertake crack repairs within slab	30	LF	\$20.00	\$600	2014	3
Total Anticipated Expenditure for A Substructure						\$600

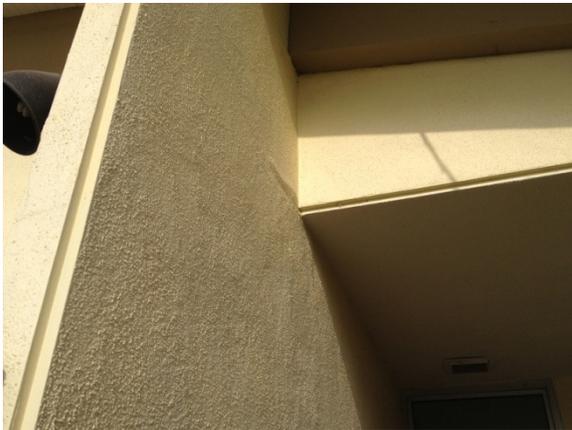
Figure 10: Bulging Stucco

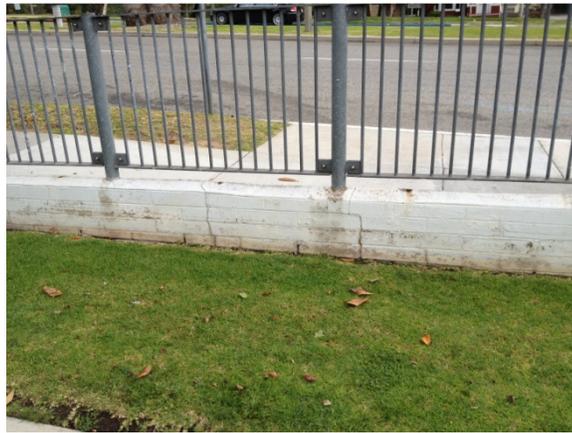
Figure 12: Crack in Low Retaining Walls

Item	Unit Cost	Quantity	Estimate Cost
Crack Repair in Planter Retaining Wall	\$30	30 feet	\$900
Crack Repair in Slab	\$20	30 feet	\$600

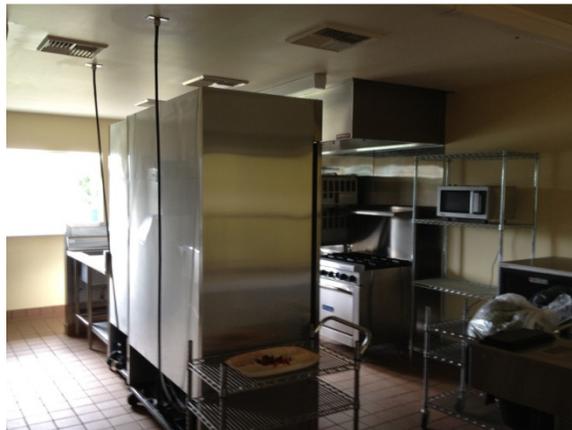
Figure 13: Unsupported Equipment
