Citywide
Facility Condition Assessment

Report of
Facility Condition Assessment

For
City of Manhattan Beach
Public Works Yard
3621 Bell Avenue, Manhattan Beach, CA

*September 4, 2013
(Rev A)*

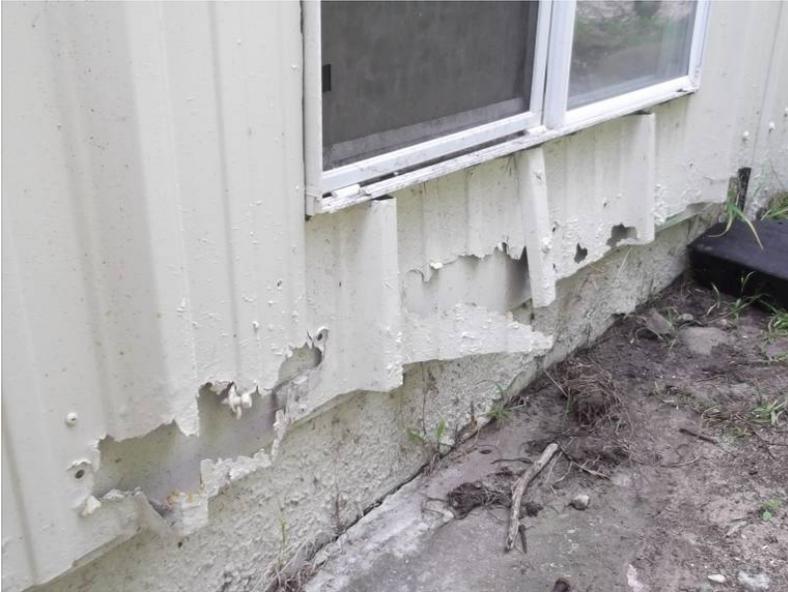
Photograph 4

View of deteriorated wood siding at Building A

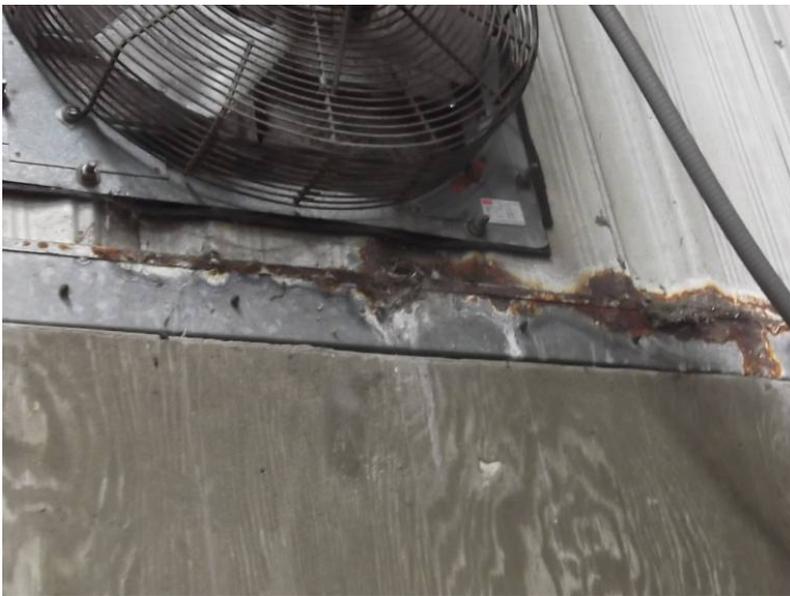
Photograph 26

View of exterior wall metal siding deterioration in Building B

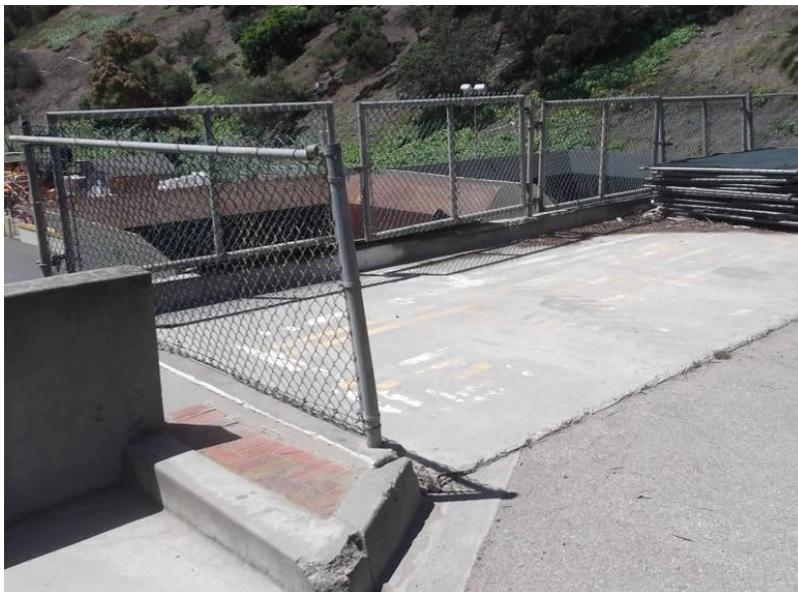
Photograph 36

View of concrete deterioration in the Sand/Gravel Hoppers

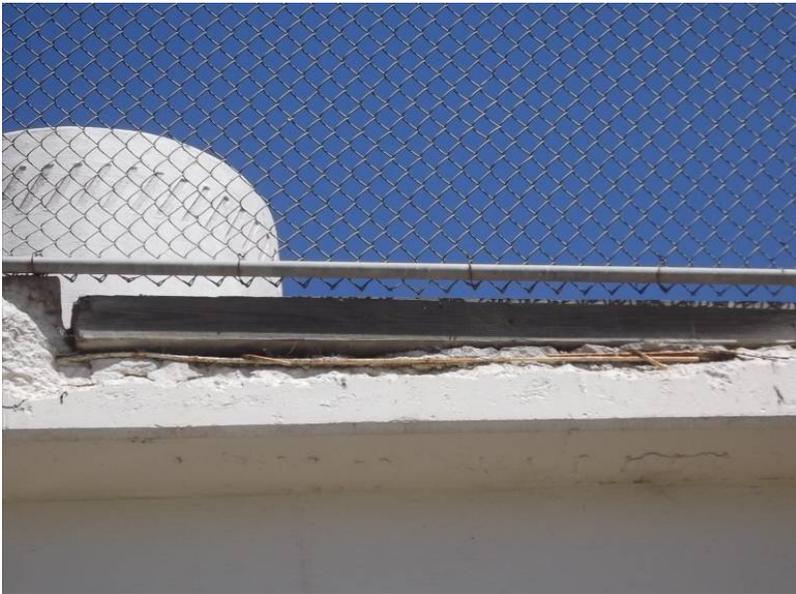
Photograph 38

View of the concrete deterioration at the upper deck of the Sand/Gravel Hoppers

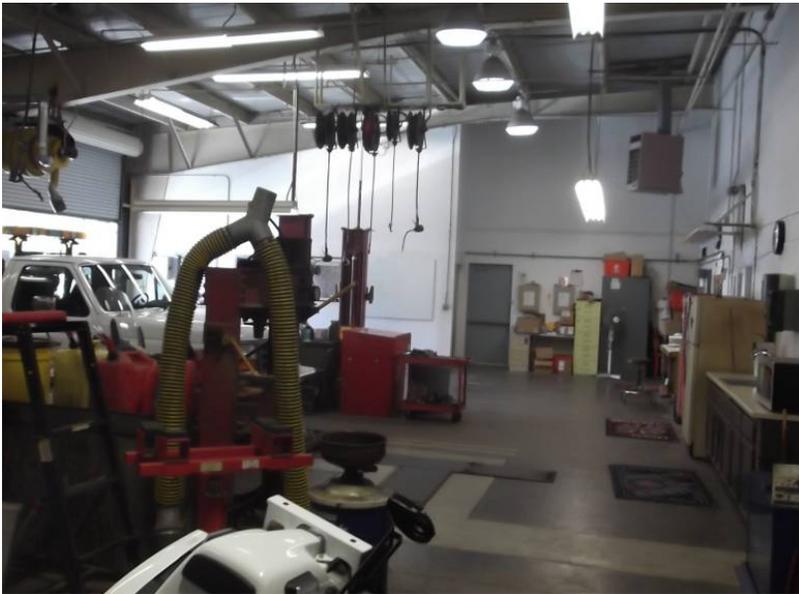
Photograph 50

View of deterioration under the skylight in Building D

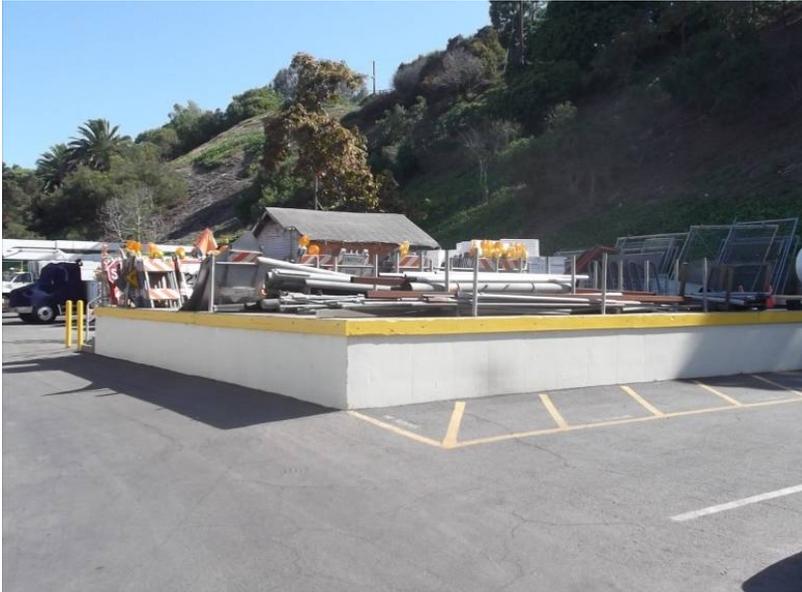
Photograph 85

View of cracking in the asphalt pavement

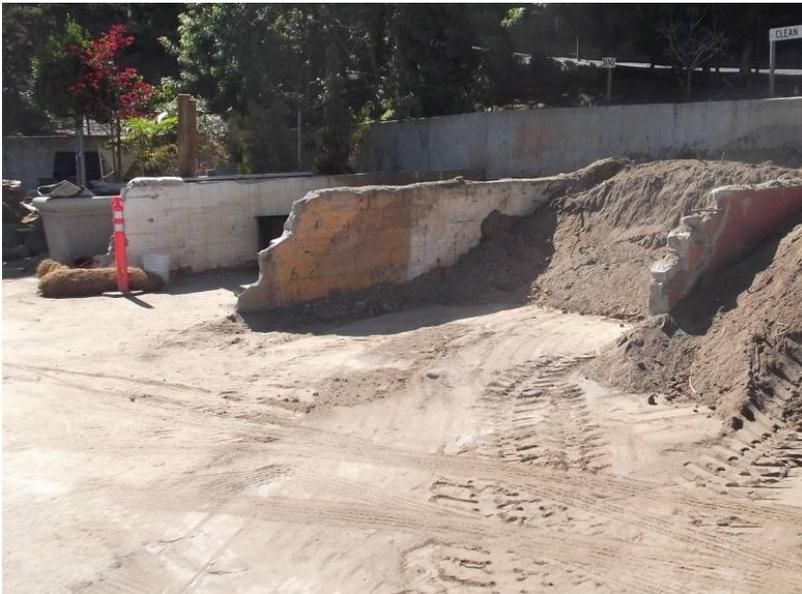
Photograph 92

View of deteriorated asphalt pavement in the bulk loading area
