Citywide  
Facility Condition Assessment

Report of  
Facility Condition Assessment

For  
City of Manhattan Beach  
Pier Roundhouse and Comfort Station  
100 Manhattan Beach Boulevard, Manhattan Beach, CA

September 18, 2013  
(Rev B)

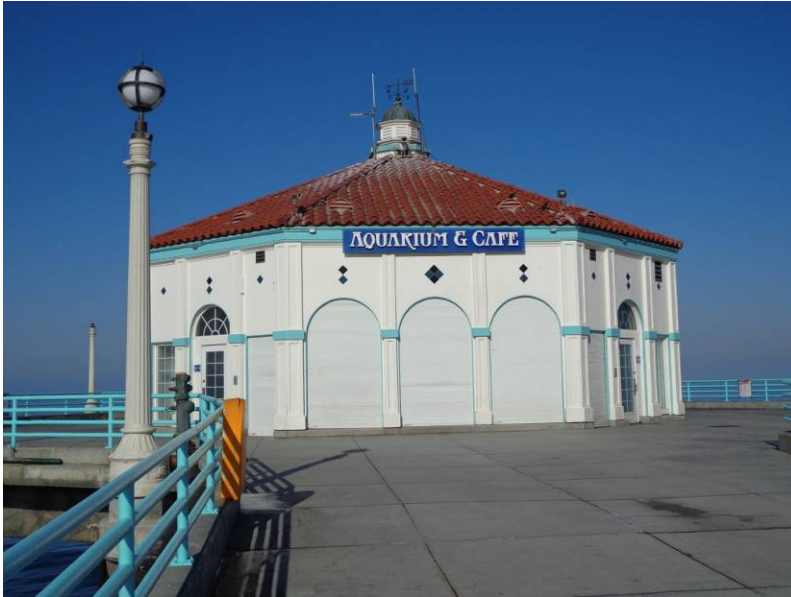
#### **Photograph No. 1**

View of the east facade facing the pier.

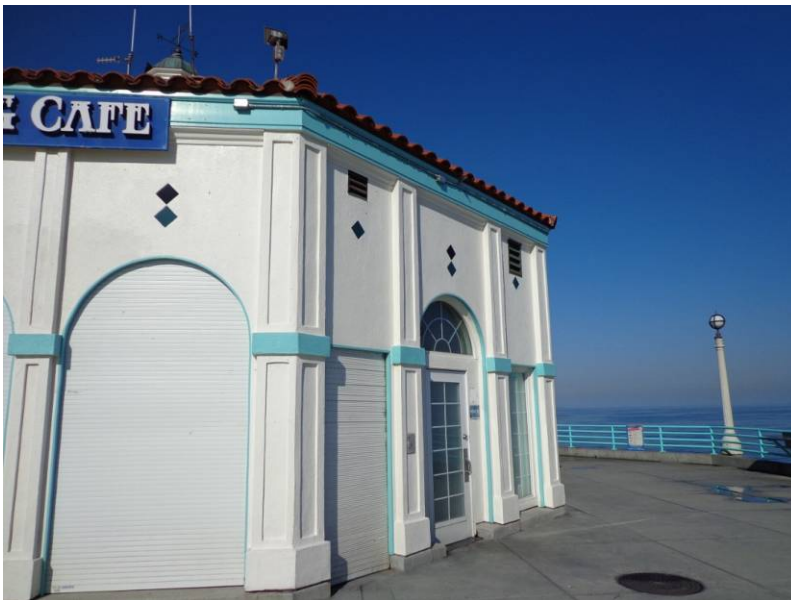
#### **Photograph No. 2**

View of the north façade.

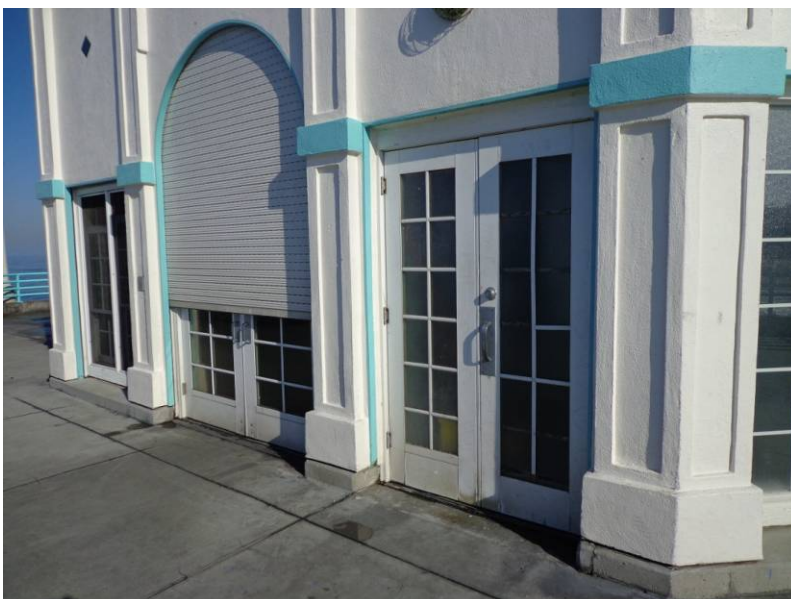
#### **Photograph No. 3**

View of the south façade.

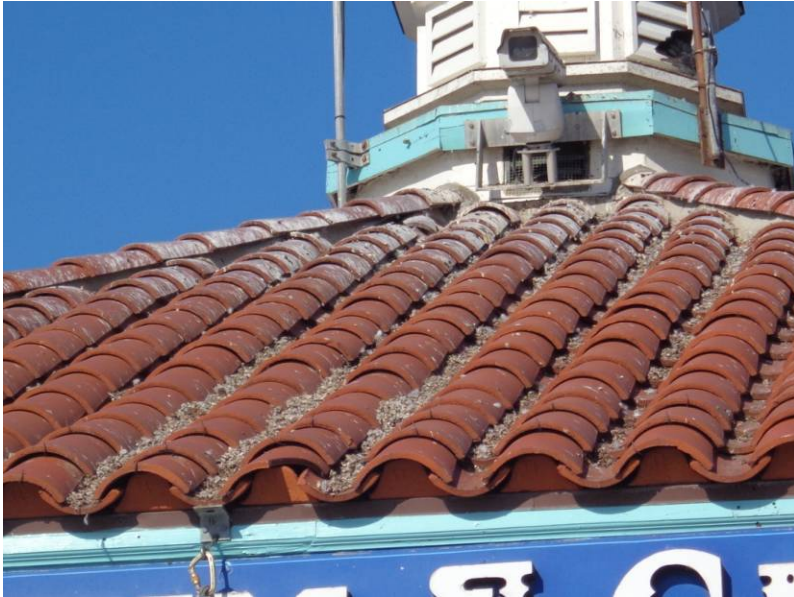
**Photograph No. 4**

View of the clay roofing.

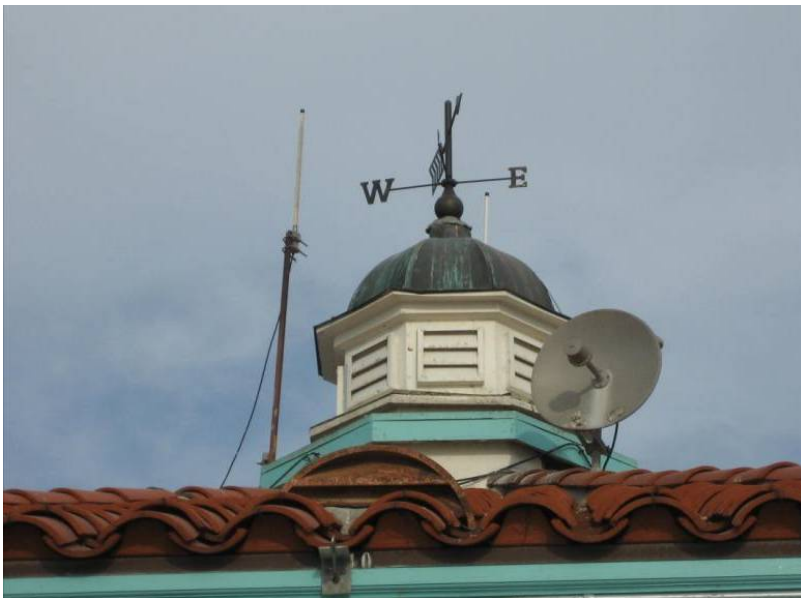
**Photograph No. 5**

View of the building's cupola.

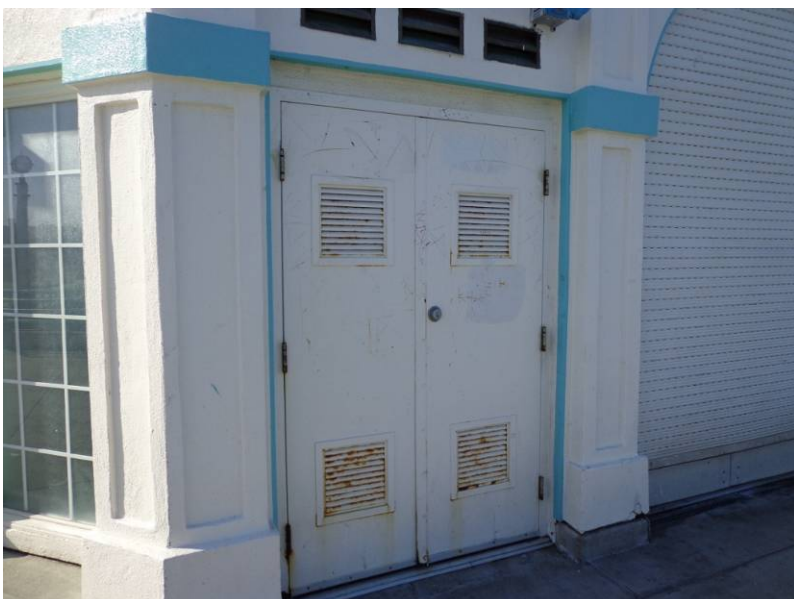
**Photograph No. 6**

View of typical metal door with louvers at the electrical room on the north façade.

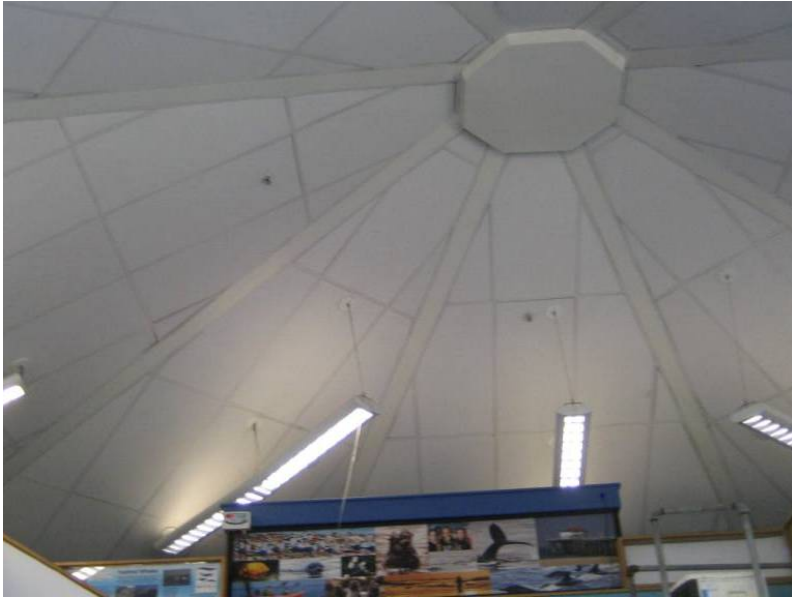
**Photograph No. 7**

Interior view of the central exhibit space's ceiling.

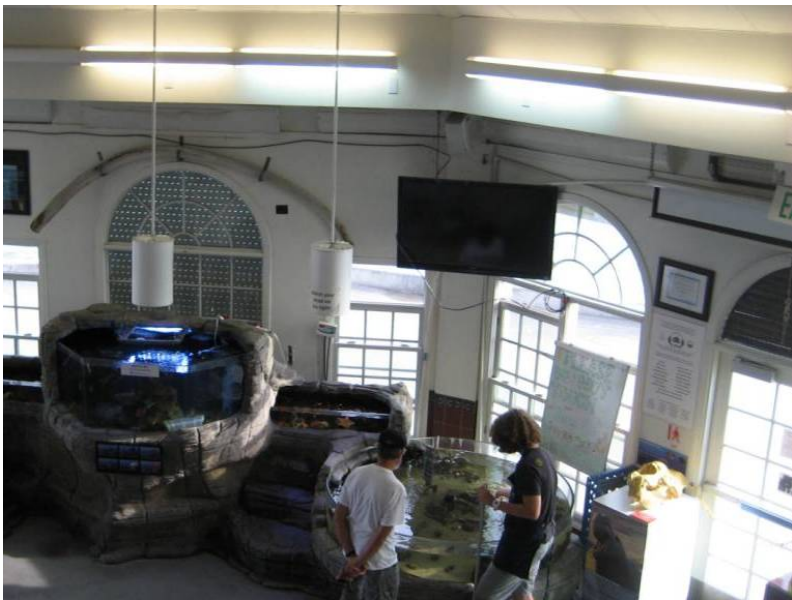
**Photograph No. 8**

Interior view of the central exhibit space.

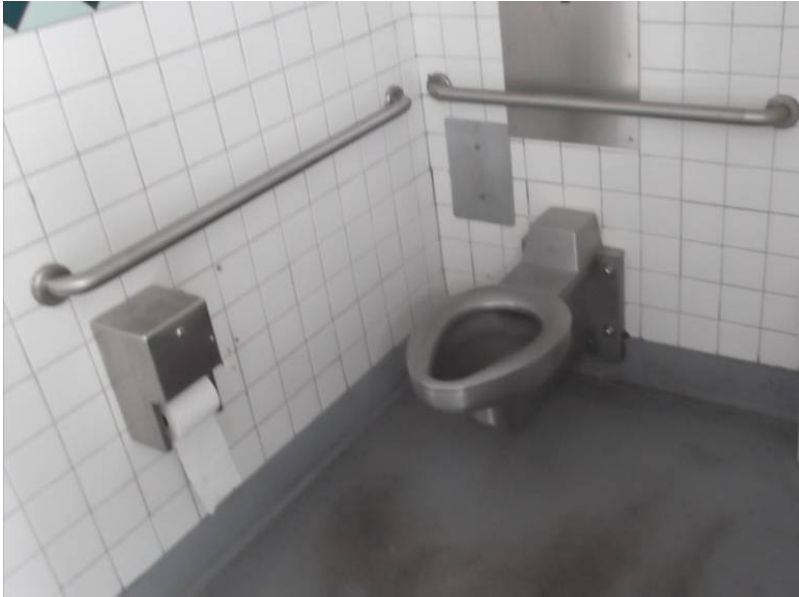
**Photograph No. 10**

View of the men's restroom water closet stall.

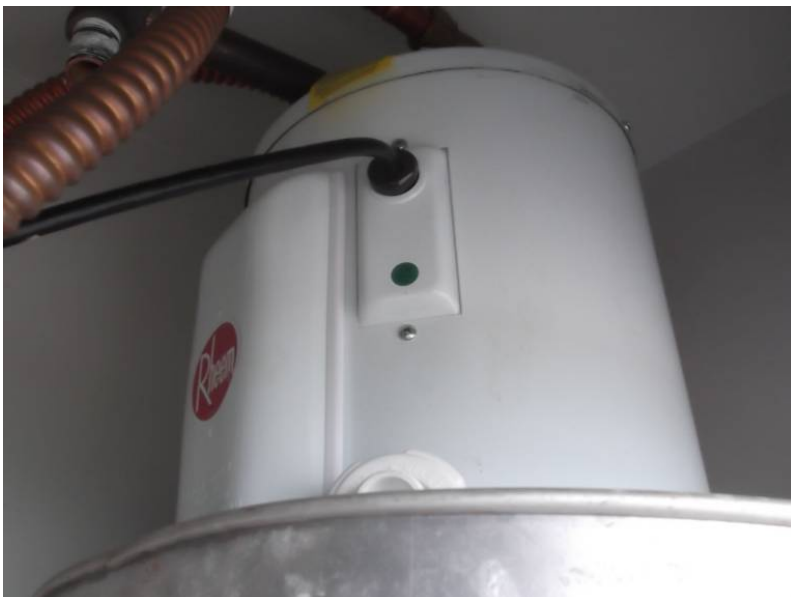
**Photograph No. 12**

View of the domestic water heater.

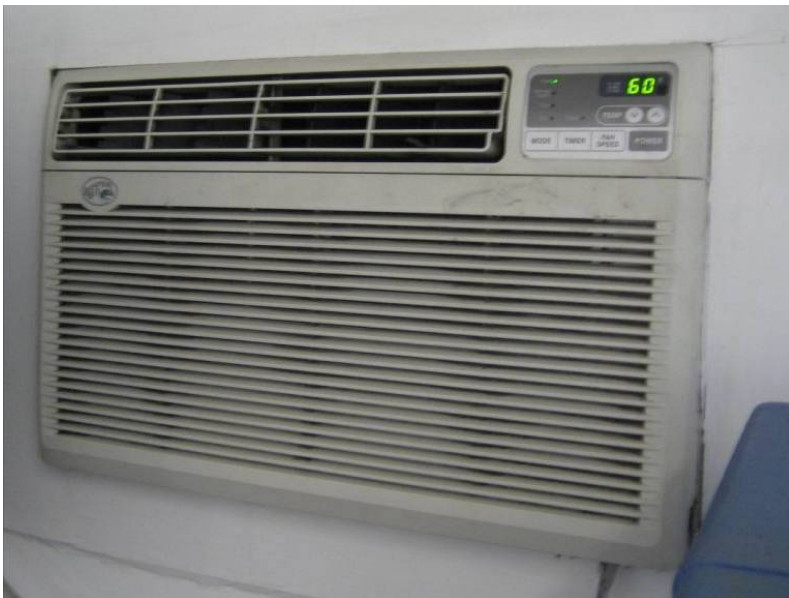
**Photograph No. 14**

View of the supplemental air conditioner.

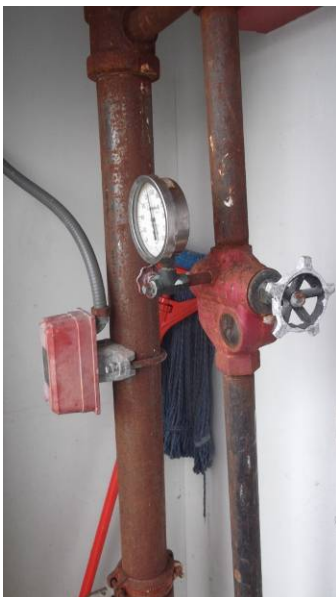
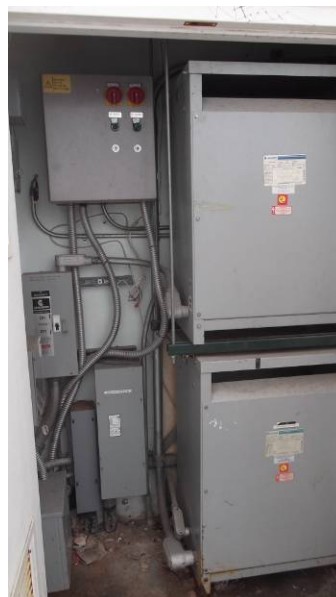
**Photograph Nos. 15A & 15B**

View of fire sprinkler system riser (15A left) and the electrical room equipment (15B right).

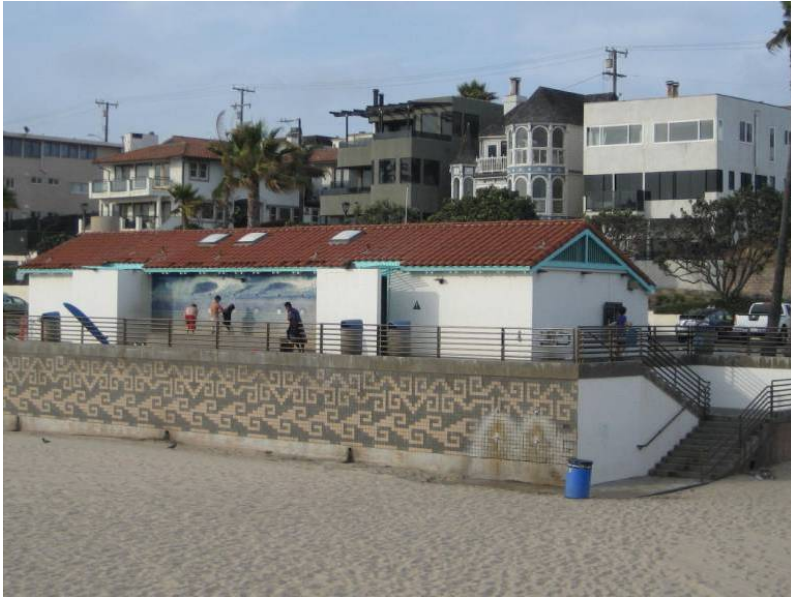
### **Photograph No. 16**

View of the west façade of the Pier Comfort Station, from the pier.

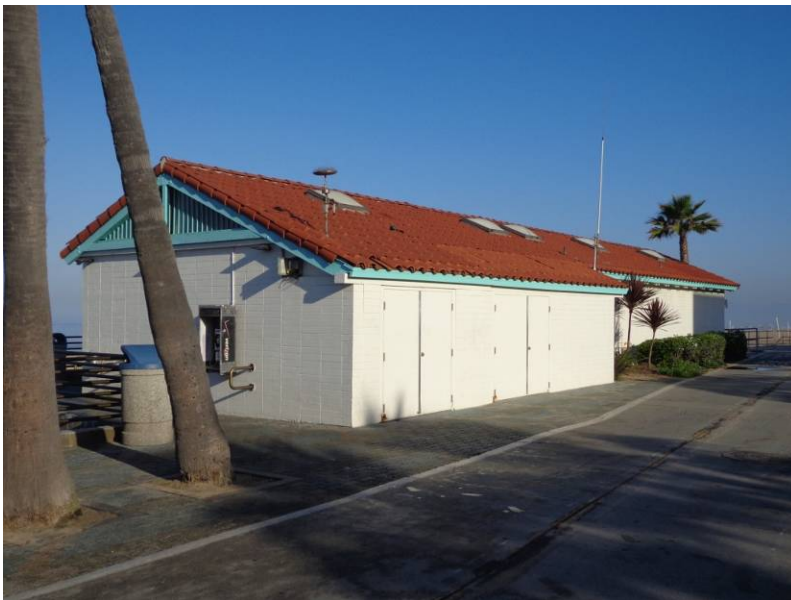
### **Photograph No. 17**

View of the south and east facades.

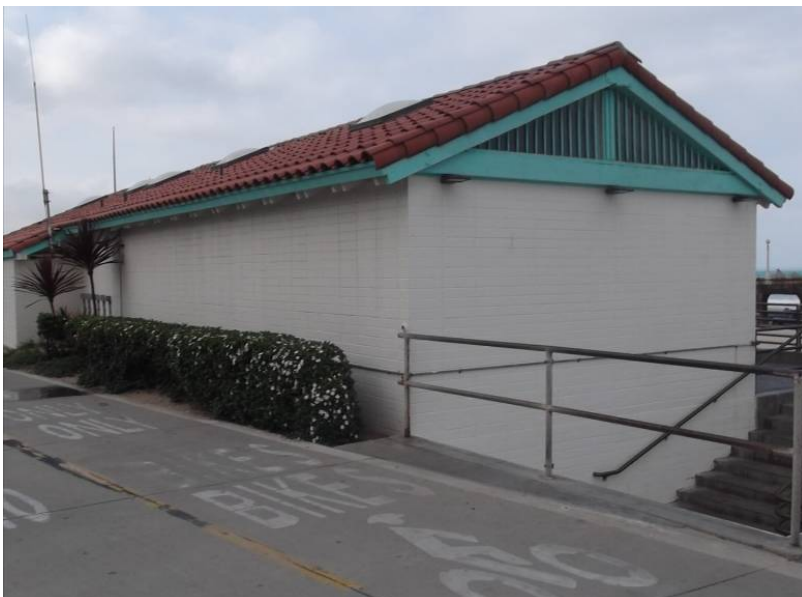
### **Photograph Nos. 18**

View of the north and east facades.

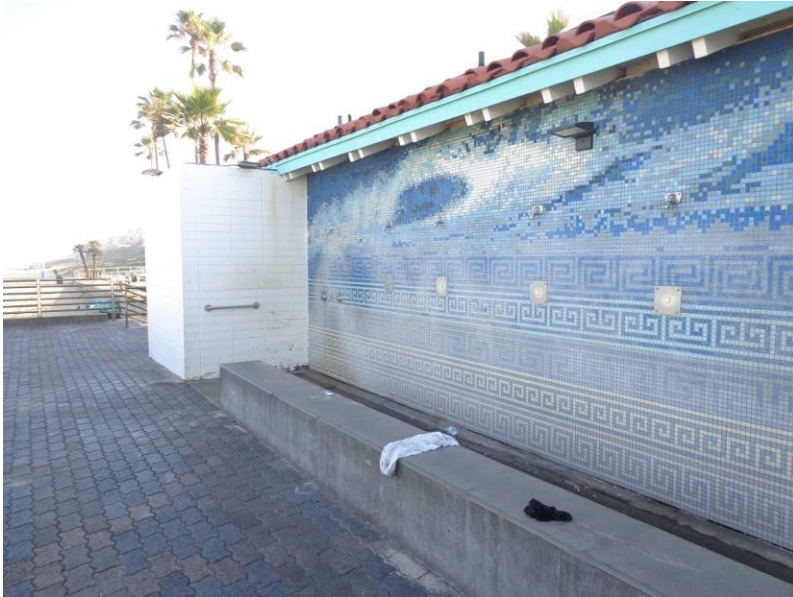
**Photograph No. 19**

View of the ceramic tiled shower area on the west façade of the building.

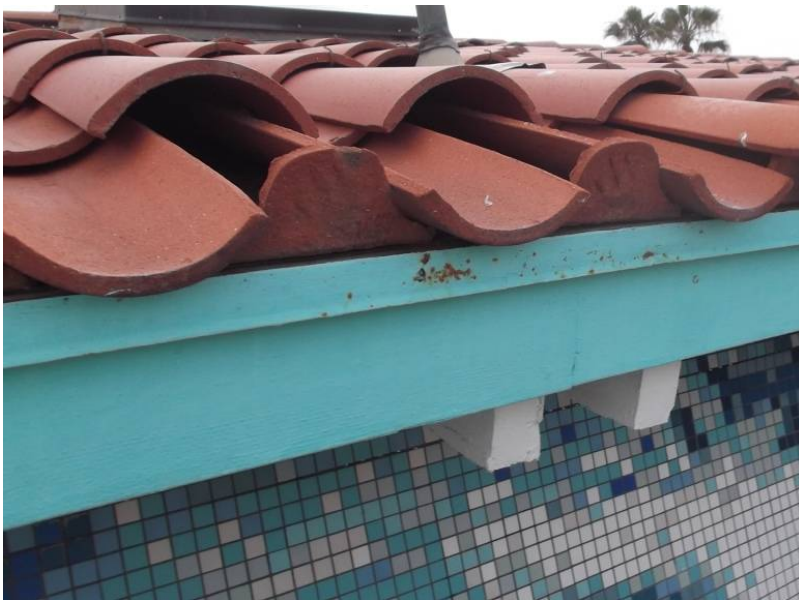
**Photograph No. 20**

View of the roof edge with detached and missing clay tiles.

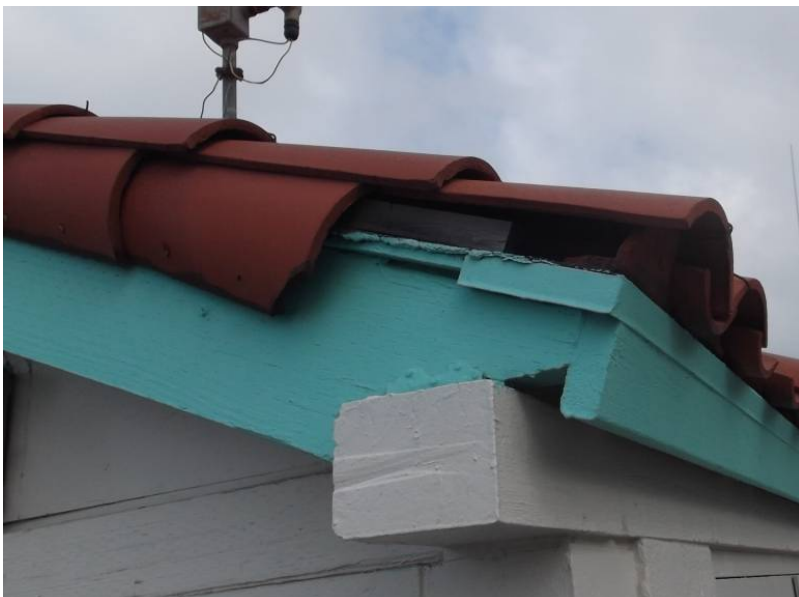
**Photograph No. 21**

View of the roof edge with missing clay tiles.

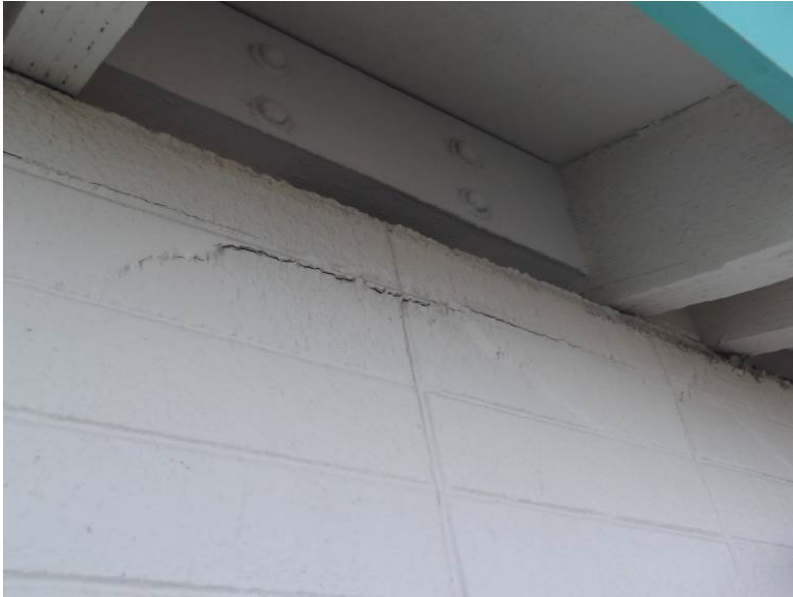
**Photograph No. 22**

The pitched roof structural construction of the Pier Roundhouse appeared to be in fair condition. There were no major signs of distress or instability noted. However, the east and west load-bearing walls of the Pier Comfort Station has horizontal cracking and splaying along the top at various locations (reference Photographs 22 and 23 in Appendix B). This cracking indicates lateral stresses have been placed on the walls, possibly by the roof framing though rebar corrosion should not be overlooked. We recommend repairs to the masonry walls and strengthening of the wall/roof framing connections be completed in the near term of the study period.

View of horizontal cracking at the top of the façade's concrete masonry wall at the east side of the building.

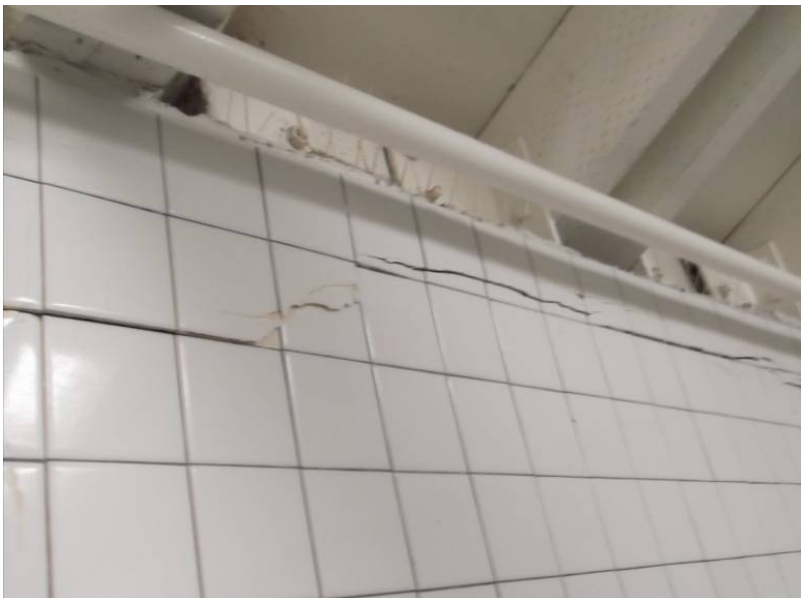
**Photograph No. 23**

Interior view of horizontal cracking in the ceramic tile at the top of the wall at the west side of the building.

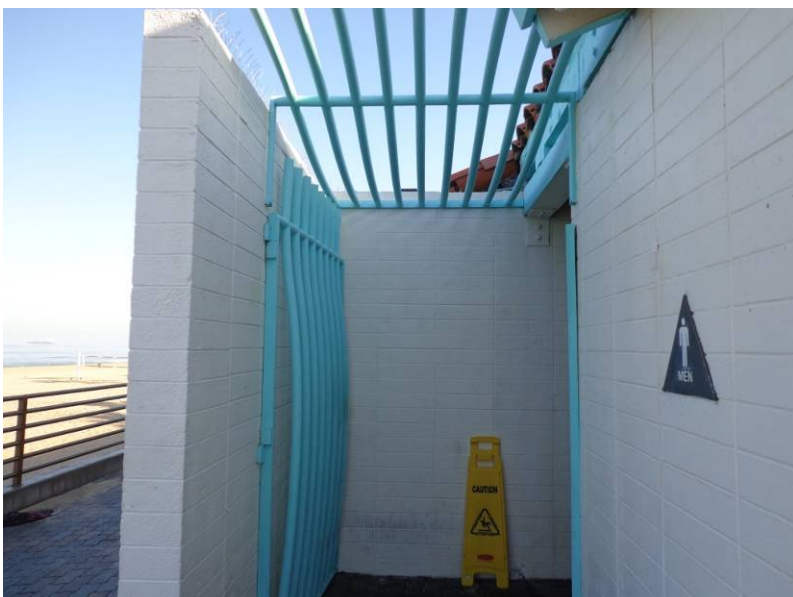
**Photograph No. 24**

View of one of the restroom entrance gates at the west side of the building.

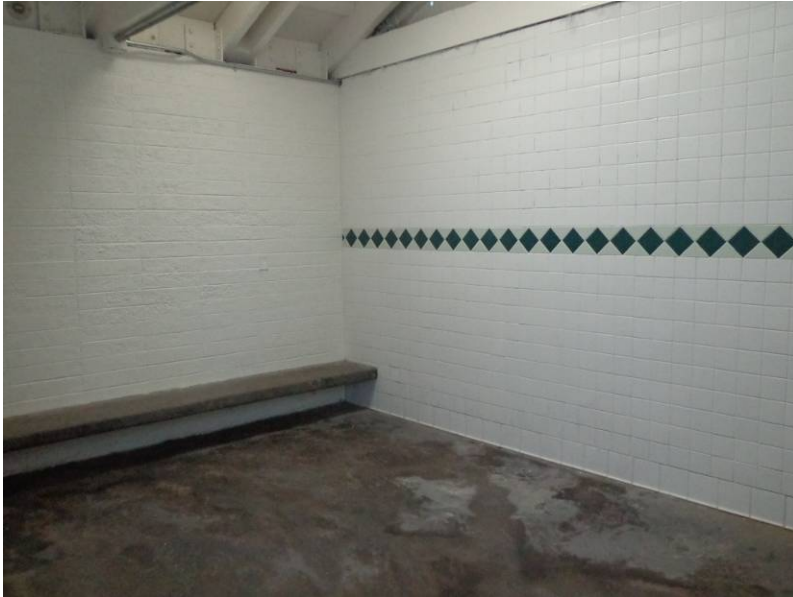
**Photograph No. 25**

Interior view of the men's restroom dressing area.

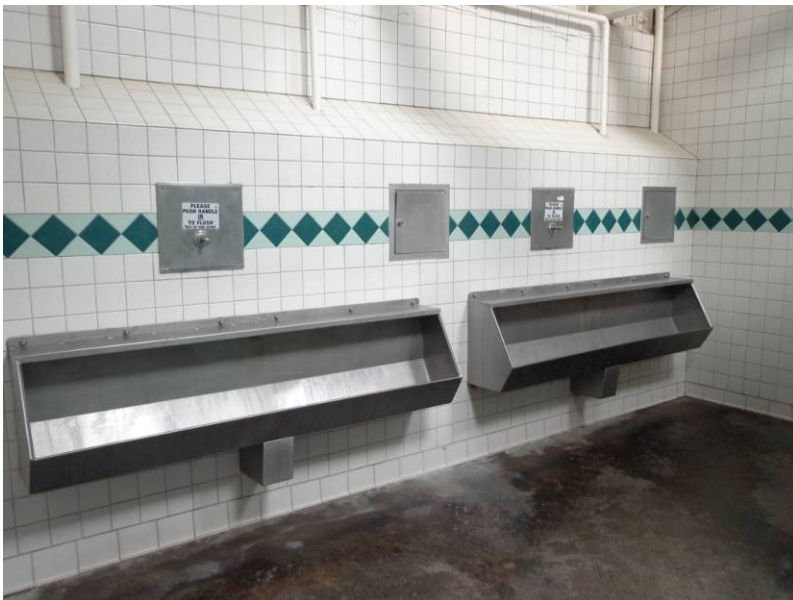
**Photograph No. 26**

Interior view of the men's restroom urinals.

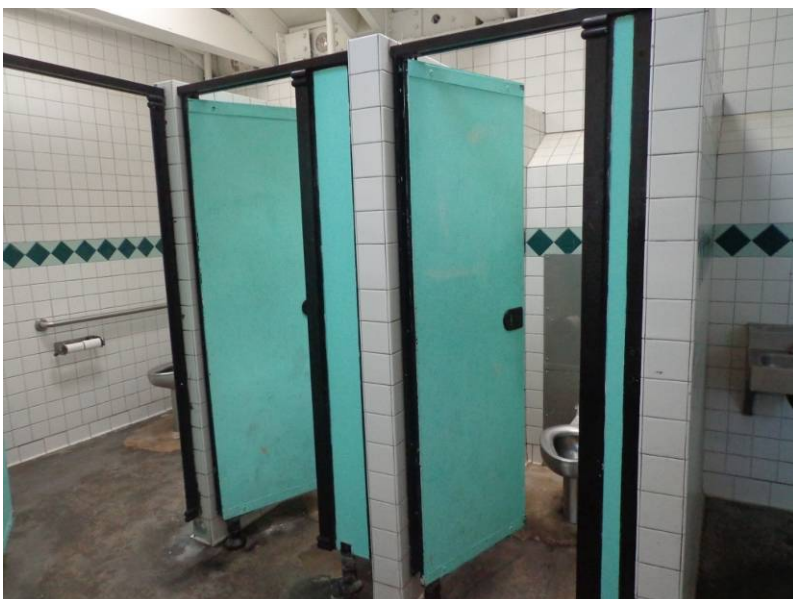
**Photograph No. 27**

Interior view of the men's restroom water closet stall.

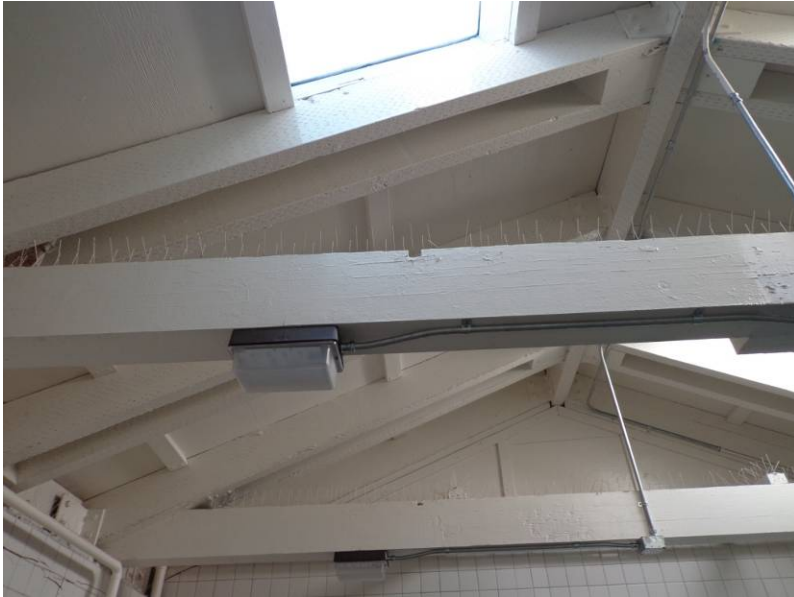
**Photograph No. 28**

Interior view of the exposed roof framing and skylight in the men's restroom.

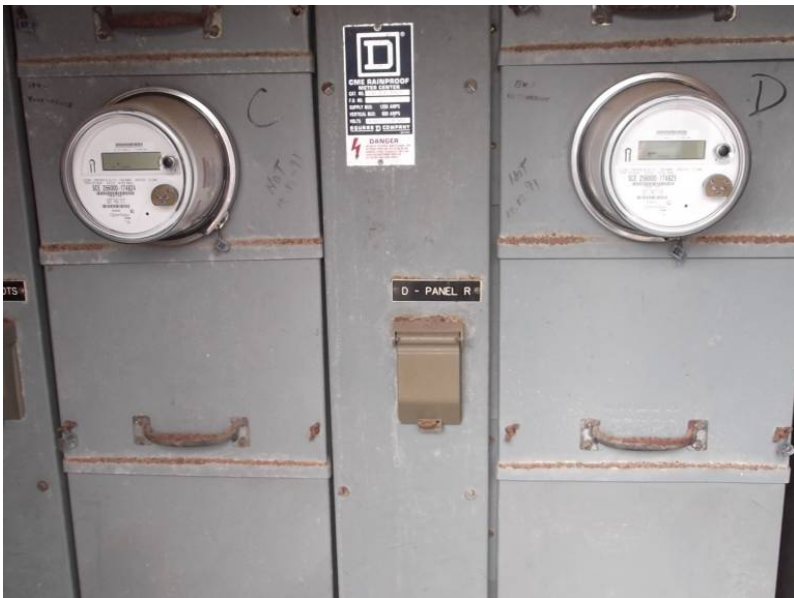
**Photograph No. 29**

View of the building's electrical main distribution panels and meters.

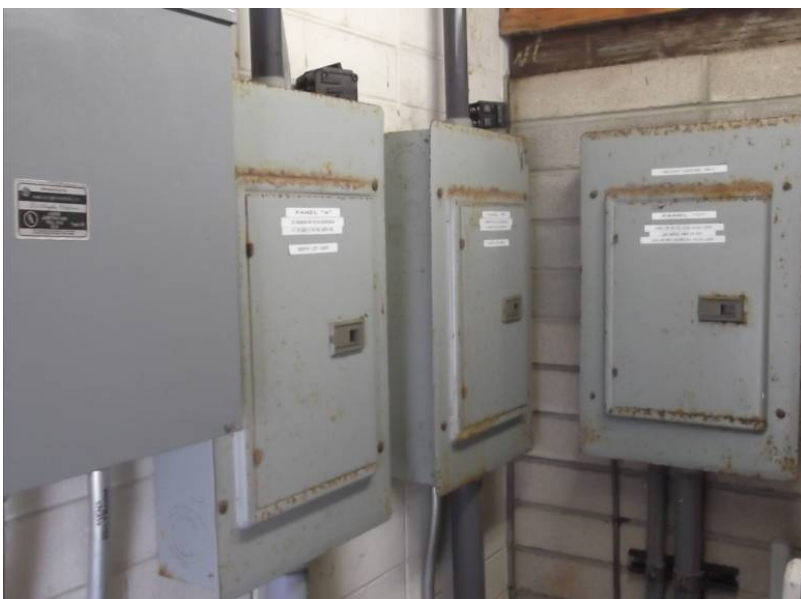
**Photograph No. 30**

View of the building's electrical panel boards.

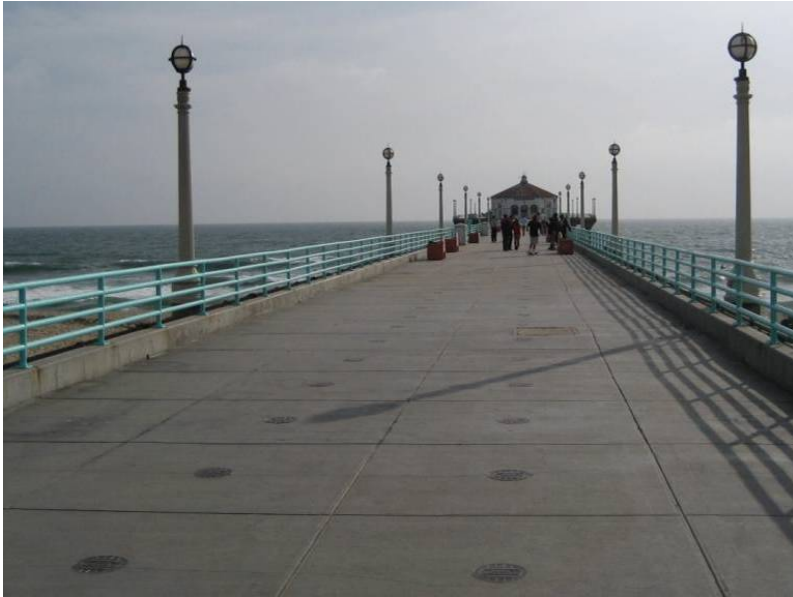
### **Photograph No. 31**

View of the pier, looking west from Manhattan Beach Boulevard and The Strand.

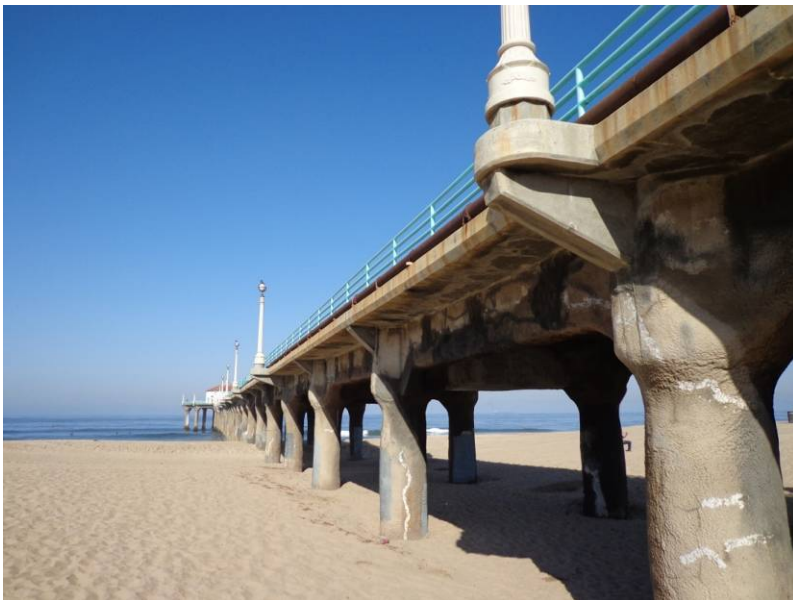
### **Photograph No. 32**

View of the pier from the beach, looking west.

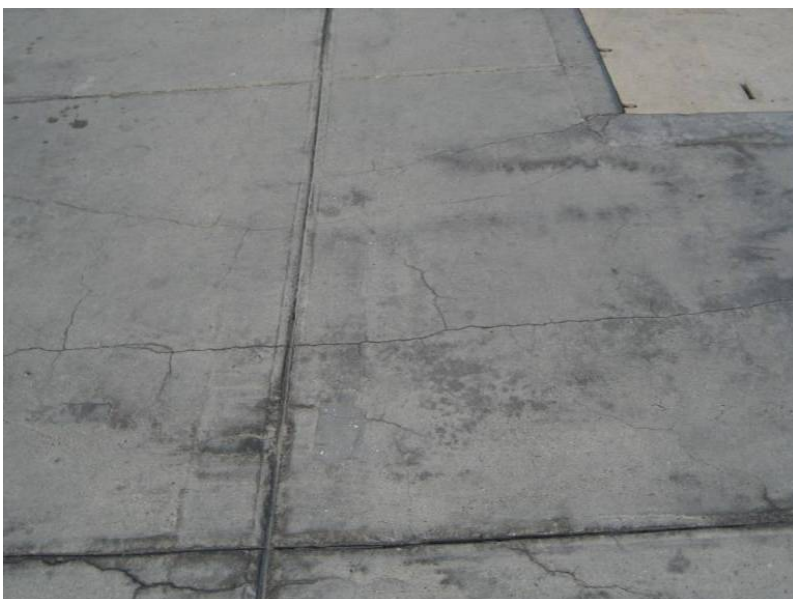
### **Photograph No. 33**

View of the surface cracking in the pier's concrete deck.

F Special Construction: Maintenance repairs to the pier deck, framing and pilings at an estimated cost of \$151,774 in years 2013, 2015, 2017, 2019 and 2021
-

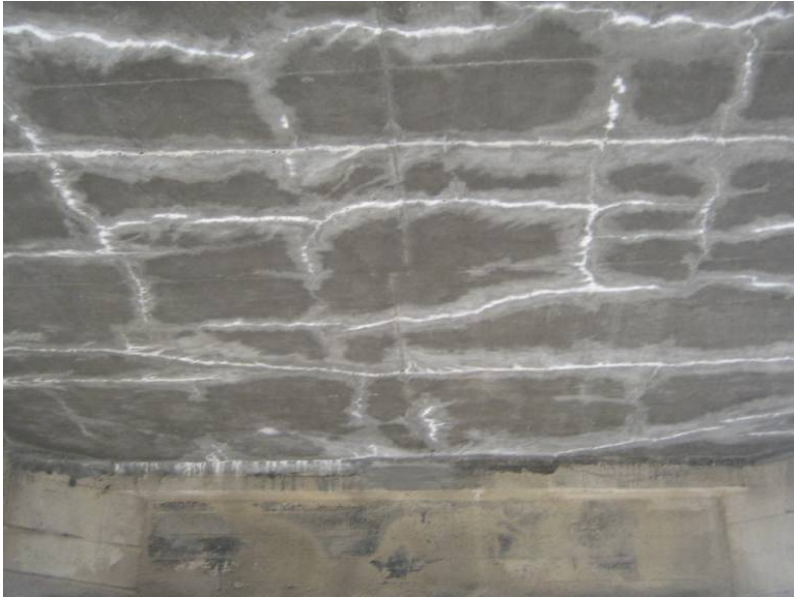
**Photograph No. 34**

View of the cracking and efflorescence on the underside of the pier deck.

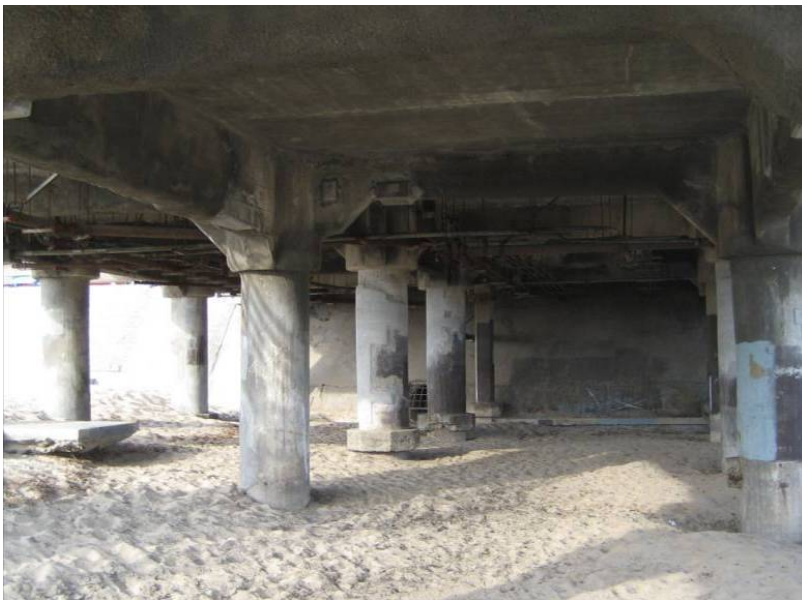
**Photograph No. 35**

View under the pier, looking east toward its connection with The Strand and Manhattan Beach Boulevard.

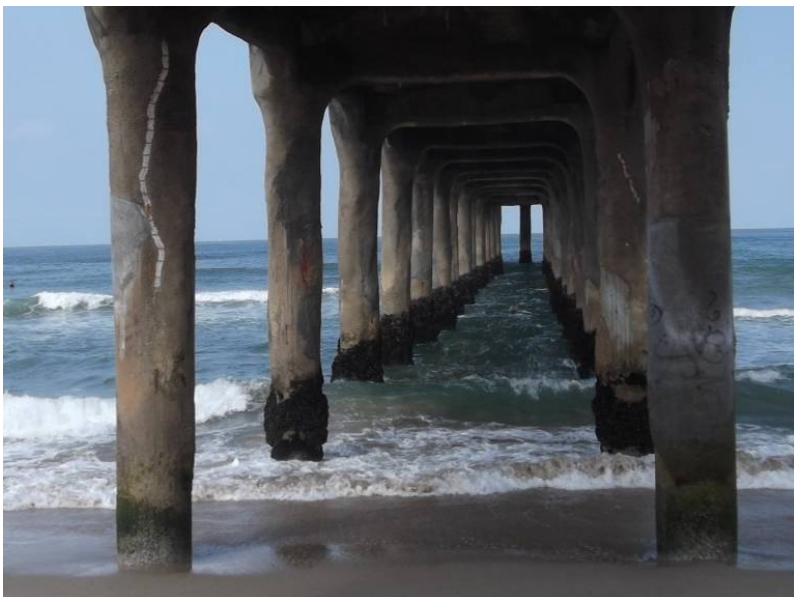
**Photograph No. 36**

View under the pier, looking west toward its terminus at the Pier Roundhouse.

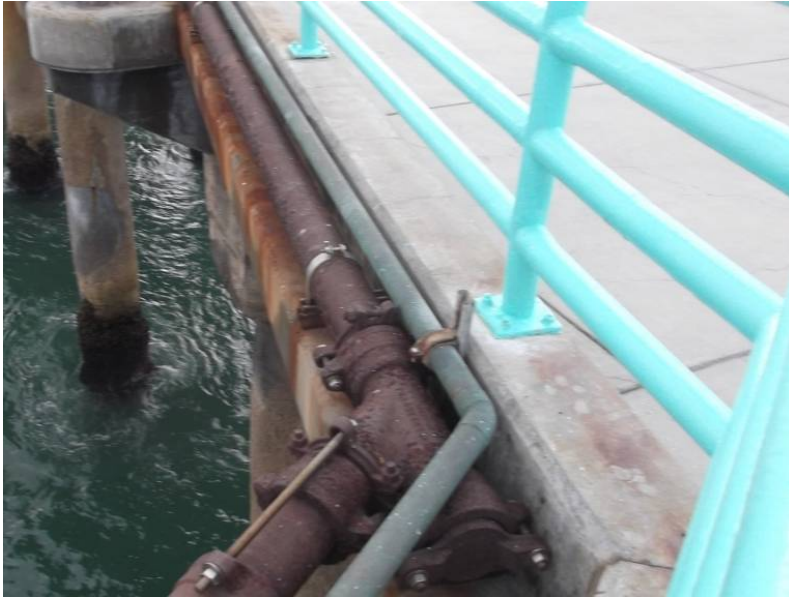
**Photograph No. 37**

View the pier's painted metal railings and corroding utility piping along the deck edge.

F Special Construction: Repaint pier railings and weld repairs at an estimated cost of \$30,000 in years 2013, 2015, 2017, 2019 and 2021
-

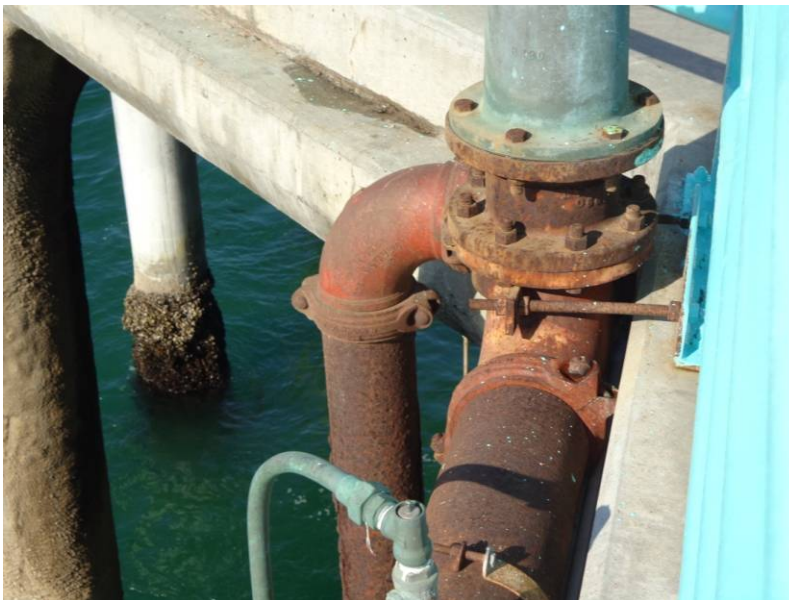
**Photograph No. 38**

View corroding utility lines at the pier's edge.

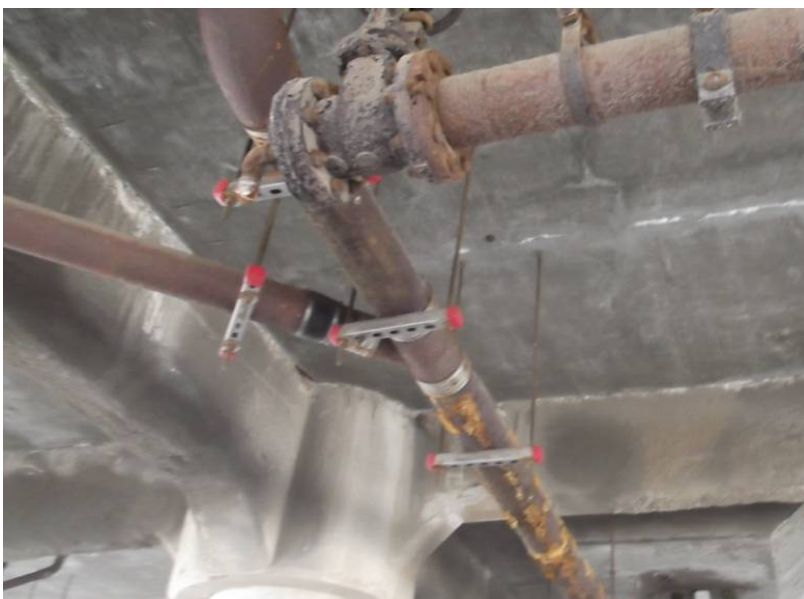
**Photograph No. 39**

Overhead view of suspended utility line under the pier deck.

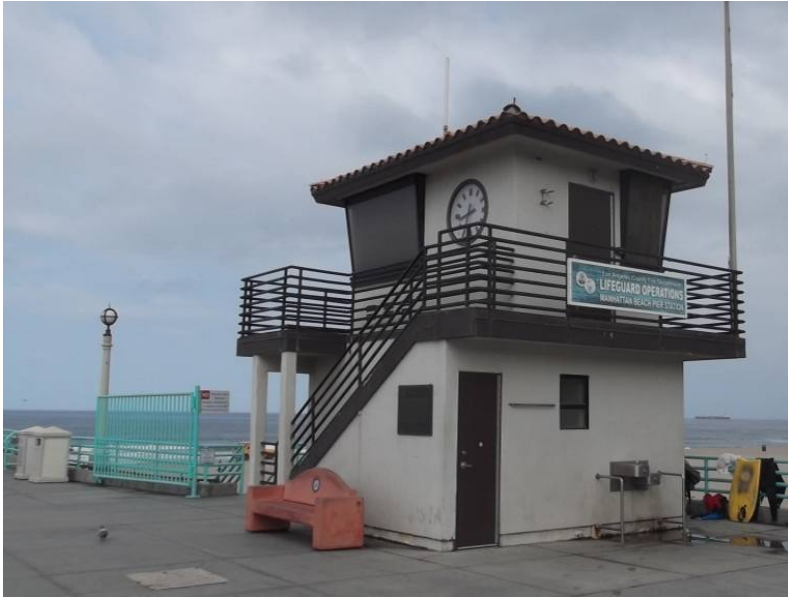
**Photograph No. 40**

View the lifeguard station and gates at the east end of the pier .

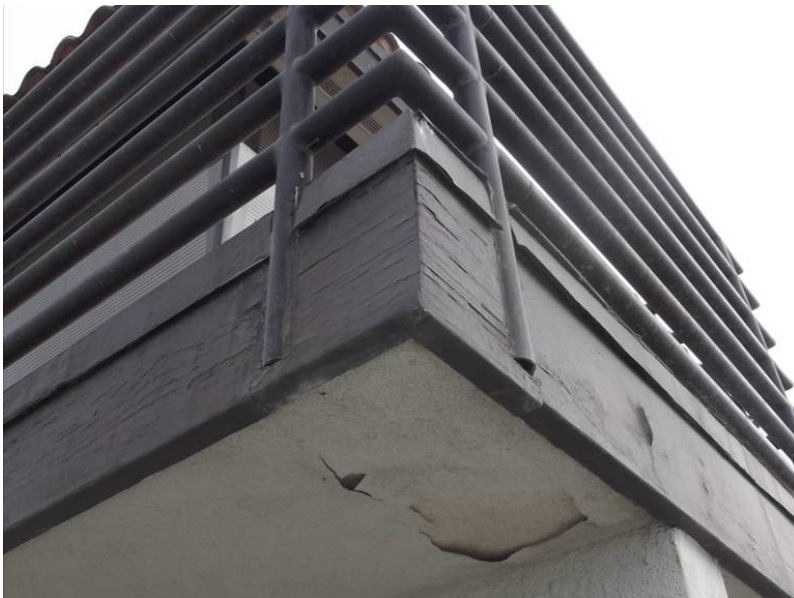
**Photograph No. 41**

View of the deteriorated conditions of the lifeguard station's upper level walkway.

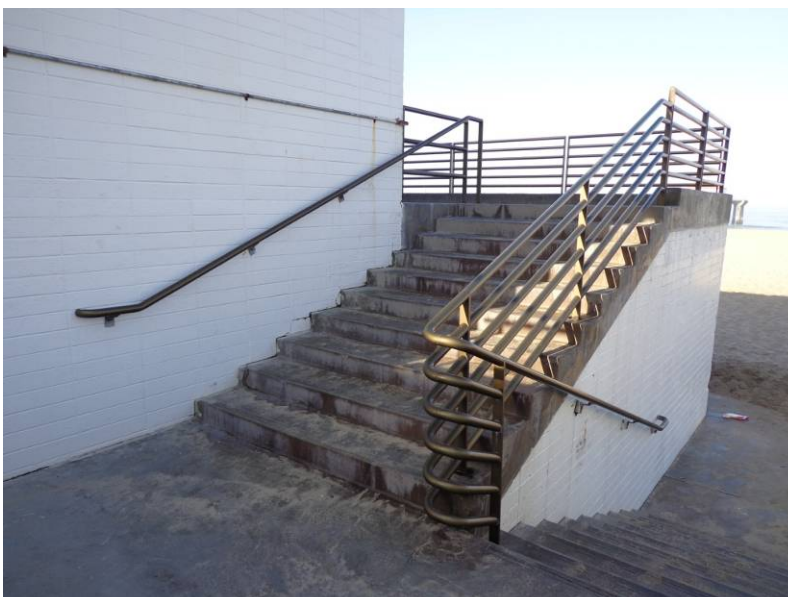
**Photograph No. 42**

View of the concrete stairs and anodized metal railings at the north end of the Pier Comfort Station.

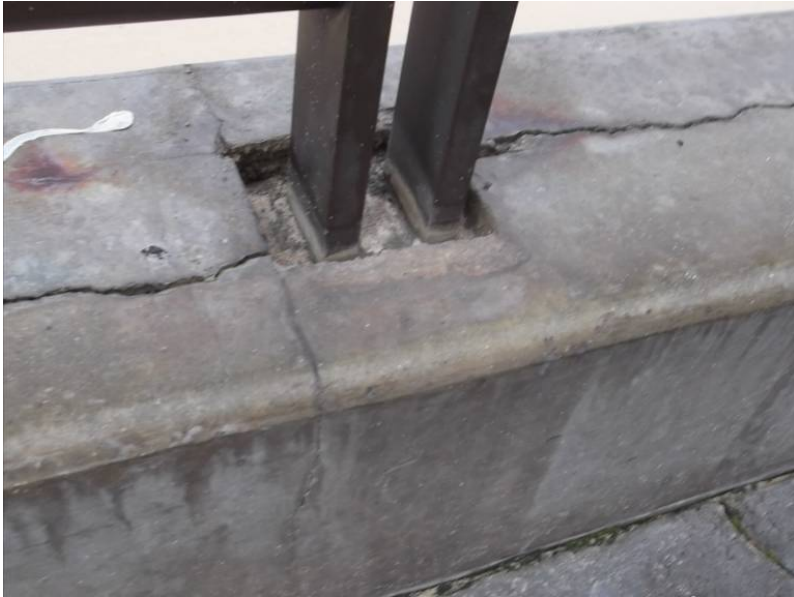
**Photograph No. 43**

View of deterioration in the concrete curbing below the railings at the west side of the Pier Comfort Station.

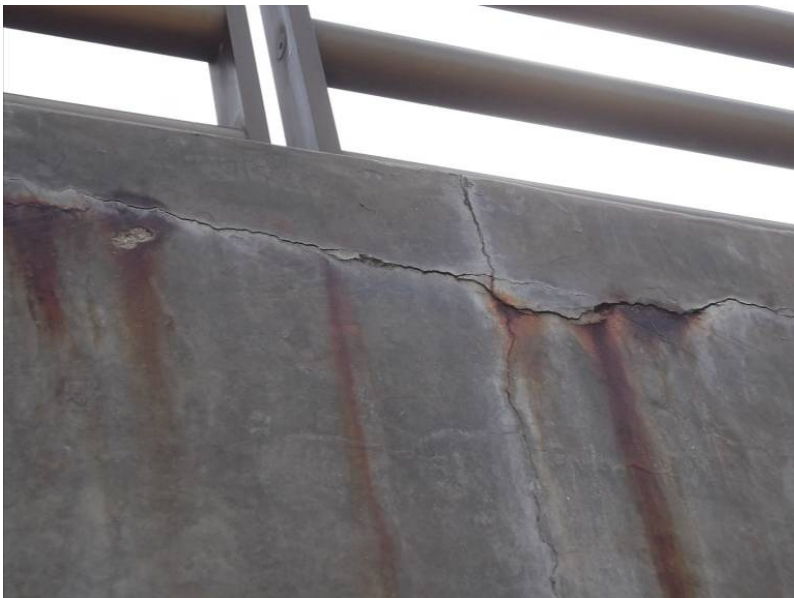
**Photograph No. 44**

View of cracking and efflorescence in the concrete wall and curbing, below the railings, at the west side of the Pier Comfort Station.

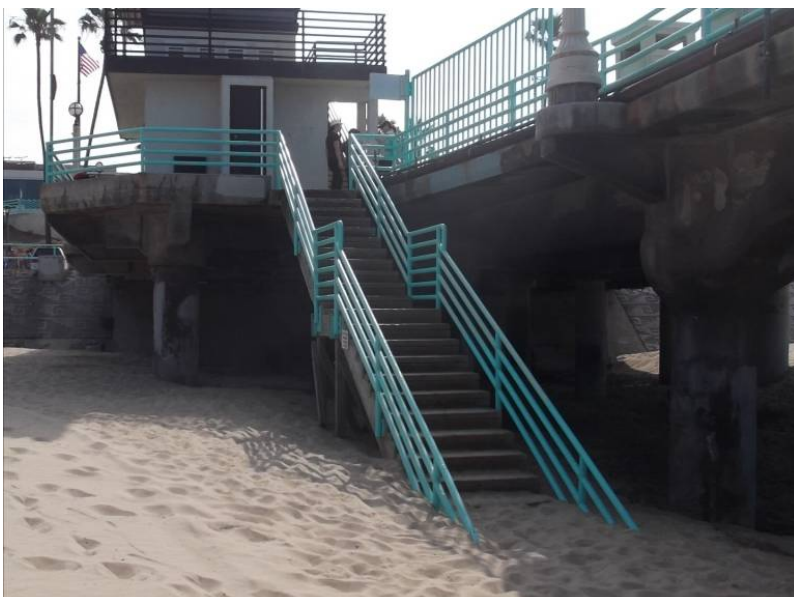
**Photograph No. 45**

View of one of the wood framed stairs at the east end of the pier.

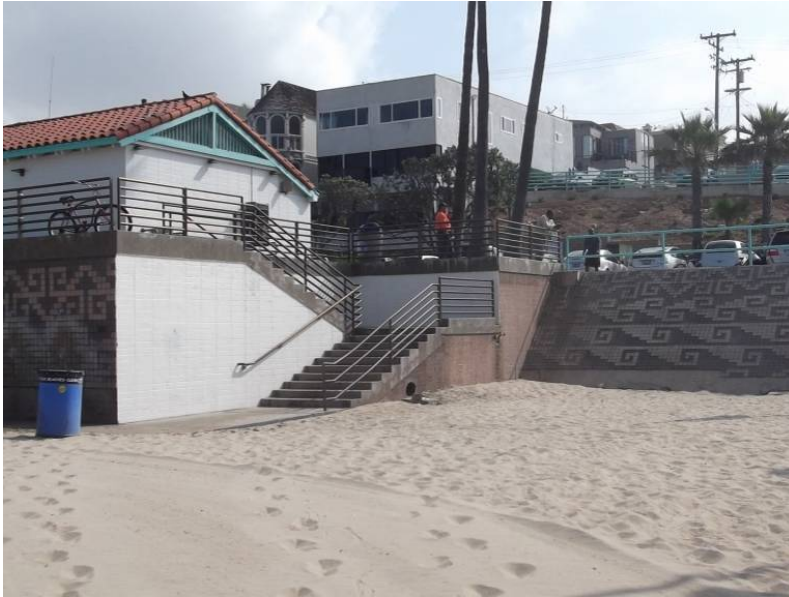
**Photograph No. 46**

View of concrete retaining walls at the Pier Comfort Station and along The Strand.

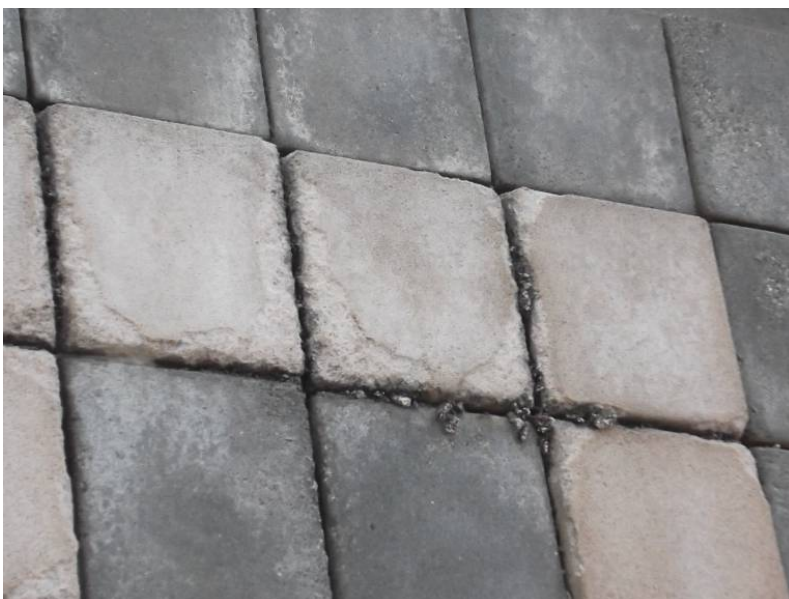
**Photograph No. 48**

Detail view of the decorative tiles applied to the retaining walls at the east side of the site.
