Citywide
Facility Condition Assessment

Report of
Facility Condition Assessment

For
City of Manhattan Beach
Pier Roundhouse and Comfort Station
100 Manhattan Beach Boulevard, Manhattan Beach, CA

*September 18, 2013
(Rev B)*

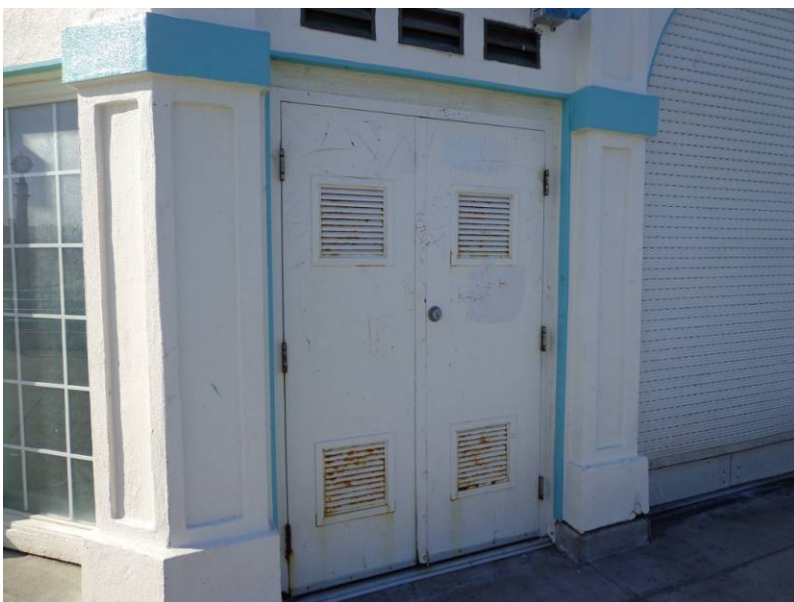
Photograph No. 6

In general, the operation of the doors was unsatisfactory, operating with difficulty. Mild corrosion was noted on the door faces and frames; re-painting, at the time of other exterior re-painting, will be necessary to maintain appearance and to protect the metal surfaces.

View of typical metal door with louvers at the electrical room on the north façade.

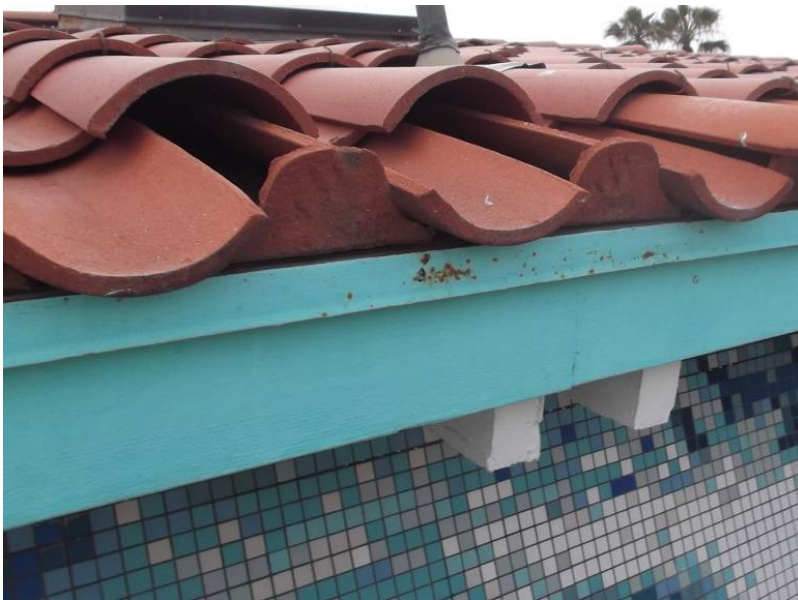
Photograph No. 20

View of the roof edge with detached and missing clay tiles.

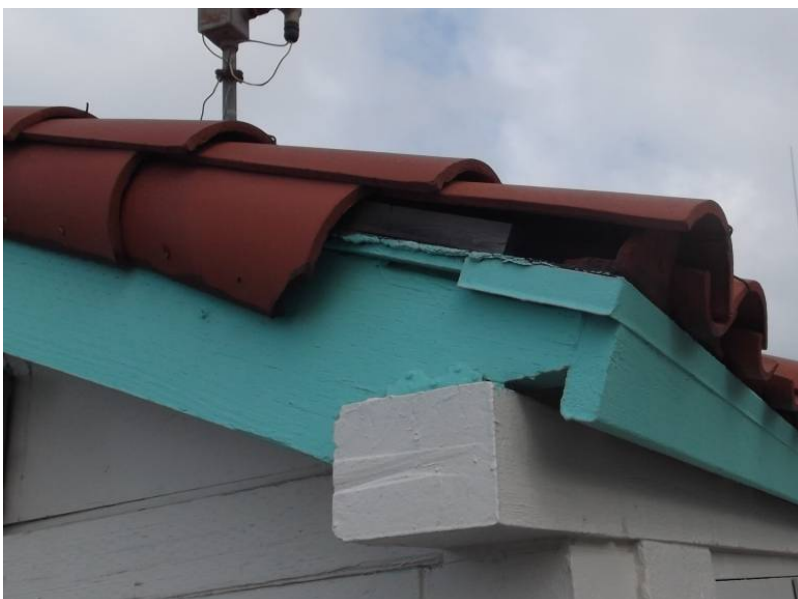
Photograph No. 21

View of the roof edge with missing clay tiles.

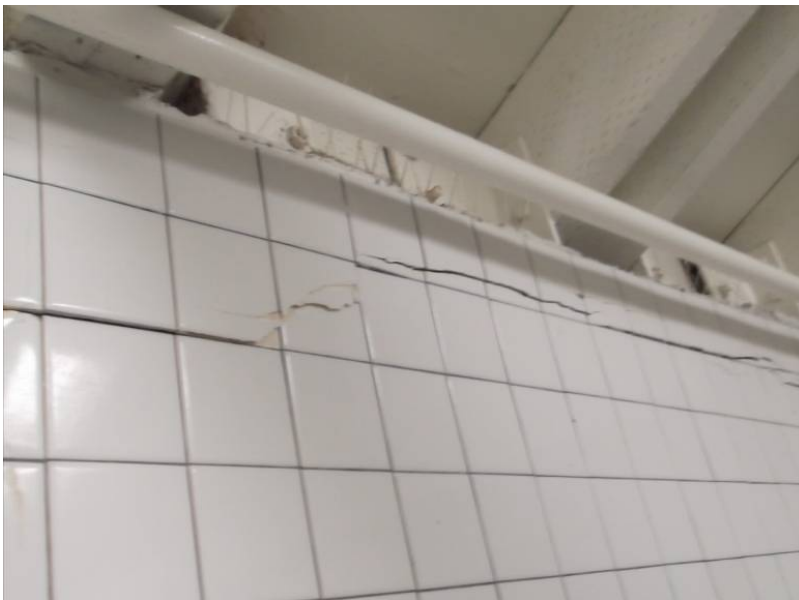
Photograph No. 23

The building's concrete masonry is in fair condition; although horizontal cracking was noted at the top of the walls in various locations (reference Photographs 22 and 23 in Appendix B). The local facilities team advises that this cracking and swelling is increasing on a yearly basis and is pushing tiles out of the shower unit walls. We have recommended repairs be completed to the masonry walls and that strengthening of the wall/roof framing connections be completed in the near term of the study period. We also recommend that a qualified structural engineer is appointed by the City to investigate/examine the structural issues further and confirm our recommendation. The reasoning behind this is that we have only undertaken an observation of the issues and have not performed any destructive investigations.

Interior view of horizontal cracking in the ceramic tile at the top of the wall at the west side of the building.

We have recommended repairs be completed to the masonry walls and that strengthening of the wall/roof framing connections be completed near-term in the study period. Based observed condition and on the EUL of 3 years for exterior paint that is exposed to the harsh environmental condition, we recommend budgeting for re-painting and replacement of sealants in the near-term of the study period, to maintain appearance and protect the exterior.

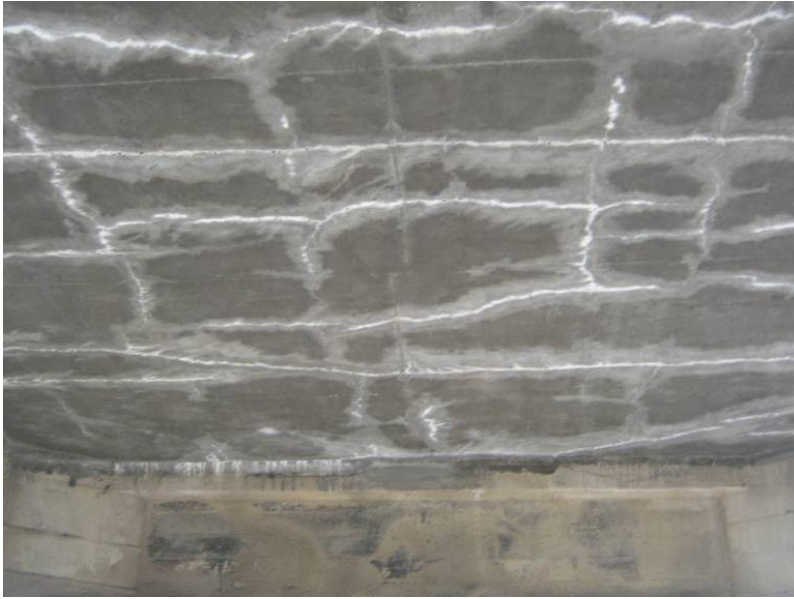
Photograph No. 34

View of the cracking and efflorescence on the underside of the pier deck.

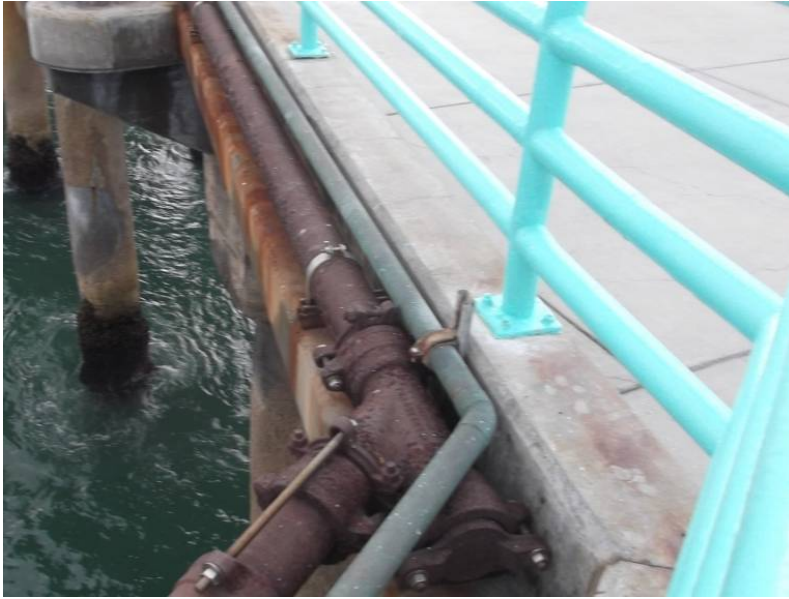
Photograph No. 37

View the pier's painted metal railings and corroding utility piping along the deck edge.

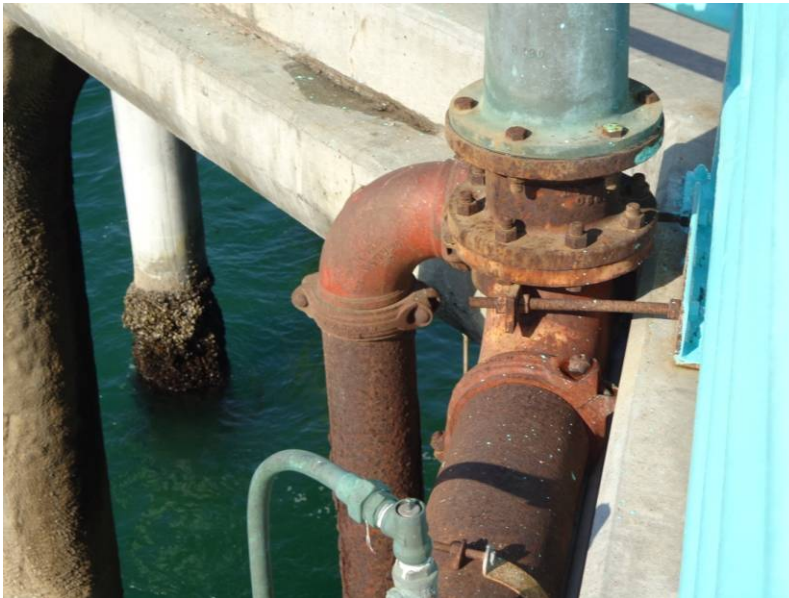
Photograph No. 38

View corroding utility lines at the pier's edge.

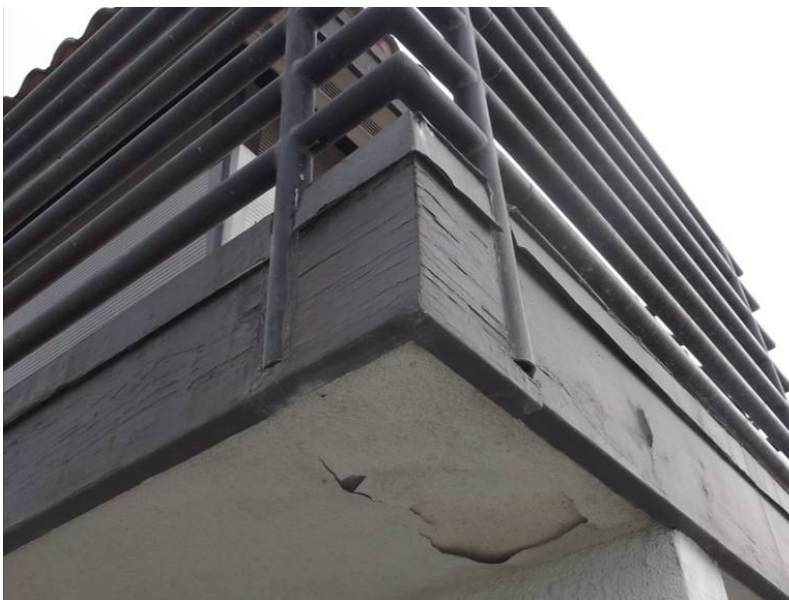
Photograph No. 41

View of the deteriorated conditions of the lifeguard station's upper level walkway.
