Citywide  
Facility Condition Assessment

Report of  
Facility Condition Assessment

For  
Premier Baseball Field  
18<sup>th</sup> Street and North Herrin Avenue, Manhattan Beach, CA

*August 23, 2013  
(Rev A)*

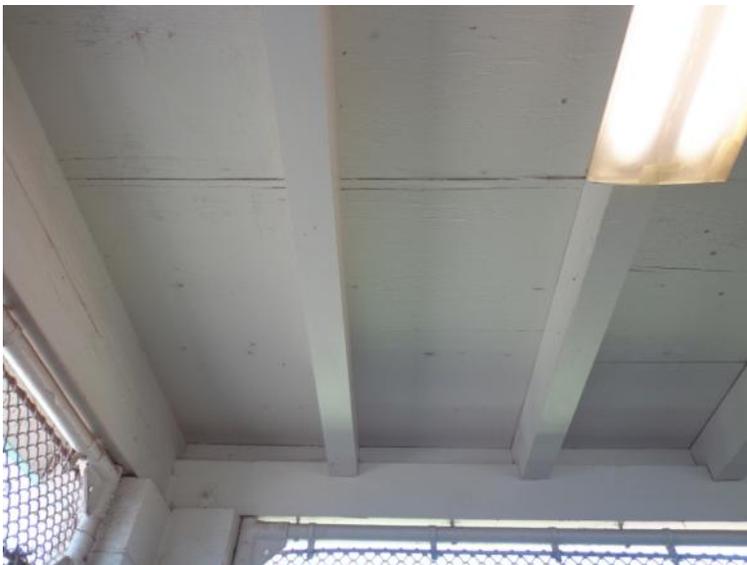
**Photograph No. 3**

View of the restroom building roof framing.

| Element No. | Building Element | Recommendation | Qty | Unit | Rate | Cost | Year | Priority Code |
|---|---|---|---|---|---|---|---|---|
| B1021 | Flat Roof Construction | Replace roof deck and repair structural issues | 1 | LS | \$5,200 | \$5,200 | 2013 | 3 |

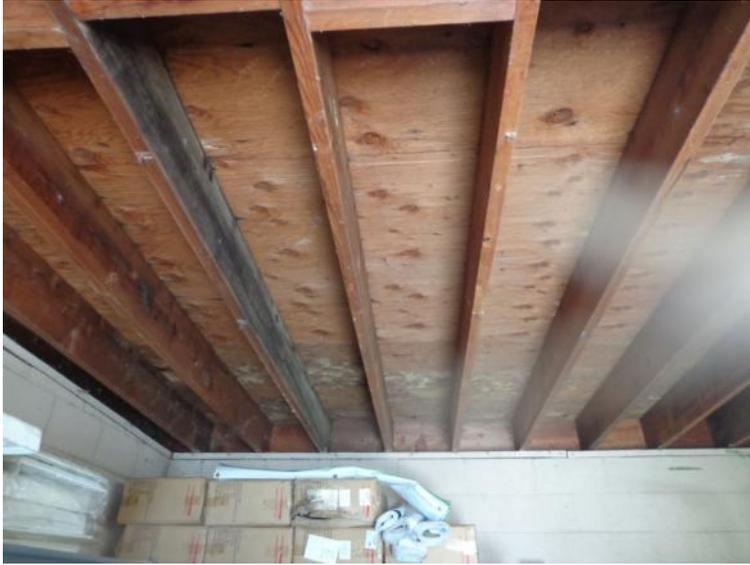
**Photograph No. 4**

View of the storage building roof framing.

| Element No. | Building Element | Recommendation | Qty | Unit | Rate | Cost | Year | Priority Code |
|---|---|---|---|---|---|---|---|---|
| B1021 | Flat Roof Construction | Replace roof deck and repair structural issues | 1 | LS | \$3,800 | \$3,800 | 2013 | 3 |

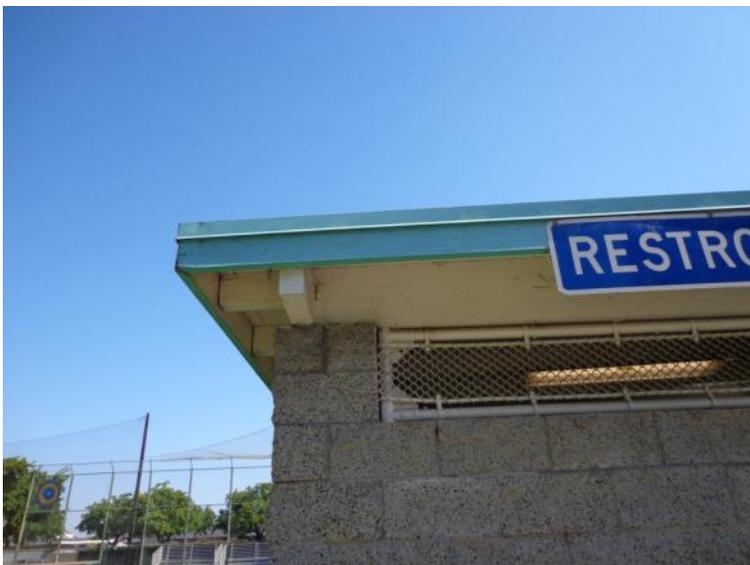
**Photograph No. 6**

The exterior wall systems at the building appeared to be in fair condition with generally no major signs of deterioration, water ingress or general failure noted (reference Photograph 6 in Appendix B). The exterior painted surfaces are worn and have not been recently painted. Based on an EUL for this building of 4 years, as well as observed conditions, painting will be necessary near- mid- and late-term in the study period to maintain the appearance and protect the exterior walls.

View of the painted wood trim at the restrooms.

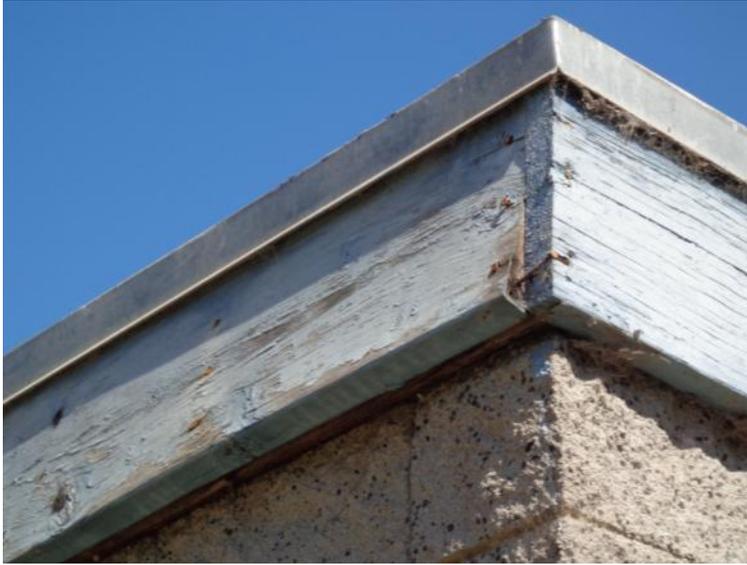
**Photograph No. 7**

The exterior wall systems at the building appeared to be in poor to fair condition. We observed various degrees of damage and rot to the wood fascia and the painted surfaces were worn at all painted surfaces (reference Photograph 7 in Appendix B). Based on an EUL for this building of 4 years painting, as well as current observed conditions, we recommend near term repair of the siding and repainting of the exterior surfaces near-, mid- and late-term to maintain the appearance and protect the exterior walls.

View of the rotted wood fascia at the storage building.

| Element No. | Building Element | Recommendation | Qty | Unit | Rate | Cost | Year | Priority Code |
|---|---|---|---|---|---|---|---|---|
| B2011 | Exterior Wall Construction | Replace the wood fascia | 80 | SF | \$50 | \$4,000 | 2013 | 4 |

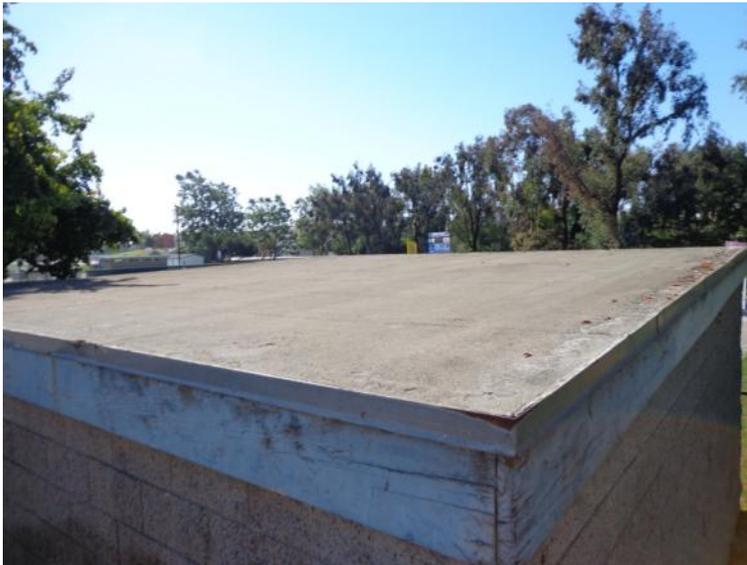
**Photograph No. 8**

The low sloped roof area appeared to be in poor overall condition. These types of roof covering have a typical EUL of 20-years and based on an age of 22-years and the observed poor condition of the roof surface we anticipate that the roof will require immediate replacement. We are unaware or could not visually see any possible areas of water ingress.

View of the storage building roof.

| Element No. | Building Element | Recommendation | Qty | Unit | Rate | Cost | Year | Priority Code |
|---|---|---|---|---|---|---|---|---|
| B3011 | Roof Finishes | Replace the BUR covering | 210 | SF | \$15.00 | \$3,150 | 2013 | 3 |

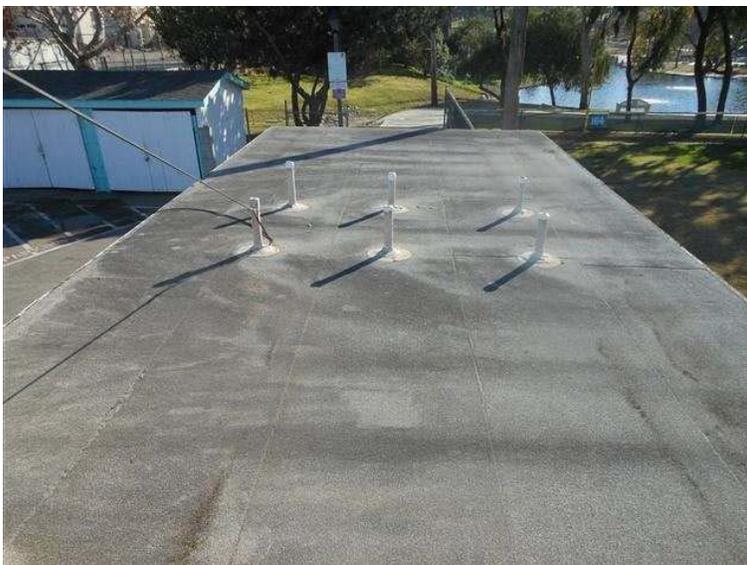
**Photograph No. 9**

The low sloped roof area appeared to be in fair to good overall condition. These types of roof covering have a typical EUL of 20-years and based on observed conditions and roof material ages we anticipate that the roof will require mid to late-term replacement. We are unaware or could not visually see any possible areas of water ingress.

View of the restroom BUR roof.

| Element No. | Building Element | Recommendation | Qty | Unit | Rate | Cost | Year | Priority Code |
|---|---|---|---|---|---|---|---|---|
| B3011 | Roof Finishes | Replace the BUR covering | 390 | SF | \$15.00 | \$5,850 | 2019 | 3 |

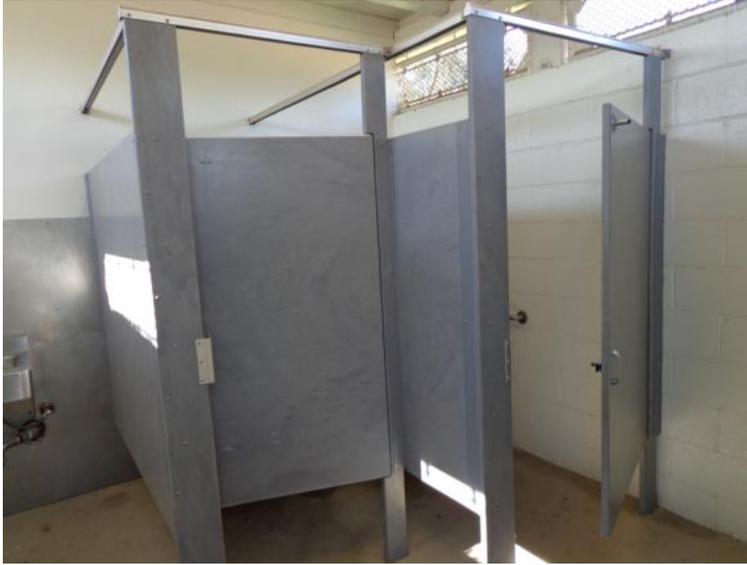
**Photograph No. 10**

Interior walls at the building generally contained painted concrete masonry units, painted gypsum drywall and stainless steel panels behind the plumbing fixtures (reference Photograph 10 in Appendix B).

View of the toilet partitions.

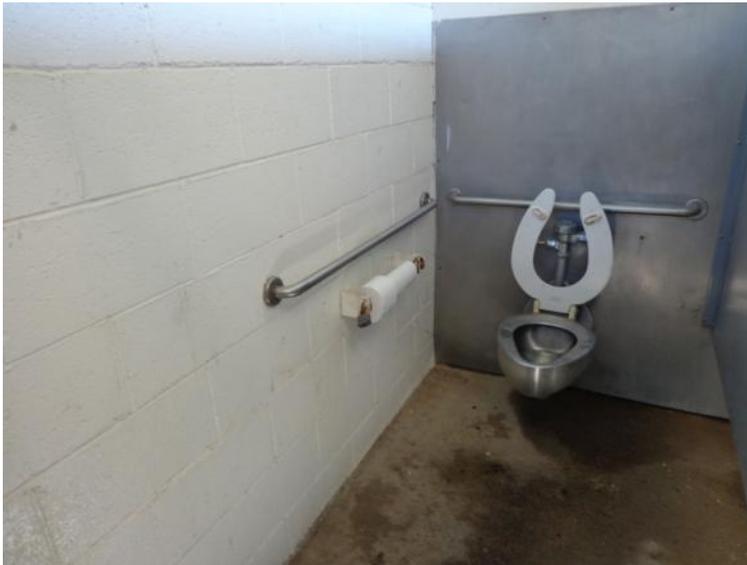
**Photograph No. 11**

The building contained wall hung mounted stainless steel tank-less water closets with manual flush valves within the men's and women's restrooms (reference Photograph 11 in Appendix B).

The water closets and flush valves appeared to be in good condition. The water closets contained water saving flush valves that operated properly. The restrooms contained ADA compliant water closets.

View of a water closet.

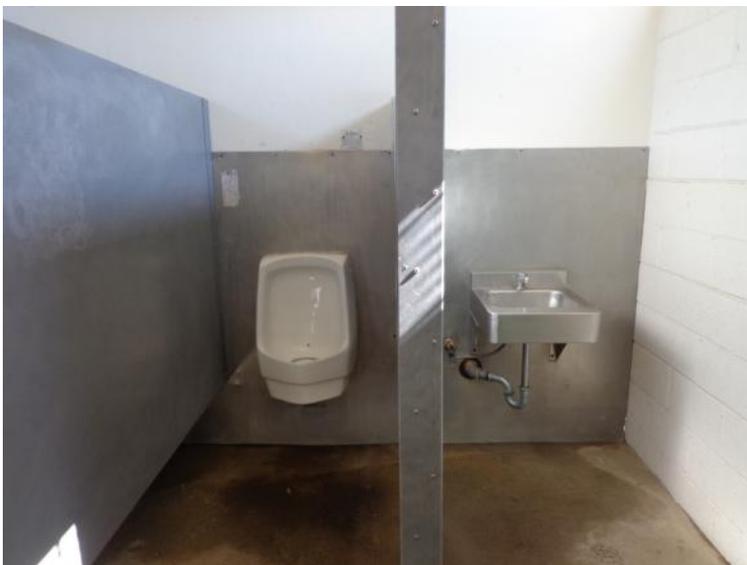
**Photograph No. 12**

The building contained wall mounted stainless steel lavatories (reference Photograph 12 in Appendix B). The lavatories generally consisted of single-handle lever type, non-metering faucets. Water is supplied via copper pipe work and drained through cast iron pipe work and fittings.

View of a urinal and lavatory.

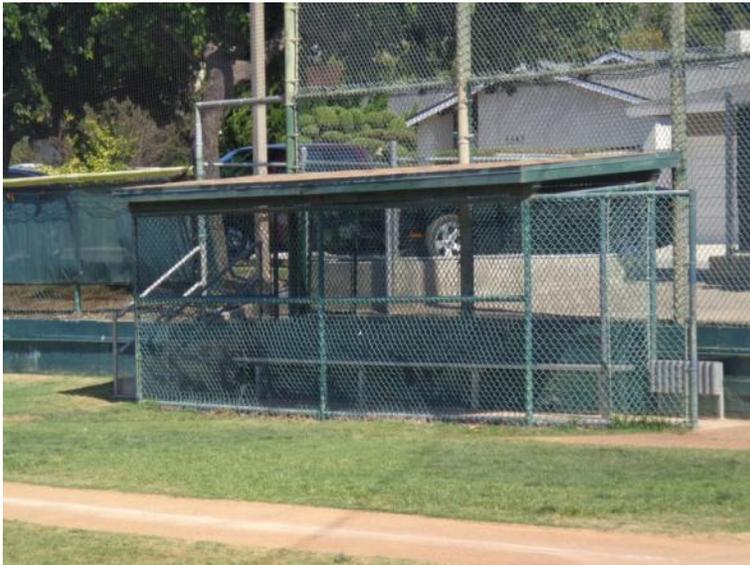
**Photograph No. 23**

View of one of the dugout awnings.

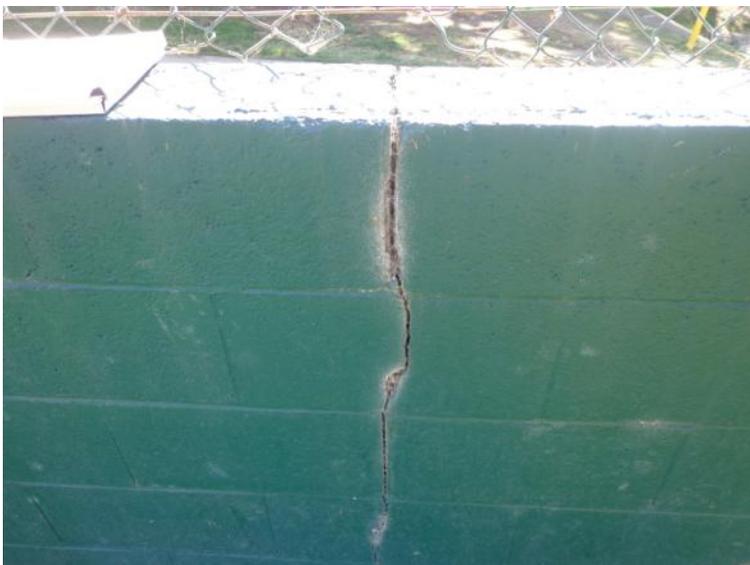
**Photograph No. 24**

View of the typical condition of the CMU walls.
