CITY OF MANHATTAN BEACH

City Hall HVAC Improvements

Final Report

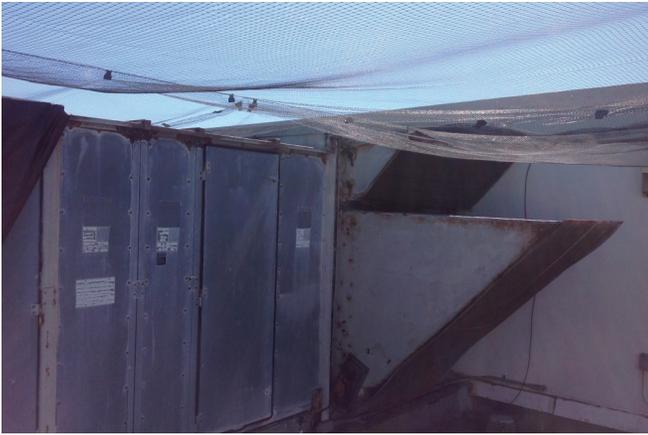
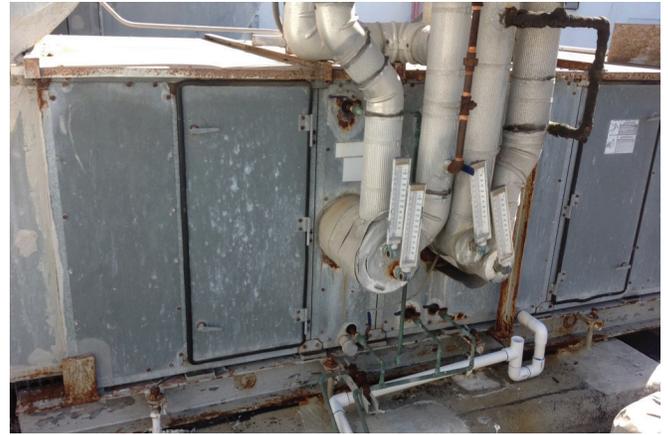
Photo 1

The building's space conditioning is provided by three (3) separate air-handling units (AH-1, AH-2 & AH-3). Air handlers AH-1 and AH-2 are exterior units and are located in an equipment roof well. The main air handler, AH-1, provides conditioned air to the entire first floor level while AH-2 serves the Council Chambers at the basement level. These units are original from 1974. The components of these two (2) air handlers include chilled and hot water coils, supply and relief fans, filter sections and ducted outside air hoods with motorized dampers and controls (see **Photos 1 and 2**).

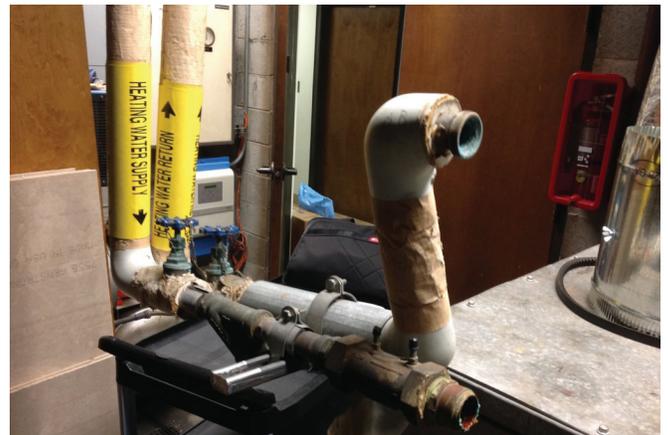
Photo 4

The indoor air handler unit, AH-3 installed in 1994, is located in the basement and serving the Administration, Storage, Training and Public Works areas. This air handling unit includes a direct expansion (DX) cooling and hot water coil, supply fan, filter section, room plenum relief and outside air intake louvers with motorized dampers and controls (see **Photo 3**). The hot water coil at AH-3 unit has been disconnected and electric heaters serving all areas except the server room have been installed in the duct mains (see **Photo 4**).

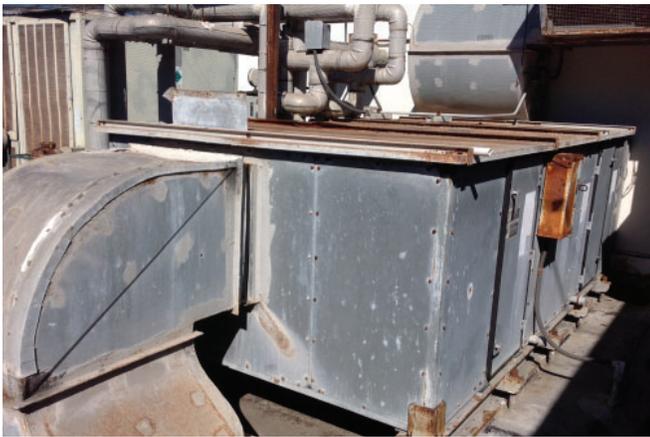
Photo 5

The exposed supply and return ductwork, in the equipment well from units AH-1 and AH-2, extends through the roof deck and into the ceiling space at both the first floor and basement levels (see Photo 5). A supply air distribution system with variable air volume (VAV) terminals is routed in the ceiling space at both floor levels and is connected to the respective air handling unit and cooling/heating zone which it serves (see Photo 6). The ceiling space above the first floor and basement serve as a return air plenum for all three (3) air handling systems and contains minimal ductwork.

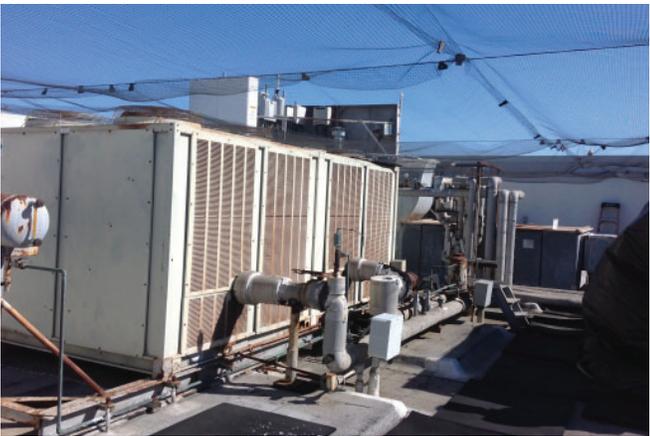
Photo 7

A roof mounted air cooled chiller (ACCH-1) installed in 1992, provides chilled water for both AH-1 and AH-2 (see Photo 7). The insulated and jacketed chilled water piping routed on the roof from the chiller to the two (2) air handlers includes pumps, valves and temperature gauges. The basement air handler, AH-3, has a dedicated air cooled condensing unit (CU-1) located in a ventilated sub-vault with an open grate at grade level (see Photo 8).

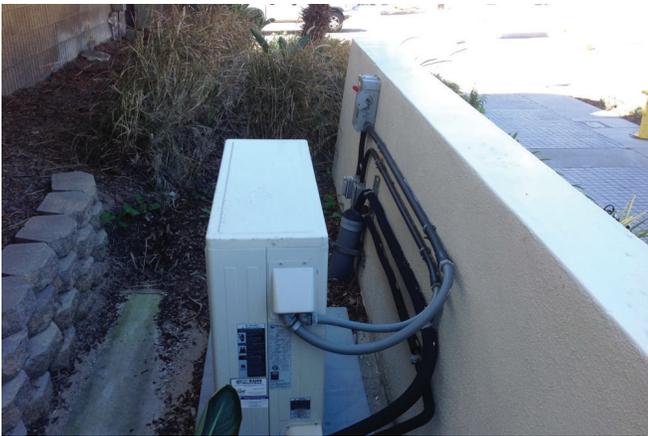
Photo 9

The building is equipped with several split heat pump systems dedicated to serve electrical and audio visual rooms (see **Photo 9**). A portable cooling unit is dedicated to serve the Data Server Room at the basement level (see **Photo 10**). The Data Server Room is also served by AH-3.

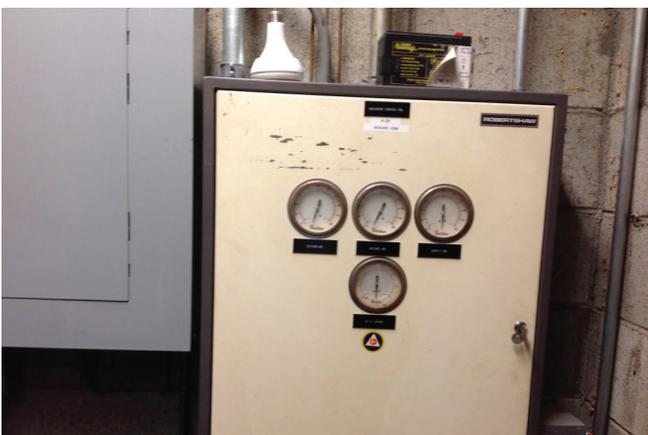
Photo 11

A partial controls system upgrade was completed the 1994 basement remodel. A new main Novar control system was installed in 2014. The existing control system is still a primarily pneumatic type with the controls system air compressor located in the basement mechanical room (see **Photos 11 and 12**). Control wiring and tubing extends to the various HVAC thermostats and components serving the building.

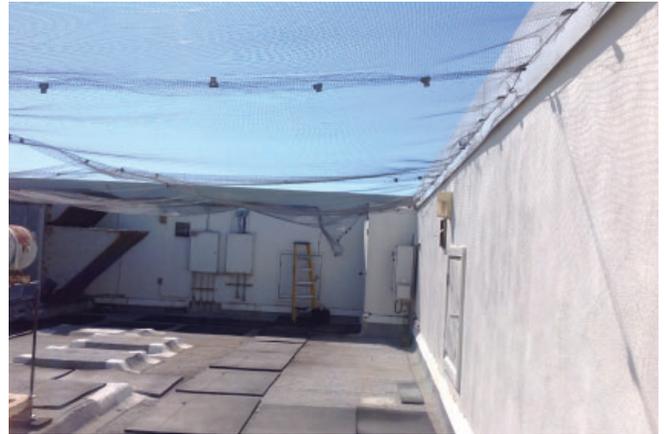
Photo 13

Both wings are covered with modified bitumen roofing membrane of indeterminate age. The roofing is in fair condition with the exception of rock grandules loss in high traffic areas. It is recommended that more rock grandules be added as they are essential for protection of the membrane assembly (see Photo 13). The screen walls around the north wing roof well are prefinished metal panels, which appear to be in fair condition. Any improvements to the rooftop HVAC systems will require the removal and replacement of the equipment, which will affect the roofing.

In areas where the roof will be impacted by the required equipment replacement, it is recommended to tear out local patching and the elastomeric coating on the roofing membrane. However, this short term solution will require the replacement of the entire roofing system within five to ten years. A long term and more cost effective solution would be to replace the entire roofing membrane in conjunction with the HVAC equipment installation.

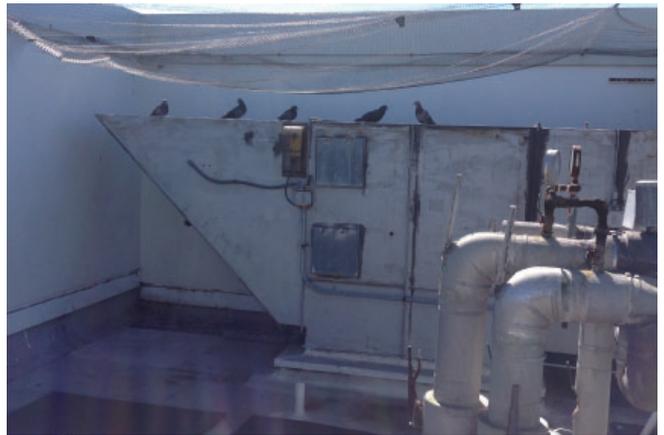
Photo 14

The roof well is covered with bird netting supported by tensioned wires at the perimeter and spanning across the well. The netting is draping and touching the top of some mechanical equipment, and it has openings that permits birds to roost inside the well (see Photo 14). For replacement of any mechanical equipment on the roof, the netting will need to be removed for equipment access by crane. After the work is done on the roof, the existing wires should be re-tensioned and new netting installed to keep the well and equipment free of birds.

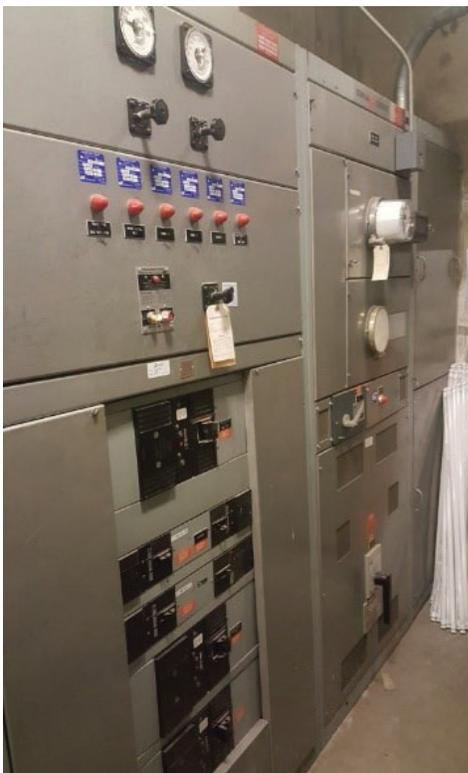
Photo 16

Main switchboard MSB, which provides power to the building, is located in the basement electrical room and is rated 1200 amps at 480/277V, 3 phase, 4 wire. The equipment appeared to be in fair condition with no issues reported by maintenance personnel (see **Photo 16**).

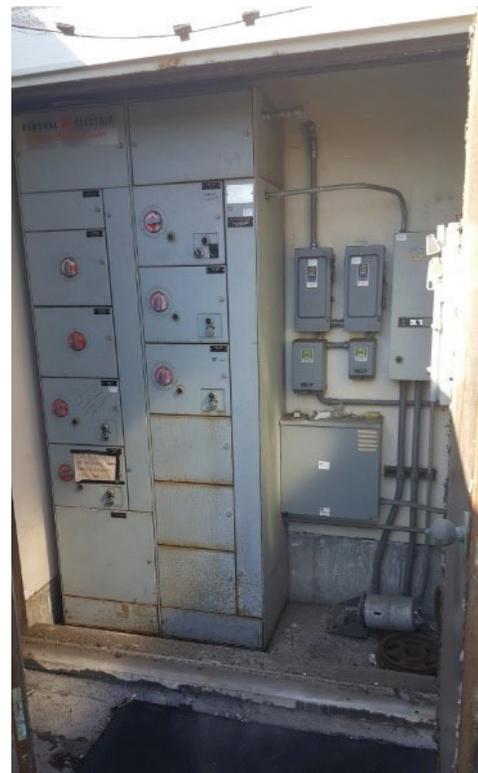
Photo 17

Main Switchboard MSB feeds Motor Control Center MCA which is located on the roof. MCA provides power to the roof mounted HVAC equipment. MCA appeared to be in fair condition with no issues reported by maintenance personnel (see **Photo 17**).

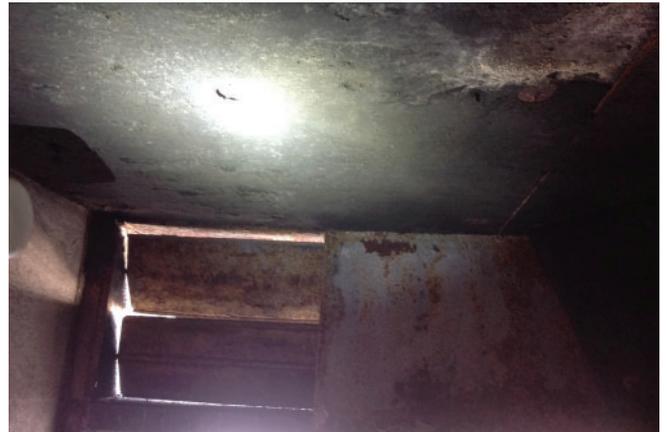
Photo 18

Extensive corrosion on air handler equipment AH-1 and chiller unit ACCH-1 shows numerous penetrations through the equipment casing which has impacted the structural integrity of the units and caused the internal insulation to separate from the casing wall (see Photos 18, 19 and 20). The deterioration has degraded the equipment allowing moisture to enter the unit and further compromising the internal components and their operation.

Replacement of the equipment with new units incorporating high efficiency motors, and compressors, and double insulated wall unit casing, will reduce maintenance and utility costs and provide

improved heating, cooling and airflow to individual thermal zones. Continued operation of the existing equipment will result in further deterioration of the HVAC components to the point where equipment and unit components will no longer function and provide the needed building space comfort.

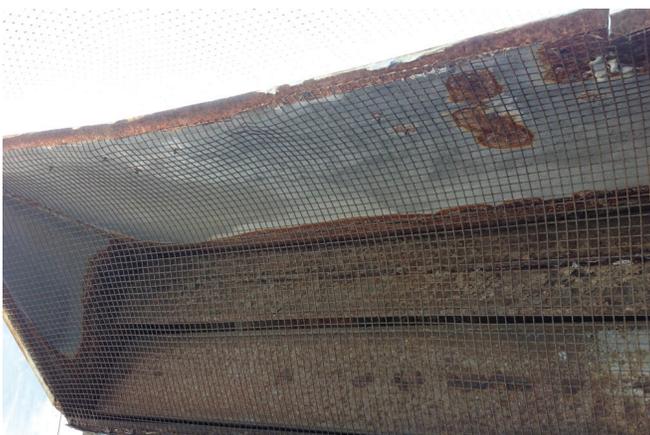
Photo 21

Air handler AH-2 also shows significant rust on the unit (see Photo 21). The survey and report developed by American Air

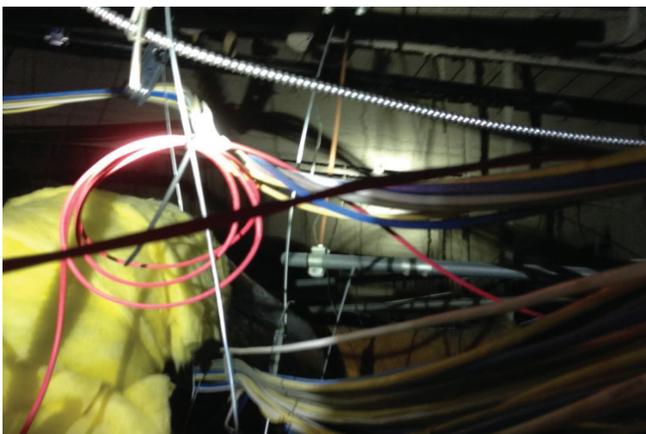
Photo 25

The controls systems are an outdated pneumatic system that have exceeded their effectiveness in managing the variable air volume (VAV) terminal unit damper actuators and other interfacing HVAC components (see Photos 25 and 26). The age of the system air tubing and control wiring will have air and signal losses that will minimize the effectiveness of system operation. Older pneumatic systems can experience an energy penalty ranging between 5% and 15% due to out of calibration system components. Continued use of the existing controls will result in poor system performance and high monthly operating costs. A new controls system utilizing a Building Management System (BMS), and new VAV actuators will significantly improve overall HVAC operating performance, provide better throttling ranges, quicker response for discharge air temperature reset from space, improved signaling for system start and stop schedules and reduction in utility costs.

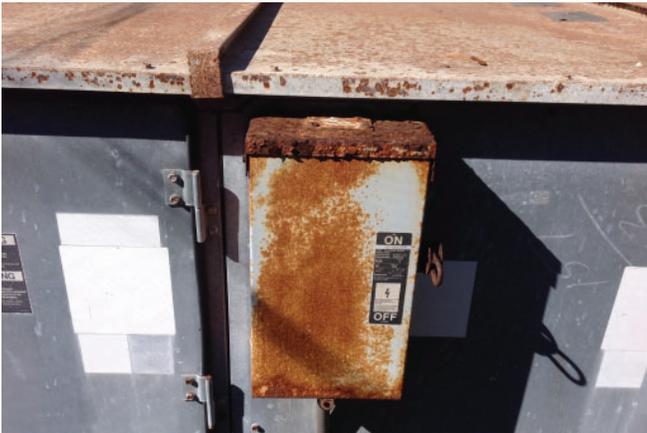
Photo 27

Air handler AH-2 also shows significant rust on the unit (see **Photo 27**). The survey and report developed by American Air Balance describes the poor condition of the equipment, the level of corrosion at the equipment, ductwork, piping and the measured airflow performance. The survey results reflect an HVAC system that lacks significantly in performance which is contributing to uncomfortable space conditions.

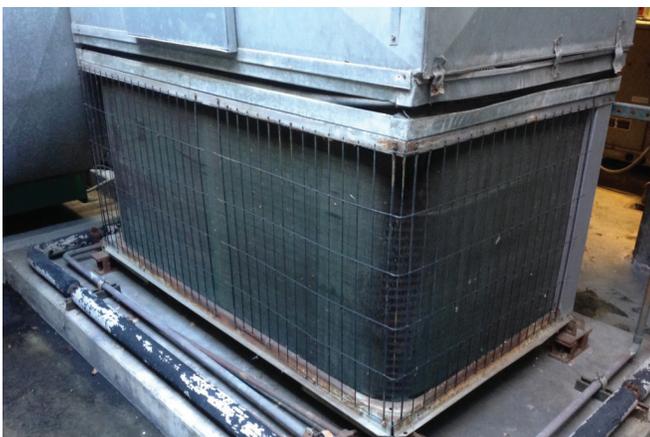
Photo 30

American Air Balance describes the poor condition of the equipment, the level of corrosion at the equipment, ductwork, piping and the measured airflow performance. The survey results reflect an HVAC system that lacks significantly in performance which is contributing to uncomfortable space conditions. The indoor AH-3 unit located in the basement mechanical room and serving this area has been field revised from its original configuration. The unit mounted hot water coil has been disconnected and multiple electric duct mounted heaters serving various thermal zones have been installed (see Photo 28). This arrangement allows cooling air from AH-3 to serve the Server Room. The use of electrical resistance heating has a tremendous impact to monthly utility costs. Any upgrades relating to the system will result in the need to bring equipment configuration to current Title 24 standards. The AH-3 unit located inside the building did not experience the corrosion as the outdoor roof mounted air handlers, however the relief air fan, dampers and motors are rusted to the point of being non-operable (see Photo 29). The interconnected outdoor cooling condensing unit also showed evidence of salt-air corrosion and was operating with audible excessive noise at the time of the site visit (see Photo 30).

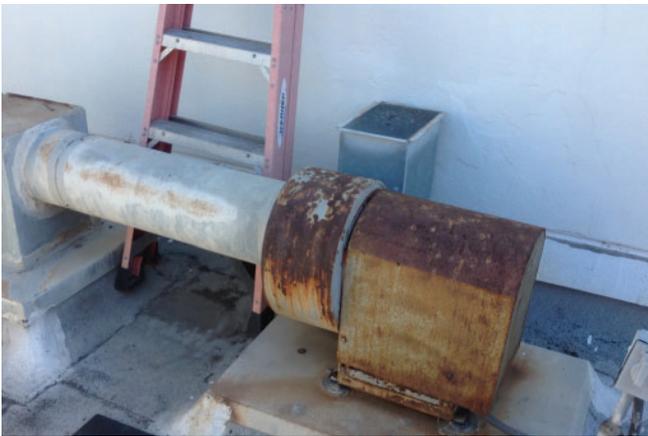
Photo 31

The exposed roof mounted exhaust fans serving various toilet room areas in this building are showing evidence of corrosion and poor system performance. Replacement of this equipment with new fans of equal performance and configuration will significantly improve proper air distribution and system performance (see **Photo 31**).

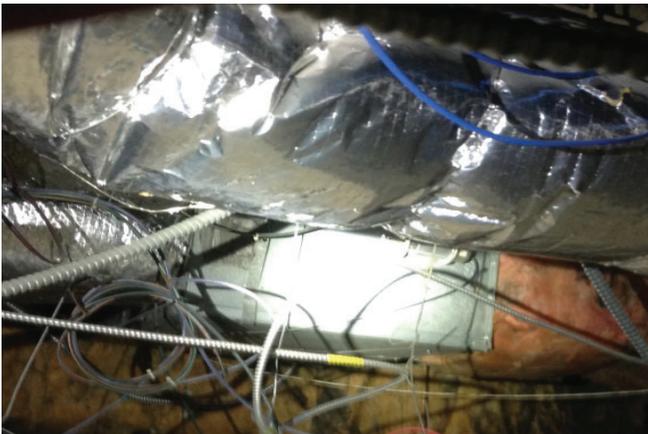
Photo 32

The VAV terminals have been updated since the original construction however the dampers, actuators and valves are slow responding due to age of the components (see **Photo 32**). The slow responding components interfacing with an outdated pneumatic controls system should be replaced. The replacement of the VAV terminals with new reheat coils, actuators and valves will improve the responsiveness to satisfy room thermostat settings, reduce maintenance and utility costs and provide enhanced zone comfort for room occupants.

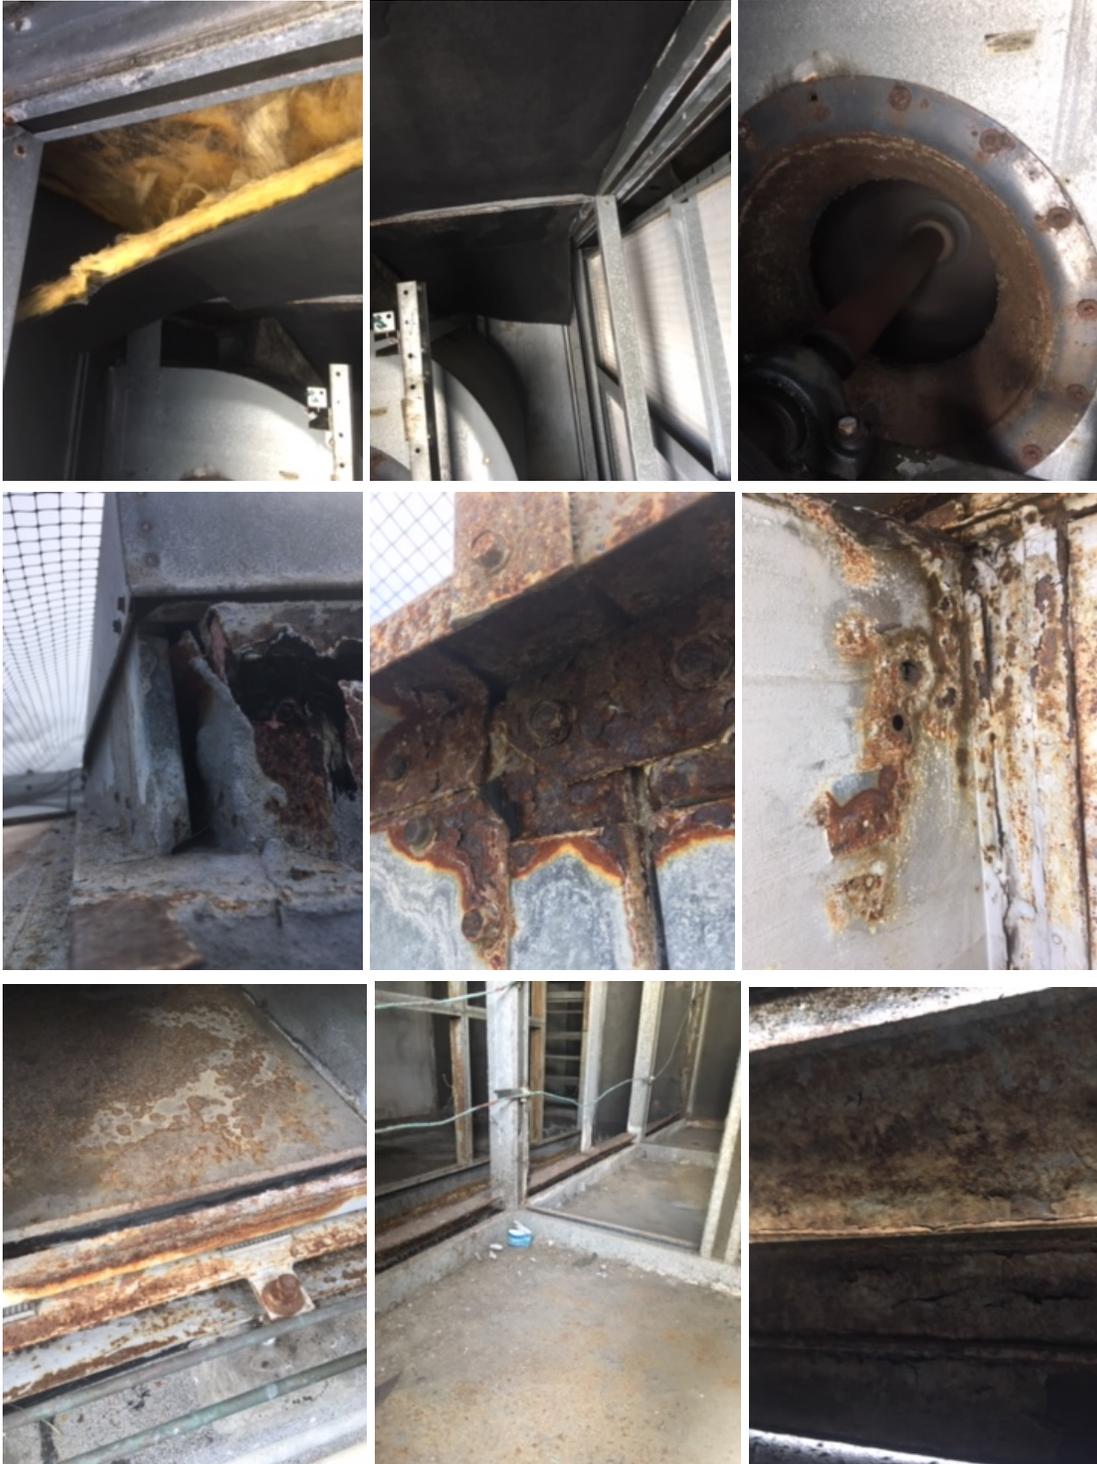
- The overall condition of the fan is poor. There are holes from corrosion throughout the unit. The dampers for the economizer and outside air are corroded. The insulation from inside the fan compartment is coming off the unit walls and the fan itself is dirty and needs to be cleaned.

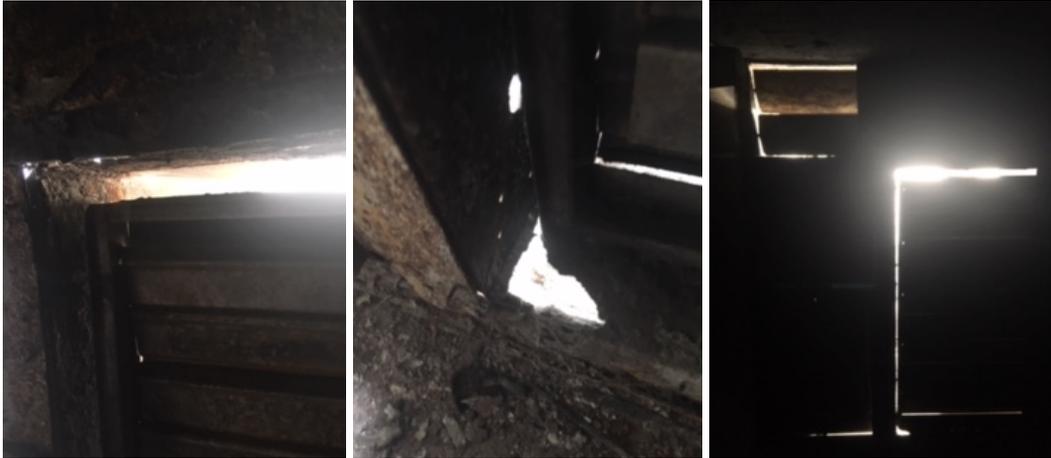
- Due to the economizer damper not being the correct size and various holes on and around the mixing plenum, the total outside air for this unit was determined by the total supply minus the traversed return.

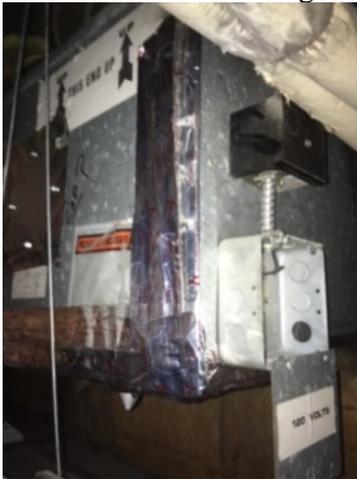
- There is no air flow on VAV's 3, 4, 12, 16, 19, 25, 29 and 38. This is due to no control's controller being hooked up to the VAV box.
- The fan powered boxes that are shown on the original print have been gutted and abandoned in the ceiling.

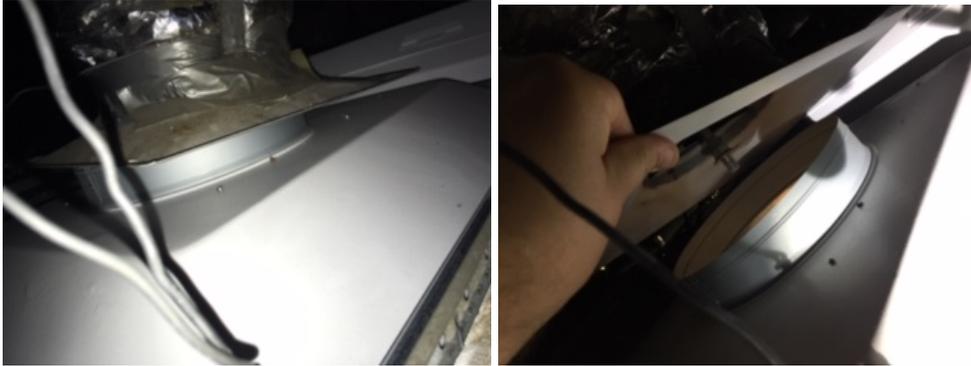
- The air distribution associated with VAV-44 which serves the chambers conference room, is not connected properly. This is allowing air to enter the attic space which in turn is not cooling the required space properly. Properly attaching the diffusers will increase the unit's ability to cool the space.

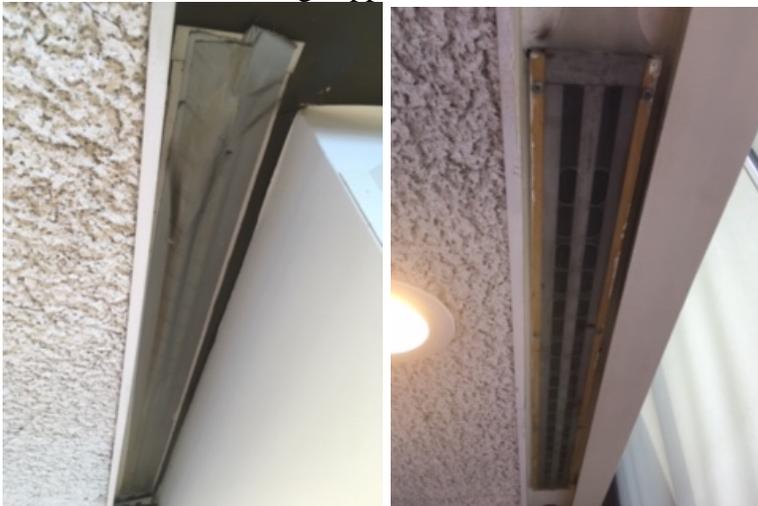
- Air Distribution 7,9 and 10 associated with VAV-30 have an actual CFM of 0. This is due to the diffuser being capped.

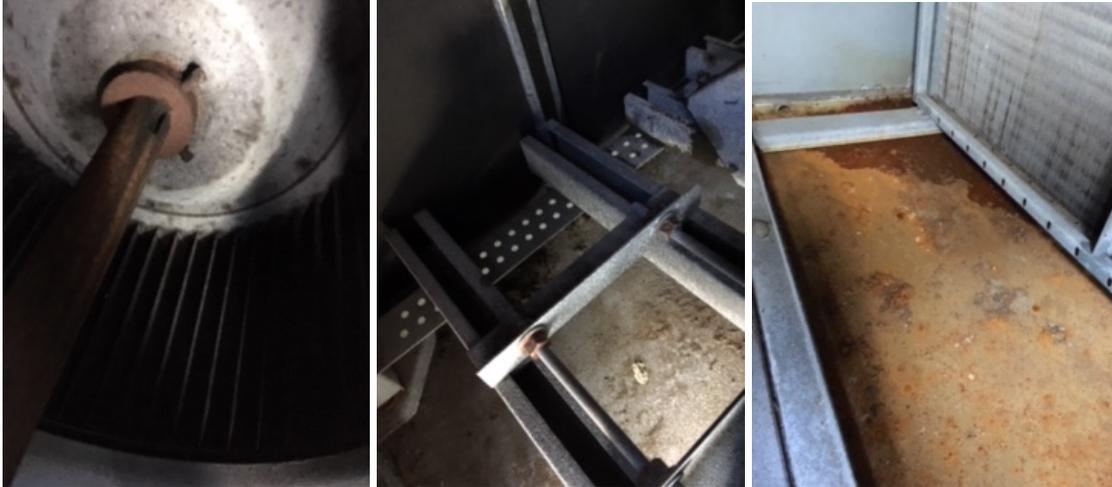
- The fan compartment and fan wheel on this unit is dirty and needs to be cleaned. There are debris located on the bottom of the unit that may enter the conditioned space.

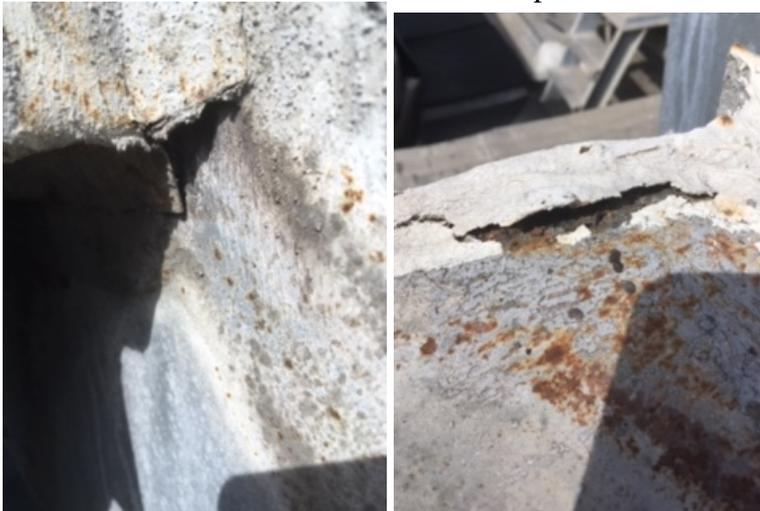
- The supply duct work has damage to it which is leaking air. Sealing this duct work will insure that it will reach the conditioned space.

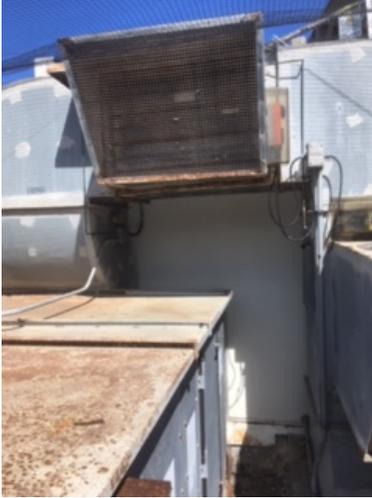
- Due to inadequate lengths of straight duct work, the return total was determined by taking traversed supply minus the traversed outside air.

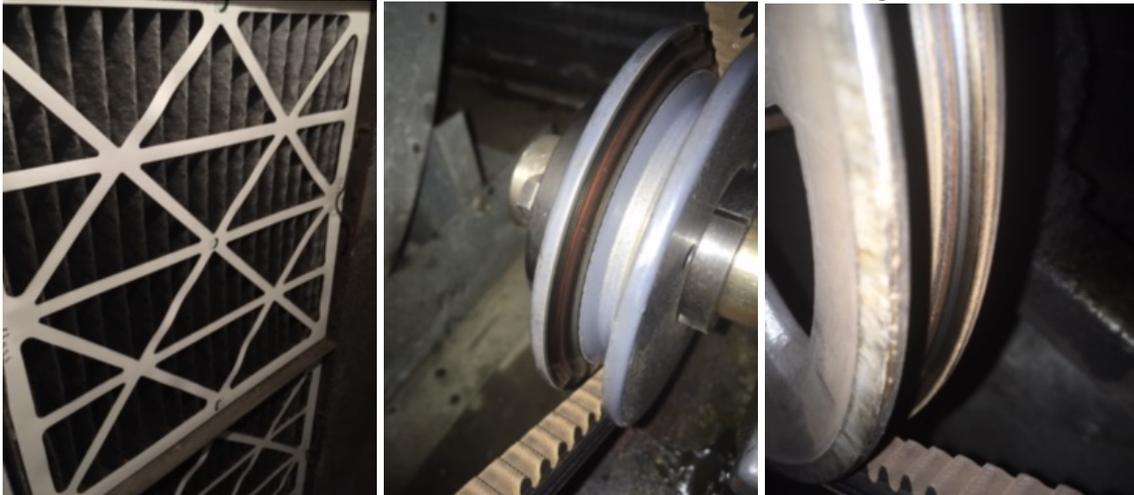
AH-3

- The filters on the unit were clean and the belts and sheaves were in good condition.

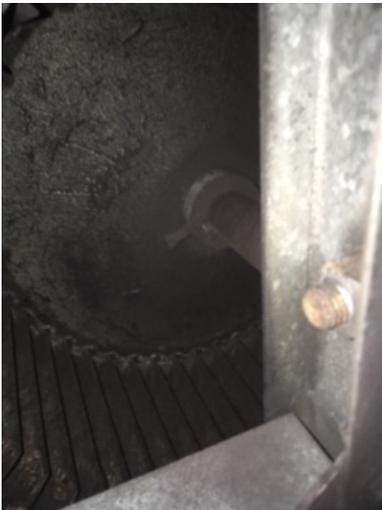
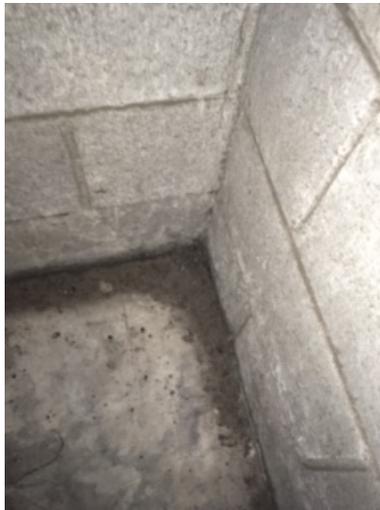
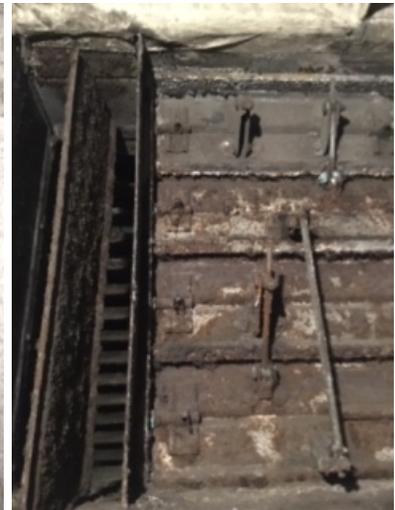
- The fan compartment and fan wheel on this unit are dirty and needs to be cleaned. There are debris that is on the bottom of the unit that may enter the conditioned space due to it being located after the filters.

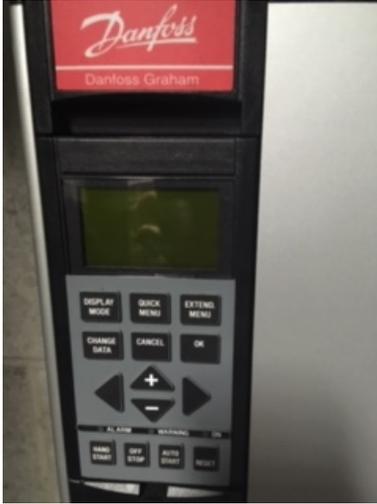
- AH-3 has a VFD that is not operational.

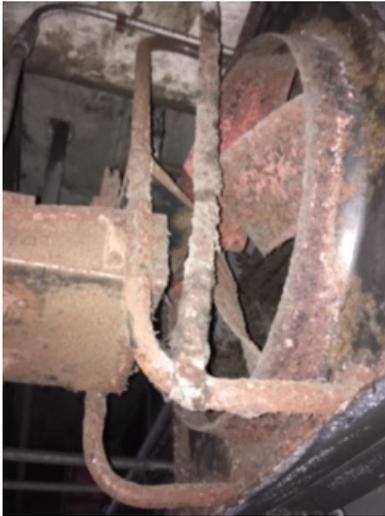
- AH-3 has a power exhaust fan that is not operational. It appears it has not functioned in some time.

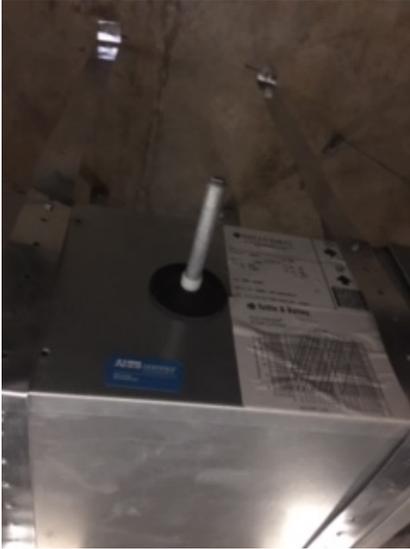
- VAV-Women's which serves the restroom does not have a controls actuator installed. The damper is set in a fixed position.

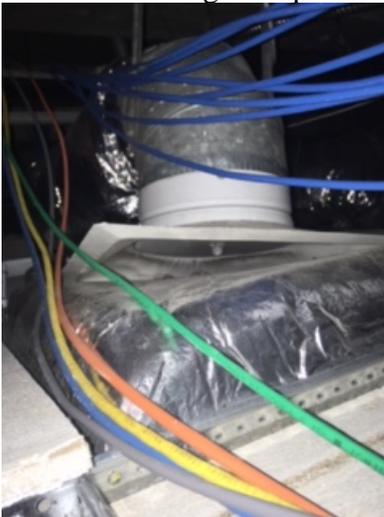
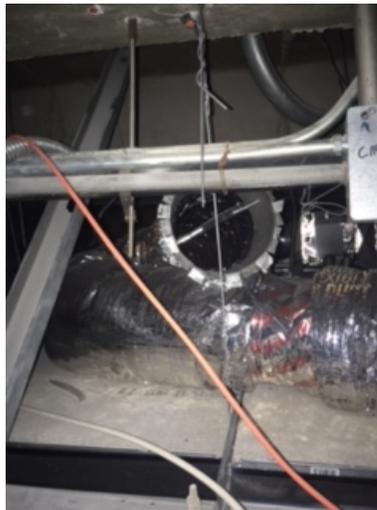
- Air Distribution 9, 10, 12 and 13 have an actual CFM of 0. On 9,10 and 12 that is due to the ductwork not being installed properly on the ceiling diffuser and possibly blowing above the ceiling. Drop 13 has no air flow due to the duct work not being connected.

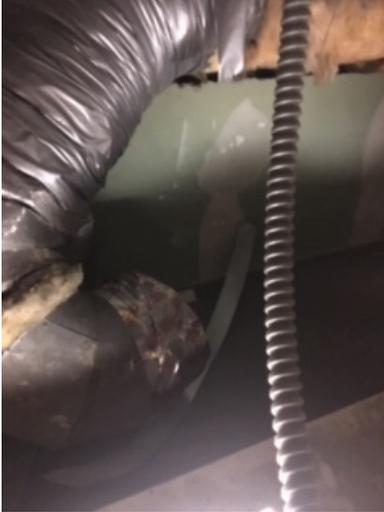
- Off VAV-40 there is a supply drop that is open to the ceiling and is possible supplying air above the ceiling.

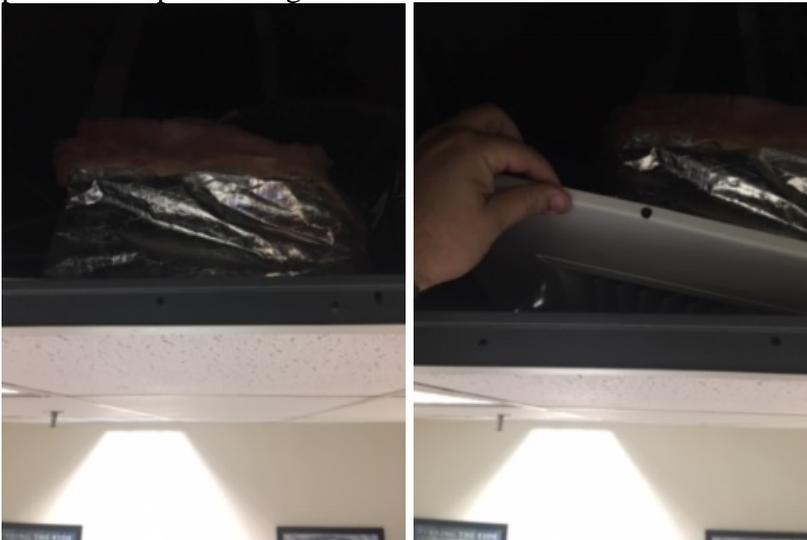
- Drop number two off VAV-53 had no air flow. This is due to the ceiling diffuser being placed on top of ceiling tile.

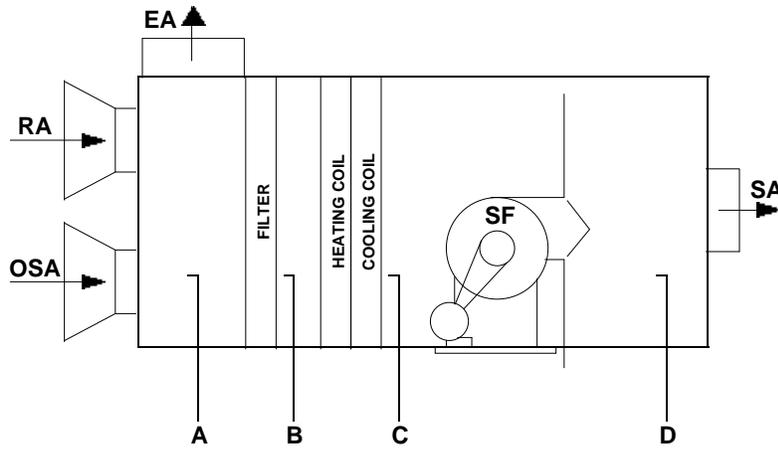
Static Pressure Profile	
PROJECT	Manhattan Beach City Hall
DESCRIPTION	EXIST AH-1 STATIC PROFILE

A	B	C	D
-0.34	-0.42	-0.70	1.96

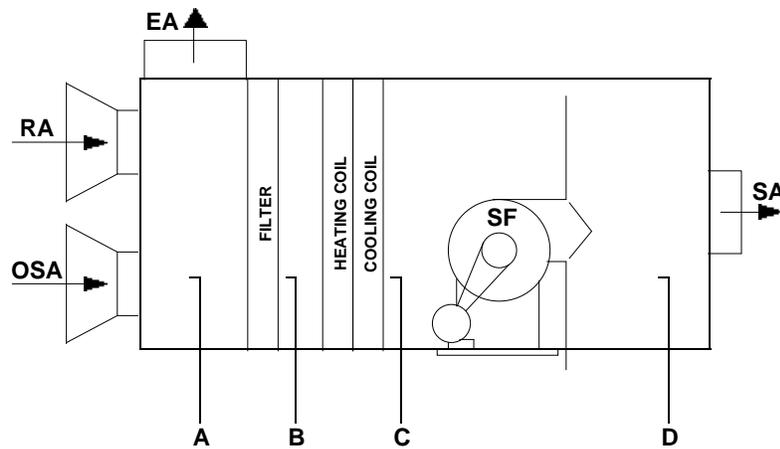
Static Pressure Profile	
PROJECT	Manhattan Beach City Hall
DESCRIPTION	EXIST AH-2 STATIC PROFILE

A	B	C	D
-1.32	-1.35	-1.94	0.41

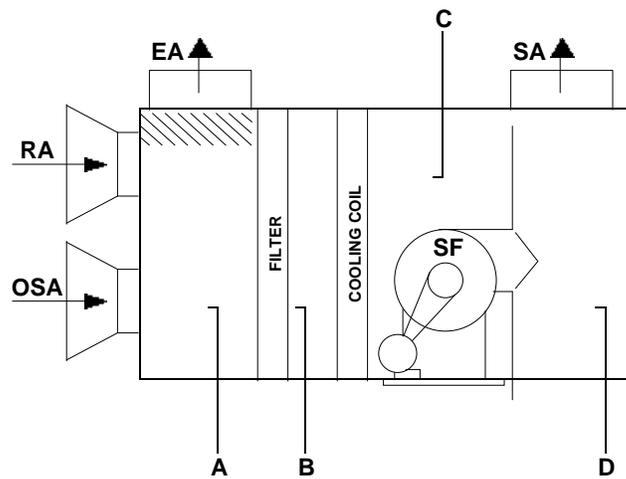
Static Pressure Profile	
PROJECT	Manhattan Beach City Hall
DESCRIPTION	EXIST AH-3 STATIC PROFILE

A	B	C	D
-0.37	-0.74	-1.25	0.56
