EXISTING CONDITIONS PHOTOS

CITY OF MANHATTAN BEACH City Hall HVAC Improvements

Final Report

July 2, 2019

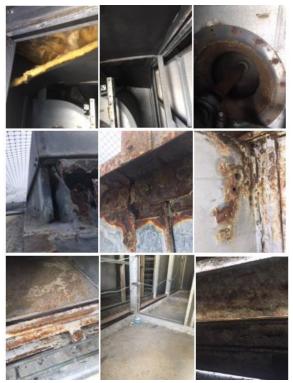
- Air Handler 1 (AH-1)
 - Extensive corrosion on air handler equipment AH-1 and chiller unit ACCH-1.

Due to deterioration and rusted shut dampers and shafts, the air distribution system does not provide the code necessary ventilation air required for space comfort.

The overall condition of the fan is poor. There are holes from corrosion throughout the unit. The dampers for the economizer and outside air are corroded. The insulation from inside the fan compartment is coming off the unit walls and the fan itself is dirty and needs to be cleaned.

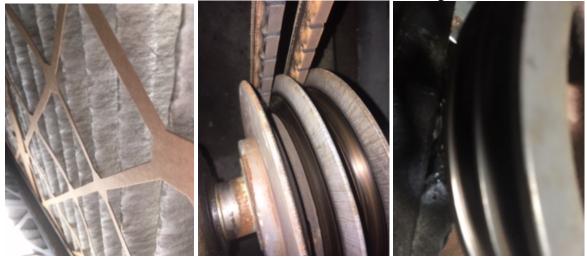
AH-1

• The filters on the unit were clean and the belts and sheaves were in good condition.

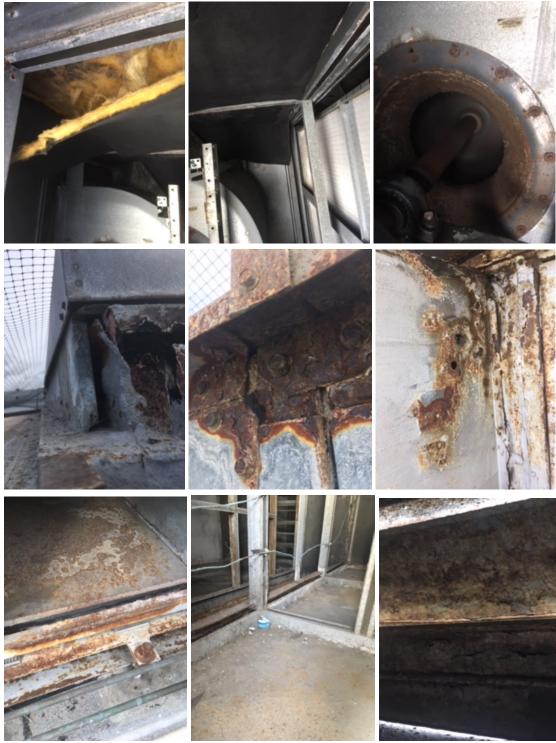
• The overall condition of the fan is poor. There are holes from corrosion throughout the unit. The dampers for the economizer and outside air are corroded. The insulation from inside the fan compartment is coming off the unit walls and the fan itself is dirty and needs to be cleaned.

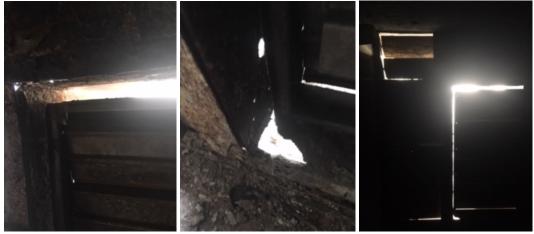
• Due to the economizer damper not being the correct size and various holes on and around the mixing plenum, the total outside air for this unit was determined by the total supply minus the traversed return.

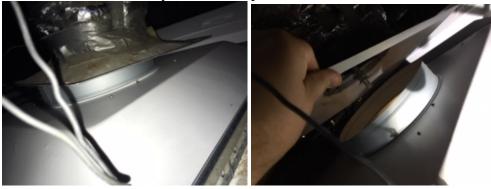
• The air distribution associated with VAV-44 which serves the chambers conference room, is not connected properly. This is allowing air to enter the attic space which in turn is not cooling the required space properly. Properly attaching the diffusers will increase the unit's ability to cool the space.

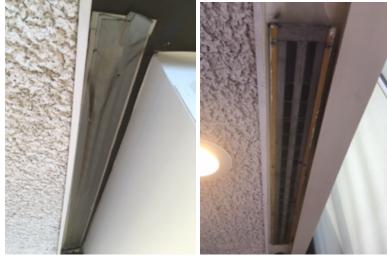
• Air Distribution 7,9 and 10 associated with VAV-30 have an actual CFM of 0. This is due to the diffuser being capped.

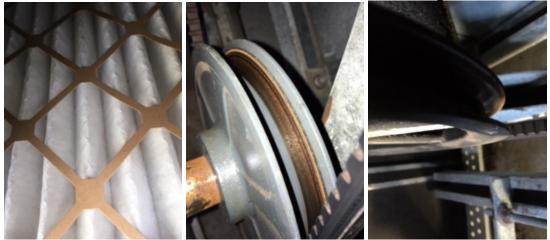
AH-2

The filters on the unit were clean and the belts and sheaves were in good condition. •

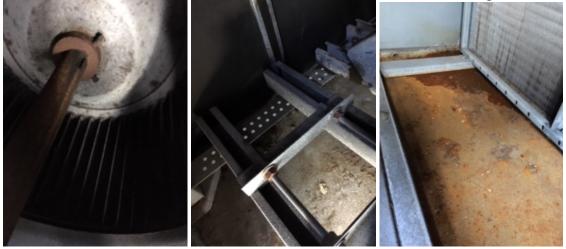
• The fan compartment and fan wheel on this unit is dirty and needs to be cleaned. There are debris located on the bottom of the unit that may enter the conditioned space.

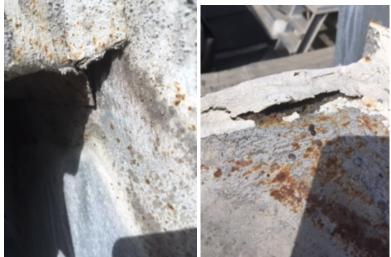
• The supply duct work has damage to it which is leaking air. Sealing this duct work will insure that it will reach the conditioned space.

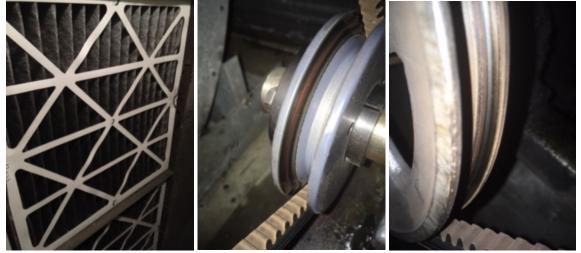
AH-3

The filters on the unit were clean and the belts and sheaves were in good condition. •

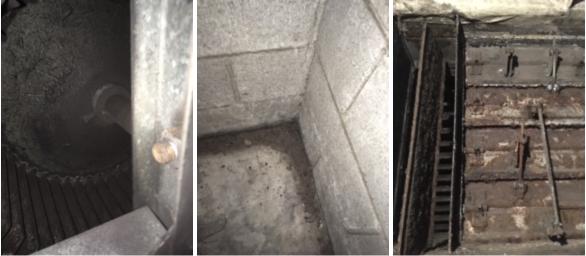
• The fan compartment and fan wheel on this unit are dirty and needs to be cleaned. There are debris that is on the bottom of the unit that may enter the conditioned space due to it being located after the filters.

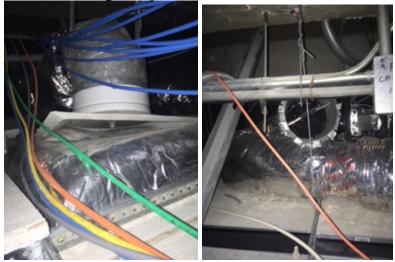
• Air Distribution 9, 10, 12 and 13 have an actual CFM of 0. On 9,10 and 12 that is due to the ductwork not being installed properly on the ceiling diffuser and possibly blowing above the ceiling. Drop 13 has no air flow due to the duct work not being connected.

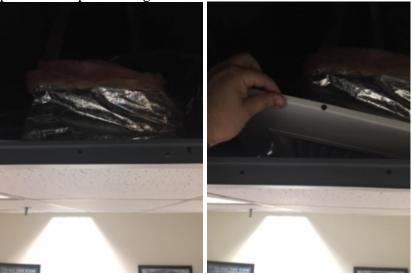
• Drop number two off VAV-53 had no air flow. This is due to the ceiling diffuser being placed on top of ceiling tile.

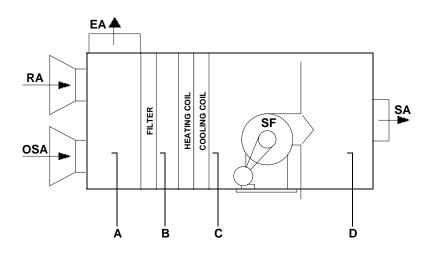
Static Pressure Profile						
PROJECT Manhattan Beach City Hall						
DESCRIPTION EXIST AH-1 STATIC PROFILE

А	В	С	D
-0.34	-0.42	-0.70	1.96

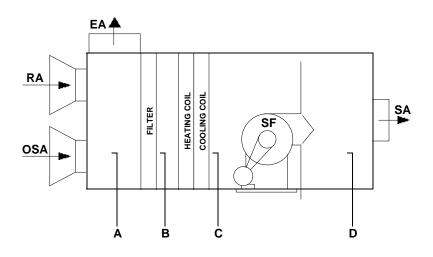
Static Pressure Profile
PROJECT
Manhattan Beach City Hall
DESCRIPTION
EXIST AH-2 STATIC PROFILE

А	В	С	D
-1.32	-1.35	-1.94	0.41

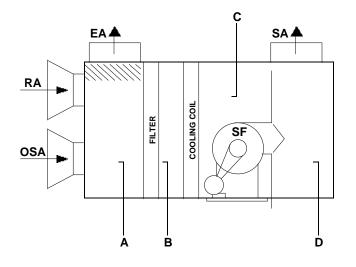
EXIST AH-3 STATIC PROFILE

А	В	С	D
-0.37	-0.74	-1.25	0.56
