Citywide
Facility Condition Assessment

Report of
Facility Condition Assessment

For
City of Manhattan Beach
Live Oak Park
1902 Valley Drive, Manhattan Beach, CA

*September 4, 2013
(Rev A)*

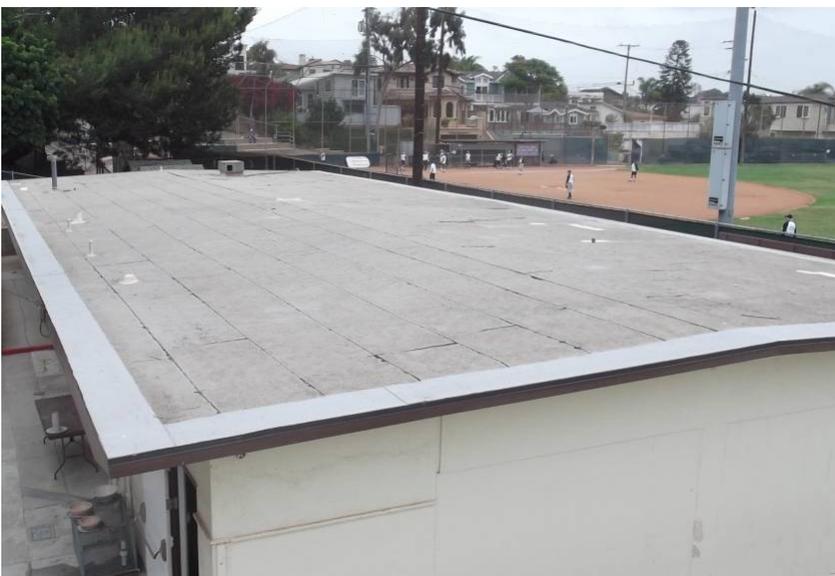
Photograph No. 3

The low-sloped roof contains a multi-layer modified bitumen built-up roof and a cap sheet with mineral surface granules (reference Photograph 3 in Appendix B). We understand that the roofing was installed in 1991 and that it was installed over older roofing.

View of the roof.

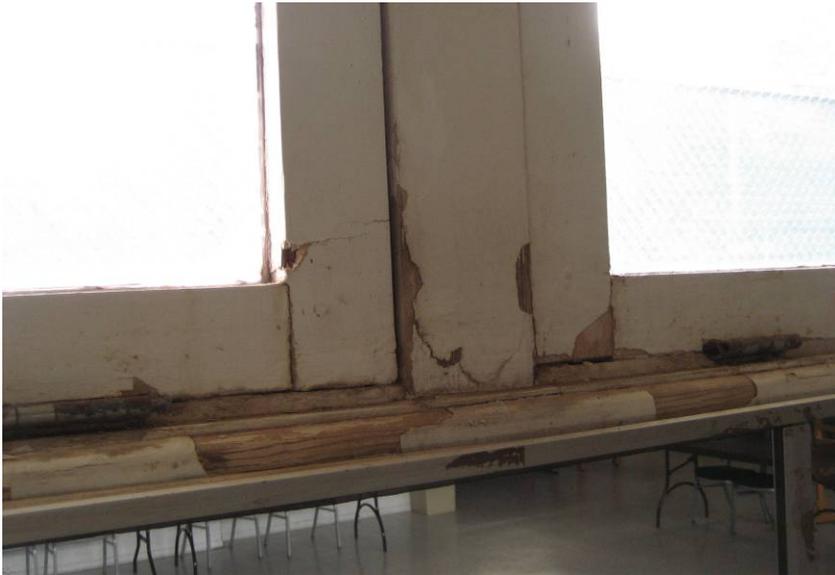
Photograph No. 7

Interior view of the windows and trim.

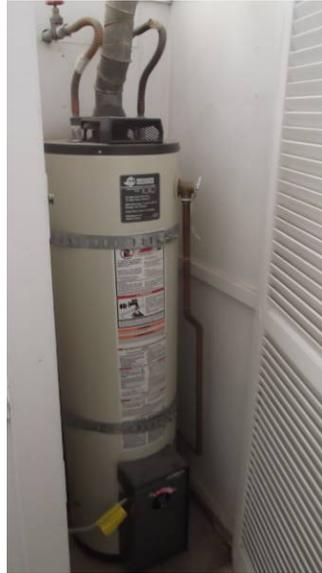
Photograph No. 13

Domestic hot water is provided in the kitchen area and restrooms of the Recreation Hall. The hot water is generated via a natural-gas-fueled water heater located in a closet in the kitchen area at the west side of the building (reference Photograph 13 in Appendix B).

View of the domestic water heater.

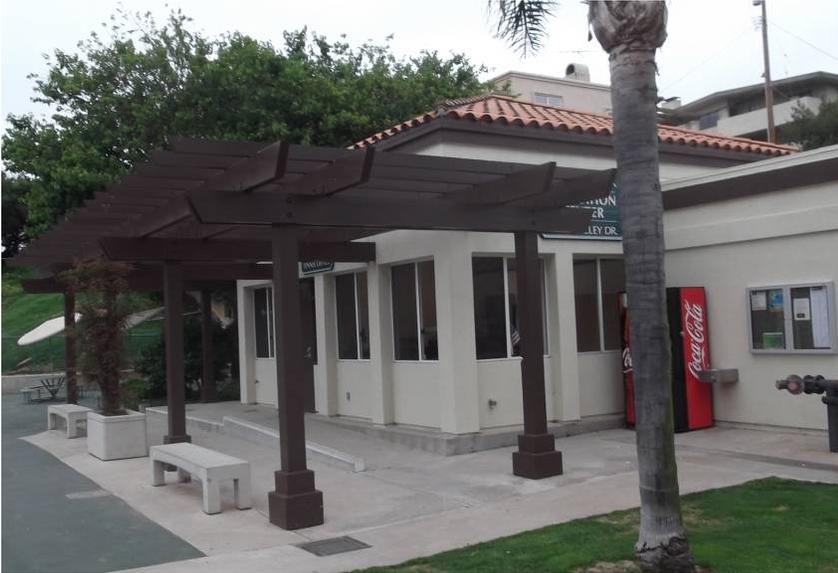
Recreation Center

There is one exterior stainless steel water fountain mounted on the exterior of the building, on the south façade (reference Photograph 16 in Appendix B).

View of the south façade and entrance arbor of the tennis center.

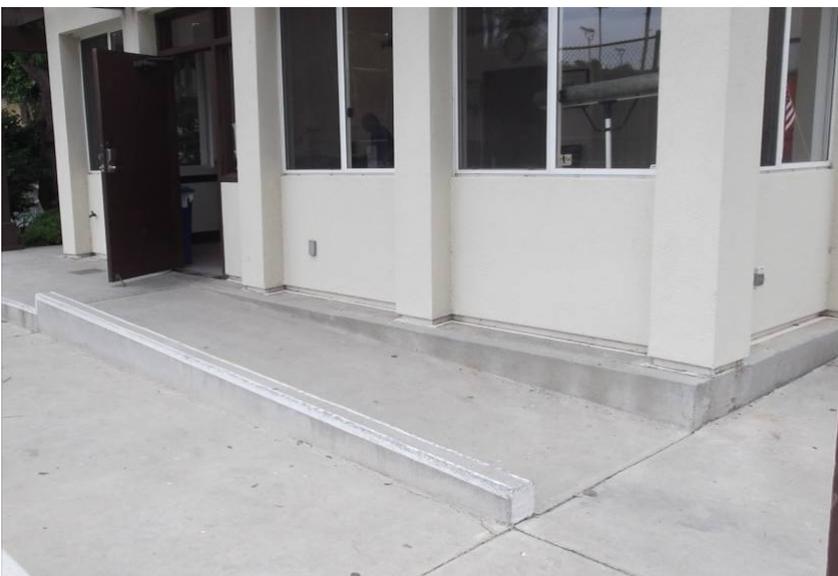
Photograph No. 18

The exterior ramp appeared to be in good condition and provides access to the building's entrance for disabled individuals. However, the ramp lacks railings and the upper landing at the entrance doors does not provide adequate clearance for door opening (reference Photograph 18 in Appendix B). We recommend budgeting for installation of railings on each side of the ramp in the near term to comply with accessibility guidelines.

View of the entrance ramp of the tennis center that lacks railings.

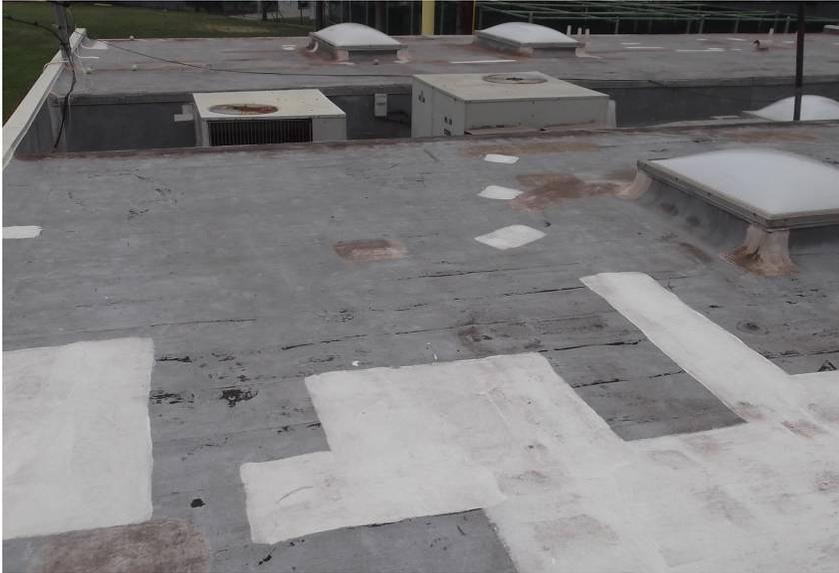
Photograph No. 19

Roof area 1 at the south side of the building is a steeply-sloped roof containing clay tiles, with the remainder of the roofing (roof area 2) multi-layer asphaltic built-up roofing and a smooth surface, aluminum coating (reference Photographs 19 through 21 in Appendix B). Roof area 2 is divided into three sections by a center, recessed section containing mechanical equipment.

View of the roof.

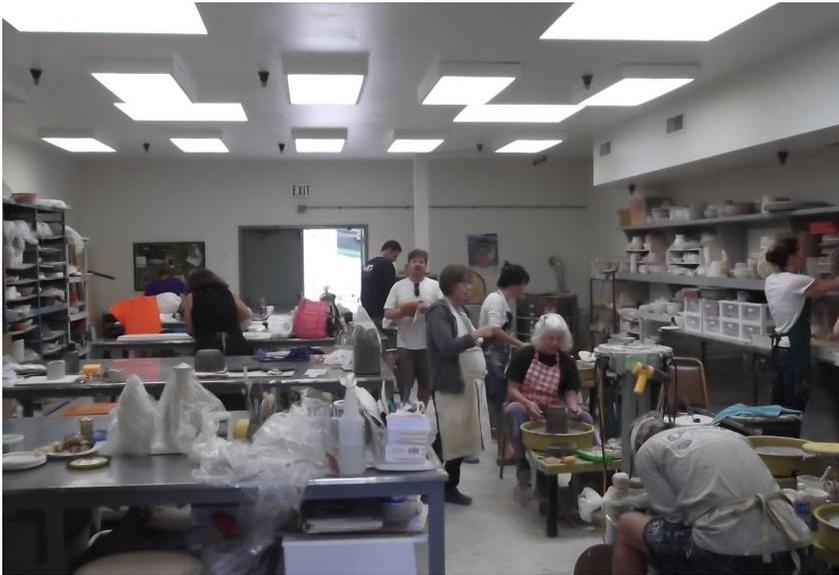
Photograph No. 25

The building contains a wet-pipe fire sprinkler system, with ceiling pendant heads supplied from an exterior riser at the west side of the building (reference Photographs 25 and 32 in Appendix B). System water supply is provided by municipal main pressure, without the use of a fire pump, and water flow is monitored by a local alarm system. The service main, with check valve assembly and Siamese hose connections, is located at the south side of the building.

View of the ceramics studio interior.

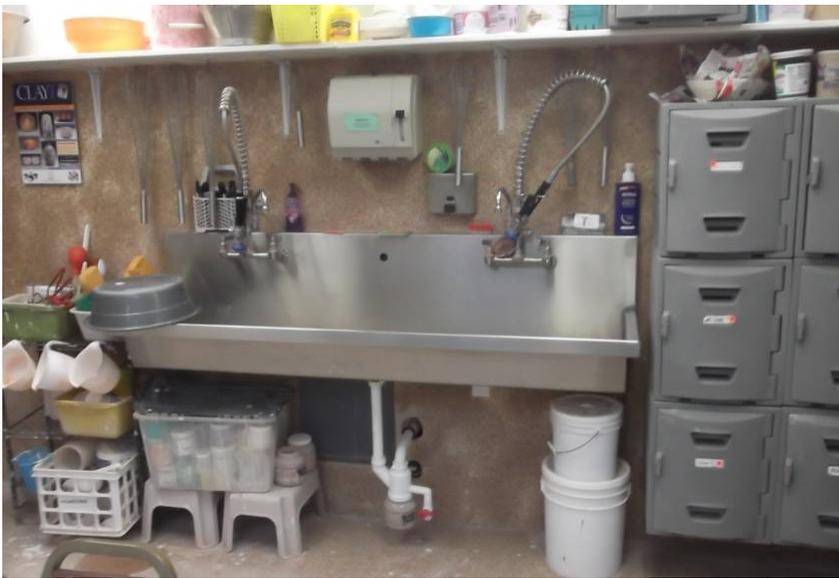
Photograph No. 26

The ceramic studio in the Recreation Center contains wall-mounted stainless steel sinks with goose-neck faucets and handheld spray attachments (reference Photograph 26 in Appendix B) and the after-school craft space has a single stainless steel sink recessed in the plastic laminate countertop/base cabinets. Water is supplied via copper piping and drained through PVC piping with sediment filtration device.

View of the ceramics studio area interior.

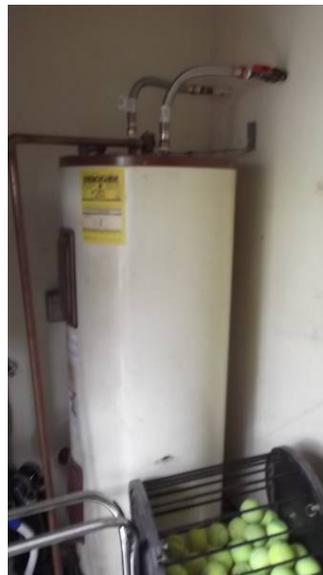
Photograph No. 29

Domestic hot water is provided in the ceramics studios, crafts room, and restrooms of the Recreation Center. The hot water is generated via an electric water heater located in a closet in the tennis center (the south side of the building) (reference Photograph 29 in Appendix B).

View of the domestic water heater.

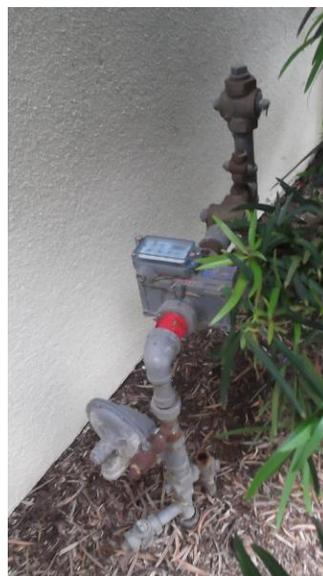
Photograph No. 30

The buildings are provided with natural gas service, typically 1" diameter steel piping, with the service meters at the east side of the Recreation Hall (assumed to also serve the Kiln) and the west side of the Recreation Center (reference Photograph 30 in Appendix B). The service is provided for HVAC and plumbing equipment, as well as ceramics-firing kilns.

View of the natural gas service meter.

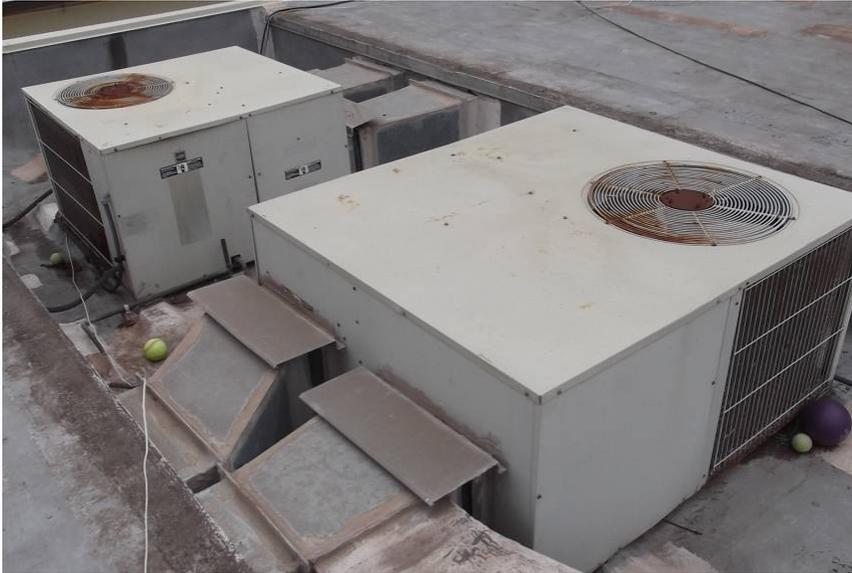
Photograph No. 31

The building contains two rooftop package heat pump heating and cooling units (reference Photograph 31 in Appendix B). The units are located in a rooftop "well" in the center of the building and were manufactured in approximately 1993 by Carrier. The units have cooling capacities of 3- and 4-tons each. Refer to the following table D30-2 for further details of the package units.

View of the rooftop package heat pump units.

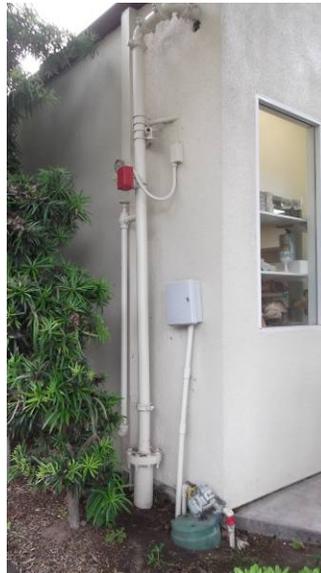
Photograph No. 32

The building's fire sprinkler system is provided with a flow-monitoring alarm system. The system appears to be locally alarming only, with a water flow monitor on the system riser valve at the building's west façade and a gong at the southeast corner (reference Photograph 32 in Appendix B).

View of the fire sprinkler riser with water flow alarm monitor.

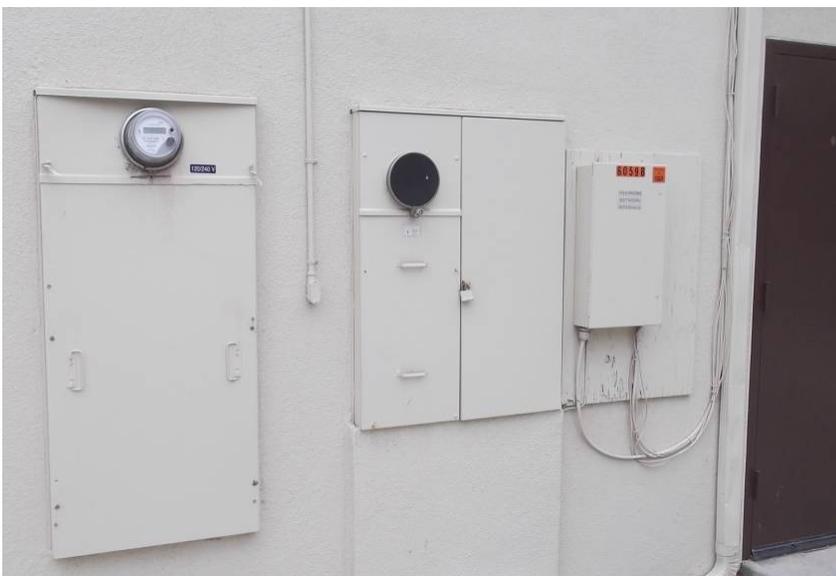
Photograph No. 33

View of the electrical service panels and meter on the rear wall of the building.

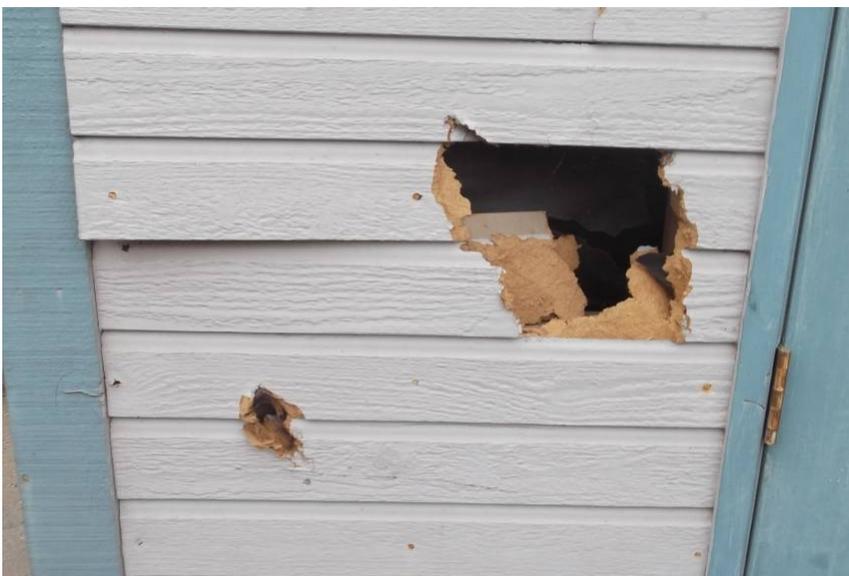
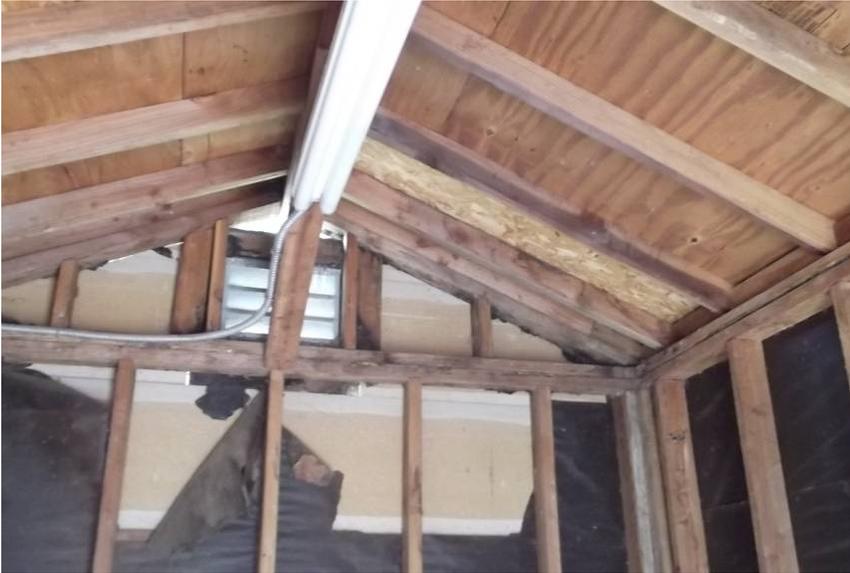
Photograph No. 37

The buildings are ventilated by gable end and sidewall louvers and do not have mechanical air distribution systems (reference Photographs 37 and 46 in Appendix B).

Interior view of the building.

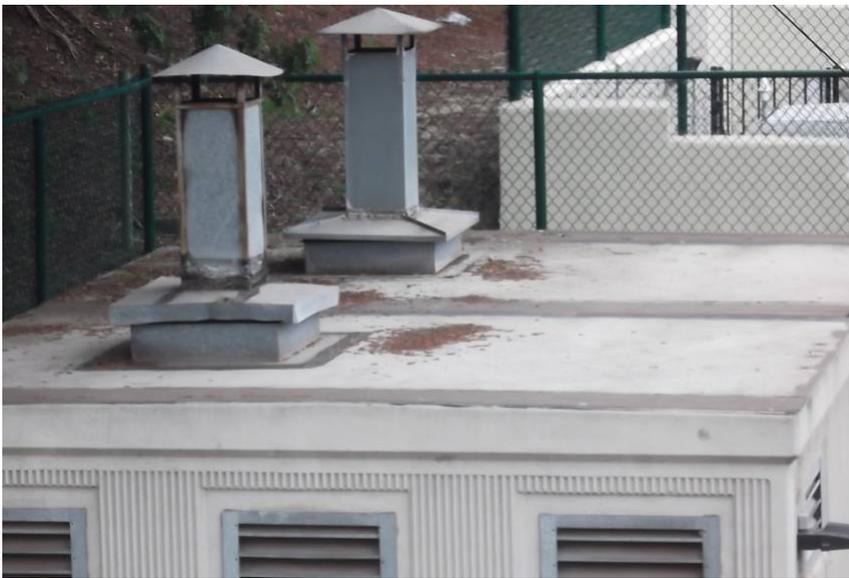
Photograph No. 44

The low-slope roof appears to be limited to an applied coating over the precast concrete roof deck (reference Photograph 44 in Appendix B).

View of the roof.

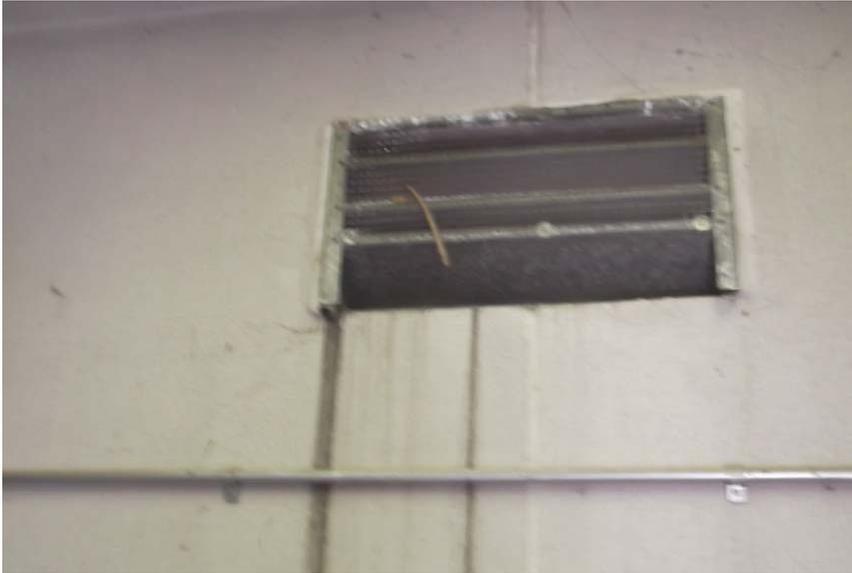
Photograph No. 46

Interior view of a ventilation louver.
