Citywide
Facility Condition Assessment

Report of
Facility Condition Assessment

For
City of Manhattan Beach
Joslyn Community Center
1601 North Valley Drive, Manhattan Beach, CA

*August 23, 2013
(Rev A)*

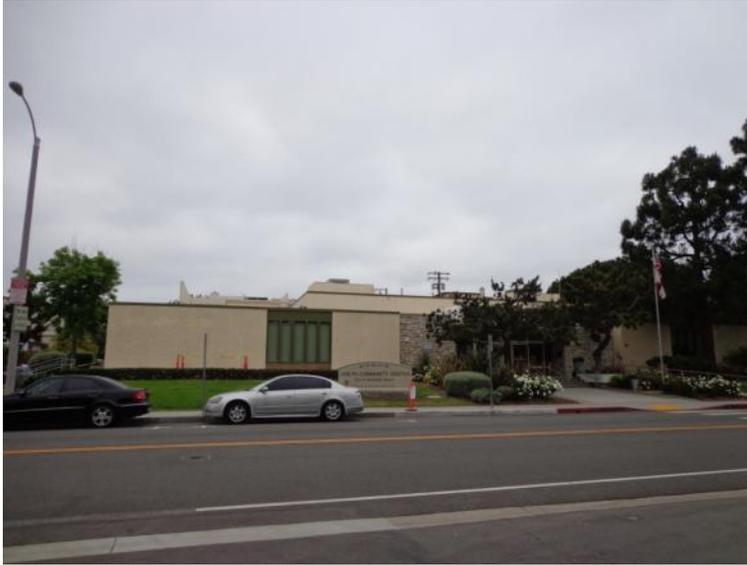
Photograph No. 1

The building is predominantly enclosed with painted cementitious stucco and wood trim (reference Photographs 1 and 2 in Appendix B). Portions of the front elevation adjacent to the entrance are accented with stone veneer. The stucco and wood trim contained a painted finish. There are wood framed wind screens finished with painted cementitious stucco and T1-11 type wood siding along the roof level of the building (reference Photograph 5 in Appendix B).

View of the front elevation of the Joslyn Community Center building.

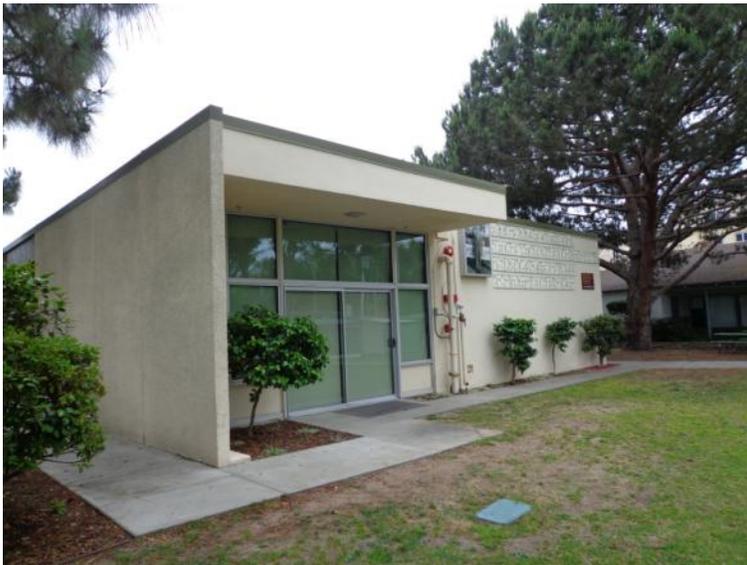
Photograph No. 2

View of the north side elevation of the Joslyn Community Center building.

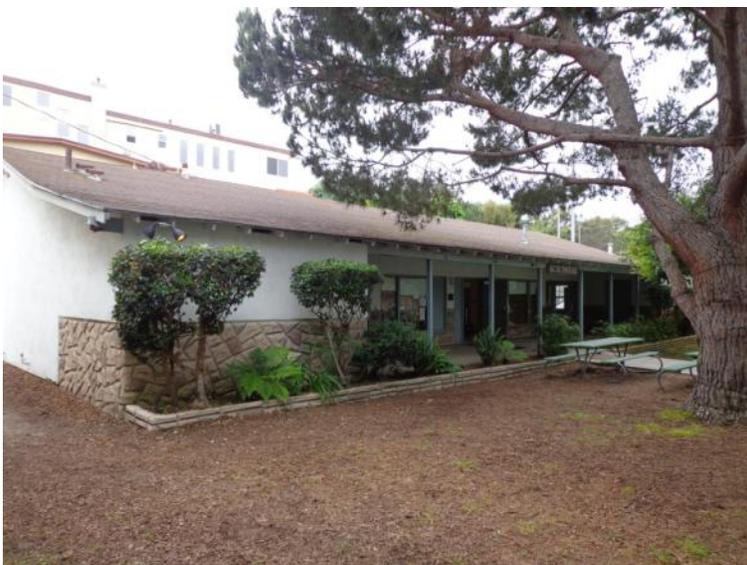
Photograph No. 3

The building is predominantly enclosed with painted cementitious stucco and wood trim (reference Photograph 3 in Appendix B). Portions of the front elevation at the storage closets are accented with stone veneer along the lower portion. The stucco and wood trim contained a painted finish.

View of the front elevation of the Scout House.

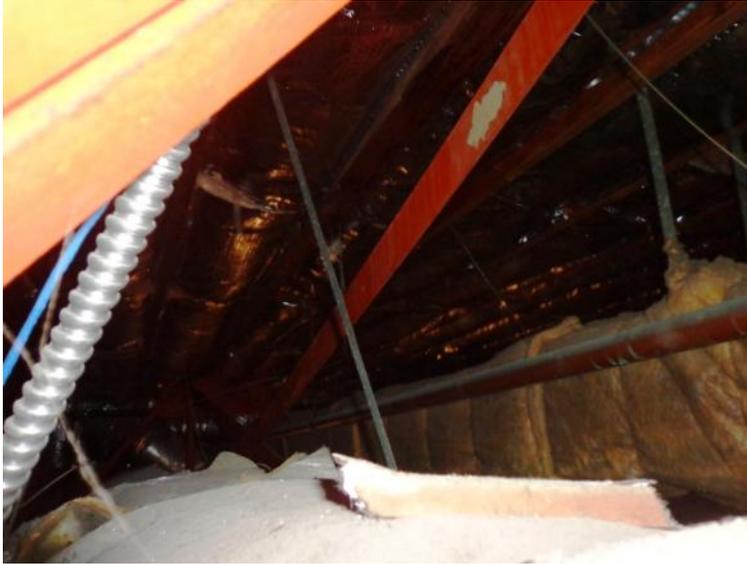
Photograph No. 4

The low-sloped roof sections consist of 2" x 6" and 2" x 8" wood joists which are also supported via the perimeter and interior load bearing walls and in turn support the plywood deck and roof covering (reference Photograph 4 in Appendix B). The wood joists at the roof level generally span east to west and are spaced at 16" and 24" centers. The wood roof framing at the central auditorium area of the building has secondary support provided by open web steel joists. The roof covering can be viewed in the roof covering section of this report.

View of the Joslyn Community Center roof structure.

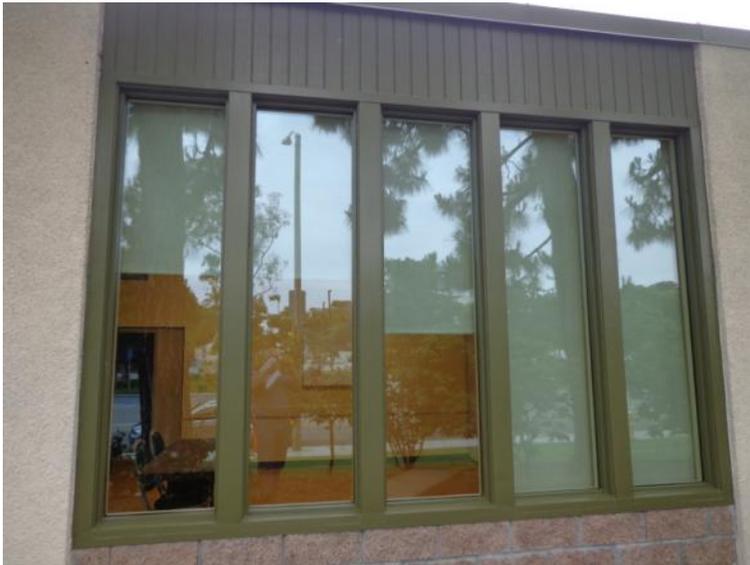
Photograph No. 8

The windows at the building consist of double glazed units (reference Photograph 8 in Appendix B). The single panes exist on the automatic doors. Several vinyl framed double glazed sliding windows are installed along the rear elevation (reference Photograph 9 in Appendix B).

View of the windows at the community center (replaced since photograph taken).

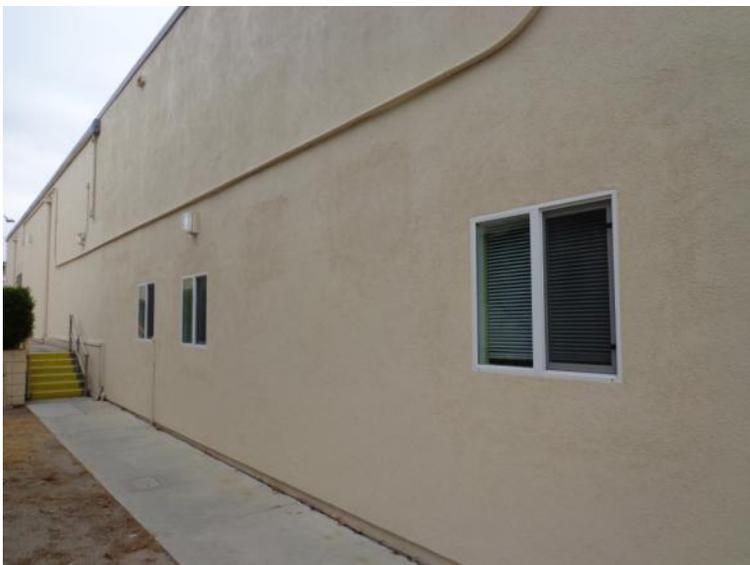
Photograph No. 9

View of the double glazed windows at the community center (replaced since photograph taken).

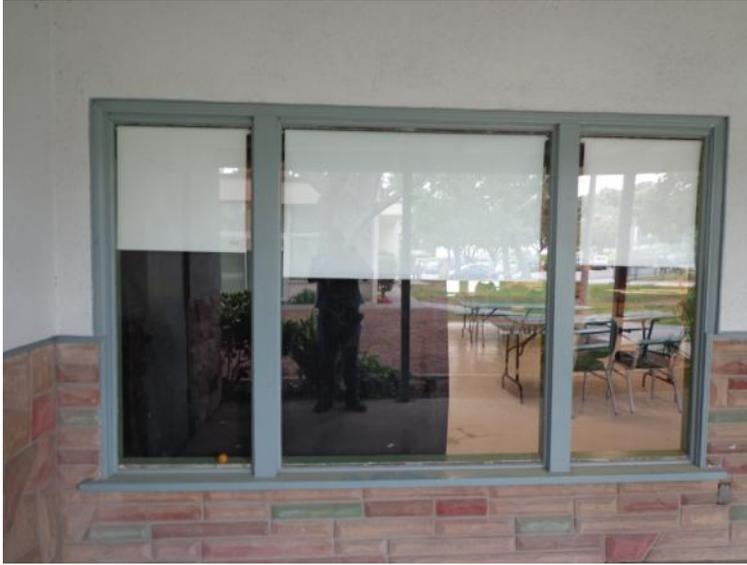
Photograph No. 10

The windows at the building consist of single glazed wood units. The wood windows consist of fixed windows along the front elevation and operable single hung units at the rear of the building (reference Photograph 10 in Appendix B).

View of the Scout House windows.

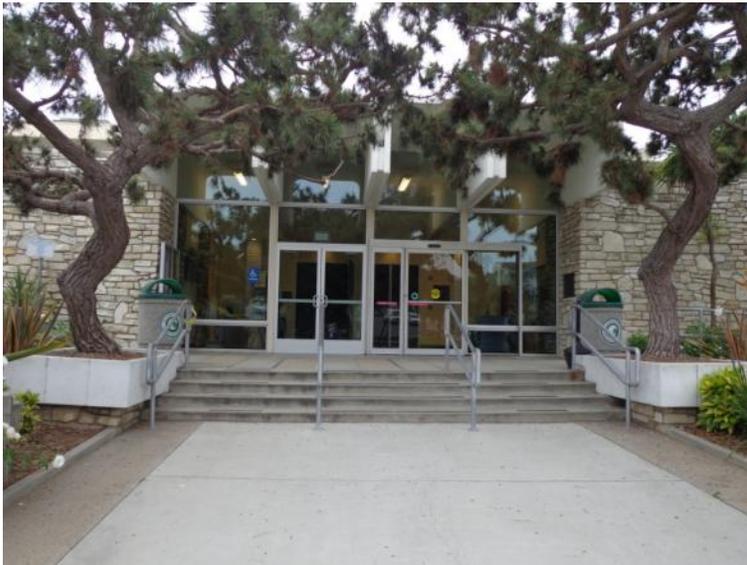
Photograph No. 11

The building contains aluminum glazed storefront consisting of dual glazed panels and glazed entrance doors. The doors consist of the pair of swinging doors and the automatic sliding door at the main entrance and the four manual sliding doors located at the left and rear elevations of the building (reference Photograph 11 in Appendix B). The main entrance automatic sliding door provided unrestricted access to disabled individuals.

View of the main entrance storefront system.

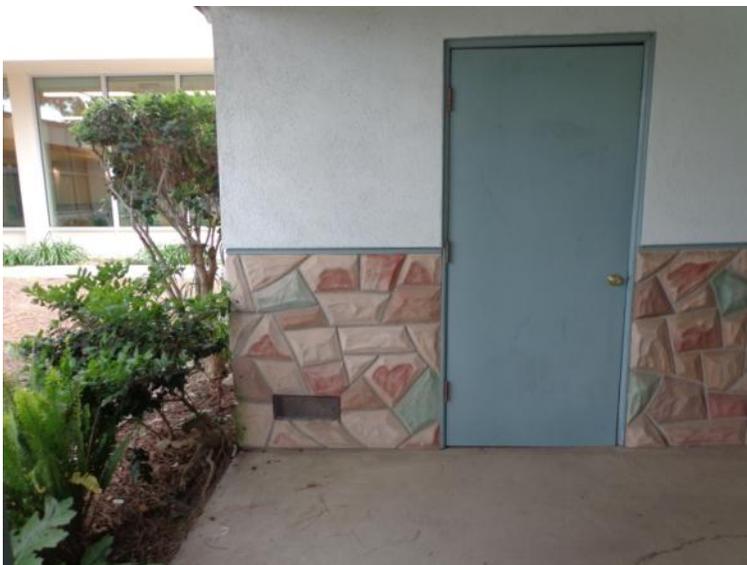
Photograph No. 12

The building contained single solid wood and hollow metal doors and frames at the entrances, storage closets and rear exits (reference Photograph 12 in Appendix B). Door hardware consisted of a knob or level handles.

View of a storage room door at the Scout House.

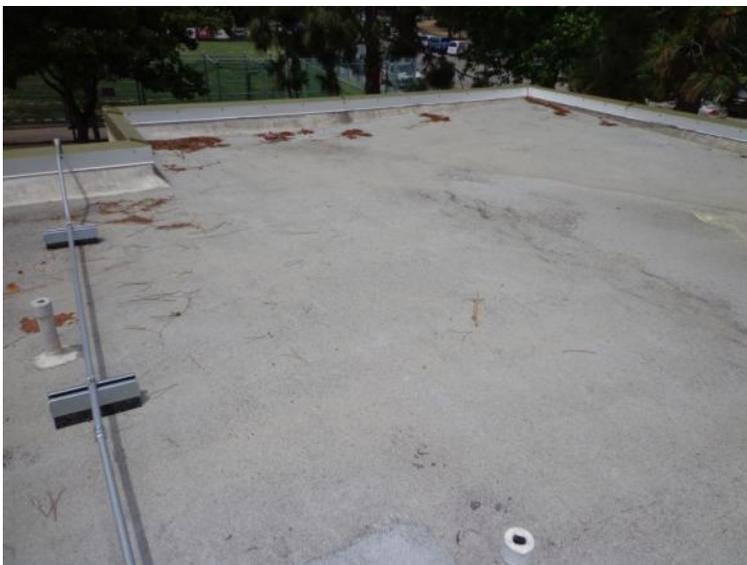
Photograph No. 15

The majority of the low-sloped roof areas 1 through 6 contained asphaltic Built-Up Roof (BUR) with a mineral cap sheet surface with loose granules applied to the surface (reference Photograph 15 in Appendix B). The roof coverings are approximately 5 years of age. Roof drainage is predominantly through roof surface mounted drains with interior leaders with two scuppers and downspout leaders provided at the rear of the building. The roof above the main entrance (Roof 6) consists of a fiberglass membrane roof with a white reflective coating (reference Photograph 16 in Appendix B). The roof drains to the surrounding low-sloped roofs.

View of the community center BBUR roofing.

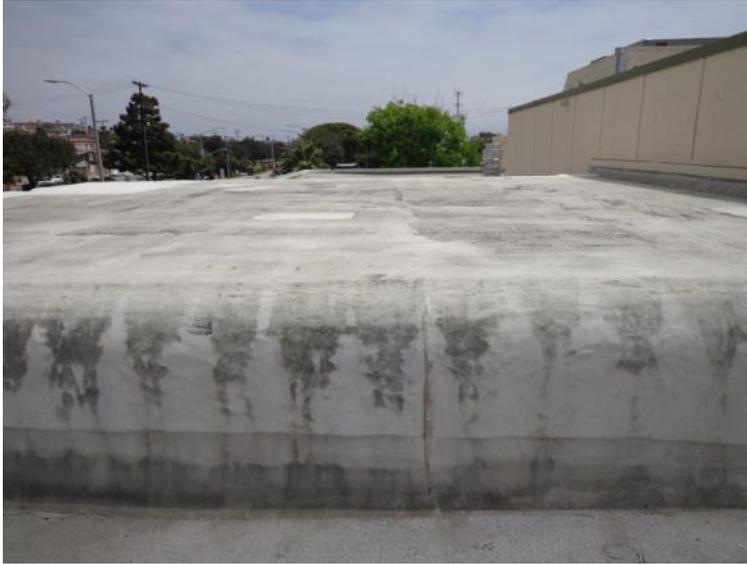
Photograph No. 16

View of community center fiberglass roof.

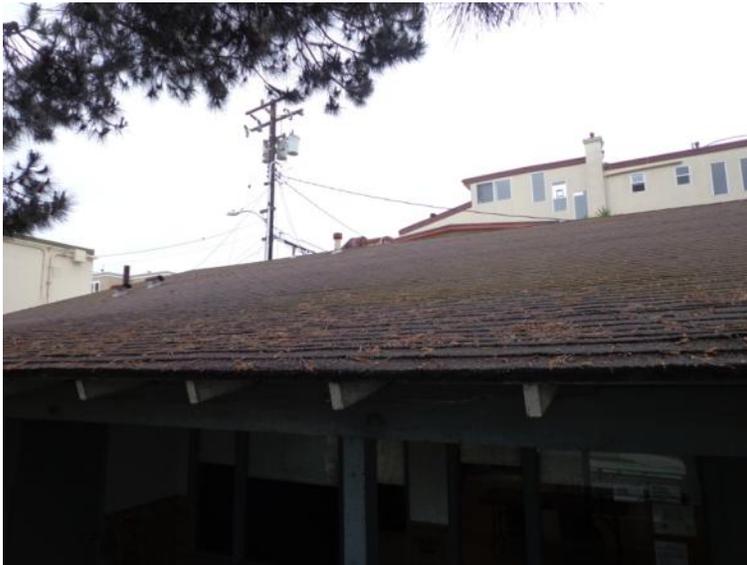
Photograph No. 17

The steep-sloped roof area 6 at the Scout House contained asphalt shingles with mineral surface granules (reference Photographs 1 and 17 in Appendix B). We understand that roof area 6 was installed sometime in the 1980's.

View of the Scout House pitched roof.

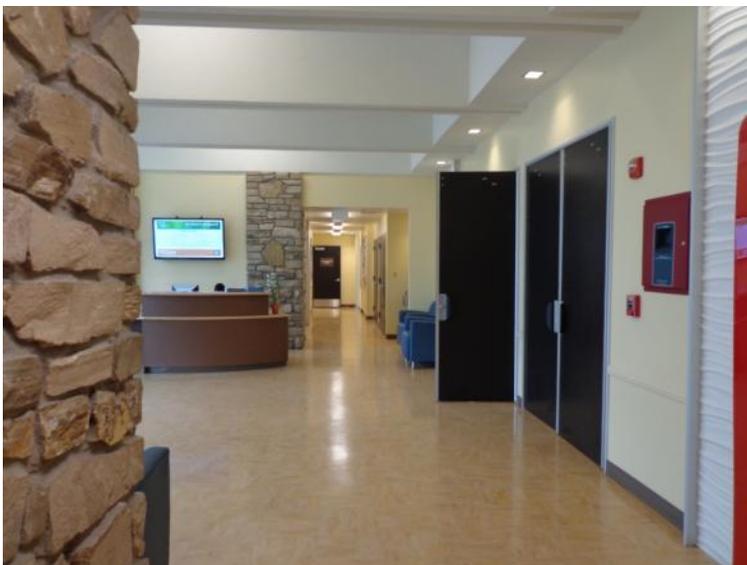
Photograph No. 18

Interior walls at each of the buildings generally contained painted gypsum wall board (reference Photographs 18, 19, 20 and 21 in Appendix B). Some of the rooms at the Scout House have wood clapboard or pressed board type wall panels. The two restrooms at the Joslyn Community Center contained 3" x 6" ceramic tile wainscot (reference Photograph 22 in Appendix B).

There was painted gypsum board ceilings throughout the majority of the buildings. The ceilings were either textured or smooth painted wallboard (reference Photographs 18 through 20 in Appendix B).

View of the Joslyn Community Center interior.

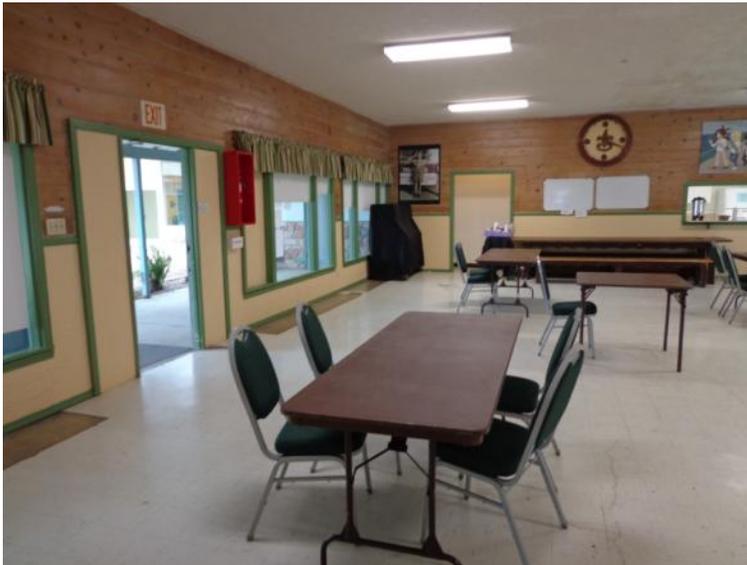
Photograph No. 19

The interior lighting within the building is provided by recessed mounted 2' x 4' fluorescent fixtures within the suspended ceiling system and 4' strip double lamped fluorescent fixtures surface mounted within the remaining interior spaces (reference Photograph 19 in Appendix B). The florescent fixtures all contained T8 lamps and electronic ballasts. All of the in-room lighting is controlled via local switching in the respective rooms.

View of the Joslyn Community Center interior.

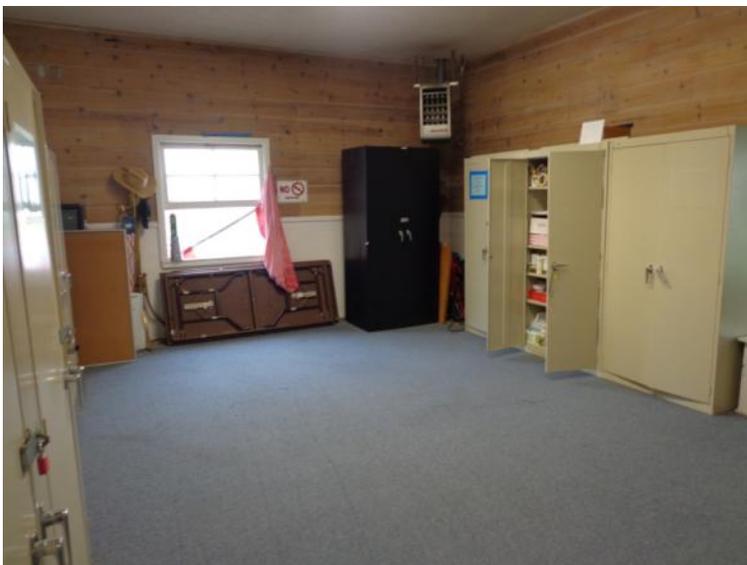
Photograph No. 20

The interior lighting within the building is provided by 4' strip double lamped fluorescent fixtures surface mounted within the interior spaces (reference Photograph 20 in Appendix B). The florescent fixtures all contained T8 lamps and electronic ballasts. All of the in-room lighting is controlled via local switching in the respective rooms.

View of the Scout House interior

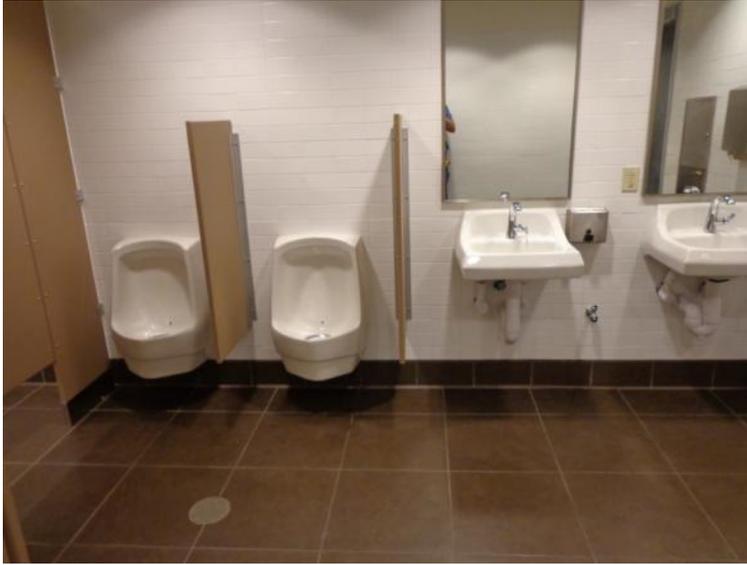
Photograph No. 21

Additional view of the Scout House interior.

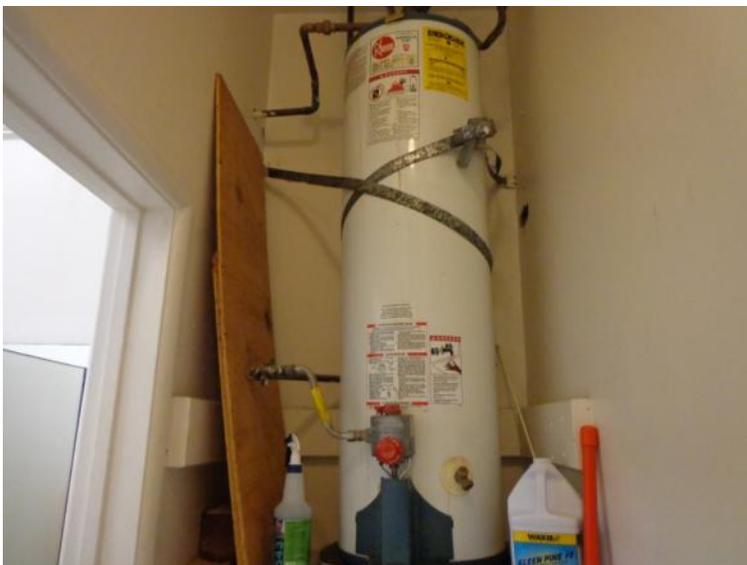
Photograph No. 23

View of the water heaters in the community center.

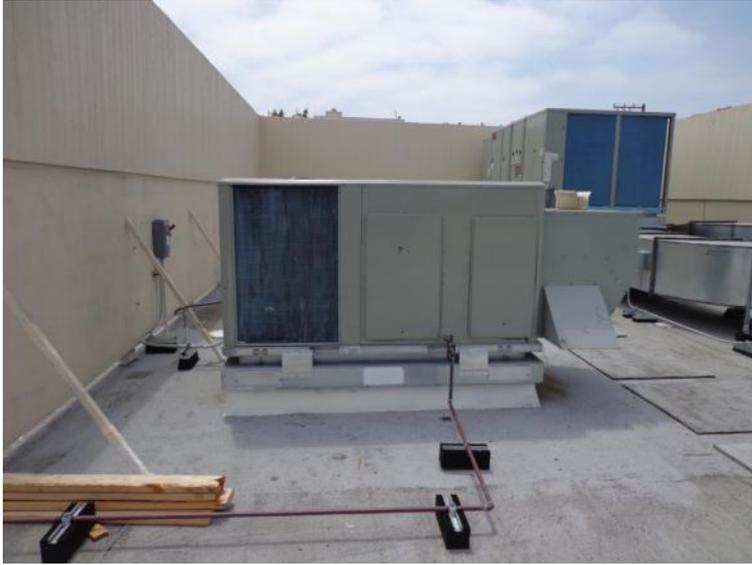
Photograph No. 27

The building contained five roof-mounted package units with natural gas heat (reference Photographs 27 and 28 in Appendix B). The rooftop units were manufactured by Trane and Greenheck have 64,000 to 203,000 BTU each. Refer to the following table D30-1 for further details of the package units.

View of the roof top packaged units at the community center.

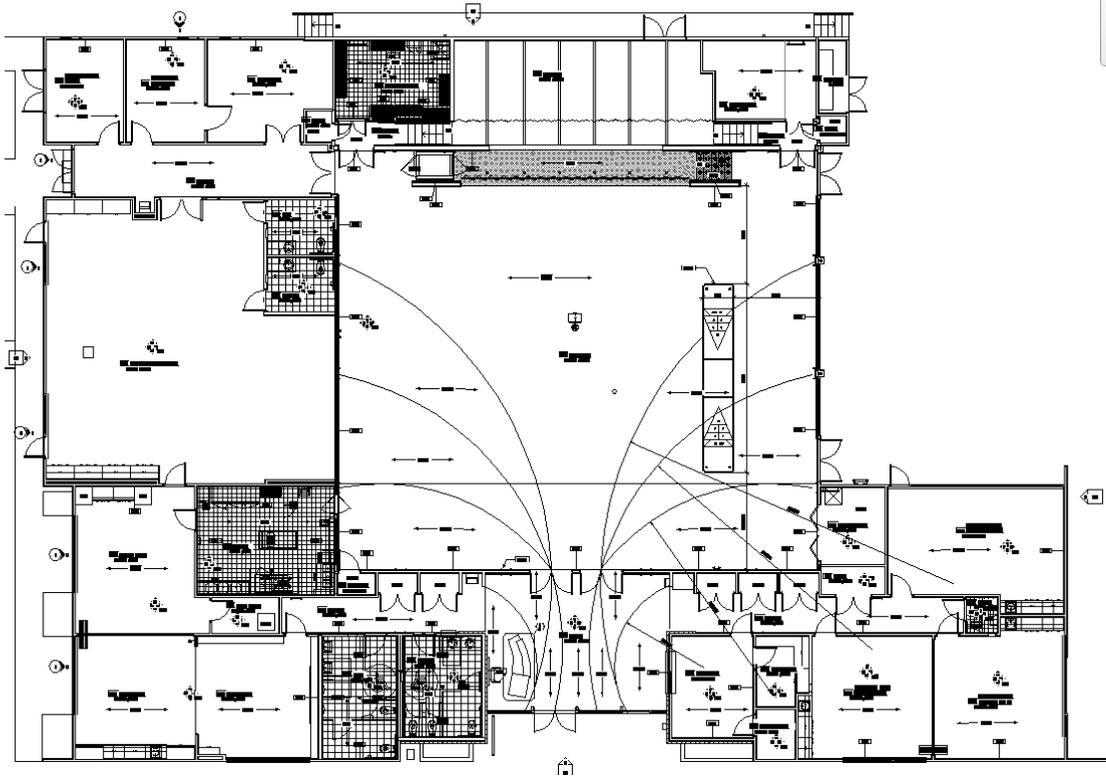
Figure 1: Building Plan (First Floor)

Constructed circa 1965, presumably based on the 1961 Uniform Building Code, the Joslyn Community Center Building consists of a one-story Type V-B wood frame structure with various steel, concrete, and masonry structural and architectural elements (Fig. 1).
