Citywide
Facility Condition Assessment

Report of
Facility Condition Assessment

For
City of Manhattan Beach
Sand Dune Park Office and Restrooms
3800 Bell Avenue, Manhattan Beach, CA

*September 4, 2013
(Rev A)*

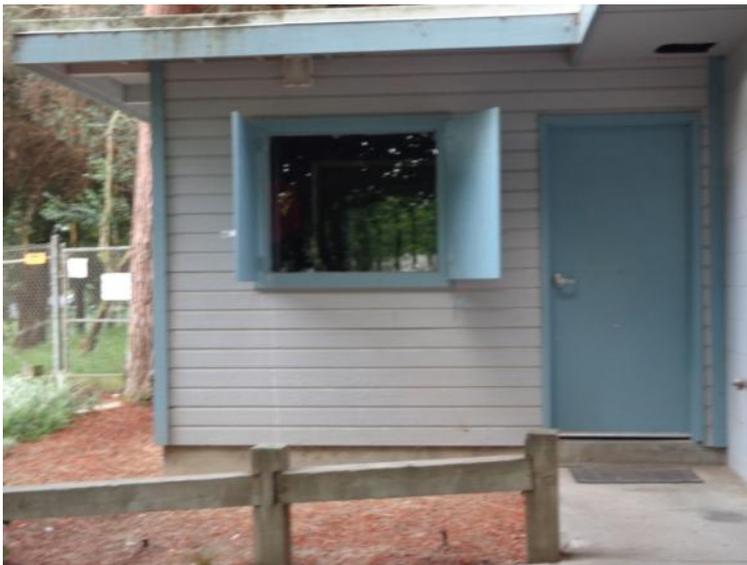
Photograph No. 4

View of exterior finishes at the office area.

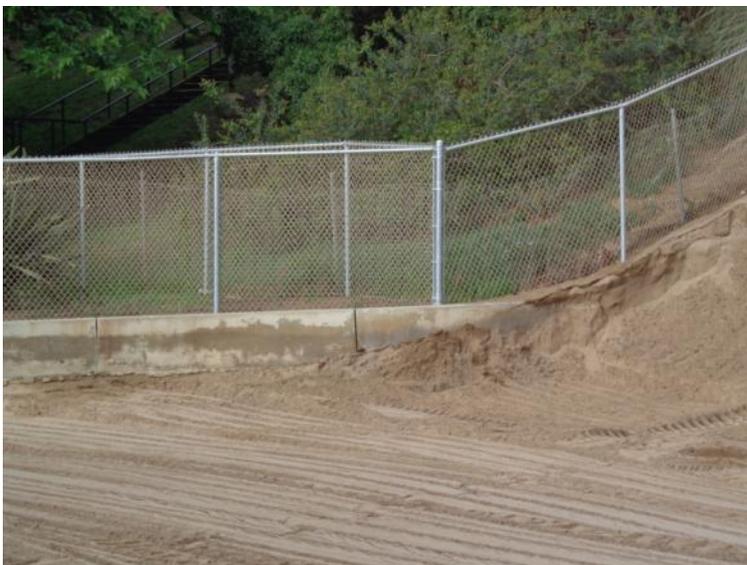
Photograph No. 17

View of the chain link fencing at the sand dune.
