Citywide  
Facility Condition Assessment

Report of  
Facility Condition Assessment

For  
City of Manhattan Beach  
Manhattan Village Soccer Field  
1300 Parkview Avenue, Manhattan Beach, CA

*September 4, 2013  
(Rev A)*

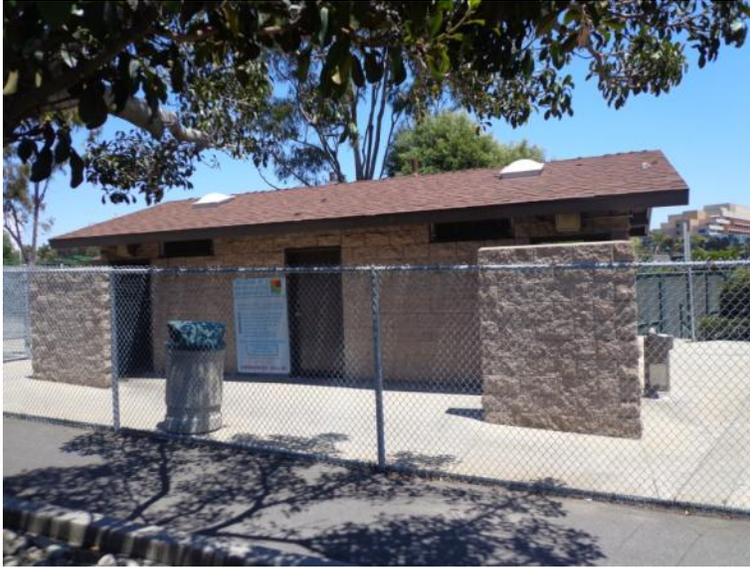
Photograph No. 1

The building is enclosed with split-faced concrete masonry units and wood trim (reference Photographs 1 and 4 in Appendix B). The wood trim contained a painted finish. There are CMU privacy walls along the front of the building at the restroom entrances (reference Photograph 1 in Appendix B).

View of the restroom building.

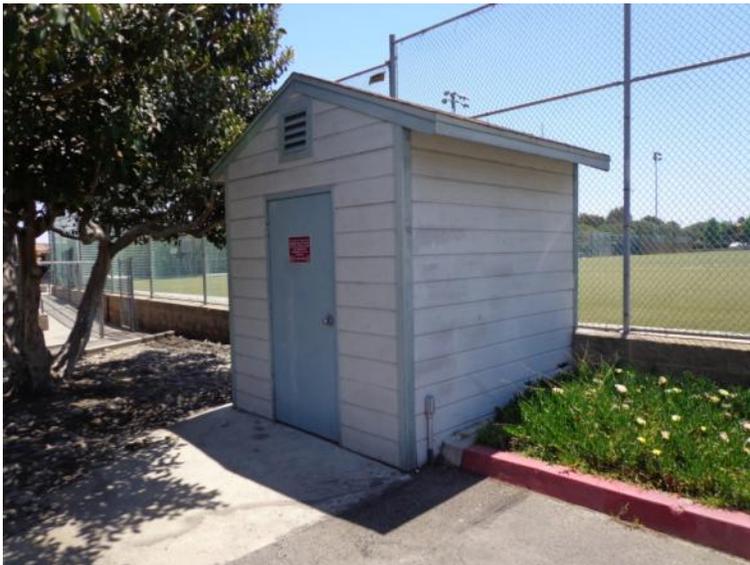
Photograph No. 2

The building is predominantly enclosed with painted pressed board clapboards and wood trim (reference Photograph 2 in Appendix B). The clapboards wood trim contained a painted finish.

View of the storage shed.

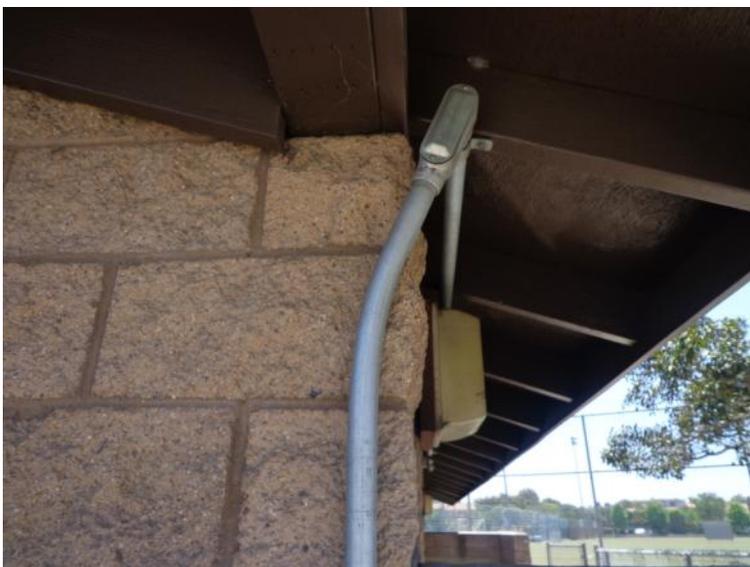
Photograph No. 3

The building contained a pitched steep-sloped roof, with 2" x 6" wood rafter construction supported via the light wood frame construction and in turn supports the plywood deck and roof covering (reference Photograph 3 in Appendix B). The wood rafters are spaced at 24" centers. The roof covering can be viewed in the roof covering section of this report.

View of the roof framing system.

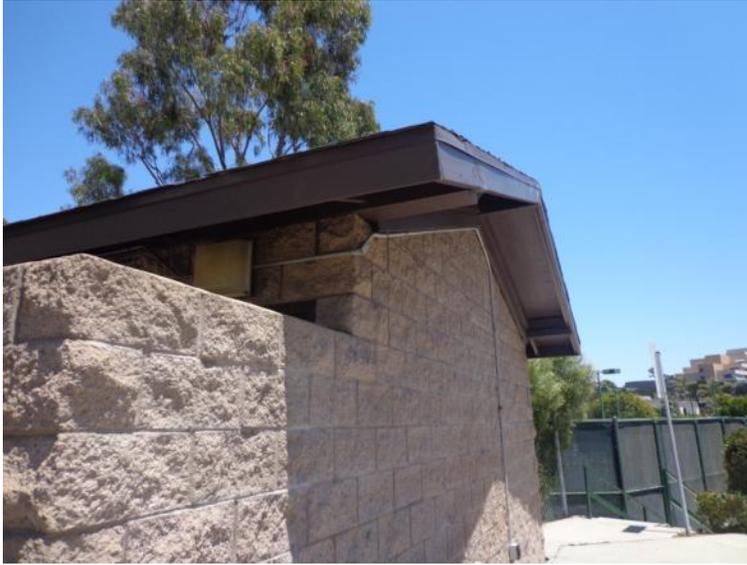
**Photograph No. 4**

View of the restroom exterior finishes.

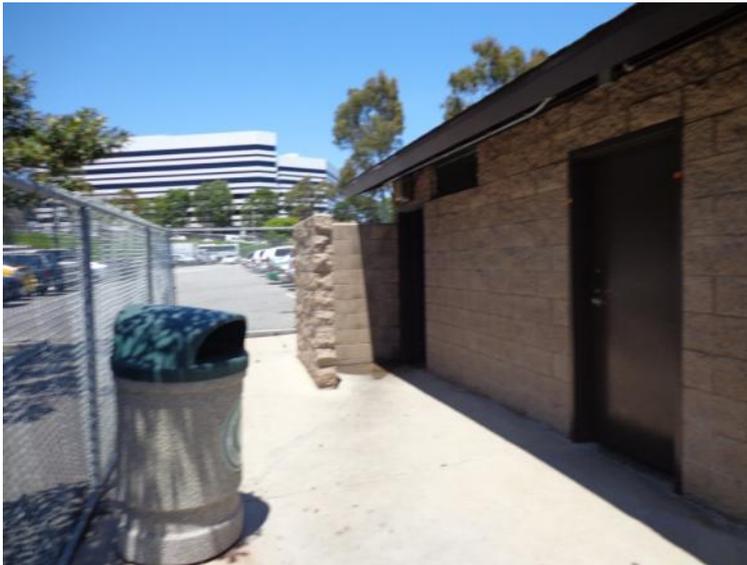
**Photograph No. 5**

The windows at the building were limited to four steel grates at the upper portion of the front and rear elevations (reference Photograph 5 in Appendix B).

View of the window grates and exterior door at the restroom.

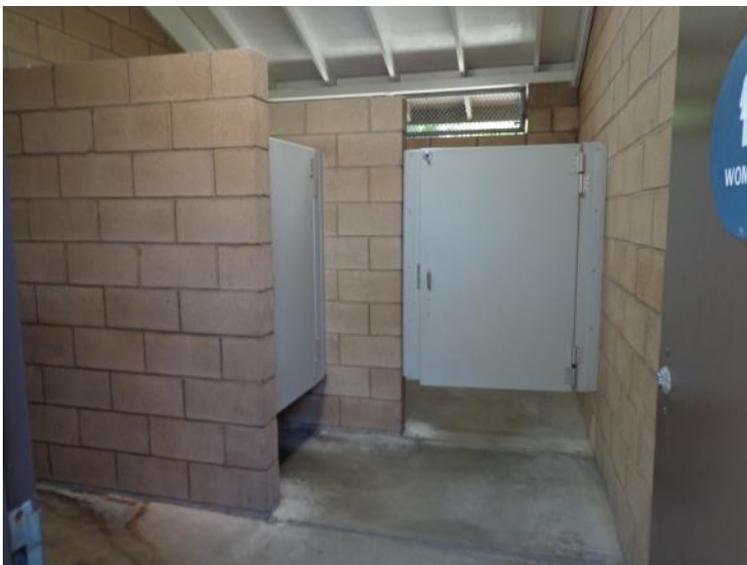
**Photograph No. 9**

The men's and women's restroom areas contained steel framed toilet partitions with acrylic panels (reference Photograph 9 in Appendix B).

The interior walls at the building generally contained unfinished concrete masonry units (reference Photograph 9 in Appendix B).

View of the interior and toilet partitions.

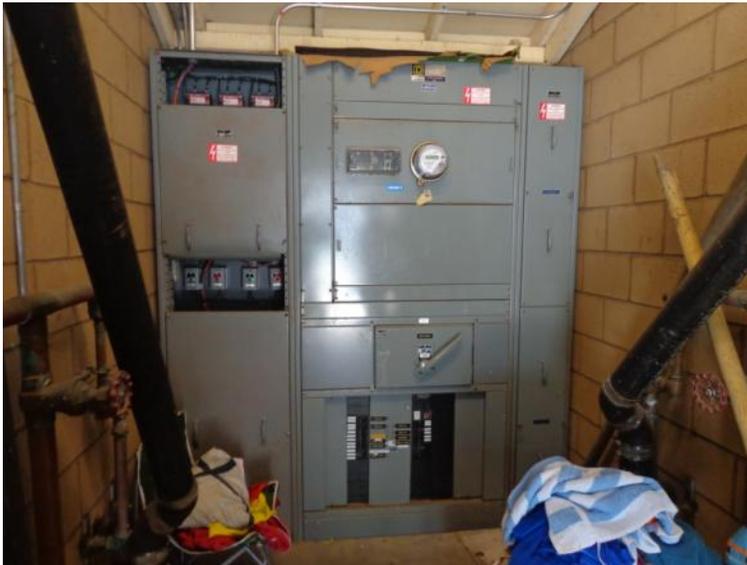
Photograph No. 14

The facility is serviced by a 400-amp, 277/480-Volt, 3-phase, 4-wire metered panel which is located in a mechanical closet in the restroom building (reference Photograph 14 in Appendix B).

View of the main electrical supply.

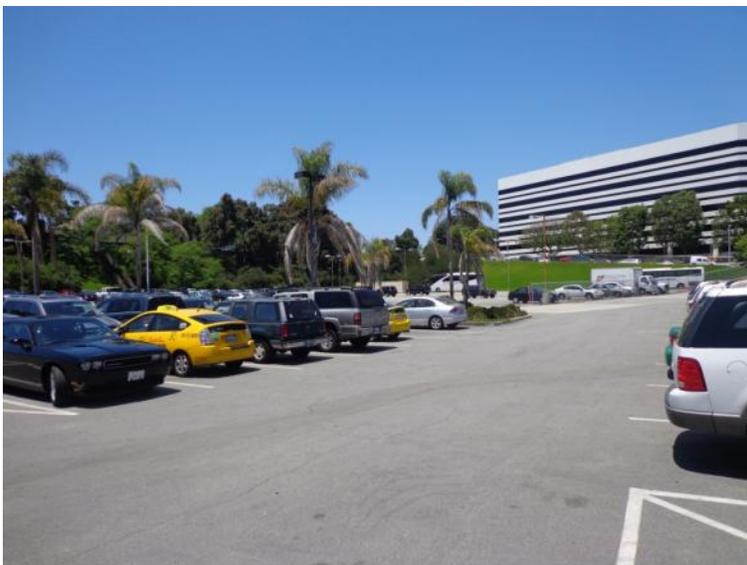
Photograph No. 15

The main facility parking lot is located at the northern end of the site and can be accessed from Parkview Avenue to the north (reference Photographs 15 in Appendix B). The parking lot and paving around the site has an asphalt surface with white line striping denoting areas of parking stalls. We were not provided with the original specification details of the paving and therefore cannot comment on the specific asphalt mix type, classification or its suitability for its existing use. Table G20-1 provides a summary of the site systems.

View of the parking area.

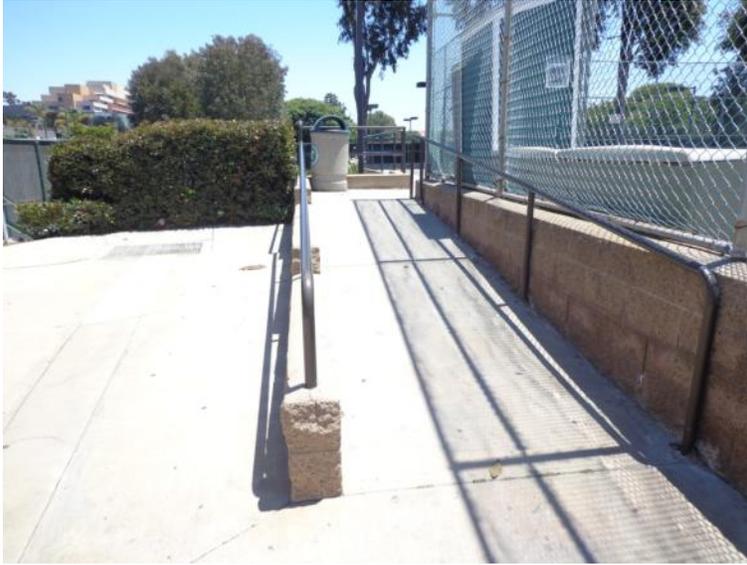
**Photograph No. 16**

The site contained cast-in-place concrete walkways throughout including at the perimeter of the building and along eastern edge of the soccer field enclosure (reference Photograph 16 in Appendix B).

View of a typical concrete walkway.

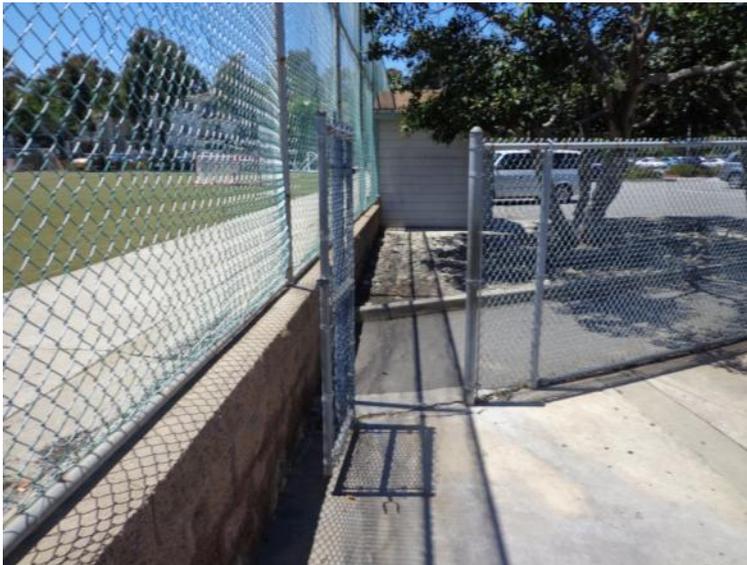
**Photograph No. 17**

The soccer field was surrounded by 12' in height chain link fence at the north east and west perimeter with 10' high chain link fencing at the southern end of the field (reference Photograph 17 in Appendix B). The perimeter of the restroom area was enclosed by 6' high chain link fencing. The playground is enclosed by a 4' high anodized aluminum fence.

View of the typical chain link fencing.

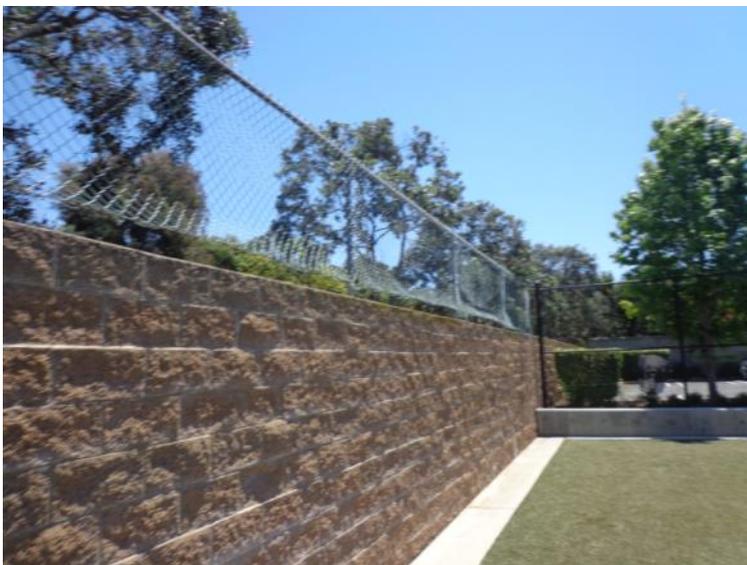
**Photograph No. 18**

There are variable height concrete masonry unit retaining walls with a decorative surface located at the southern and northern ends of the soccer field and at the rear of the restroom building (reference Photographs 18 in Appendix B).

View of a typical retaining wall.

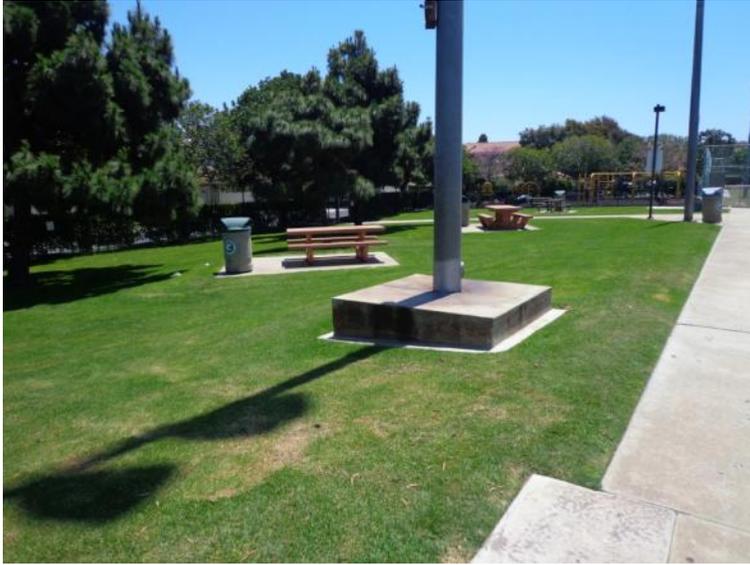
**Photograph No. 19**

There are several picnic tables located in the picnic area along the eastern end of the site. The tables are typically constructed of concrete or vinyl coated metal (reference Photograph 19 in Appendix B).

View of the picnic area.

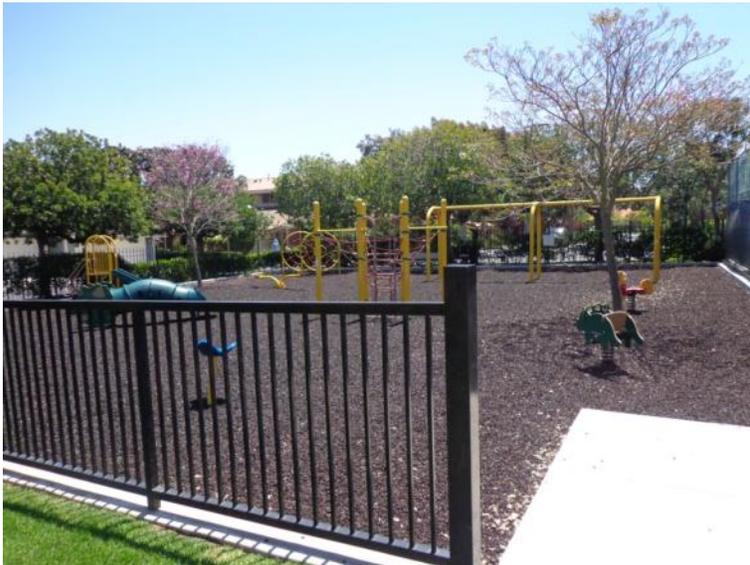
**Photograph No. 20**

There is one playground structure at the site. The playground is located at the eastern section of the site adjacent to the picnic area (reference Photograph 20 in Appendix B). The playground is comprised of metal and composite equipment. The ground surface at the play area is covered with synthetic mulch.

View of the playground.

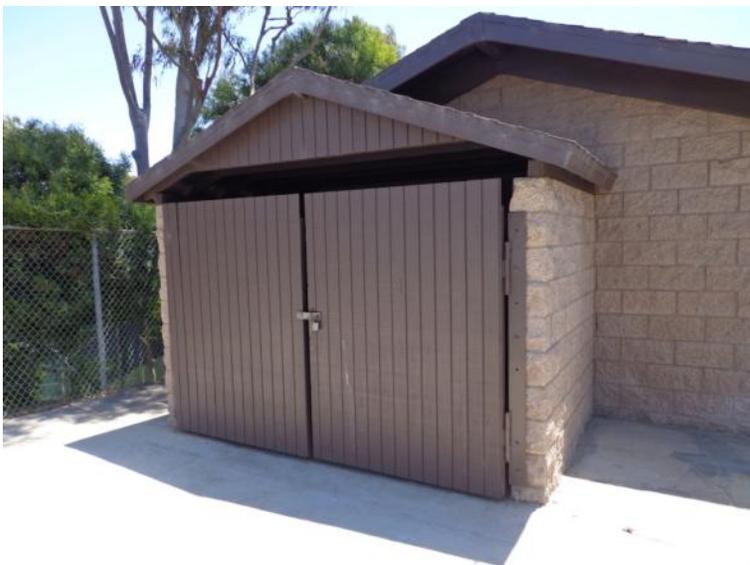
**Photograph No. 21**

The site contained a concrete masonry framed dumpster enclosure at the northern end adjacent to the restrooms. The enclosure has a wood roof and wood gates (reference Photograph 21 in Appendix B). The steel and wood framed pavilion contained a tubular steel framed gazebo at the west side of the site.

View of the dumpster enclosure.

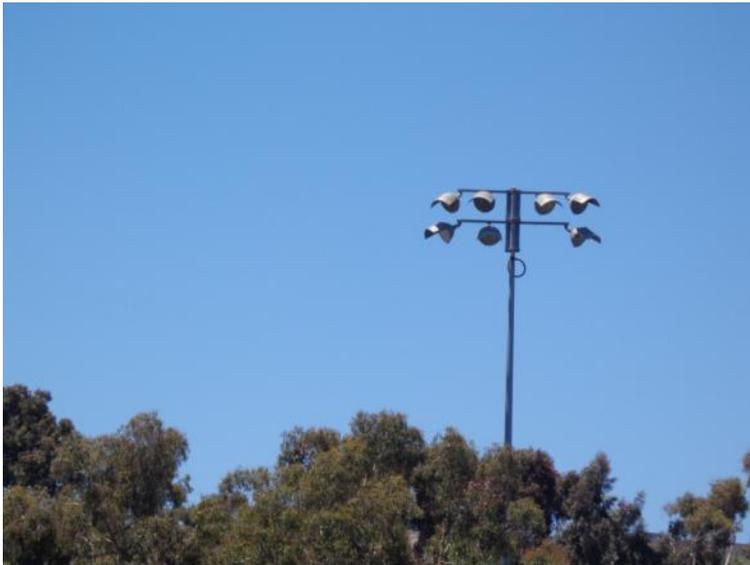
**Photograph No. 23**

Exterior lighting along the perimeter of the soccer field consisted of pole mounted metal halide fixtures mounted on galvanized steel poles approximately 50' in height (reference Photograph 23 in Appendix B). The lights contained various amounts of fixtures each. Additional exterior lighting also includes seven pole mounted lights at the parking area (reference Photograph 24 in Appendix B).

View of one of the soccer field light.

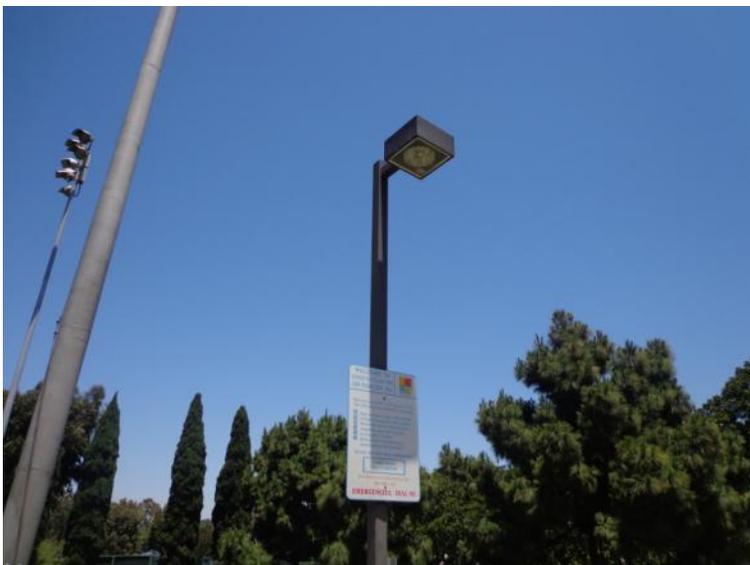
**Photograph No. 24**

View of a parking area light.
