Citywide  
Facility Condition Assessment

Report of  
Facility Condition Assessment

For  
City of Manhattan Beach  
Marine Avenue Sports Complex  
1600 Marine Avenue, Manhattan Beach, CA

*September 4, 2013  
(Rev A)*

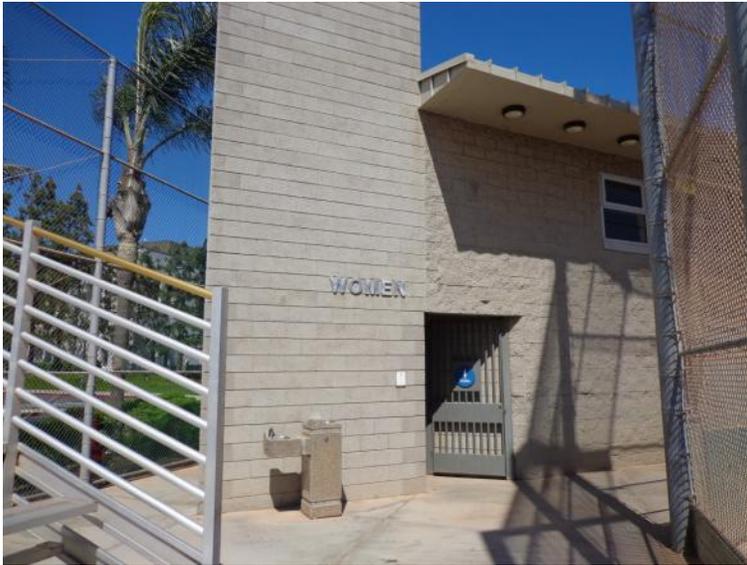
**Photograph No. 3**

The buildings are enclosed with predominantly split-faced concrete masonry units and aluminum trim (reference Photograph 3 in Appendix B). Sections of the masonry walls have a smooth finish (reference Photograph 4 in Appendix B). There are CMU privacy walls at each of the restroom entrances.

The exterior wall systems at all of the buildings appeared to be in good condition with generally no major signs of deterioration, water ingress or general failure noted. The exterior painted surfaces do not appear to have been painted recently painted and therefore based on the EUL of 4 years for these buildings exterior paint, as well as current observed conditions, re-painting will be necessary near-term in the study period to maintain the appearance and protect the exterior walls, doors, etc.

View of the typical exterior walls.

Element No.	Building Element	Recommendation	Qty	Unit	Rate	Cost	Year	Priority Code
B2011	Exterior Wall Construction	Repaint exterior wall surfaces, doors and stairway	750	SF	\$3.25	\$2,438	2014	5
B2011	Exterior Wall Construction	Repaint exterior wall surfaces, doors and stairway	750	SF	\$3.25	\$2,438	2018	5
B2011	Exterior Wall Construction	Repaint exterior wall surfaces, doors and stairway	750	SF	\$3.25	\$2,438	2022	5
Total Anticipated Expenditure for B Shell						\$7,313

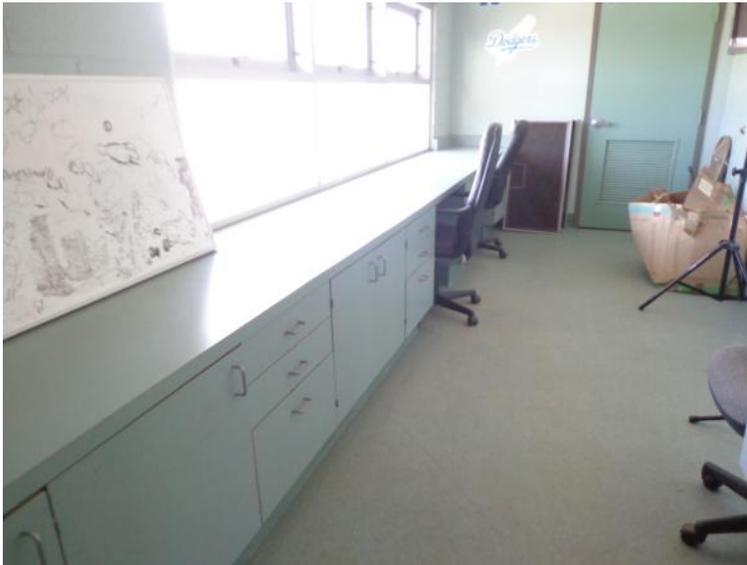
Photograph No. 10

Interior walls at the buildings generally contained painted concrete masonry units or painted gypsum drywall (reference Photographs 9 and 10 in Appendix B). The unisex restroom at the snack bar has ceramic tiled walls (reference Photograph 11 in Appendix B). The restroom and snack bar walls utilized an ant graffiti coating.

View of the snack bar interior.

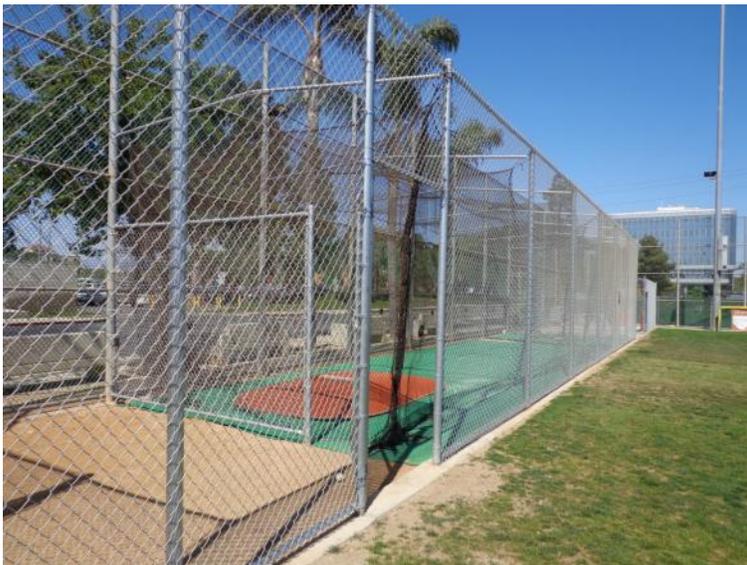
**Photograph No. 22**

The site contained chain link fencing at numerous locations (reference Photographs 22 and 23 in Appendix B). The fencing observed was 4' to approximately 30' in height and surrounded the park complex as well as at the batting cages, between the playing fields, and at the backstop of the fields.

There are awning structures at each of the dugout areas (reference Photograph 22 in Appendix B). The structures are steel framed with standing seam metal panel roofs.

View of one of the dugout awnings and chain linked fencing.
