Citywide
Facility Condition Assessment

Report of
Facility Condition Assessment

For
City of Manhattan Beach
City Hall
1400 Highland Avenue, Manhattan Beach, CA

*August 23, 2013
(Rev A)*

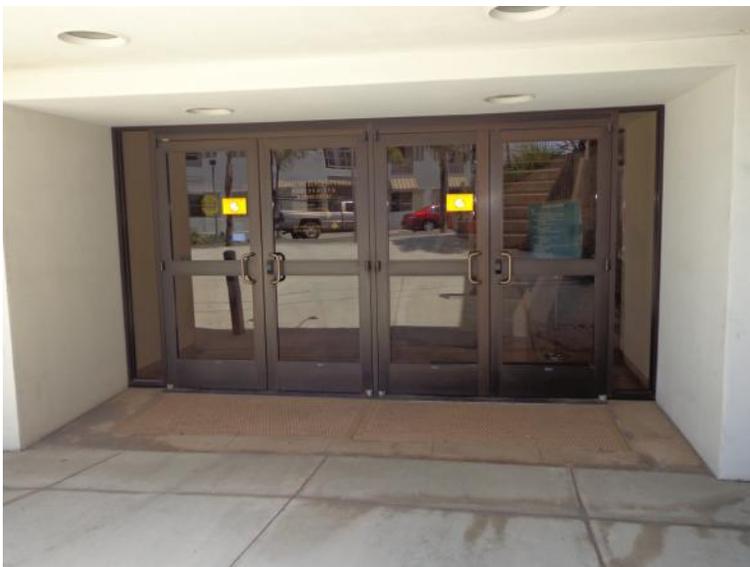
Photograph No. 8

View of the automatic entrance doors at the north elevation.

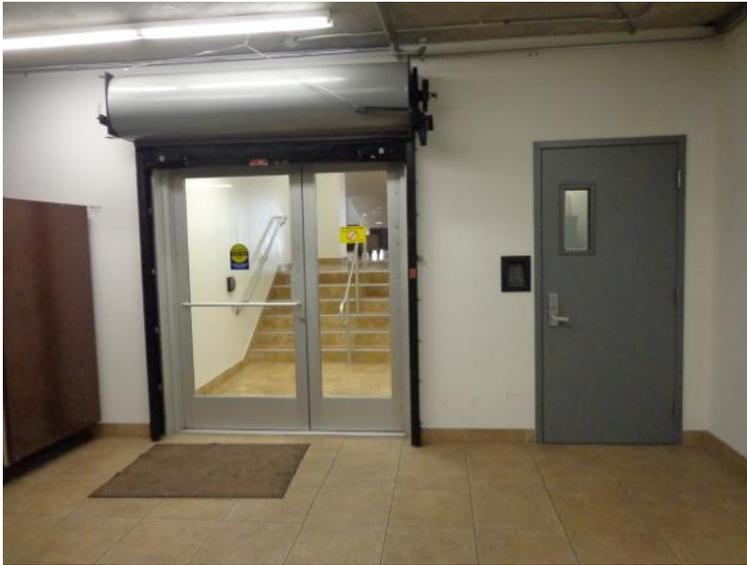
Photograph No. 9

The building contains aluminum glazed storefront consisting of single glazed panels and glazed entrance doors at the lower and upper level entrances. The doors consist of automatic sliding doors at the main upper level entrance and manual swinging doors at the east and west entrances to the building (reference Photograph 9 in Appendix B). The garage level and main entrance automatic sliding door provided unrestricted access to disabled individuals.

View of the storefront system at the south elevation.

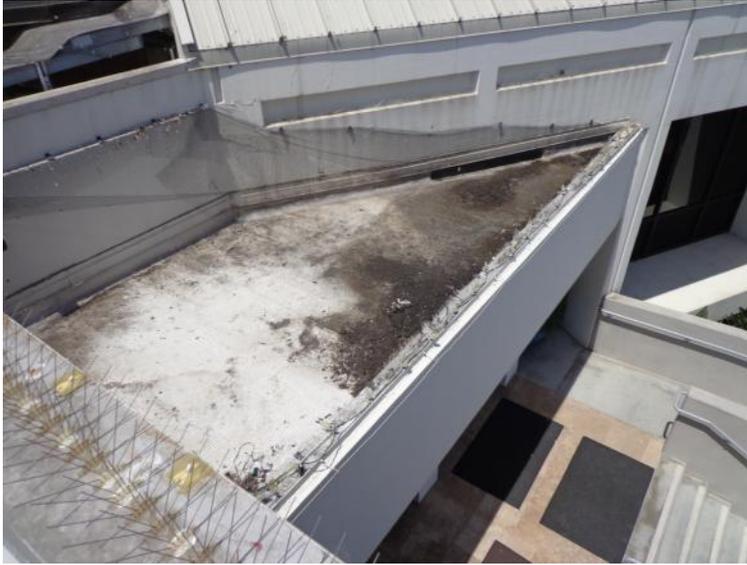
Photograph No. 12

The low-sloped roof areas contained a combination of asphaltic Built-Up Roof (BUR) with a mineral cap sheet surface with loose granules applied to the surface and Thermoplastic Tri-Polymer Alloy (TPA) single-ply membranes (reference Photographs 12 and 13 in Appendix B). The roof coverings are approximately 7 to 12-years of age. Roof drainage is provided by surface mounted drains with internal leaders and perimeter scuppers.

View of a typical BUR roof.

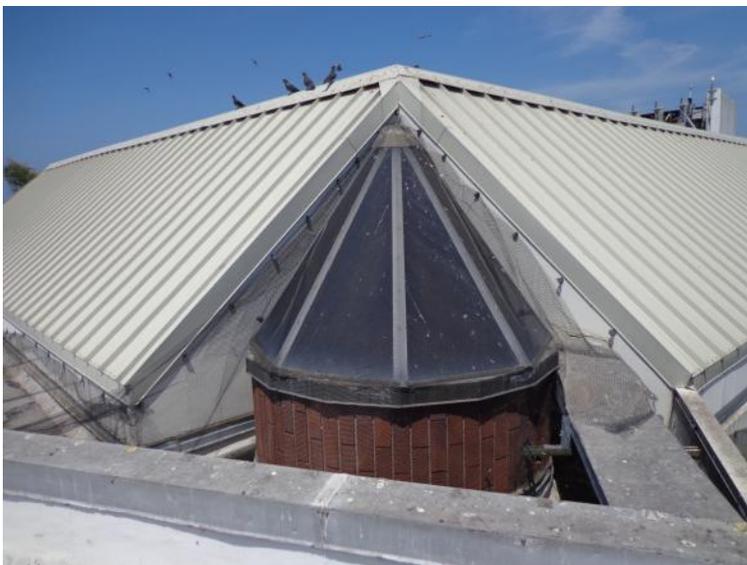
Photograph No. 14

The pitched mansard roof around the perimeter of the City Council Chambers section of the building contained standing seam metal panels with a factory applied painted finish (reference Photograph 14 in Appendix B). The mansard roof coverings are approximately six-years of age. Roof drainage is provided by perimeter drainage to the surrounding low-slope roofs. Tables B30-1 and B30-2 provide a summary of the roof coverings:

View of the mansard roof.

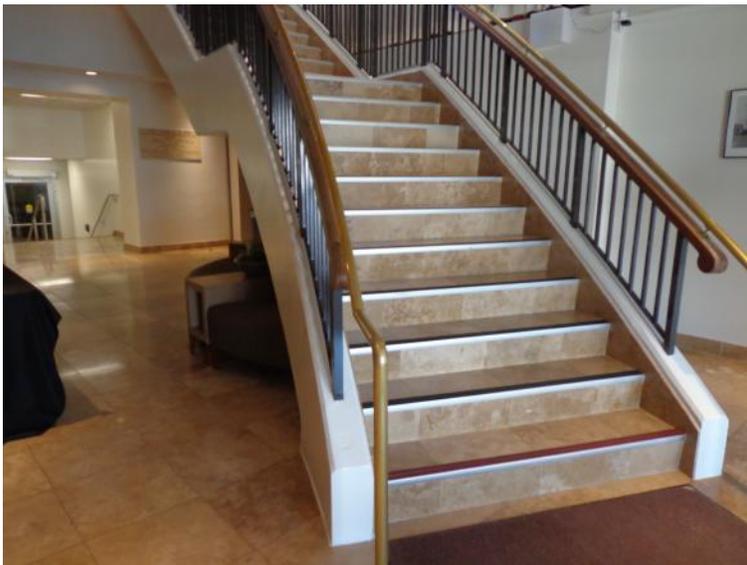
Photograph No. 16

There are three half-turn stairways within the building that provided access from the first floor to second floor level (reference Photograph 16 in Appendix B). The stairway landings are of steel construction with closed risers and concrete treads. The stairways have metal handrails mounted on both sides.

View of a typical steel framed stairway.

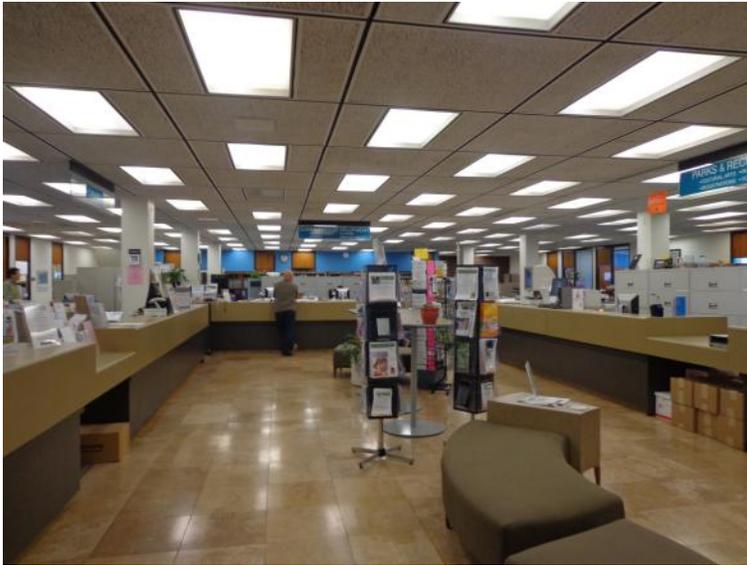
Photograph No. 18

View of the typical office finishes.

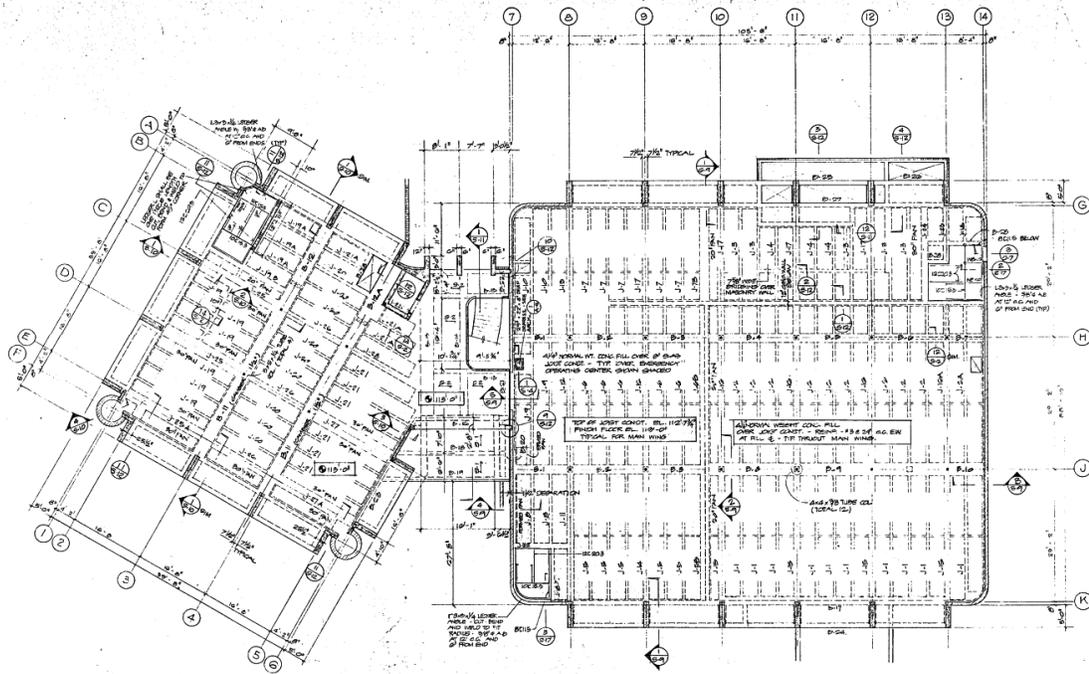
Figure 1: Building Structural Plan (First Floor)

Designed in 1973, presumably based on the 1972 Uniform Building Code, the City Hall Building consists of two two-story (basement level and first floor level) wings linked by a central stair well (Fig. 1). The primary structural construction materials are reinforced concrete, structural steel, and masonry. When the building was first completed, parking was provided by the at-grade parking lot to the east of the building. The parking lot was later converted into a subterranean parking garage, and the basement level of the City Hall was linked to the garage structure.

The first floors are constructed of reinforced concrete joist slabs supported by reinforced concrete girders and columns (Fig. 1). A 4-1/4" normal weight concrete fill lays over the structural slab. 15" thick by 5' long concrete buttress walls are present on the east and west facades to function as brise soleil and provide lateral load resistance. The exterior perimeter walls are reinforced concrete walls, some of which are partial subterranean and function as basement retaining walls.

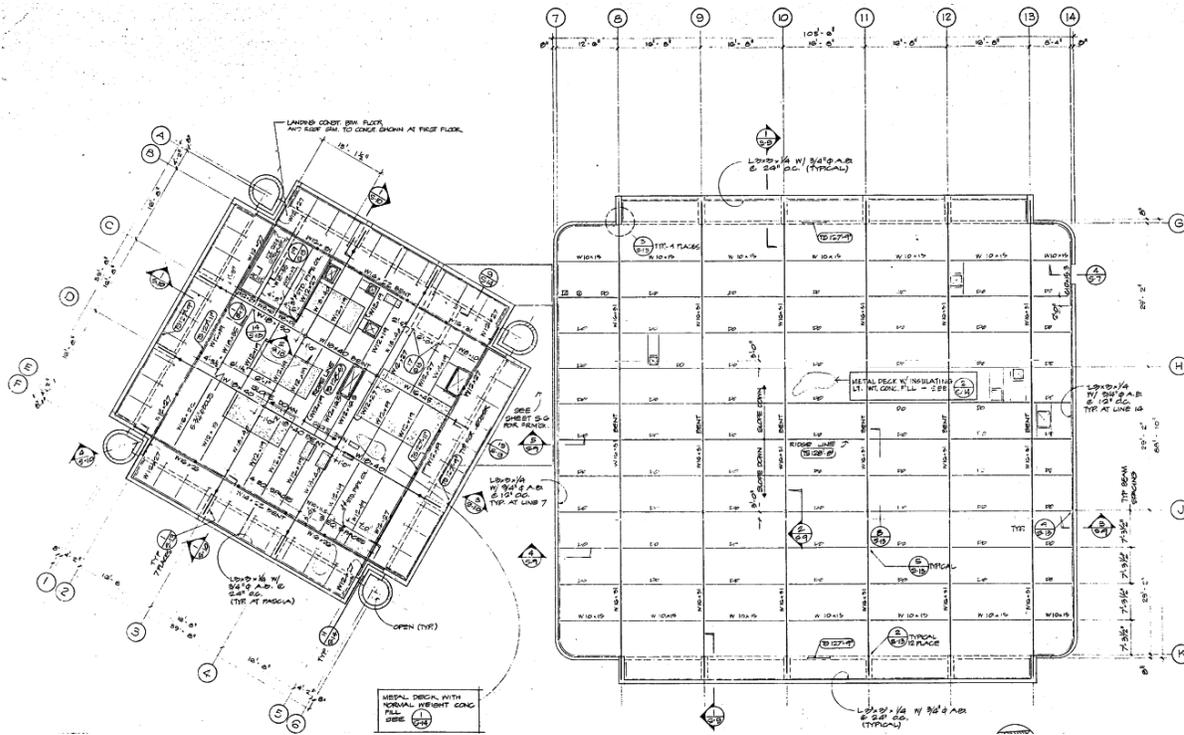
Figure 2: Roof Framing Plan

weight concrete, supported by structural steel beams and columns (Fig. 2). The exterior walls of the South Wing are typically 8" clay masonry bearing walls. The four sides of the North Wing roof are enclosed with mansards constructed of structural steel trusses (Fig. 3) supported by 8" reinforced concrete walls to provide screening of the rooftop mechanical equipment (Fig. 4).

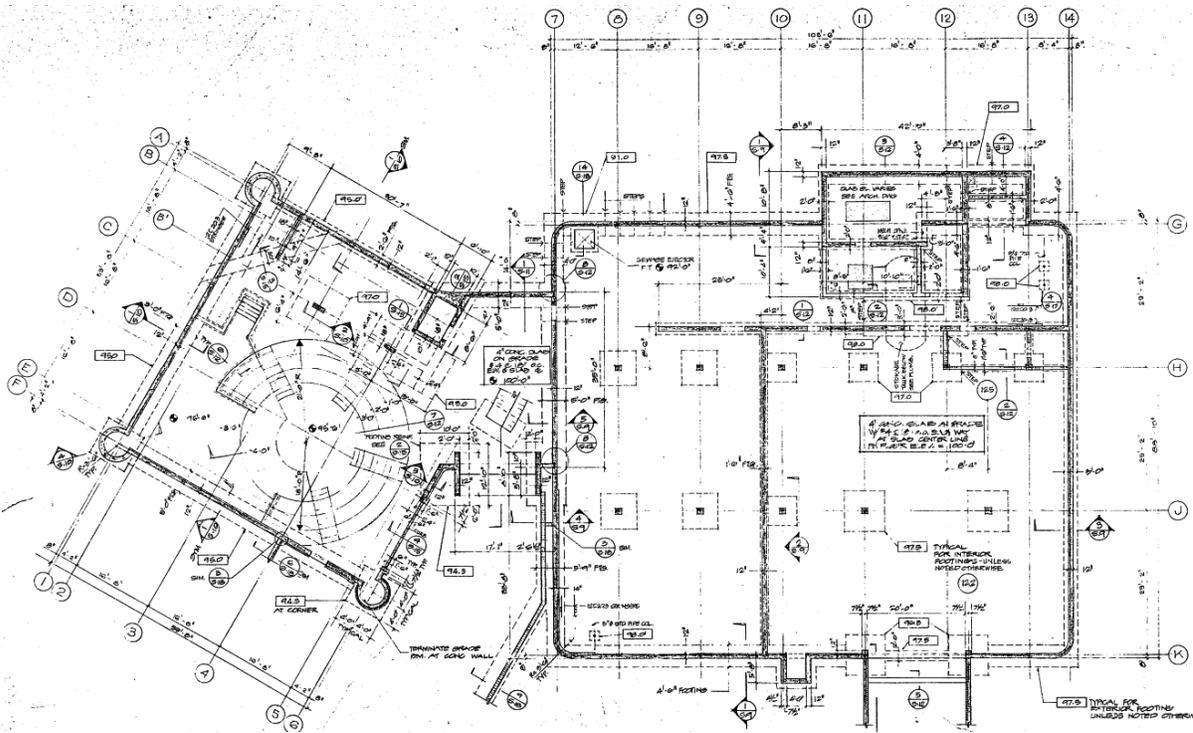
Figure 5: Basement Level Structural Plan

The basement level consists of concrete slabs on grade (Fig. 5) over spread footings and continuous wall footings. Since the site topography slopes down from east to west, the western side of the basement level is accessible to pedestrians from the street level via the central stair well.
