Citywide  
Facility Condition Assessment

Report of  
Facility Condition Assessment

For  
City of Manhattan Beach  
City Hall Annex  
421 15th Street, Manhattan Beach, CA

*August 23, 2013  
(Rev A)*

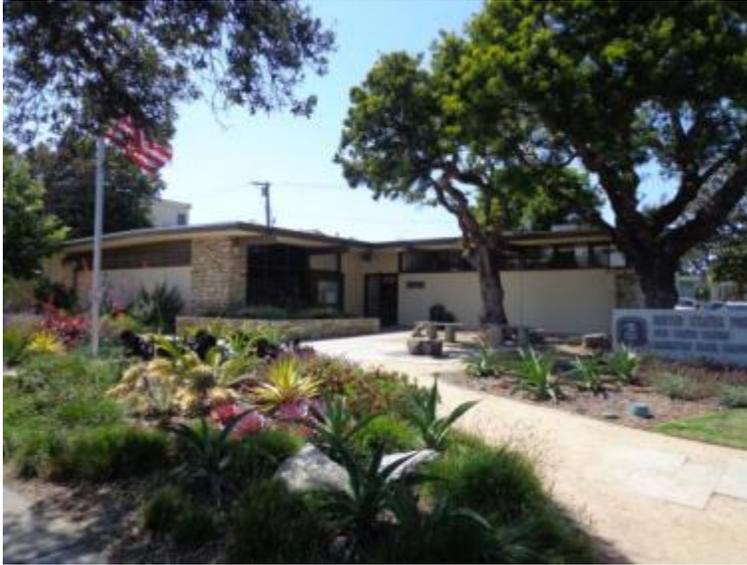
**Photograph No. 1**

The building is predominantly enclosed with painted cementitious stucco and wood trim (reference Photographs 1 through 3 and 5 in Appendix B). Portions of the front elevation are accented with stone veneer. The stucco and wood trim contained a painted finish.

View of the front elevation of the building.

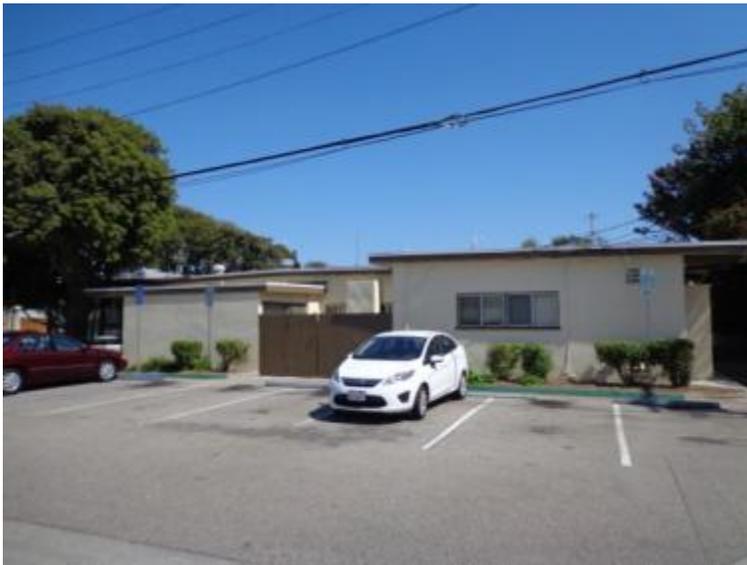
**Photograph No. 2**

View of the side elevation.

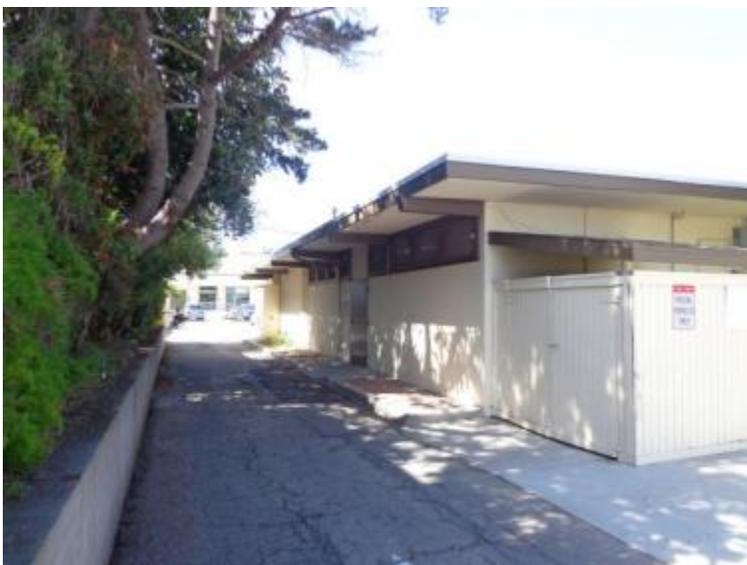
**Photograph No. 3**

The canopy enclosing the dumpster at the southwest corner of the building is constructed of wood framing with a wood joist framed roof with plywood framing (reference Photographs 3 and 4 in Appendix B).

View of the rear elevation and canopy.

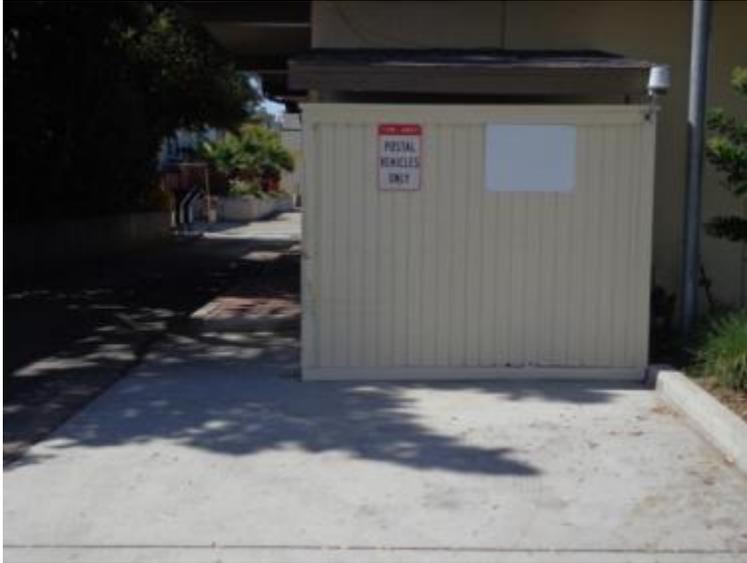
**Photograph No. 4**

View of the canopy structure.

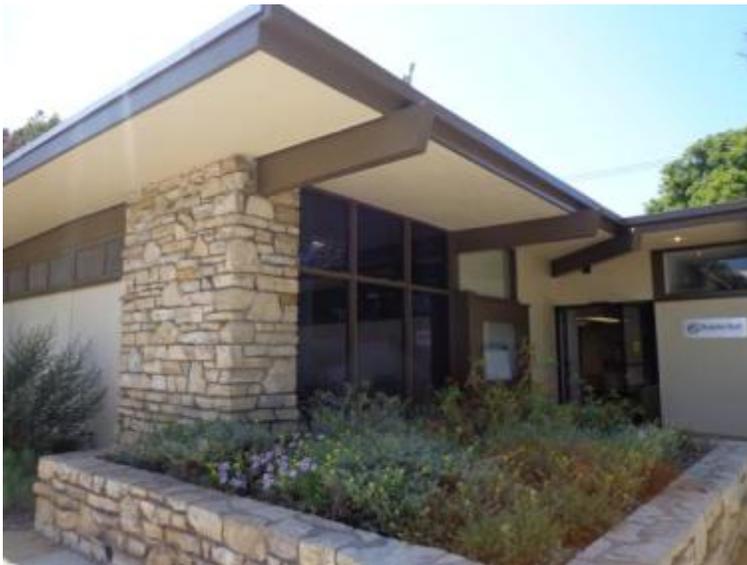
**Photograph No. 5**

A portion of the Chamber of Commerce section of the building along the west elevation was comprised of a glazed wood framed curtain walling system (reference Photograph 5 in Appendix B).

View of the exterior finishes and curtain wall.

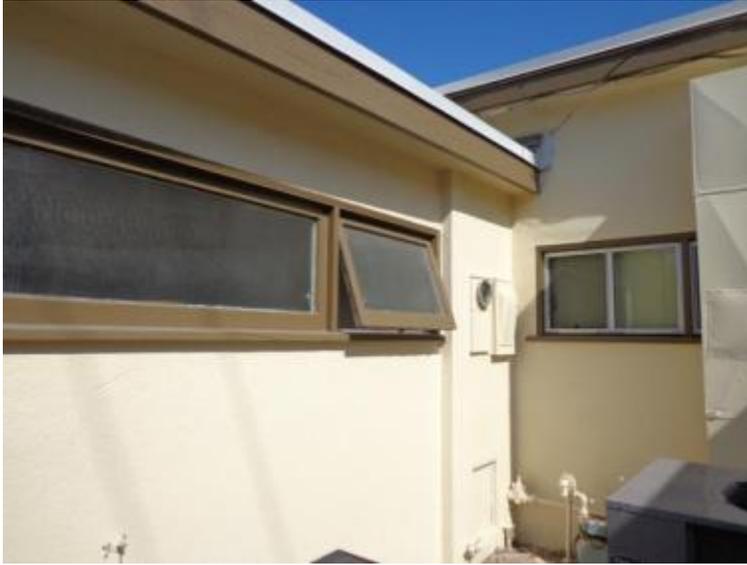
**Photograph No. 7**

All windows at the building are single glazed units. The windows consist of fixed and hopper type wood framed units and aluminum framed sliding windows (reference Photographs 6 and 7 in Appendix B).

View of an awning type window.

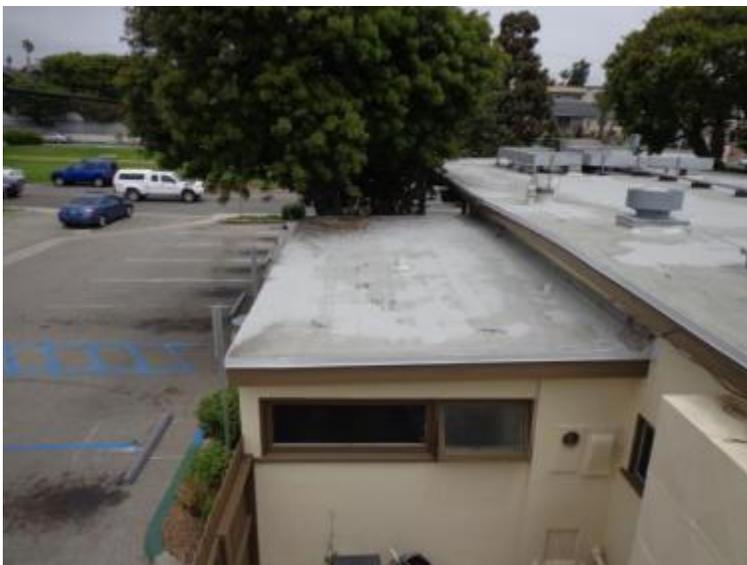
**Photograph No. 12**

The two low-sloped roof areas contained asphaltic Built-Up Roof (BUR) with a mineral cap sheet surface with loose granules applied to the surface (reference Photographs 10 through 12 in Appendix B). The roof coverings are approximately five-years of age. Roof drainage gutters and downspouts are provided at the rear service door and above the two main entrances. The remaining roof areas drain via edge drainage along the perimeter of the roof. Table B30-1 provides a summary of the roof coverings:

View of the BUR roof at the north elevation.

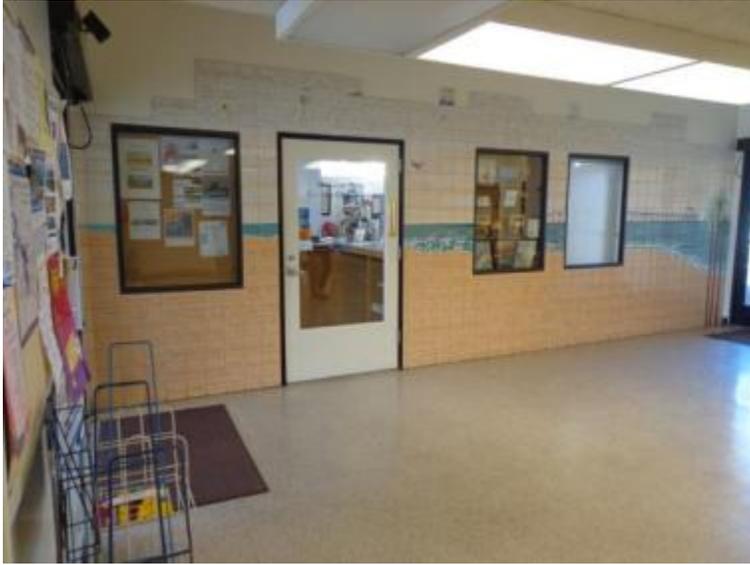
**Photograph No. 13**

The majority of the building interior contained 12" x 12" resilient vinyl tile floor coverings (reference Photographs 13 through 15 in Appendix B). The two restrooms have 1" x 1" ceramic tile floor coverings. The floor at the entrance to the Chamber of Commerce is covered with 6" x 6" ceramic tile.

View of the typical interior finishes.

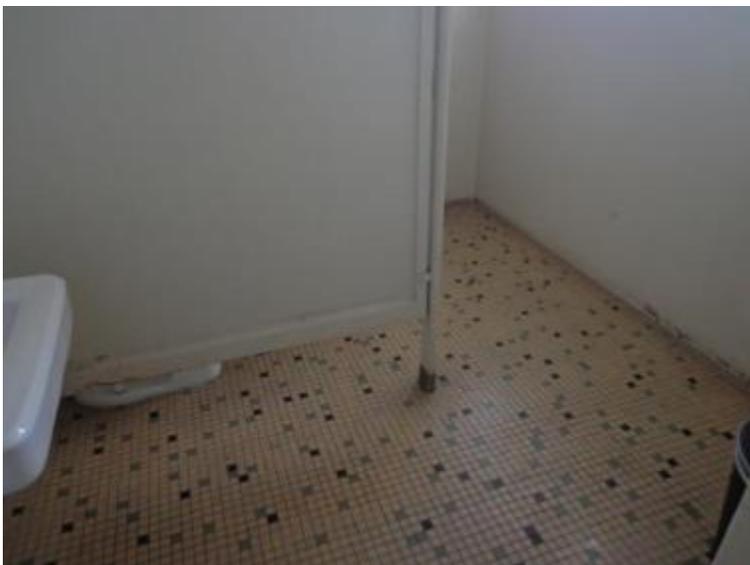
**Photograph No. 15**

View of the restroom finishes.

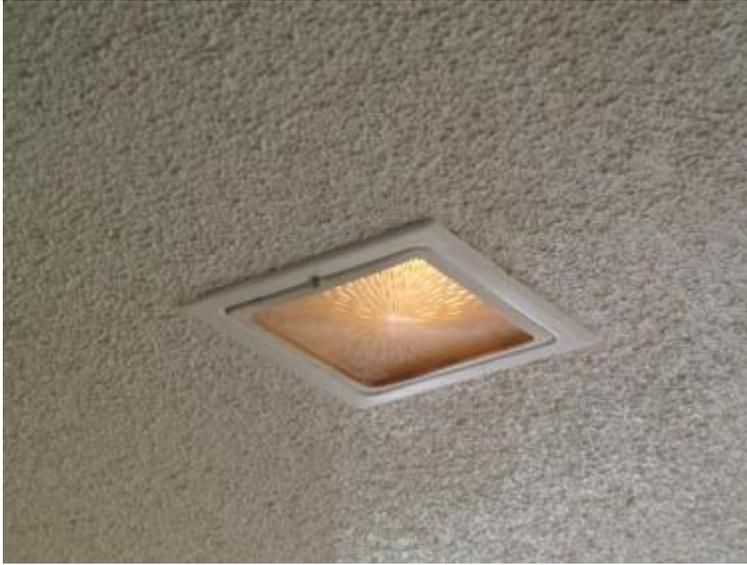
**Photograph No. 16**

There was painted gypsum board ceilings throughout the majority of the building. The ceilings were generally textured; however the restroom ceilings were smooth painted wallboard (reference Photograph 16 in Appendix B).

View of a typical textured ceiling.

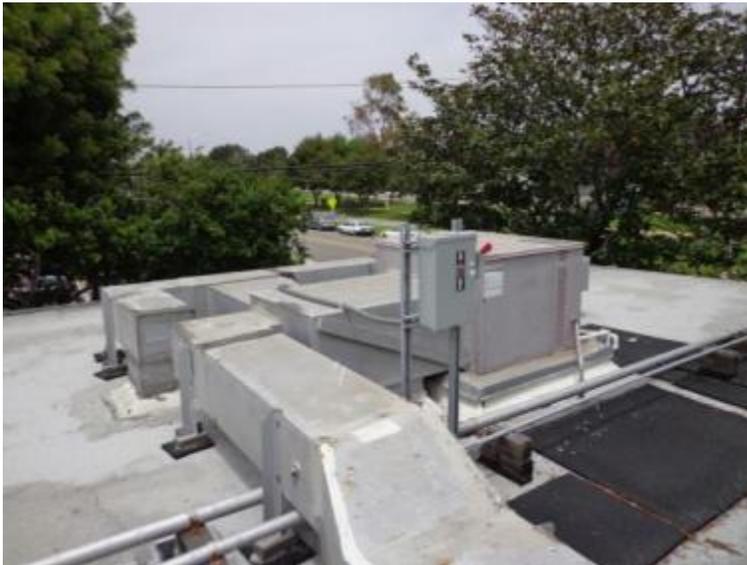
**Photograph No. 20**

The building contained two pad-mounted heat pump package units and one roof-mounted heat pump package unit (reference Photographs 20 and 21 in Appendix B). The pad-mounted units service the Post Office and Dial a Ride office and the rooftop heat pump services the Chamber of Commerce space. They are manufactured by Carrier or BDP Bard and have a cooling capacity of 3-tons each.

View of the rooftop heat pump packaged unit.

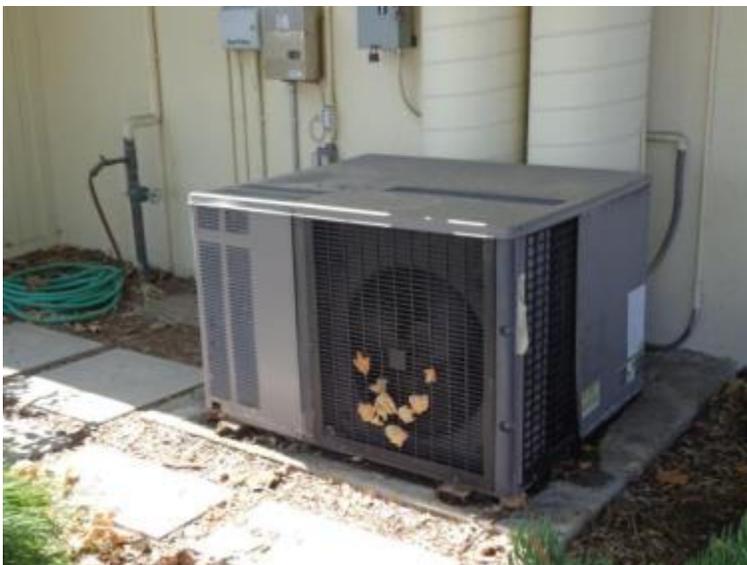
**Photograph No. 21**

View of one of the pad mounted heat pump packaged units.

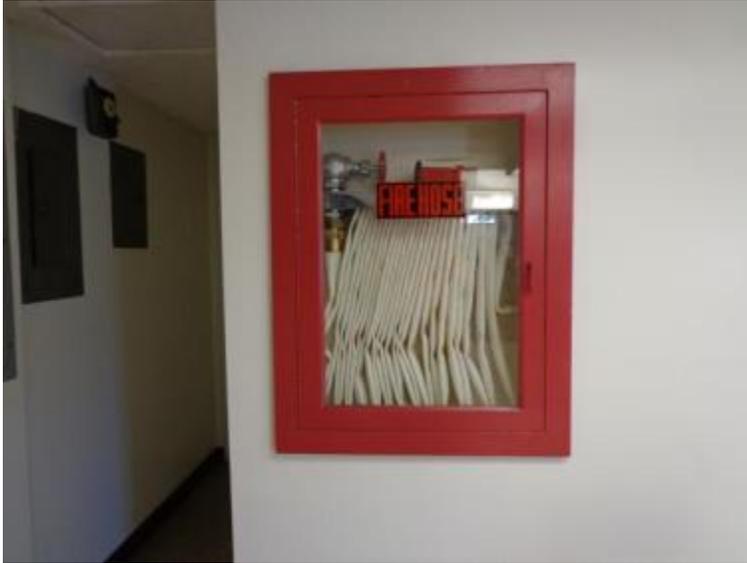
**Photograph No. 22**

View of the fire hose cabinet.

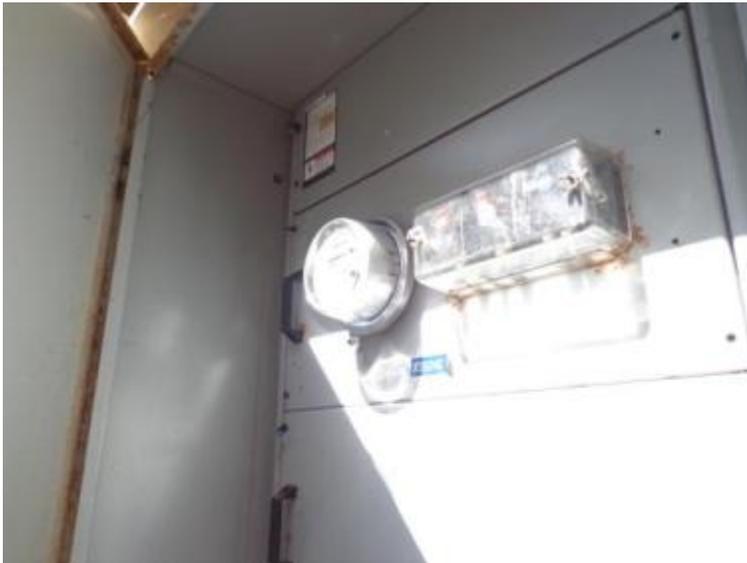
**Photograph No. 23**

The facility is serviced by a 600-amp, 120/208-Volt, 3-phase, 4-wire metered panel which is located at the northwest corner of the building, within an exterior metal enclosure (reference Photograph 23 in Appendix B).

View of the metering located in the main electrical cabinet at the rear alley.

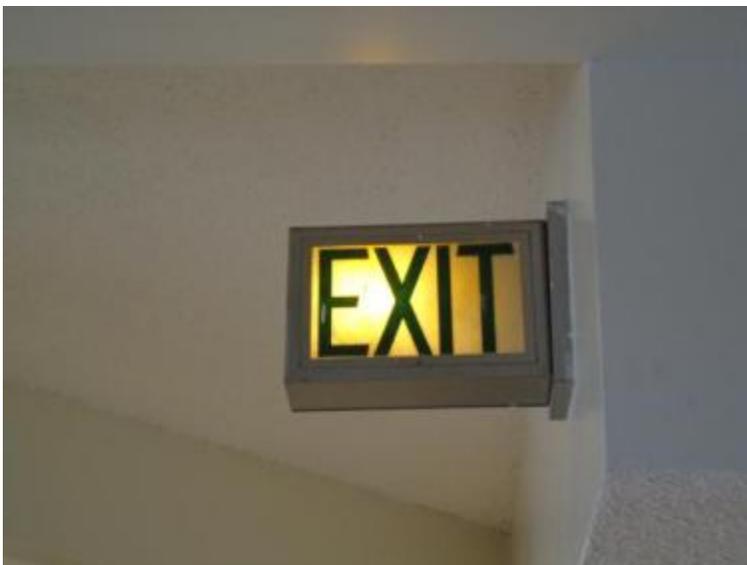
**Photograph No. 24**

Emergency egress exit lighting signs are provided at exit routes from the building (reference Photograph 24 in Appendix B).

View of an illuminated exit sign.

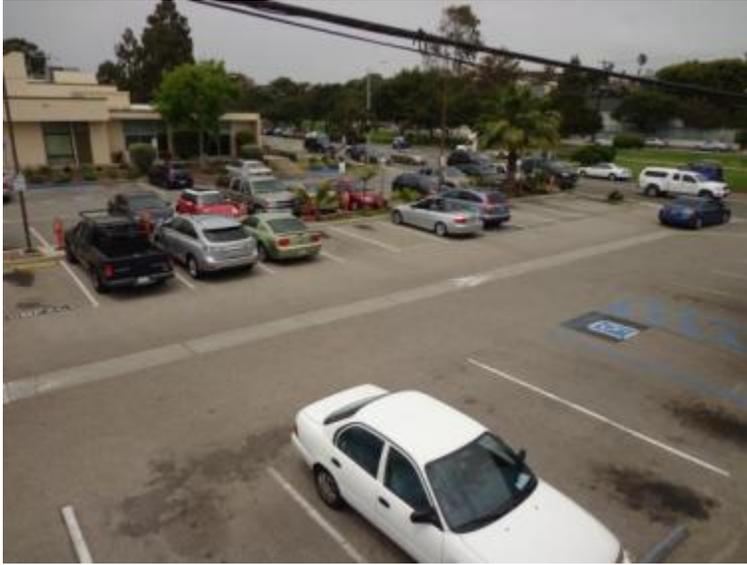
**Photograph No. 25**

The main facility parking lot is located at the northern section of the site and can be access from North Valley Drive to the west and from an alley along the east elevation of the building off of 15th Street (reference Photographs 25 and 26 in Appendix B). The parking lot and paving around the site has an asphalt surface with white line striping denoting areas of parking stalls. We were not provided with the original specification details of the paving and therefore cannot comment on the specific asphalt mix type, classification or its suitability for its existing use. Table G20-1 provides a summary of the site systems.

View of the asphalt parking area.

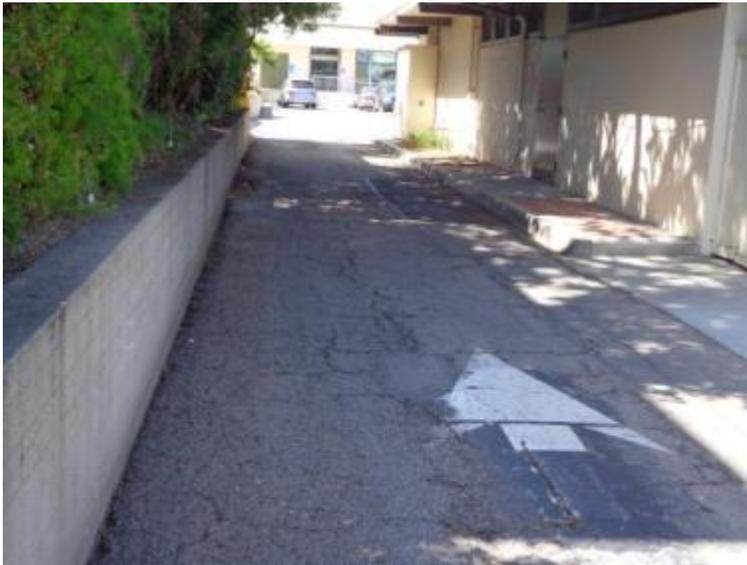
**Photograph No. 26**

View of the asphalt paved alley.

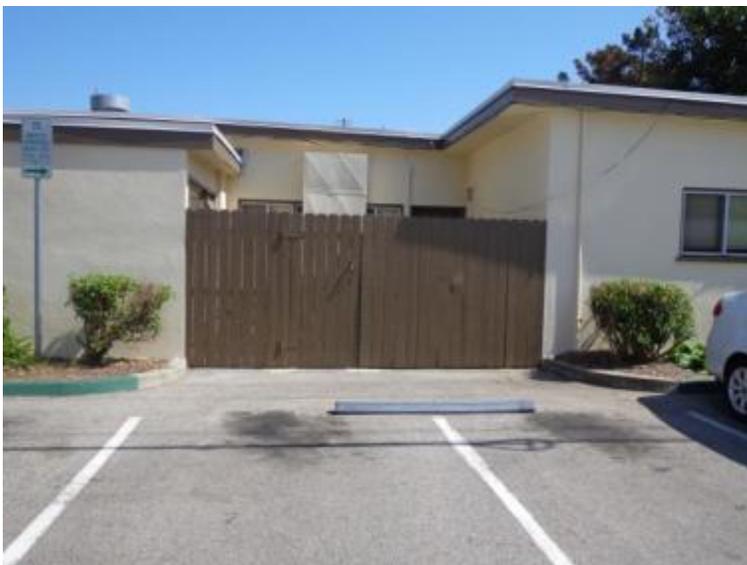
**Photograph No. 27**

The building contained a wood stockade type fence creating an enclosure at the north elevation of the building (reference Photograph 27 in Appendix B).

View of the wood fence along the north elevation of the building.

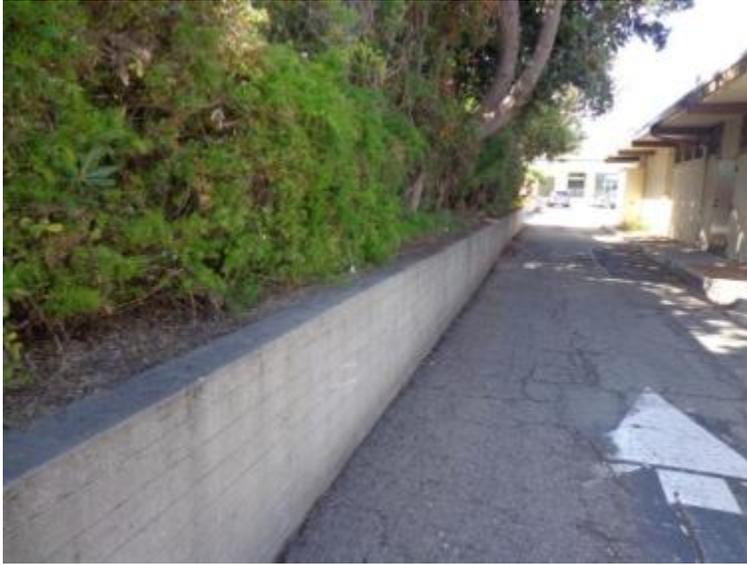
**Photograph No. 28**

There is a 43" high concrete masonry unit retaining wall located along the western perimeter of the asphalt alley (reference Photograph 28 in Appendix B).

View of the masonry retaining wall.

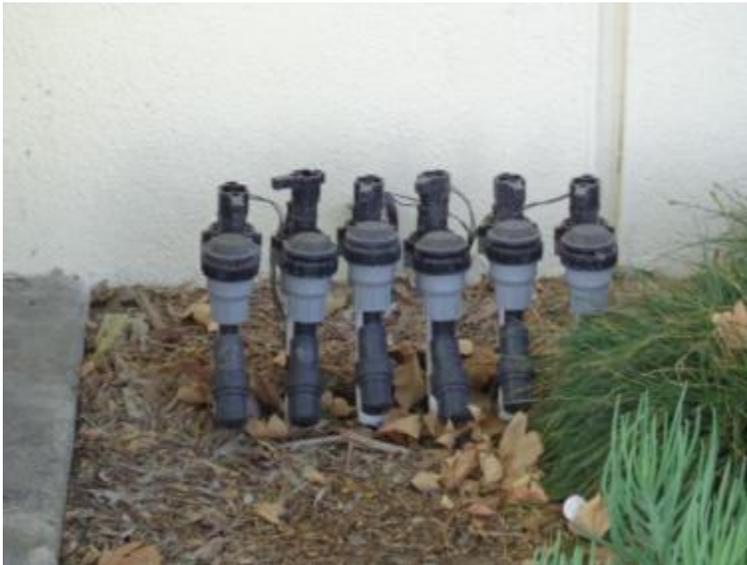
**Photograph No. 29**

The landscaped areas along the east and south elevations of the building are irrigated via a below grade automatic irrigation system (reference Photograph 29 in Appendix B). The irrigation system is supplied by below grade PVC piping and a wall mounted Rain Bird controller. Above ground sprinkler heads are scattered throughout the site.

View of the irrigation system.
