Citywide
Facility Condition Assessment

Report of
Facility Condition Assessment

For
City of Manhattan Beach
Creative Arts Center
1560 Manhattan Beach Boulevard, Manhattan Beach, CA

*August 23, 2013
(Rev A)*

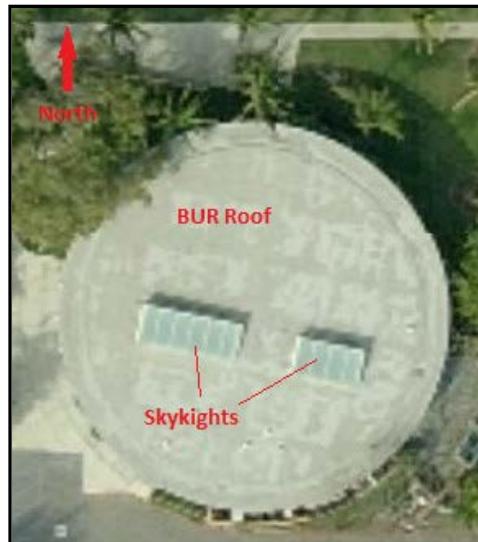
Overview of Roof Locations & Configurations

The low-sloped roof contained an asphaltic Built-Up Roof (BUR) with a mineral cap sheet surface with loose granules applied to the surface. We understand that the roof covering is approximately 12 years of age. Roof surface mounted drains with downspout leaders are provide at several locations around the building perimeter. The downspouts discharge below grade, presumably to the municipal drainage system.

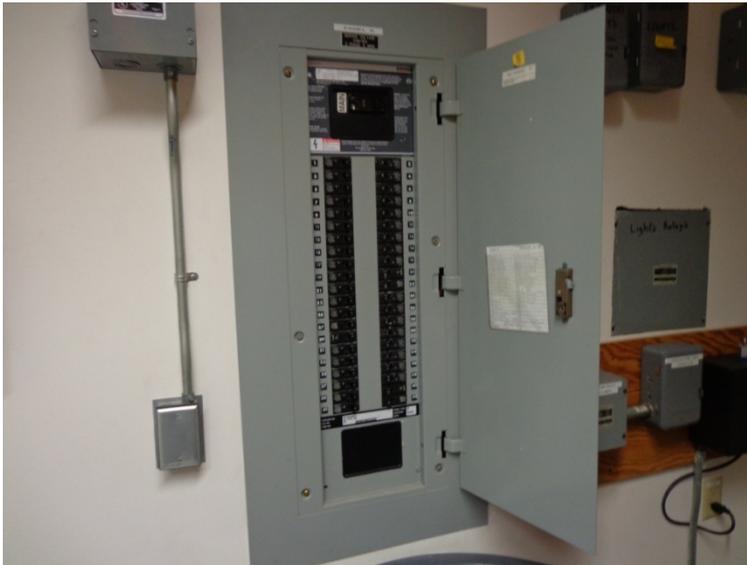
Photograph No. 19

The facility is serviced by a 200-amp, 120/208-Volt, 3-phase, 4-wire metered panel which is located in an exterior cabinet at the rear exterior of the building (reference Photograph 19 in Appendix B).

View of the main electrical service panel.

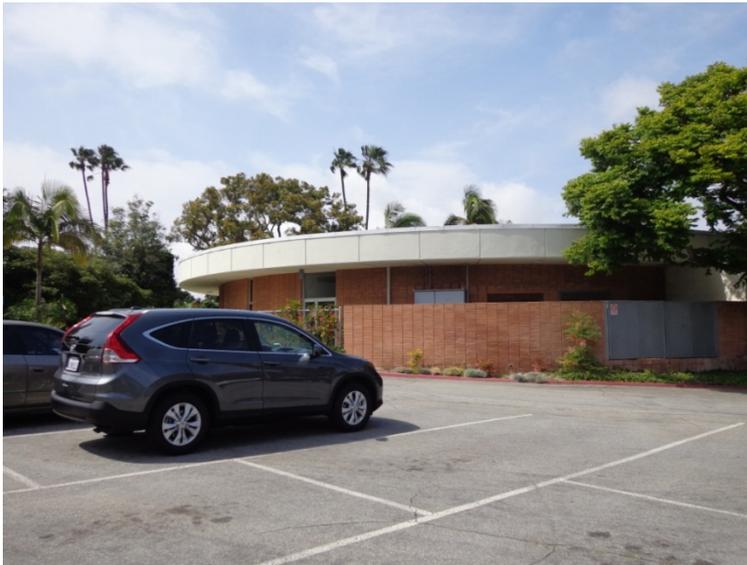
Photograph No. 22

The parking lot is located at the rear of the site and can be access from Manhattan Beach Boulevard to the North and from Eleventh Street to the South along the rear of the site (reference Photographs 22 and 23 in Appendix B). The parking lot and paving around the site has an asphalt surface with white line striping denoting areas of parking stalls. We were not provided with the original specification details of the paving and therefore cannot comment on the specific asphalt mix type, classification or its suitability for its existing use. Table G20-1 provides a summary of the site systems.

View of the main driveway.

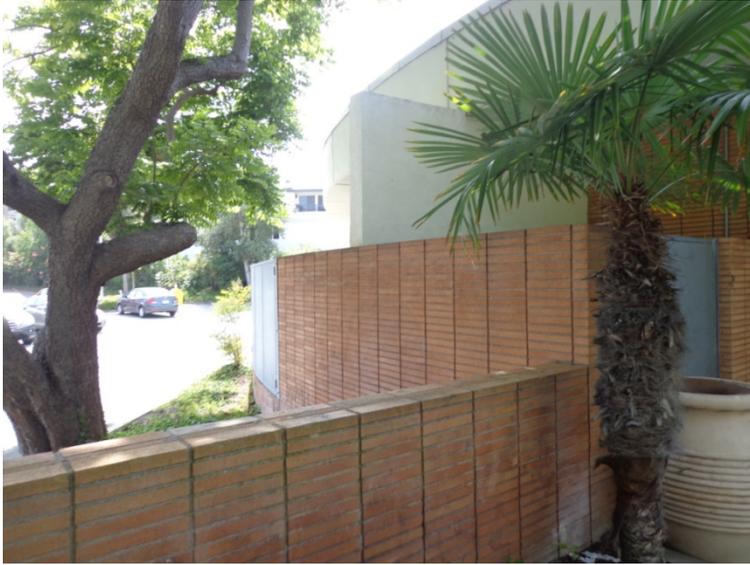
Photograph No. 24

Variable width concrete walkways are located throughout the site (reference Photograph 24 in Appendix B). Additionally, a concrete patio is located along the rear of the building. We were not provided with the original specification details of the paving and therefore cannot comment on the specific concrete mix type, classification or its suitability for its existing use.

View of a typical concrete walkway.

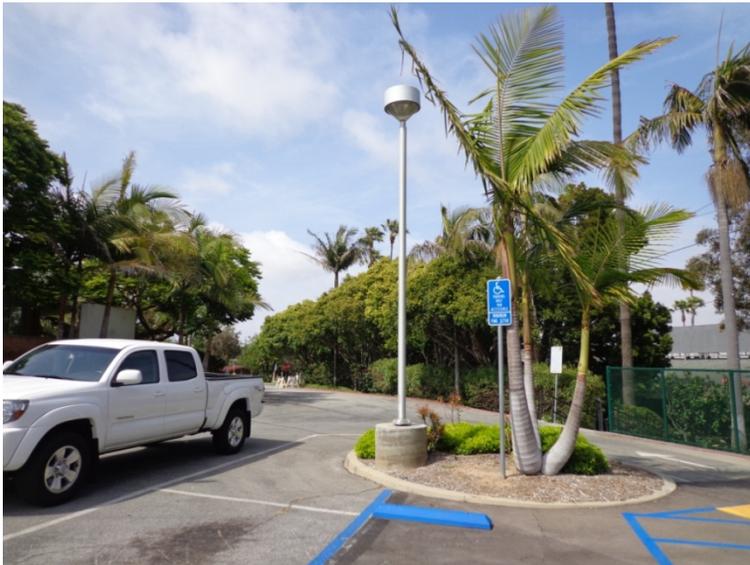
Photograph No. 28

Exterior lighting at the building consisted of fascia and soffit mounted fluorescent lights as well as planter, walkway, signage and pole mounted parking lot lighting (reference Photographs 28 through 30 in Appendix B).

View of the bollard light.
