Citywide
Facility Condition Assessment

Report of
Facility Condition Assessment

For
City of Manhattan Beach
Marine Avenue Park
1625 Marine Avenue, Manhattan Beach, CA

September 4, 2013
(Rev A)

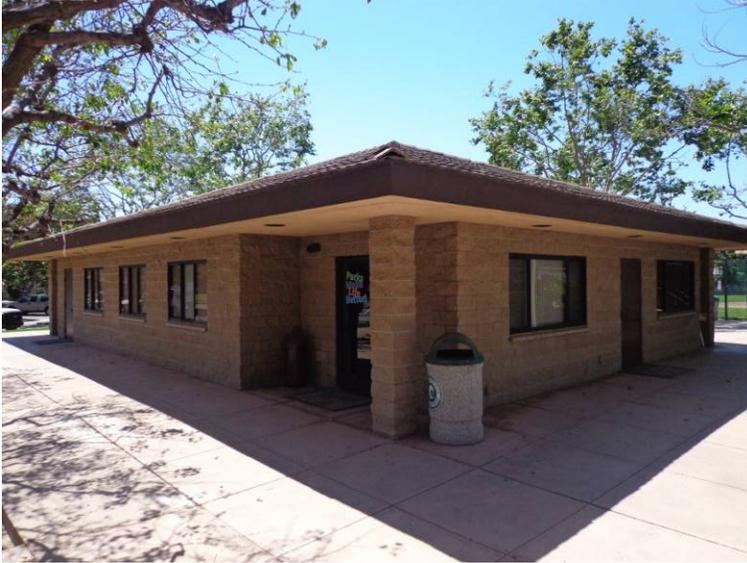
Photograph No. 1

View of the Community Building.

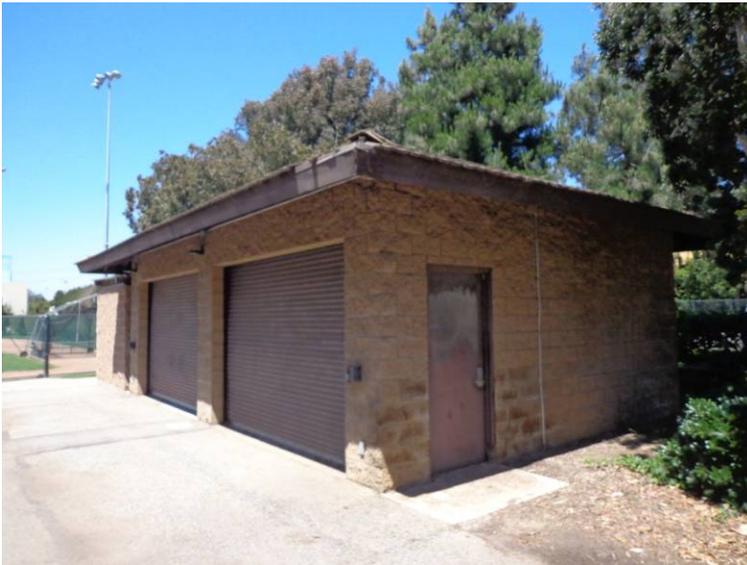
Photograph No. 2

The building contained two coiling type overhead doors at the front elevation (reference Photograph 2 in Appendix B). The doors are manually operated.

View of the East Storage Building.

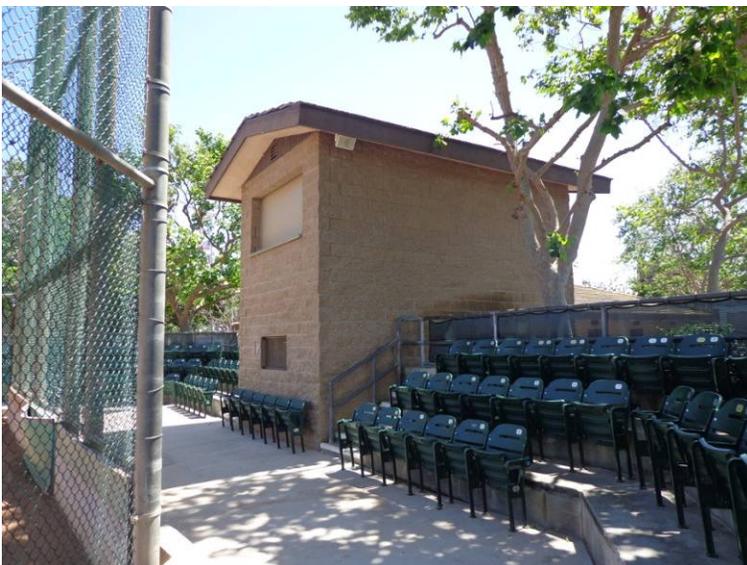
Photograph No. 3

View of the Snack Bar and Score Booth.

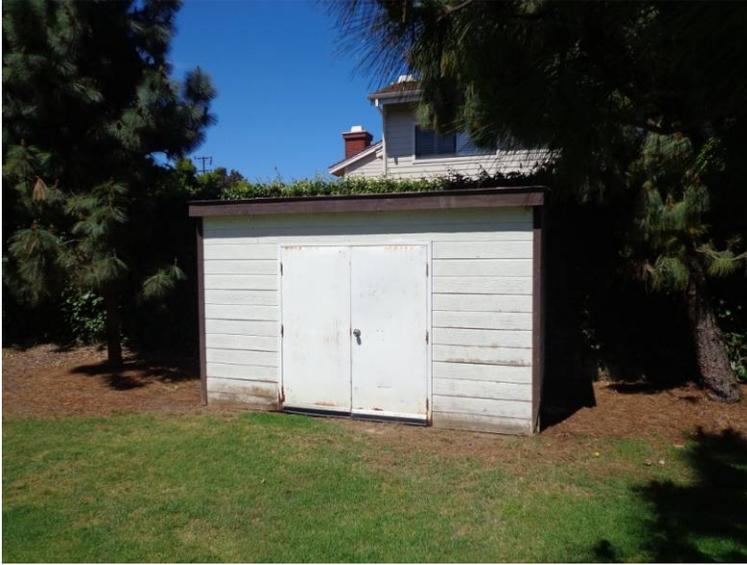
Photograph No. 4

The storage shed building is finished with horizontal pressed board and cementitious clapboard siding with a painted finish (reference Photograph 4 in Appendix B).

View of the Storage Shed.

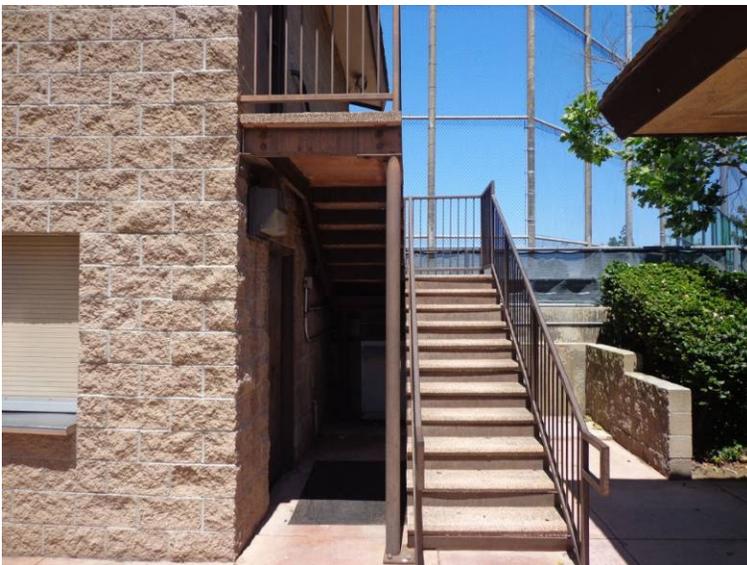
Photograph No. 6

View of exterior stairway at the Score Booth.

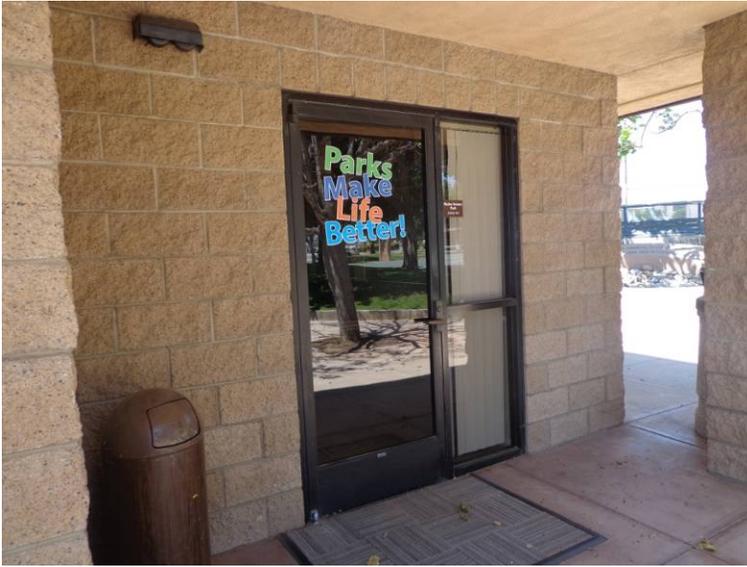
Photograph No. 10

The main entrance at the northeast corner of the building contained an insulated glazed brown anodized aluminum entrance door (reference Photograph 10 in Appendix B).

View of the Community Building entrance.

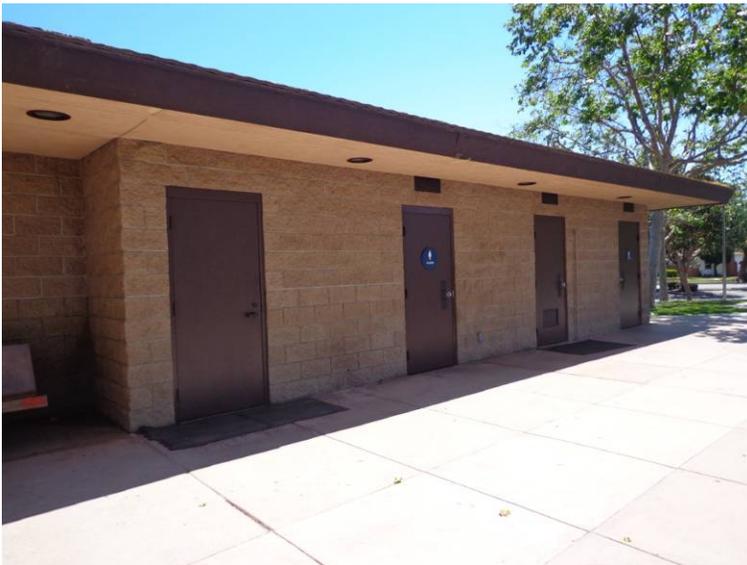
Photograph No. 11

The buildings contained single or double hollow core steel panel doors. The Community Building has steel doors at the restrooms, mechanical rooms and exits; the East Storage Shed has one hollow core door; the Snack Bar and Score Booth has metal doors at the first and second floor entrances with coiling overhead door type security doors at the window openings; and the Storage Shed has double hollow core steel entrance doors (reference Photograph 11 in Appendix B). Door hardware consisted of knob type, push / pull or level handles.

View of the typical steel doors.

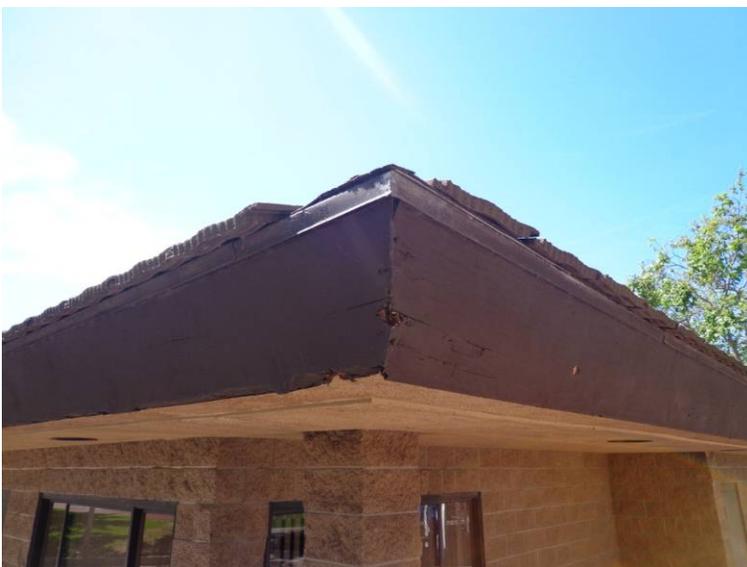
Photograph No. 12

View of the typical damage observed at the Community Building trim.

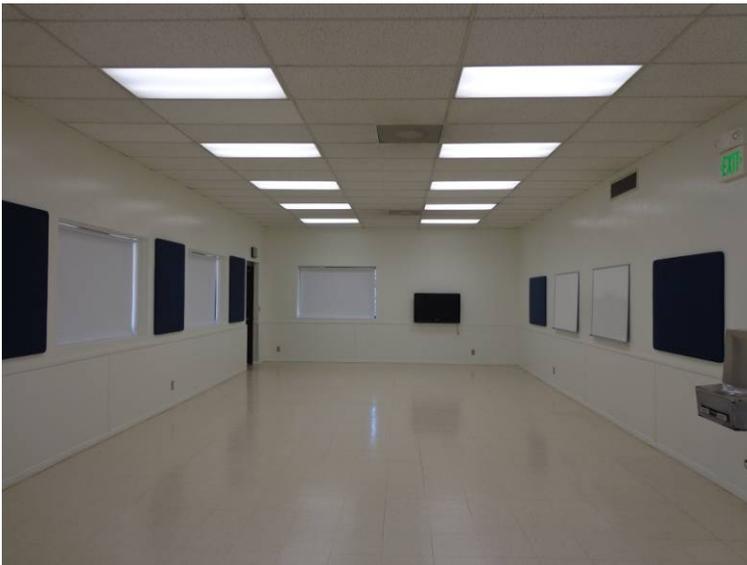
Photograph No. 17

Interior walls at each of the buildings generally contained painted gypsum wall board with wood panel wainscot along the lower portion of the activity areas (reference Photograph 17 in Appendix B). The walls at the two restrooms were coated with anti-graffiti paint.

The building contained 2' x 4' suspended acoustical tiled ceilings within a white enameled exposed grid system (reference Photograph 17 in Appendix B). The system is supported with wires from the underside of the roof construction above. The ceiling panels are generally 5/8" thick mineral board in fissured pattern. The ceiling system incorporated lighting and air-handling components.

View of Community Building interior.

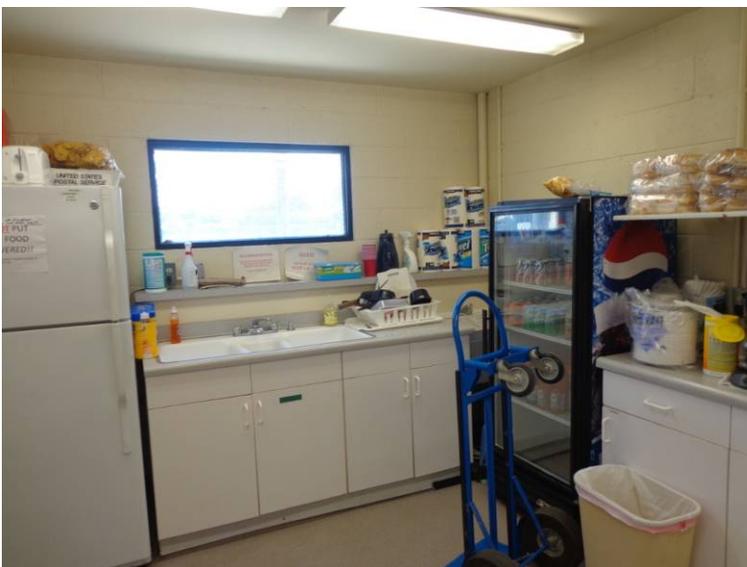
Photograph No. 18

Interior walls at each level of the building were generally painted CMU (reference Photograph 18 in Appendix B).

View of the Snack Bar interior.

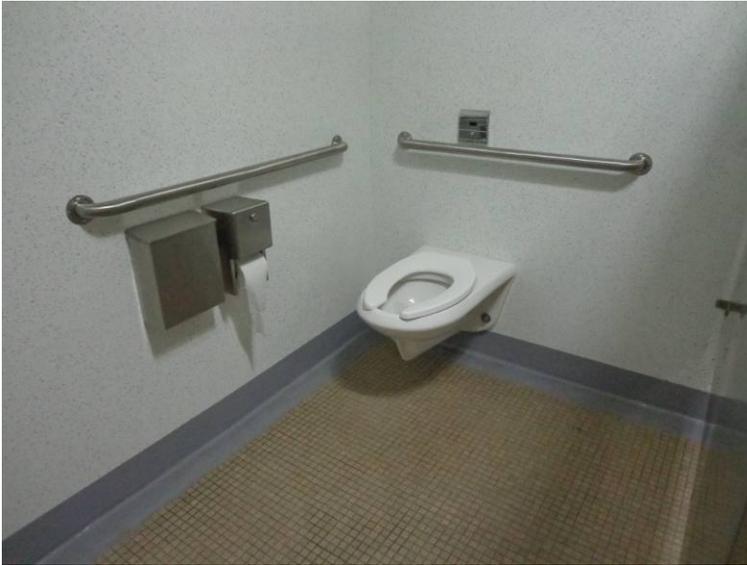
Photograph No. 19

The building contained wall mounted vitreous china tank-less water closets which have automatic flush valves (reference Photograph 19 in Appendix B).

View of a water closet.

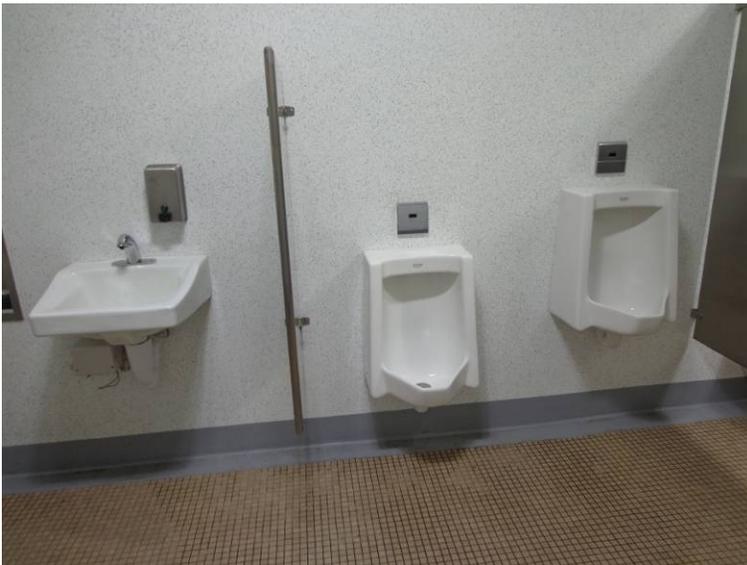
Photograph No. 20

The men's room contained vitreous china wall hung urinals which have automatic flush valves (reference Photograph 20 in Appendix B).

The building contained wall mounted vitreous china wall hung lavatories (reference Photograph 20 in Appendix B). The lavatories consisted of automatic, non-metering faucets. Water is supplied via copper pipe work and drained through cast iron pipe work and fittings.

View of a wall mounted lavatory and urinals.

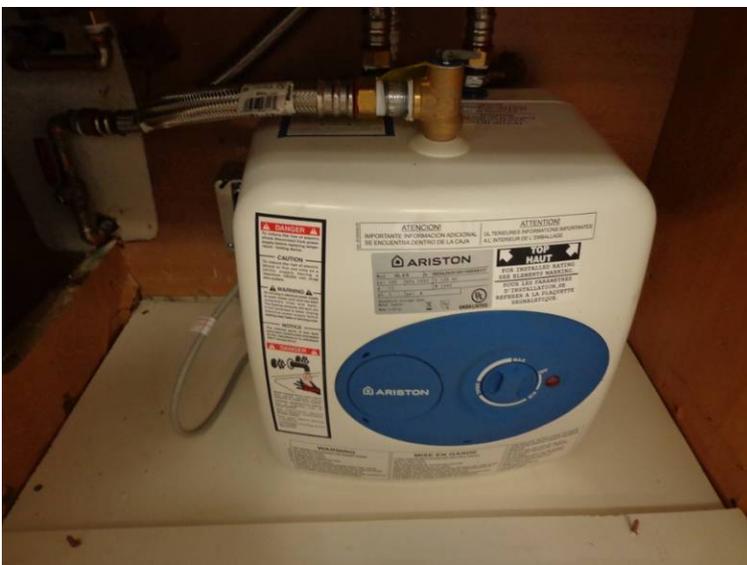
Photograph No. 21

Domestic hot water was present at the Community Building and Snack Bar and Score Booth buildings at the facility. The hot water at the Community Building is generated via electric instant water heater located in the mechanical areas. Hot water at the Snack Bar is generated by an electric water heater with a 4 gallon storage capacity (reference Photograph 21 in Appendix B).

View of the water heater at the snack bar.

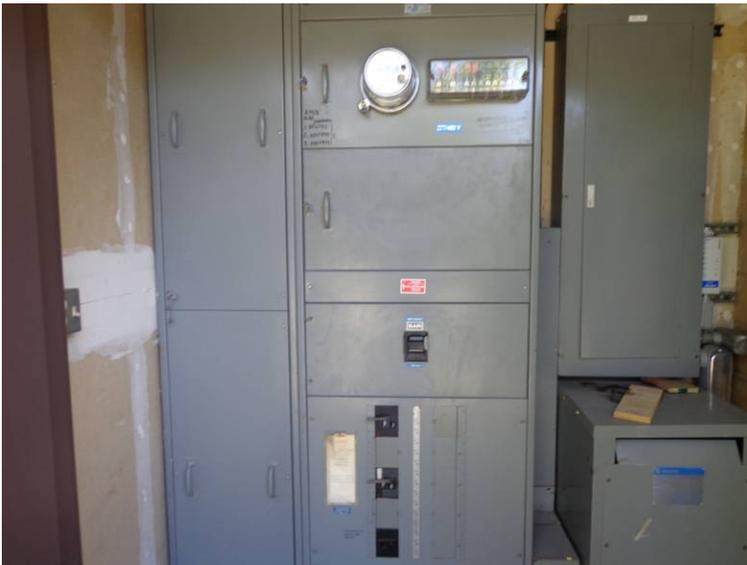
Photograph No. 23

The building is serviced by a main panel-board consisting of a 400-amp, 277/480-volt, 3-phase, 4-wire metered panel which is located in the mechanical room (reference Photograph 23 in Appendix B). The building also has one 90-amp panel board (reference Photograph 25 in Appendix B).

View of the electrical equipment at the Community Room.

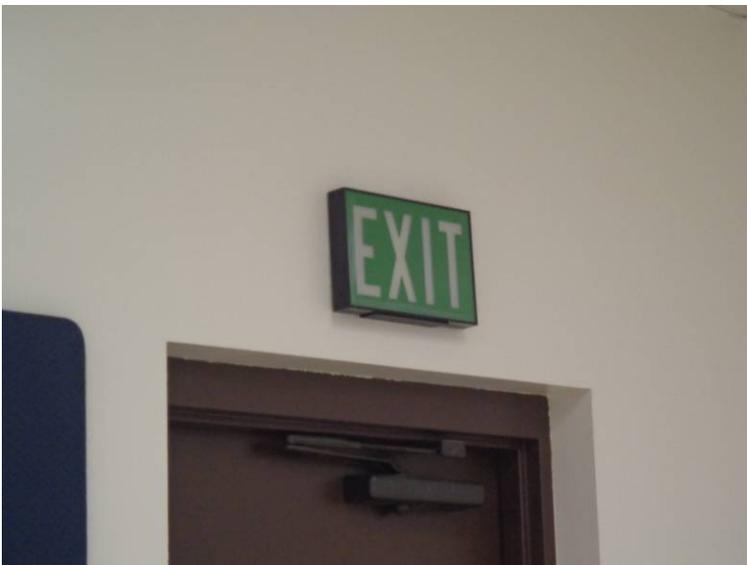
Photograph No. 24

Emergency egress exit lighting signs are provided at exit routes from the building (reference Photograph 24 in Appendix B).

View of a typical exit light.

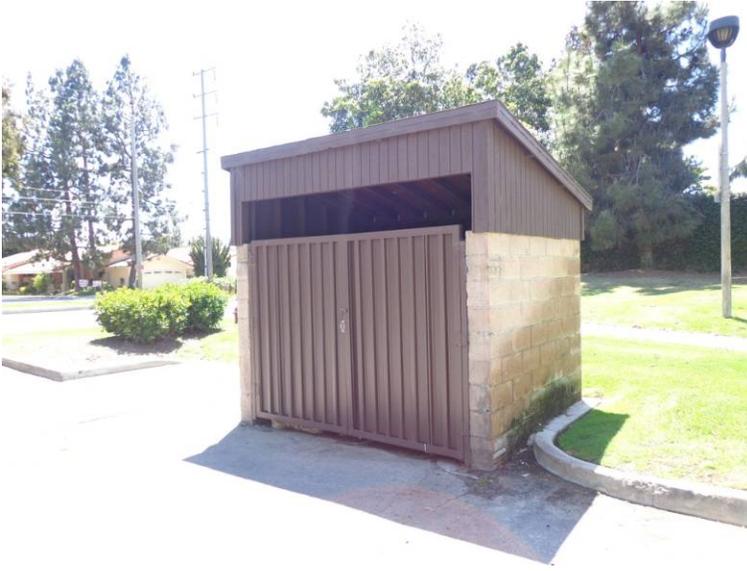
Photograph No. 25

There is a dumpster enclosure along the front of the park. The enclosure is constructed with concrete masonry unit walls and a galvanized metal panel roof (reference Photograph 25 in Appendix B).

View of the dumpster enclosure.

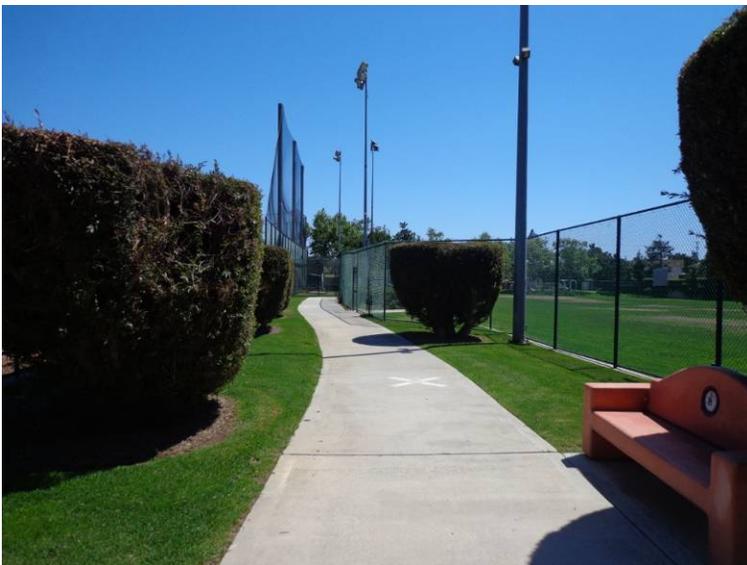
Photograph No. 33

Exterior lighting along the perimeter of the baseball field consisted of four pole mounted metal halide fixtures mounted on galvanized steel poles approximately 50' in height (reference Photograph 33 in Appendix B). The lights contained five fixtures each. Additional exterior lighting also includes several single head fixtures along the walkways and four pole mounted lights at the basketball courts.

View of the lighting.
