Citywide  
Facility Condition Assessment

Report of  
Facility Condition Assessment

For  
City of Manhattan Beach  
Fire Station #2  
1400 Manhattan Beach Boulevard, Manhattan Beach, CA

*August 23, 2013  
(Rev A)*

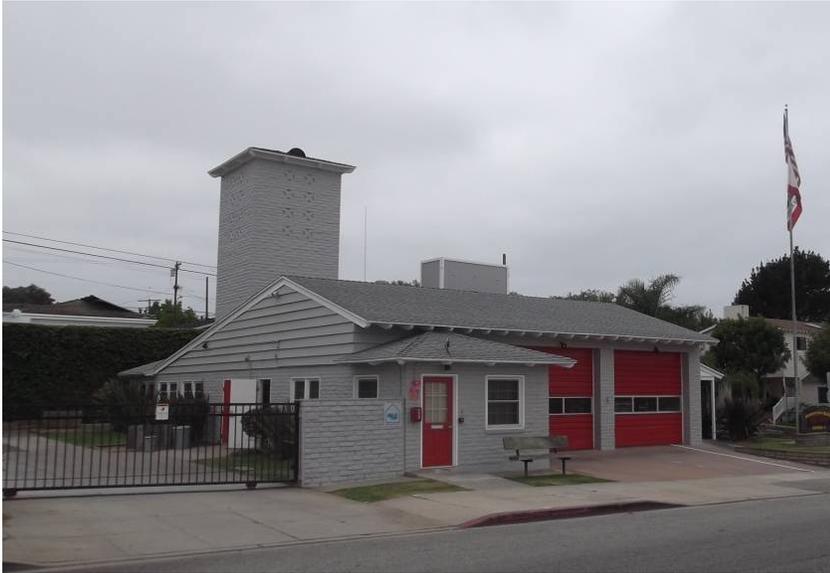
**Photograph No. 1**

View of the north façade facing Manhattan Beach Boulevard.

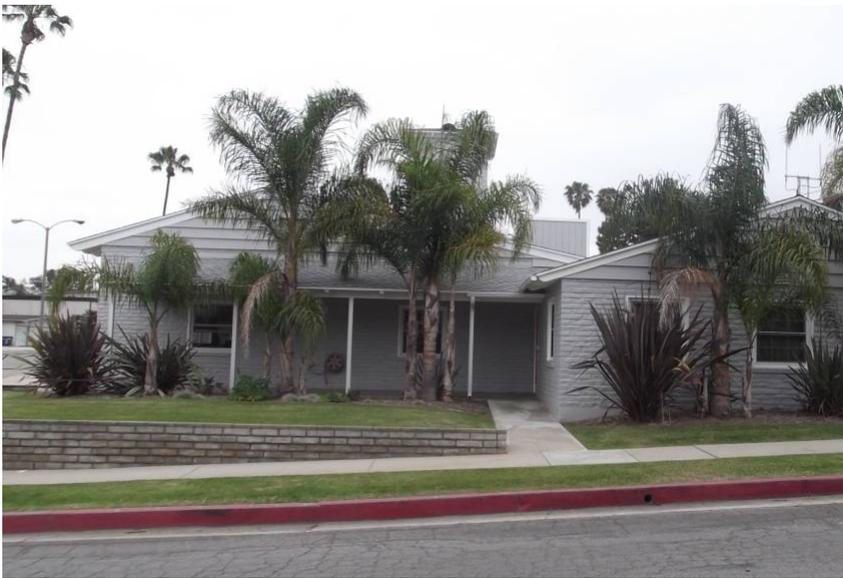
**Photograph No. 2**

View of the west façade facing Rowell Drive.

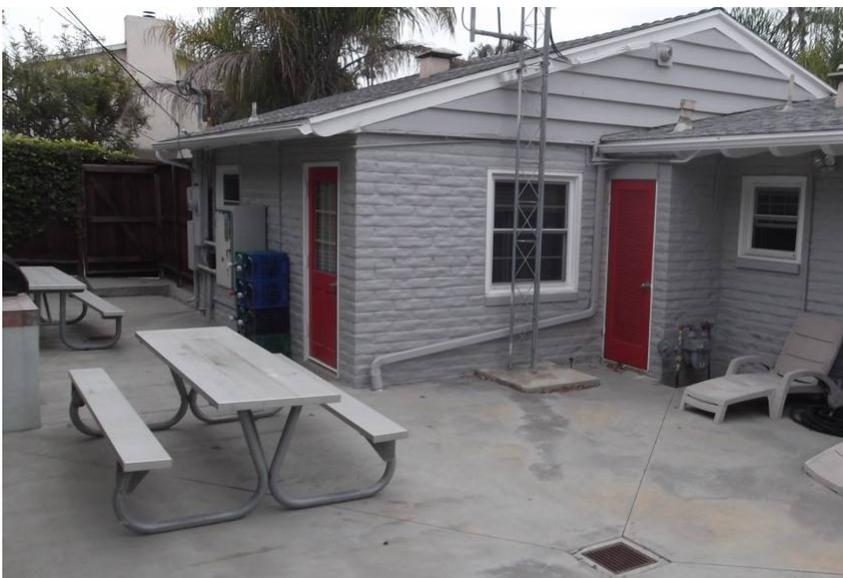
**Photograph No. 3**

View of the south façade and patio area

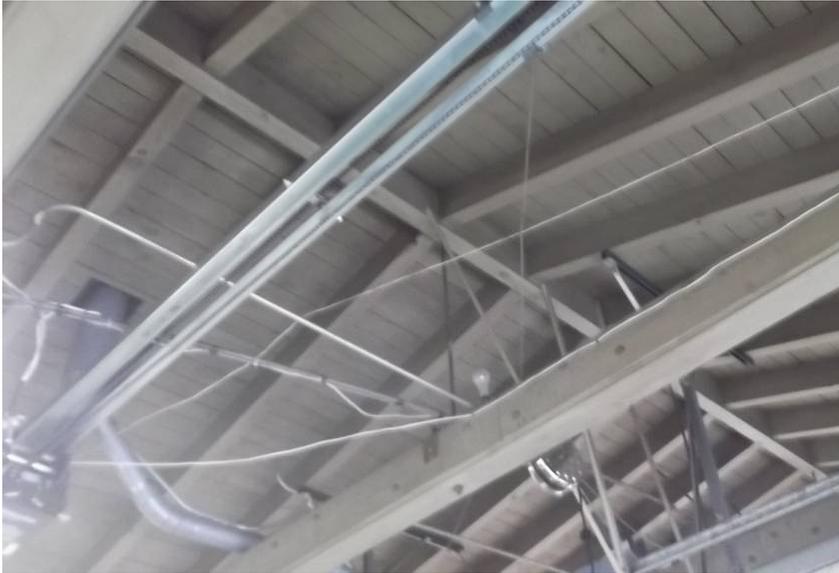
**Photograph No. 4**

The apparatus bay section of the Station House contains sloped solid wood rafter framing that is exposed on the underside, with connections of through-bolts, steel clips and anchor bolts at load-bearing. The sloped rafters run from north to south and are 4" x 8" at 4' on center, with horizontal framing of 4" x 8" joists at 3' - 4" on center walls (reference Photographs 4 and 5 in Appendix B). The drawings indicate that solid wood decking of tongue-and-groove 1' x 6" planks spans diagonally across the roof framing.

The pitched roof construction appeared to be in good condition. There were no visible signs of deflection or failure noted. We do not anticipate any expenditure during the cost study period relating to significant repair or replacement of the roofs' structural systems.

View of the exposed roof framing in the apparatus bays.

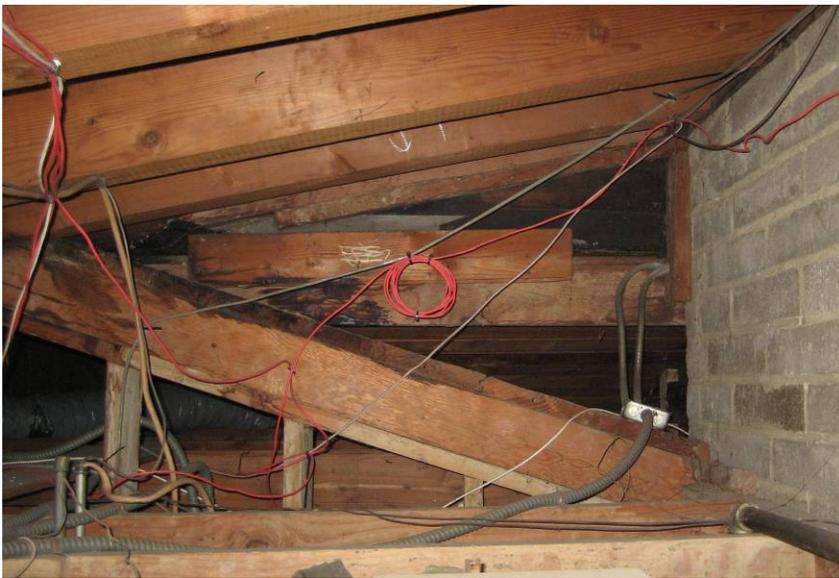
**Photograph No. 5**

View of the roof framing over the living areas at the south side of the building.

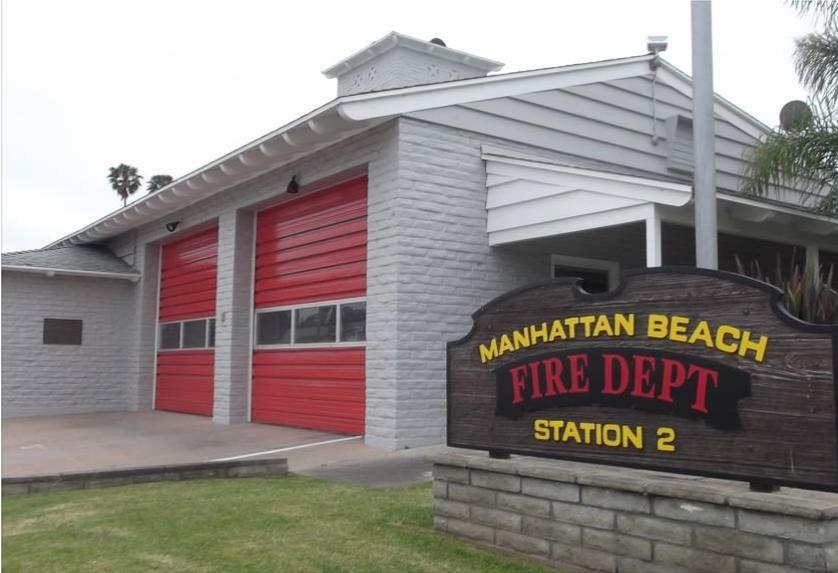
**Photograph No. 7**

View of the north façade and apparatus bay doors.

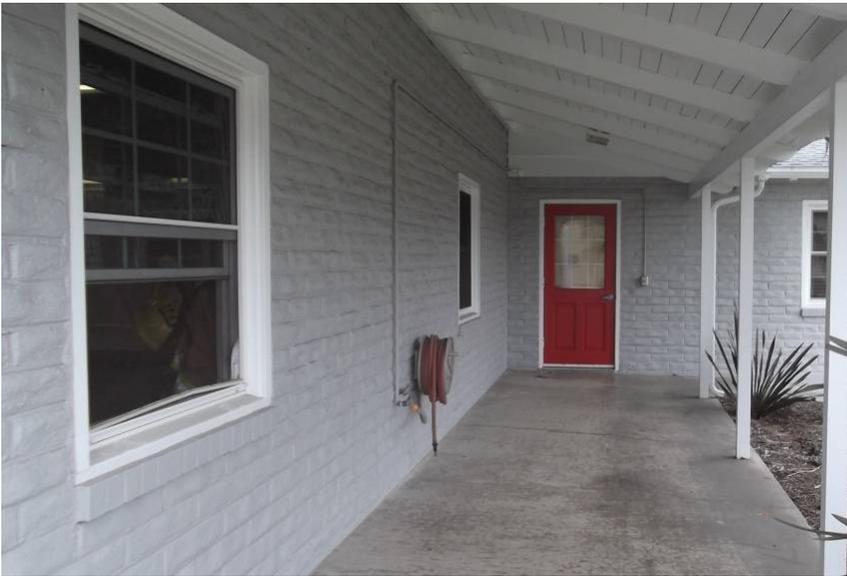
**Photograph No. 8**

View of the covered entrance at the west side of the building and typical window unit.

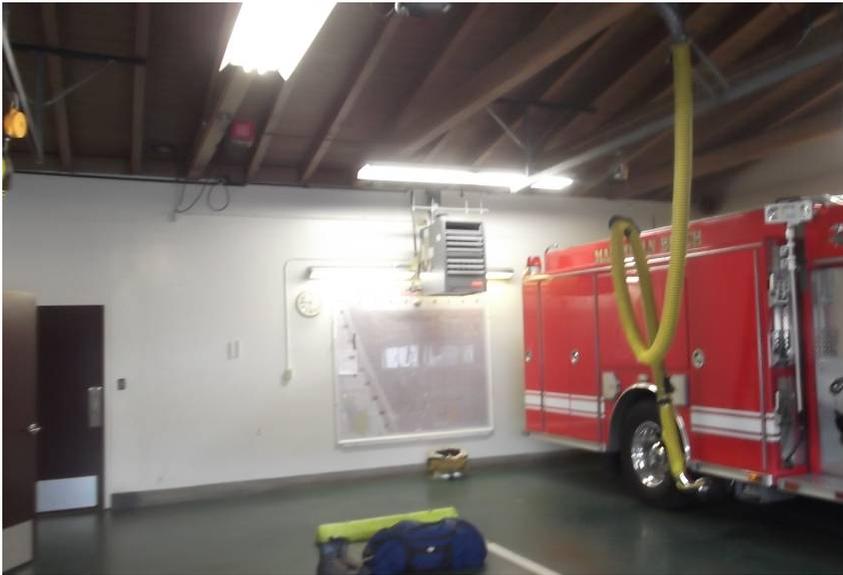
**Photograph No. 10**

View of the apparatus bays.

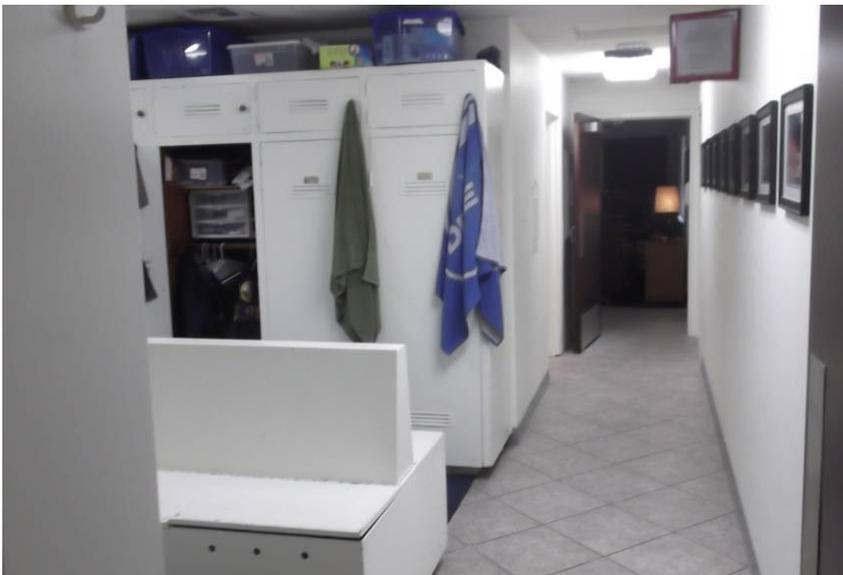
**Photograph No. 11**

The men's locker room contains twelve painted wood lockers and bench with base storage (reference Photograph 11 in Appendix B).

View of the locker room.

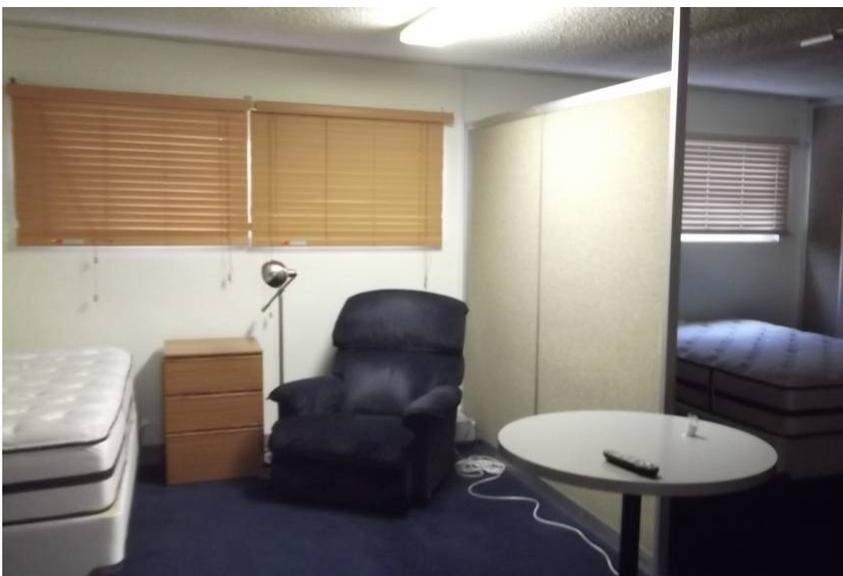
**Photograph No. 12**

View of the dormitory area.

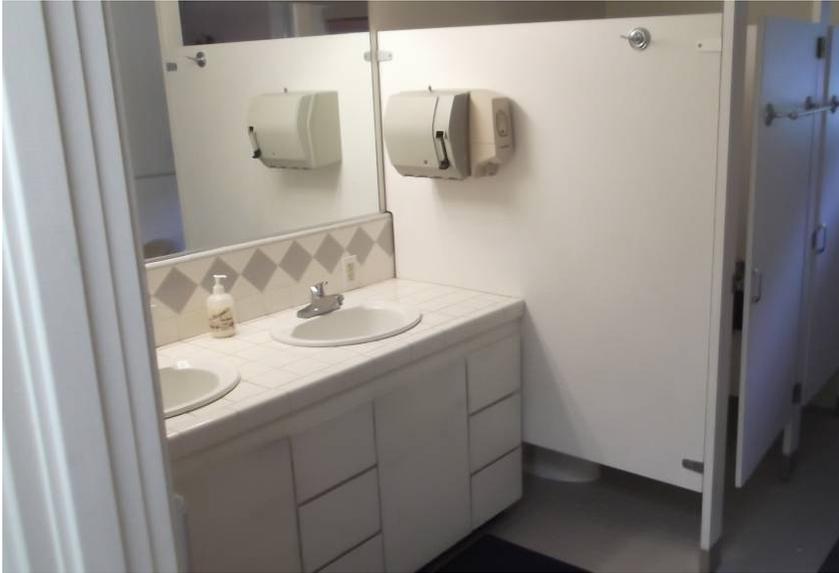
**Photograph No. 13**

The men's locker room and restroom contains floor mounted and wall fixed plastic laminate water closet stall partitions and doors (reference Photograph 13 in Appendix B). The ceramic tiled shower stalls contain glazed shower doors in aluminum frames (reference Photograph 15 in Appendix B).

View of the restroom

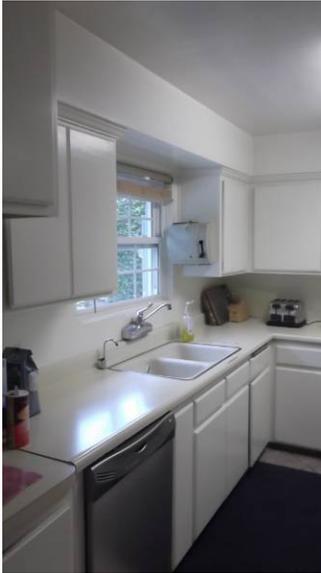
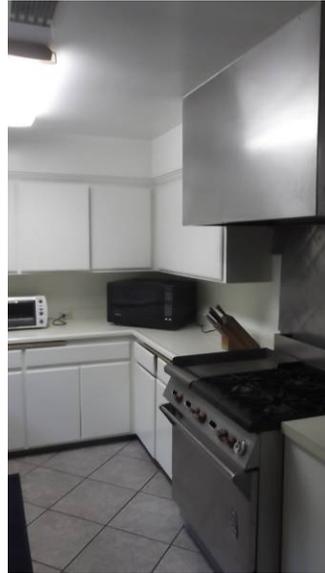
**Photograph No. 17 & 18**

The Station House kitchen contains residential kitchen appliances, including gas range/oven, stainless steel exhaust hood, refrigerators/freezers, dishwasher, and laundry washer and dryer (reference Photographs 17 and 18 in Appendix B).

View of the kitchen.

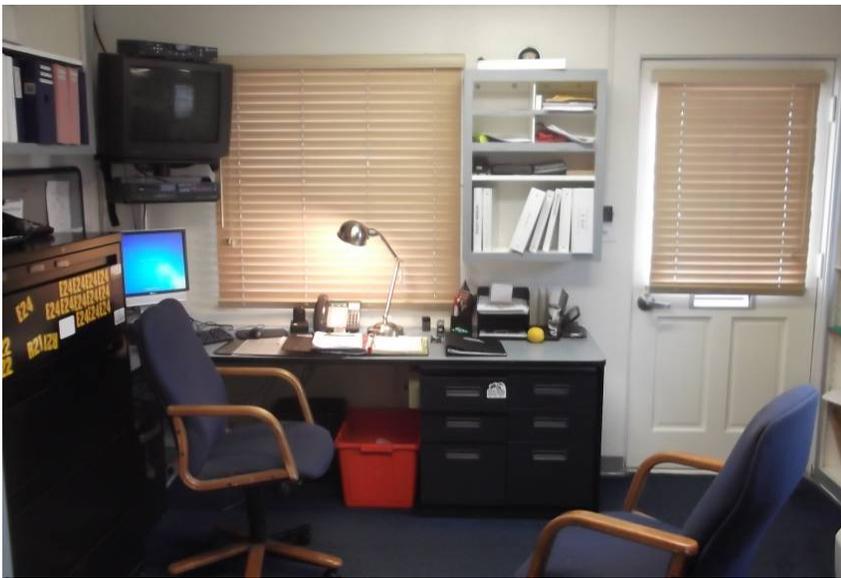
**Photograph No. 19**

View of the office area.

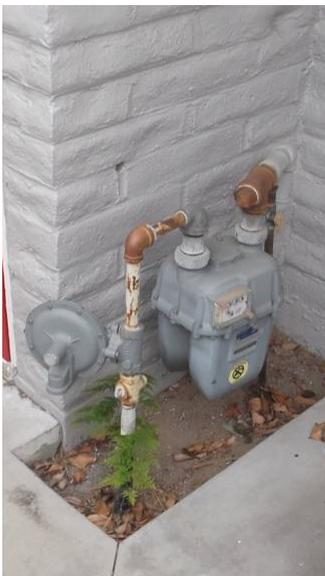
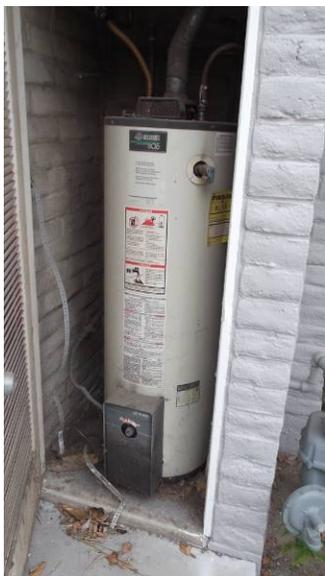
**Photograph Nos. 20 & 21**

View of the gas service meter and domestic water heater, at the south side of the building.

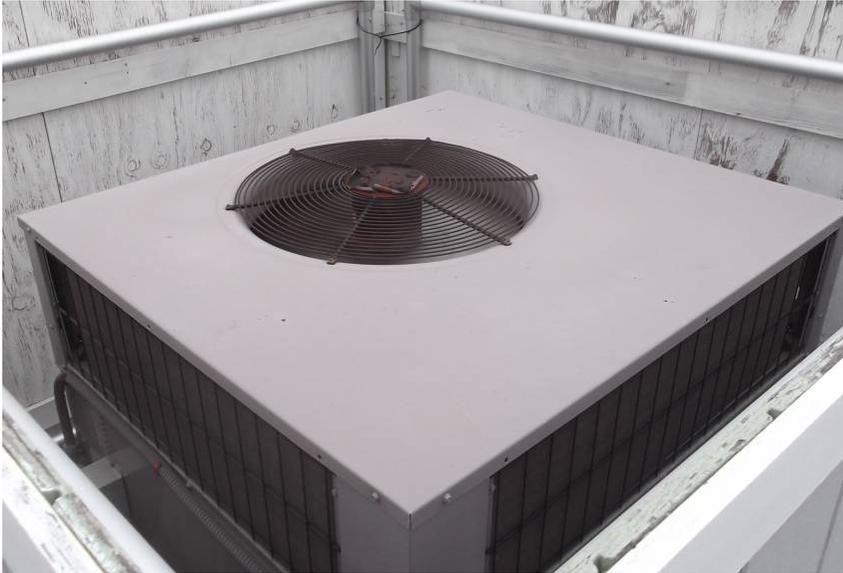
**Photograph No. 22**

Primary heating and cooling at the Station House is provided by one rooftop gas-fired package unit. The equipment was manufactured by Bryant (reference Photograph 22 in Appendix B). The unit has an indicated heating capacity of 90,000 BTU/HR and cooling capacity of 5 tons.

View of the building's primary rooftop package HVAC unit.

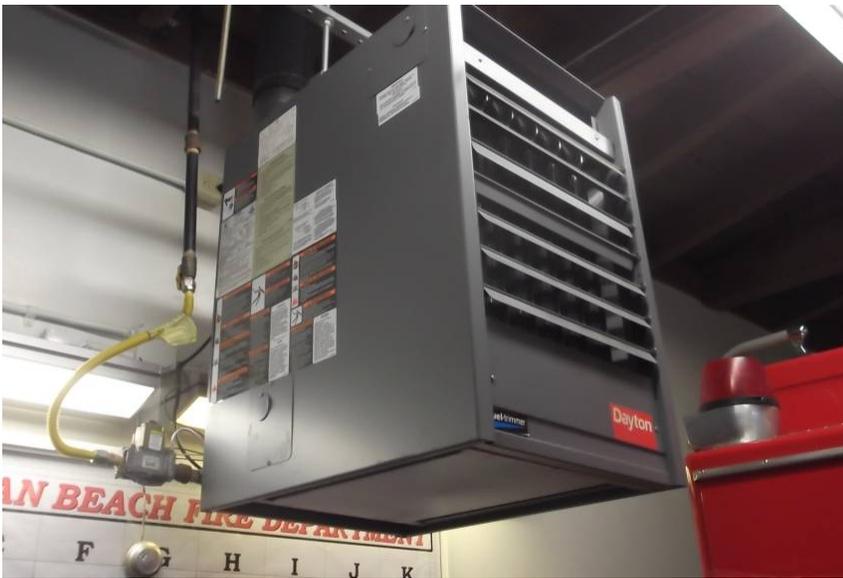
**Photograph No. 23**

The building has one natural gas-fire unit heater that is hung from the roof structure in the apparatus bays (reference Photograph 23 in Appendix B). Refer to the following Table D30-1 for further details of the unit heater.

View of the gas-fire cabinet heater in the apparatus bays.

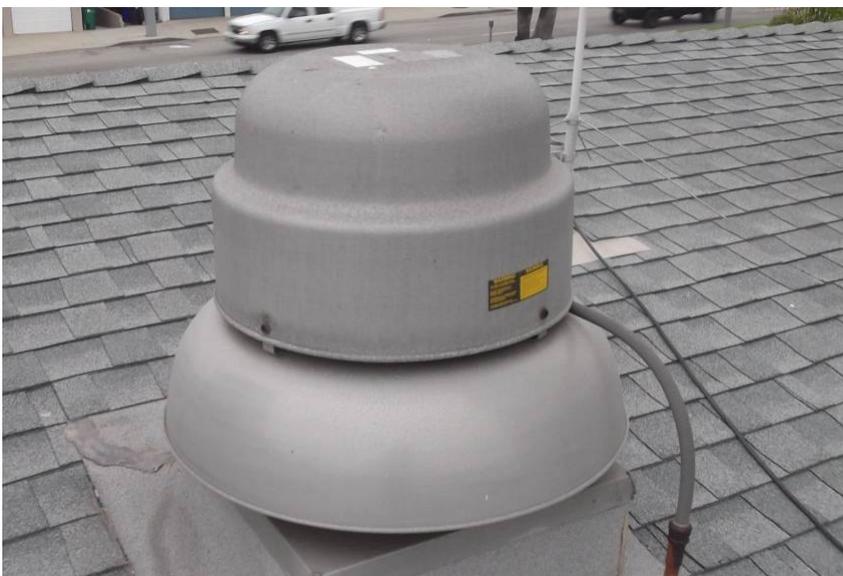
**Photograph No. 24**

The building contains rooftop and sidewall-mounted exhaust fans, a kitchen range exhaust hood, and a rooftop apparatus bay vehicle exhaust fan (reference Photographs 24 and 25 in Appendix B). The rooftop mounted exhaust fan, manufactured by Loren Cook, serves the restroom / shower room and is assumed to have a capacity of approximately 100 - 200 cubic feet per minute (CFM).

View of the rooftop exhaust fan.

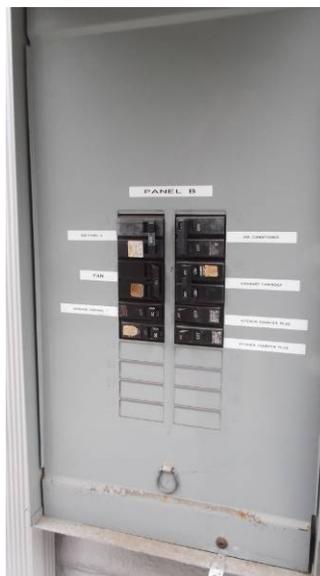
**Photograph No. 26**

The main incoming service for the site is routed from the utility pole-mounted transformer to the meter on the south side of the Station House. Adjacent to the meter, the main distribution panel (MDP), designated panel "A", is also located on the south side of the building within a metal cabinet. This is the service entrance equipment for these buildings. The MDP, manufactured by Crouse-Hinds, is rated at 120/240 volts for 200-amp, 1-phase, and 3-wire service and assumed to use fusible switches. A branch panel (panel "B") is located adjacent to the MDP, as well as other sub-panels within each building, with varying ratings from 100- to 200-amperes (reference Photographs 26 through 28 and 36 in Appendix B). Service to the Gymnasium is provided by a single circuit from the Station House panel "C" in the dormitory area to a 100-amp panel adjacent to the Gymnasium entrance door (panel "D").

View of the electrical main distribution panel, meter and generator's automatic transfer switch at the south side of the building.

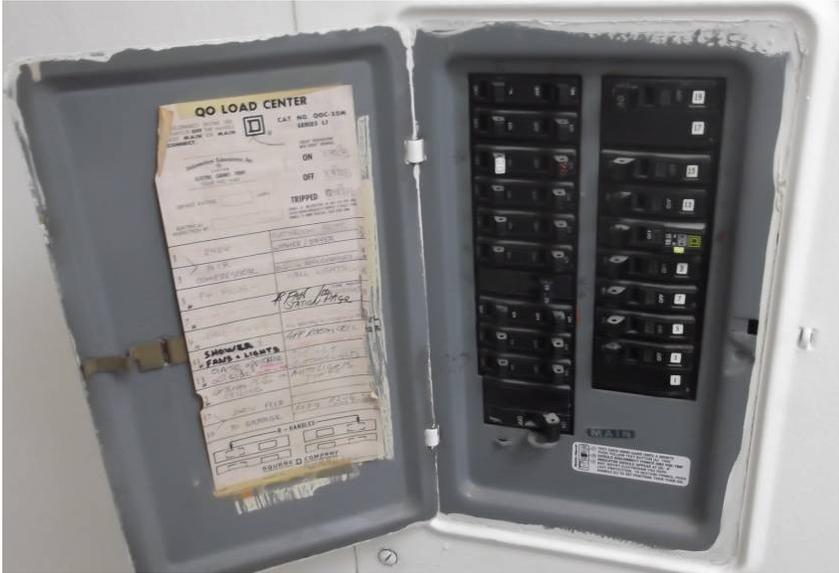
**Photograph No. 27**

View of the secondary service electrical panel on the south side of the building.

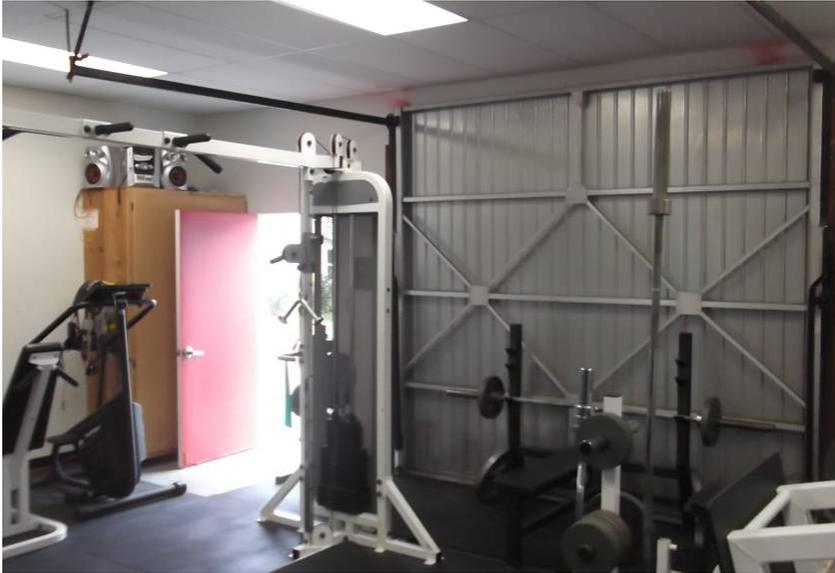
**Photograph No. 33**

The Gymnasium contains various types of fitness and exercise equipment, including treadmills, elliptical trainers, multi-station weight training equipment and benches and free weights (reference Photographs 33 and 34 in Appendix B).

View of the building interior and fitness equipment.

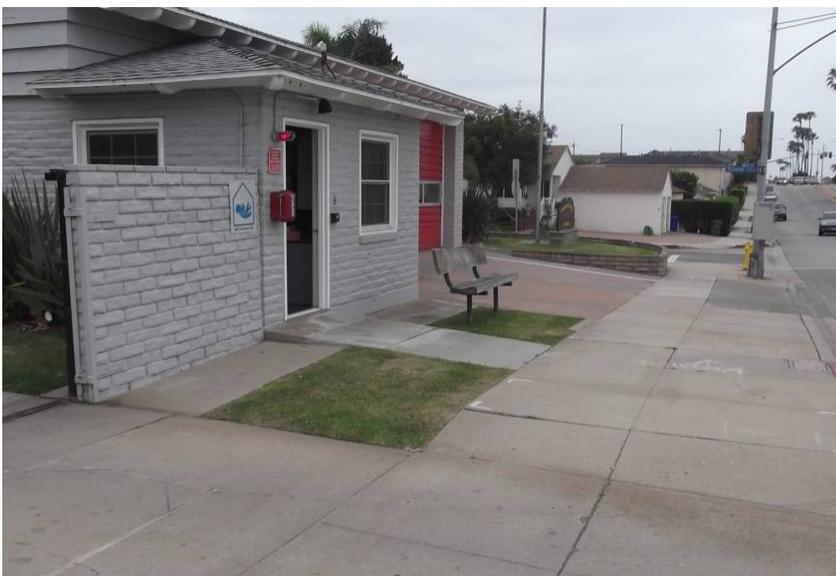
**Photograph No. 38**

The concrete paved areas appeared to be in good to fair condition, with open cracking in some locations and evidence of previous patching repairs. The asphalt paved parking lot appeared to be in fair condition, with areas of large cracking, smaller alligator-type cracking and surface erosion (reference Photographs 37 and 38 in Appendix B). We recommend that all areas of the asphalt undergo asphaltic-based seal coating and the re-application of surface markings every three-years to extend the life of the pavements. In the latter part of the study period, based on observed conditions and an EUL of 30 years, budgeting for the surface milling and application of an asphalt overlay in the parking area is recommended.

View of asphalt pavement deterioration.

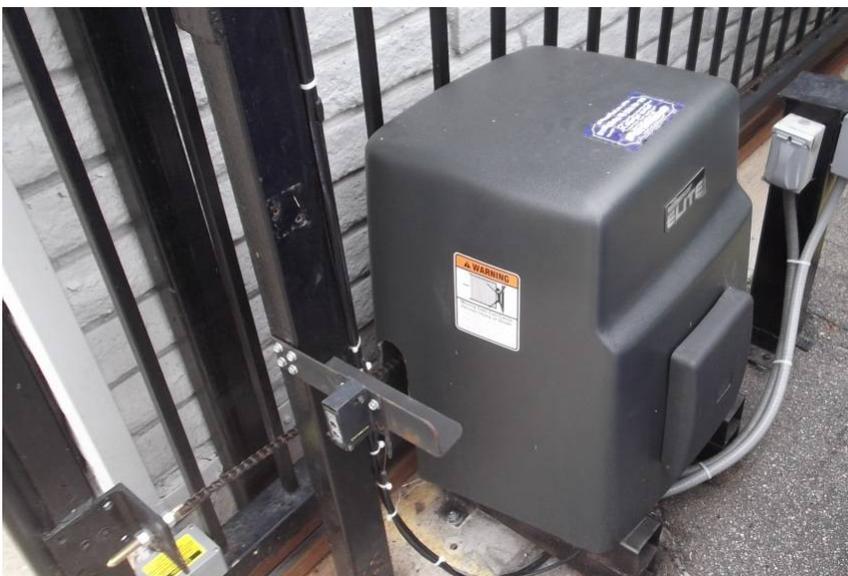
**Photograph No. 44**

Access to the parking area at the east side of the site is controlled by a motorized rolling gate (reference Photographs 44 and 45 in Appendix B). Approximately 18' wide and 6' in height, the gate is controlled by security keypad and was installed in 2012. The Chamberlain controller (model number SL3000UL3) has a ½ horsepower motor, with chain drive.

View of the secured parking area's entrance gate.

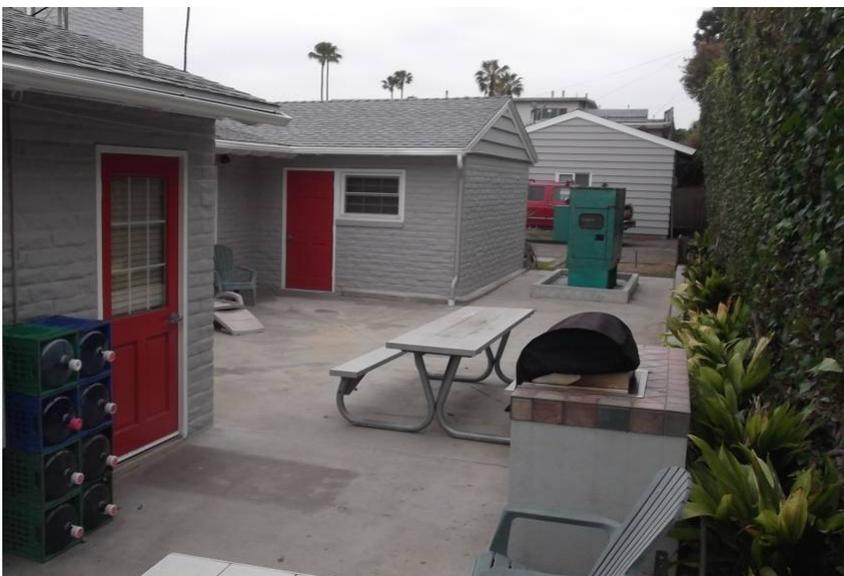
**Photograph No. 47**

The east, south and a portion of the west boundaries of the site are enclosed with fencing. Galvanized metal chain-link fencing, approximately 4' in height, is located along the east and south boundaries; wood privacy fencing, approximately 8' in height, is located along a portion of the southwest corner of the site, at the rear patio (reference Photographs 41, 42 and 47 in Appendix B).

View of the wood fencing at the southwest corner of the site.
