Citywide
Facility Condition Assessment

Report of
Facility Condition Assessment

For
City of Manhattan Beach
Polliwog Park
1601 Manhattan Beach Boulevard, Manhattan Beach, CA

*September 4, 2013
(Rev A)*

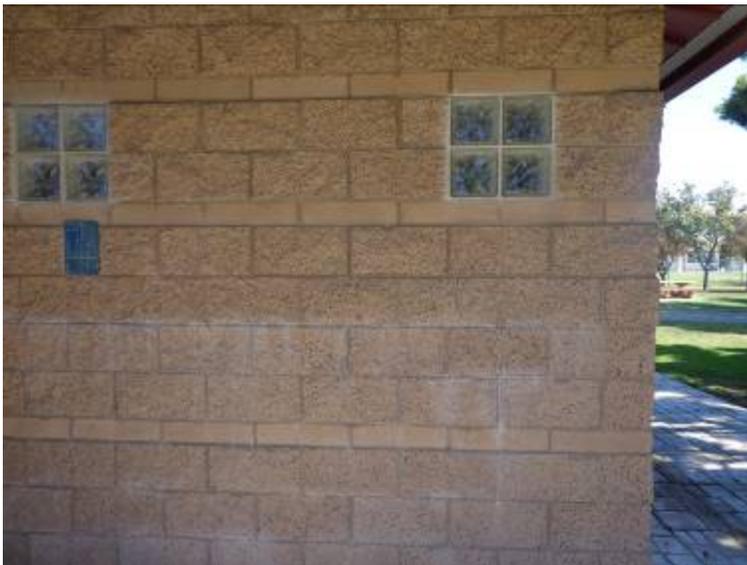
Photograph No. 7

The building is finished with decorative split-faced CMU exterior walls with aluminum trim and soffits (reference Photograph 7 in Appendix B).

The building contained metal vents at the gable ends to allow for natural ventilation of the restrooms (reference Photograph 7 in Appendix B).

View of the restroom exterior finishes

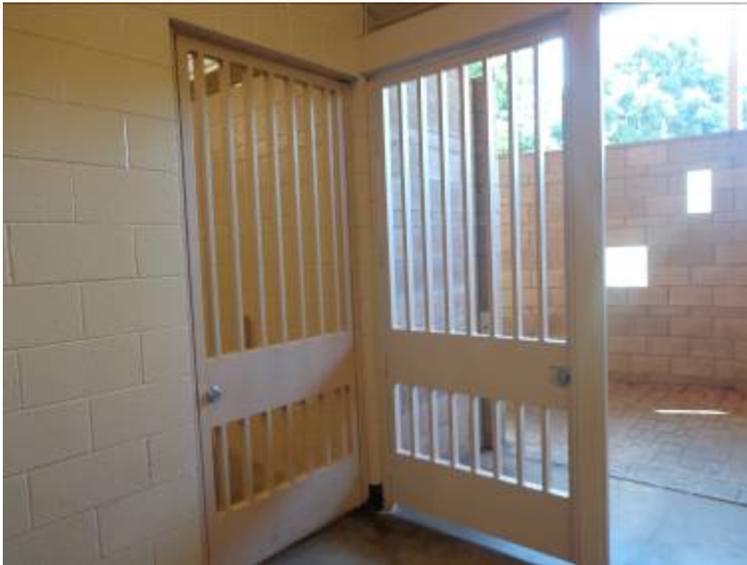
Photograph No. 10

View of the one of the doors at the restrooms.

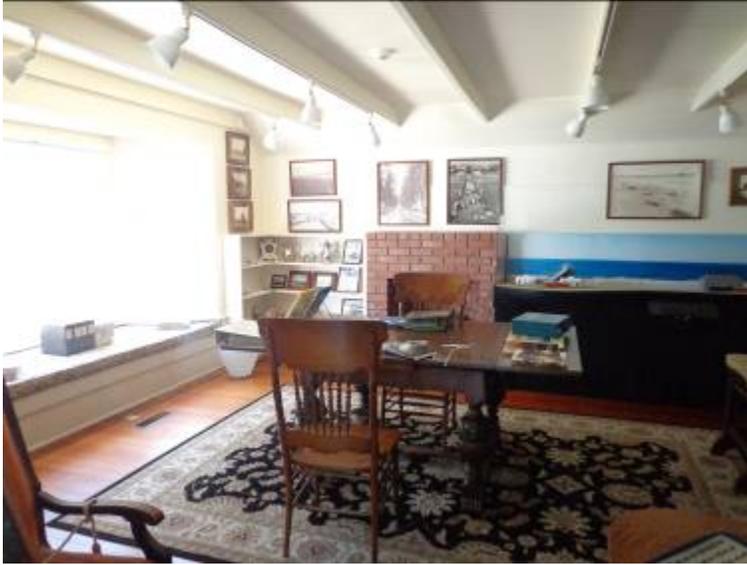
Photograph No. 15

Interior walls at the building generally contained the painted interior surface of the perimeter wood sheathing or painted wood panelboard (reference Photographs 15 and 16 in Appendix B).

The ceiling finishes throughout the building predominantly consisted painted wood boards (reference Photographs 15 and 16 in Appendix B).

View of the interior of the Historic House.

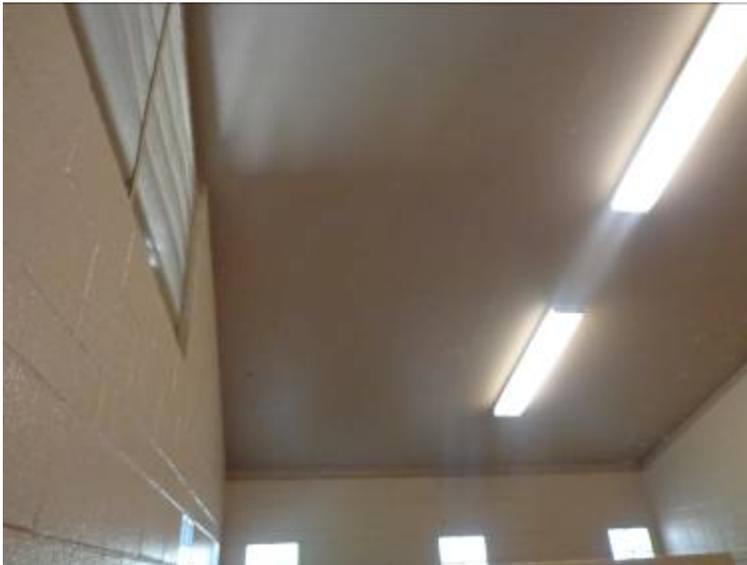
Photograph No. 16

Additional view of the interior of the Historic House.

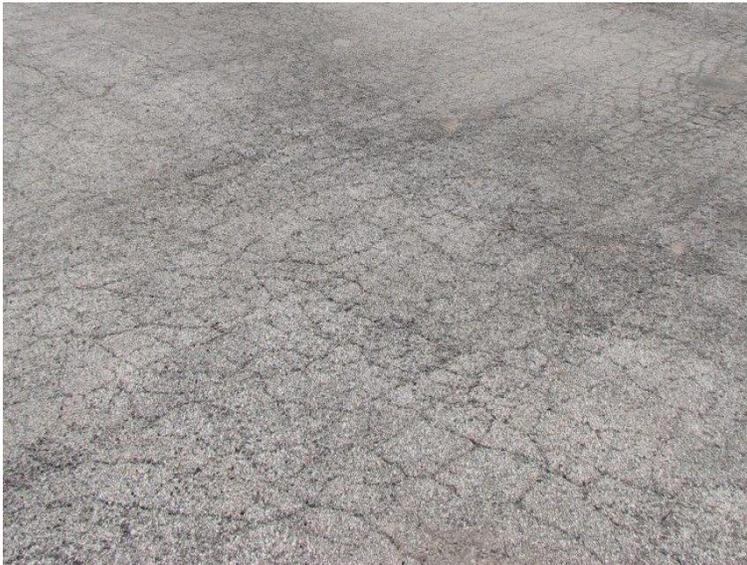
Photograph No. 37

View of the asphalt pavement at the interior drive.
