Citywide  
Facility Condition Assessment

Report of  
Facility Condition Assessment

For  
City of Manhattan Beach  
Pier Roundhouse and Comfort Station  
100 Manhattan Beach Boulevard, Manhattan Beach, CA

September 18, 2013  
(Rev B)

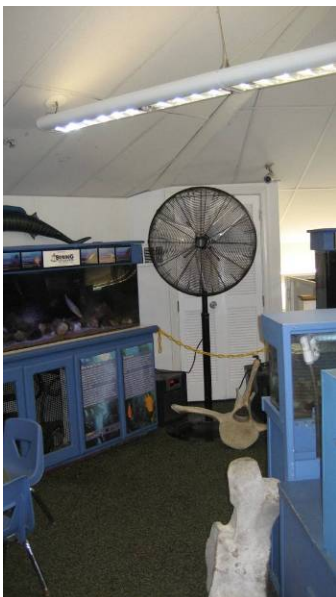
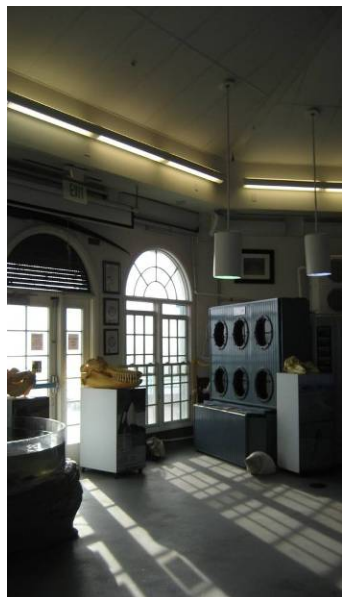
**Photograph Nos. 9A & 9B**

The building contains painted wood and plastic-laminate constructed fixed casework (reference Photographs 8, 9A and 9B in Appendix B). The cabinets and display cases are located in the central exhibit space and relate to the tenant's exhibit and teaching programs. The building also contains plastic-laminate-faced base cabinets with ceramic-tiled countertops in the restrooms.

Interior view of mezzanine office area (9A left) and of the main exhibit space (9B right).

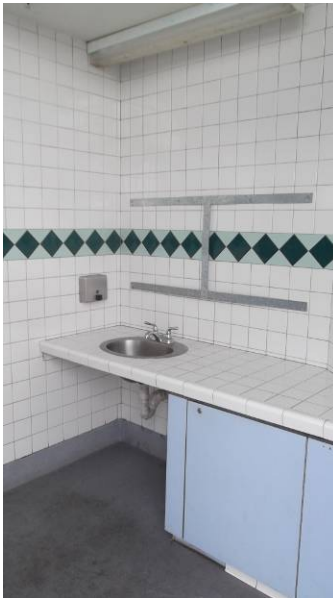
**Photograph No. 11**

The building contains two stainless steel lavatories recessed in ceramic tiled countertops (reference Photograph 11 in Appendix B). The lavatories have dual-handle type, non-metering faucets.

View of the men's restroom lavatory.

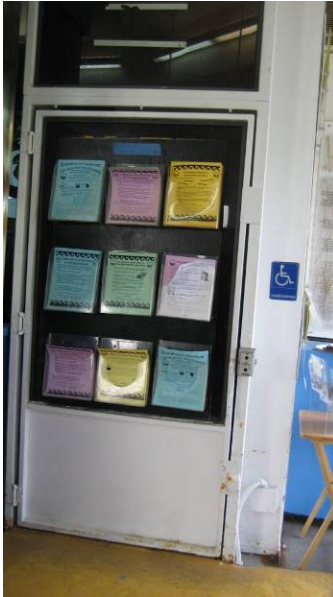
**Photograph No. 13**

A wheelchair lift is provided for access at the mezzanine level, located near the south entrance to the central exhibit space (reference Photograph 13 in Appendix B). A data tag was not visible on the equipment and information regarding capacity and date of installation was not available for reference.

View of the inoperable wheelchair lift in the central exhibit space.

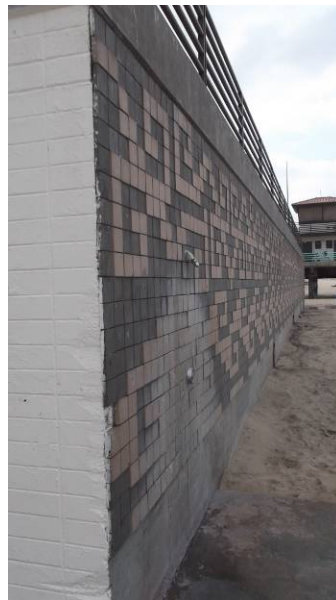
**Photograph No. 47**

There are concrete retaining walls located along the north, south and west sides of the Pier Comfort Station and to the north and south sides of the pier entrance along The Strand (reference Photographs 46 through 48 in Appendix B). The surfaces of the walls are covered with patterns of decorative tile, are typically 8' to 10' in height and are topped by painted or anodized metal railings.

View of retaining wall, with shower stations, at the west side of the Pier Comfort Station.
