Citywide
Facility Condition Assessment

Report of
Facility Condition Assessment

For
City of Manhattan Beach
Pier Roundhouse and Comfort Station
100 Manhattan Beach Boulevard, Manhattan Beach, CA

*September 18, 2013
(Rev B)*

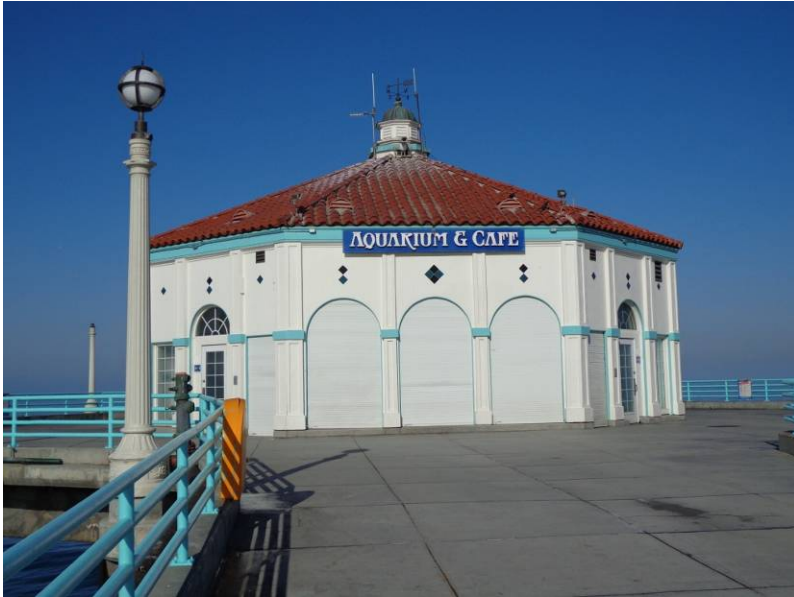
Photograph No. 1

The building has exterior walls of painted cementitious stucco over plywood or solid wood sheathing, with painted wood trim and inset ceramic tile (reference Photographs 1 to 3 in Appendix B). The drawings indicate 7/8" of Portland cement plaster on paper-backed lath secured to the wood-framed walls, with R-11 batt insulation placed within the exterior walls.

The building's 5" in 12" sloped roof contains barrel-shaped mortared clay tiles placed over a roofing membrane, with clay tile ridge caps, metal flashing and drip edge and a pre-fabricated fiberglass cupola with a copper-clad dome, copper flashing and decorative weather vane (reference Photographs 1, 4 and 5 in Appendix B). Half-round fiberglass attic vent dormers are located on each roofing section. We understand that the roofing and cupola were installed in 1992.

View of the east facade facing the pier.

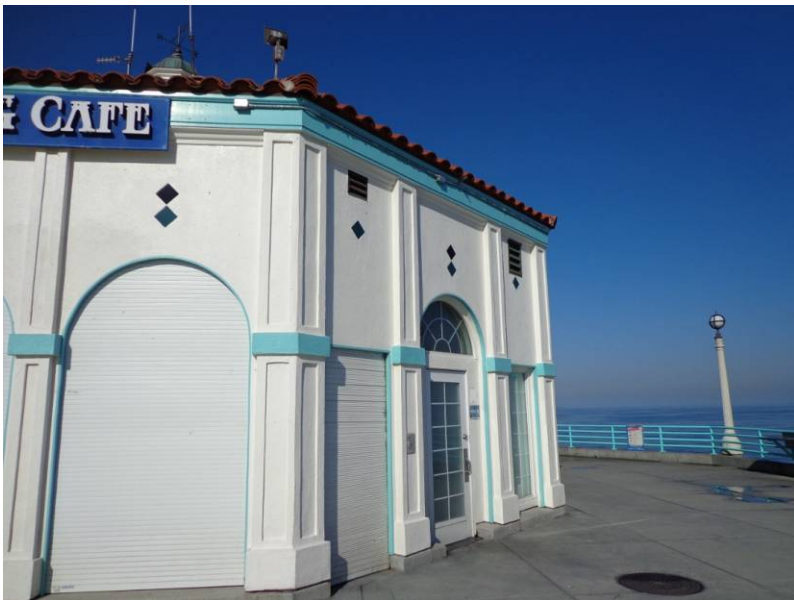
Photograph No. 2

The building's primary doors are wood-framed units with double-pane glazing, painted wood trim and aluminum thresholds (reference Photographs 2 and 3 in Appendix B). The doors are placed in pairs on the north and south facades and as single units on the east façade, with exterior pull, interior panic-type push bar, overhead closer and hinge hardware. Pull-down aluminum storm protection grilles are provided over the doors on each façade.

View of the north façade.

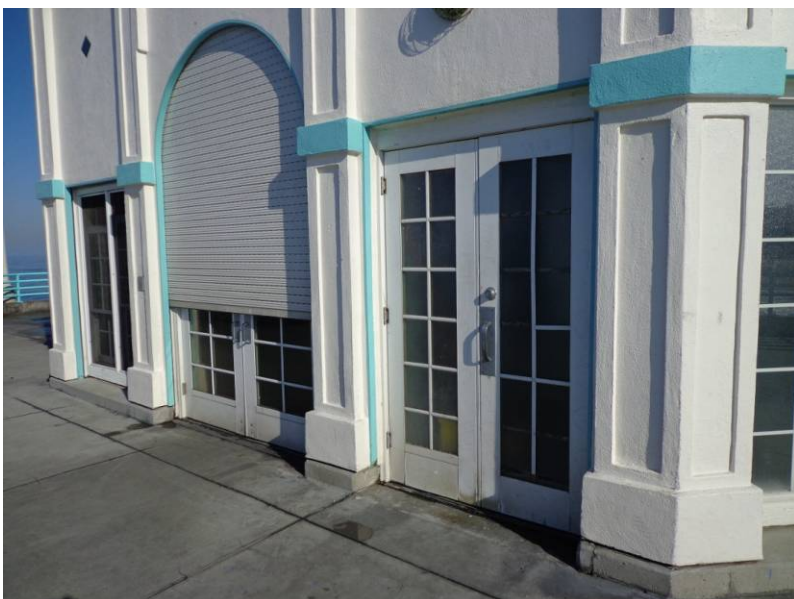
Photograph No. 3

View of the south façade.

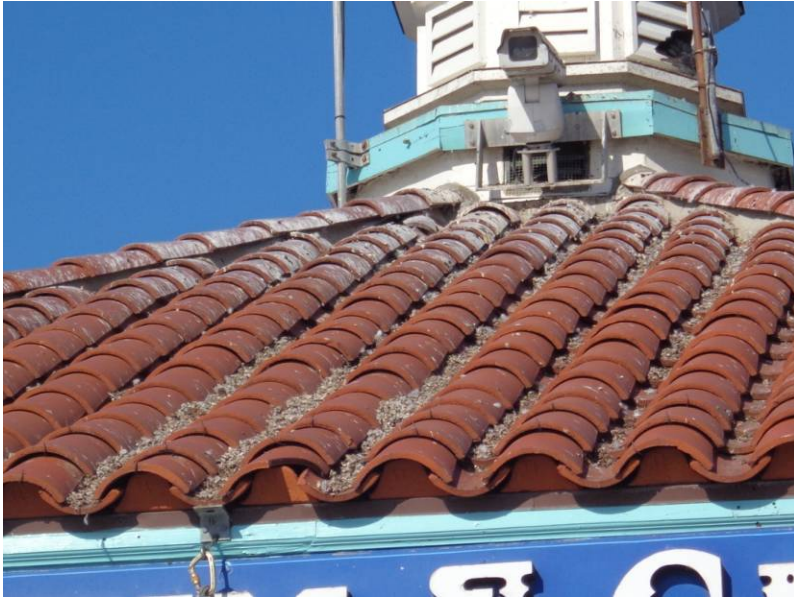
Photograph No. 4

View of the clay roofing.

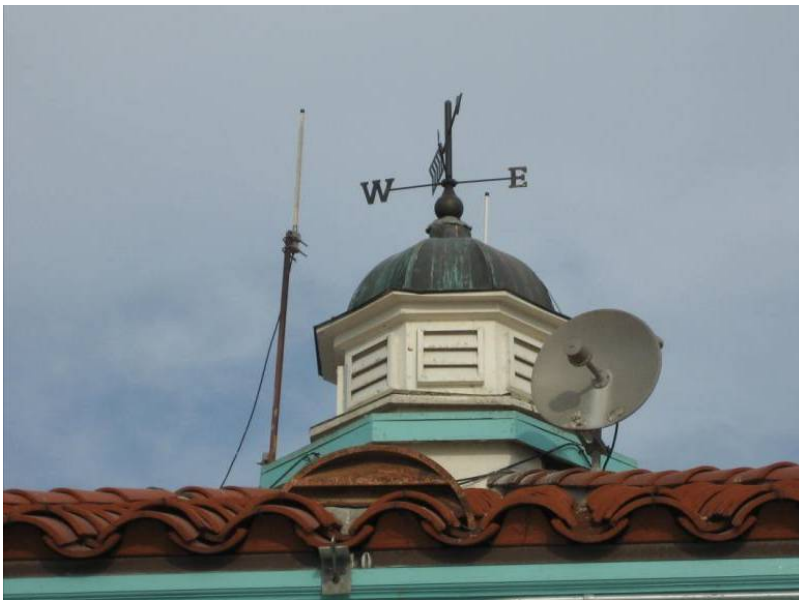
Photograph No. 5

View of the building's cupola.

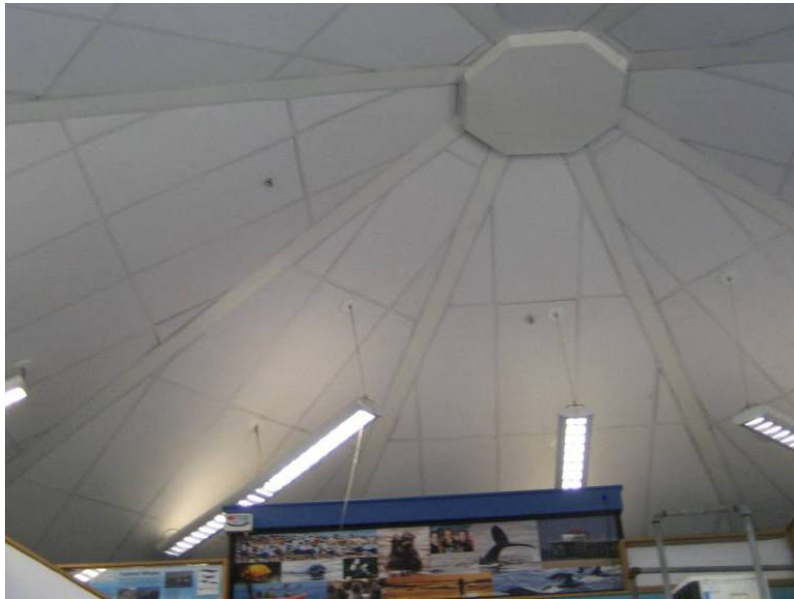
Photograph No. 7

The ceiling finishes throughout the building are predominantly suspended acoustical tile, with painted gypsum board soffits and bulkheads (reference Photograph 7 in Appendix B).

The building contains a wet-pipe fire sprinkler system, with ceiling pendant heads, supplied from a riser at the south side of the building (reference Photographs 7 & 15A in Appendix B). System water supply is provided by municipal main pressure through a 6" steel line under the pier, without the use of a fire pump, and water flow is monitored by a local alarm system.

Interior view of the central exhibit space's ceiling.

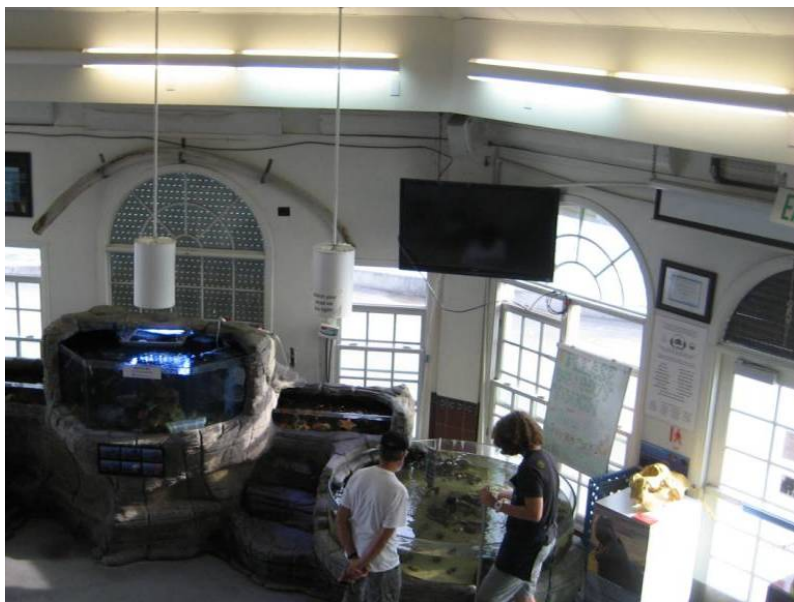
Photograph No. 8

The interior walls typically have painted finishes, with ceramic tile in the restrooms (reference Photographs 8 through 11 in Appendix B).

The building contains aquarium equipment related to the primary tenant's exhibit and teaching programs, including live fish tanks and audio-visual equipment (reference Photographs 8 and 9B in Appendix B). The building also contains limited tenant commercial kitchen equipment for the small walk-up food service at the east side of the building.

Interior view of the central exhibit space.

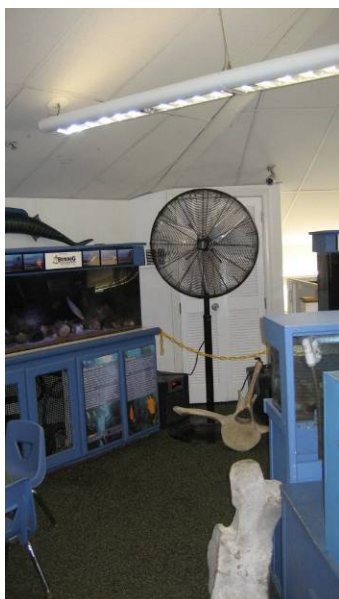
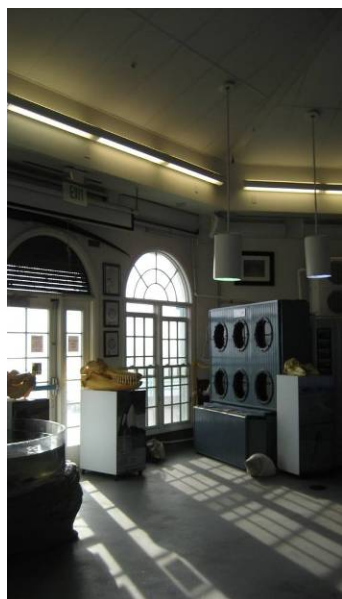
Photograph Nos. 9A & 9B

The building contains painted wood and plastic-laminate constructed fixed casework (reference Photographs 8, 9A and 9B in Appendix B). The cabinets and display cases are located in the central exhibit space and relate to the tenant's exhibit and teaching programs. The building also contains plastic-laminate-faced base cabinets with ceramic-tiled countertops in the restrooms.

Interior view of mezzanine office area (9A left) and of the main exhibit space (9B right).

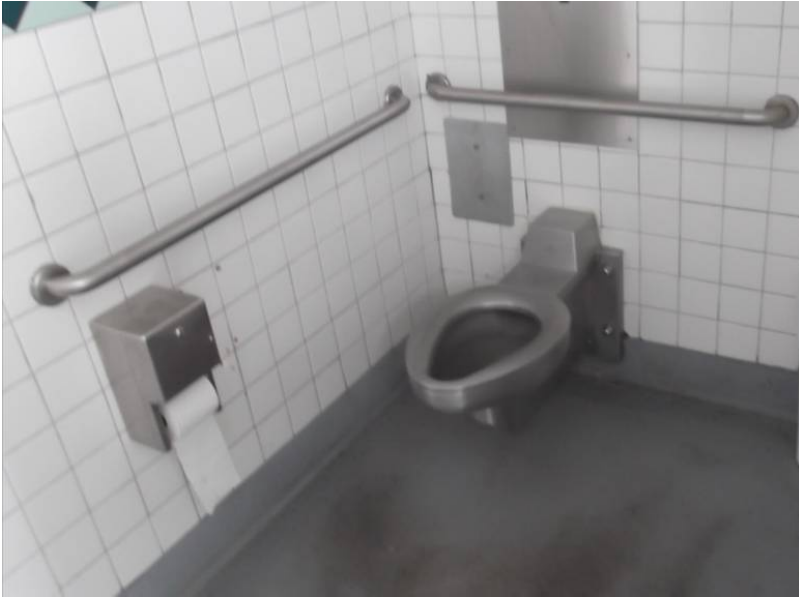
Photograph No. 10

The building contains two wall-mounted stainless steel tank-less water closets with automatic flush controls (reference Photograph 10 in Appendix B).

View of the men's restroom water closet stall.

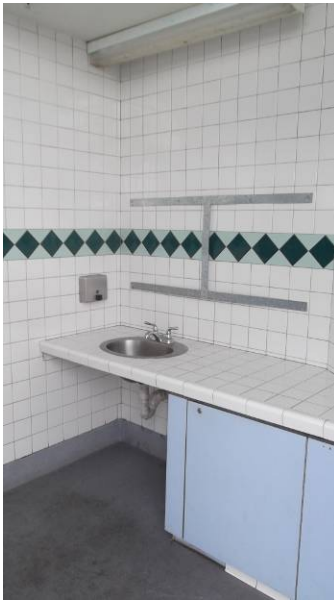
Photograph No. 11

The building contains two stainless steel lavatories recessed in ceramic tiled countertops (reference Photograph 11 in Appendix B). The lavatories have dual-handle type, non-metering faucets.

View of the men's restroom lavatory.

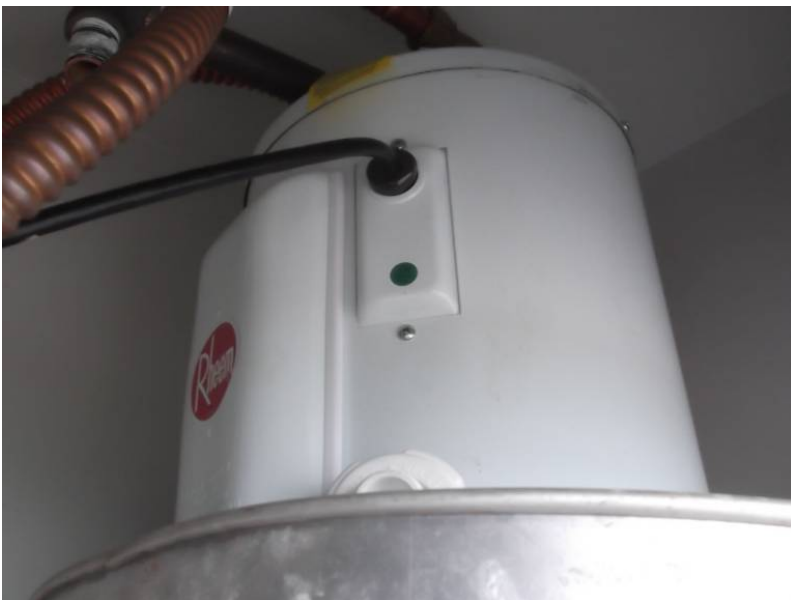
Photograph No. 12

Domestic hot water is provided in the restaurant's kitchen area and restrooms. The hot water is generated via an electric water heater located in a small room at the south side of the building (reference Photograph 12 in Appendix B).

View of the domestic water heater.

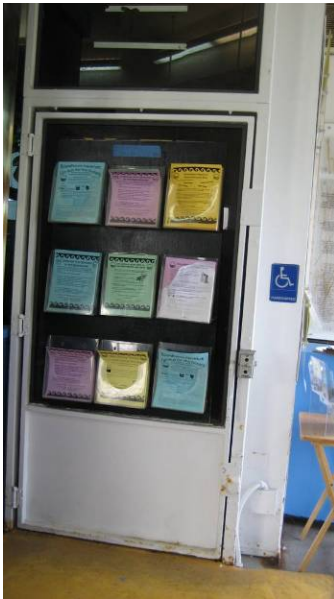
Photograph No. 13

A wheelchair lift is provided for access at the mezzanine level, located near the south entrance to the central exhibit space (reference Photograph 13 in Appendix B). A data tag was not visible on the equipment and information regarding capacity and date of installation was not available for reference.

View of the inoperable wheelchair lift in the central exhibit space.

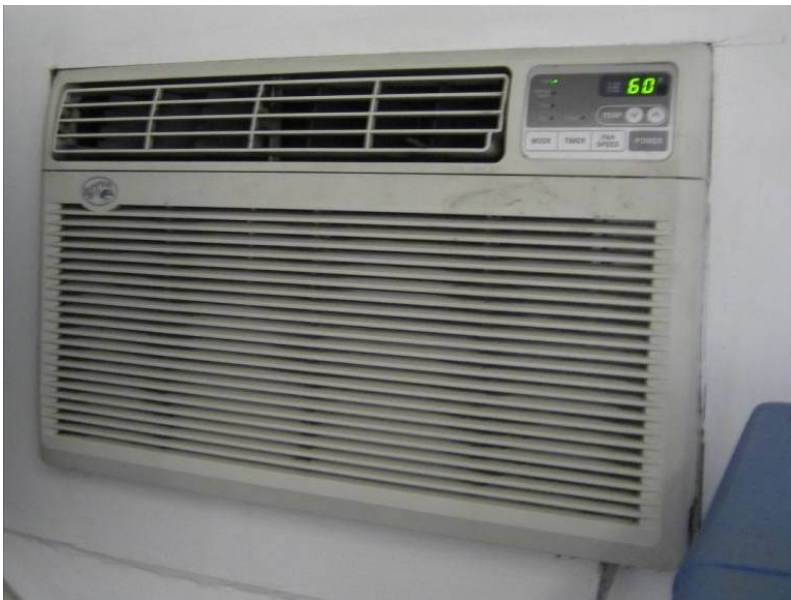
Photograph No. 14

View of the supplemental air conditioner.

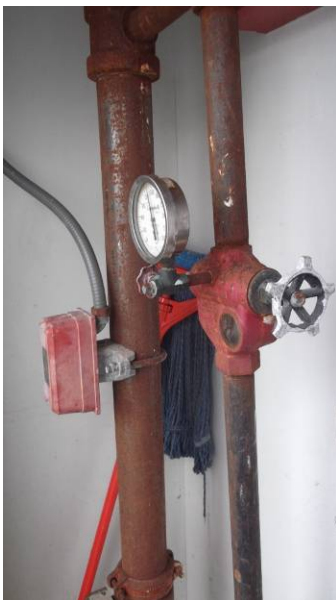
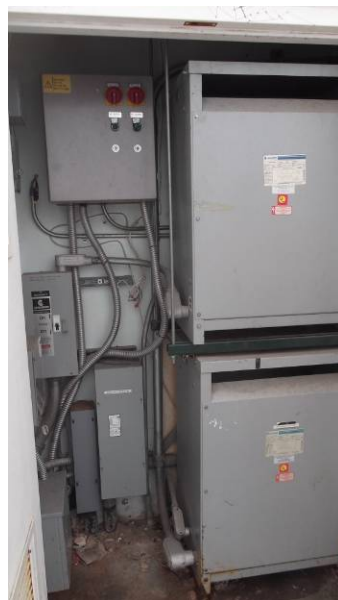
Photograph Nos. 15A & 15B

View of fire sprinkler system riser (15A left) and the electrical room equipment (15B right).

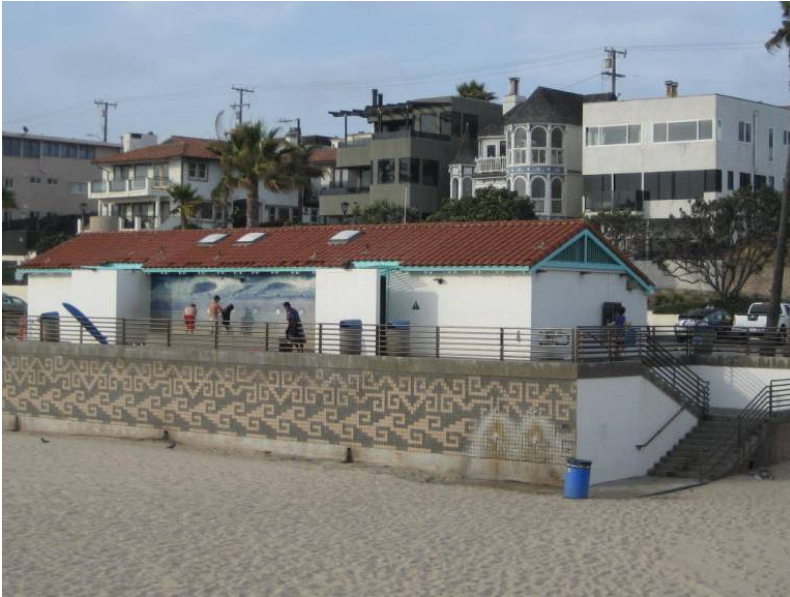
Photograph No. 16

Variable-width concrete and concrete paver walkways are located along the public road The Strand at the east end of the pier and around the Pier Comfort Station (reference Photographs 16 through 19 in Appendix B). Also bordering the east edge of the site is a concrete-paved bicycle lane along The Strand. We were not provided with construction specifications or original installation details for the paving; therefore specific concrete mix, design strength, or its suitability for its existing use is not known.

View of the west façade of the Pier Comfort Station, from the pier.

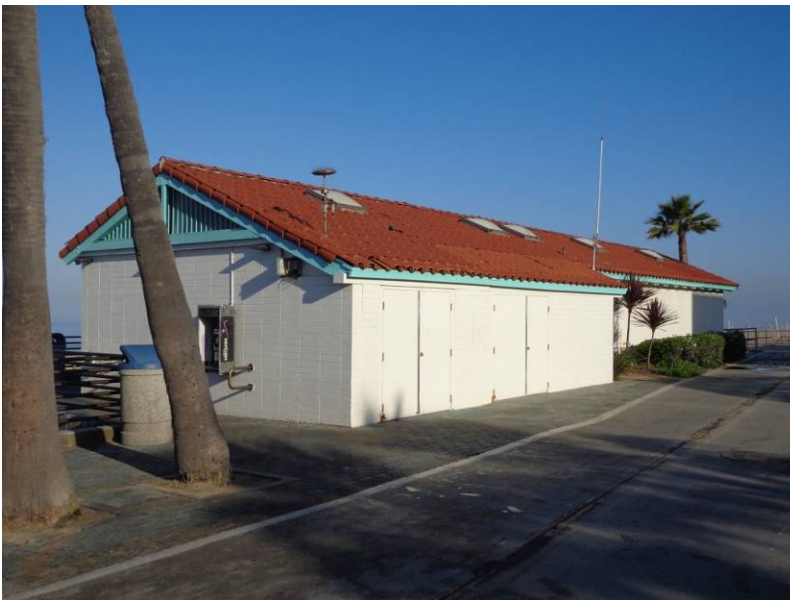
Photograph No. 17

The site furnishings include precast-concrete benches, precast concrete and plastic waste receptacles, flagpoles, beach viewing telescopes, and at the Pier Roundhouse, exterior stainless steel sinks for fish cleaning (reference Photographs 17, 31 and 40 in Appendix B).

Landscaping is limited to locations around the Pier Comfort Station and at the east side of the site along The Strand and consists of small shrubs and small and large palm trees (reference Photographs 17 and 18 in Appendix B).

View of the south and east facades.

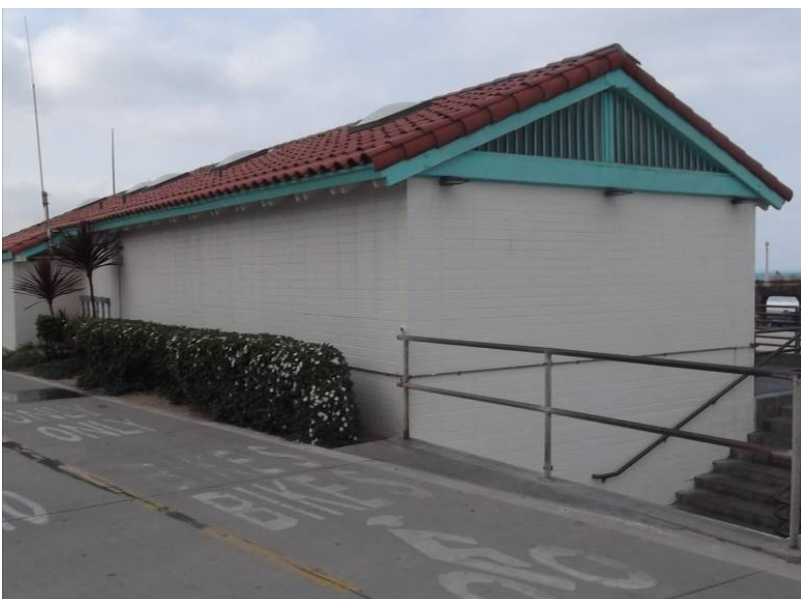
Photograph Nos. 18

View of the north and east facades.

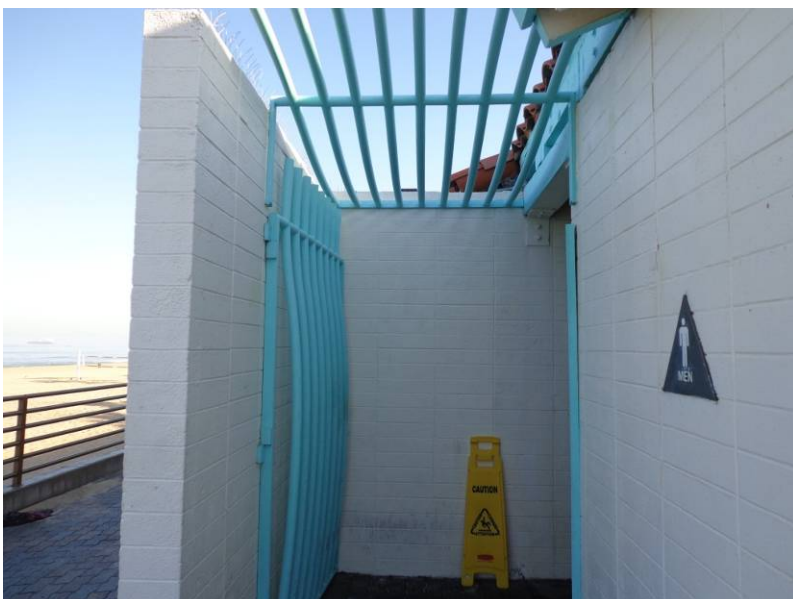
Photograph No. 24

View of one of the restroom entrance gates at the west side of the building.

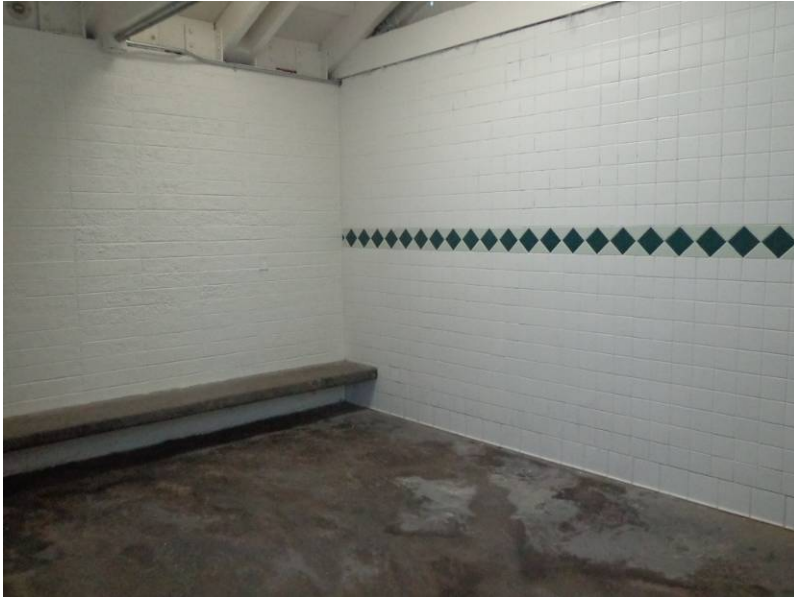
Photograph No. 25

The interior walls have painted finishes at exposed concrete masonry locations and also ceramic wall tile at plumbing fixture walls (reference Photographs 23 and 25 through 27 in Appendix B).

The floors in the building are exposed concrete with a clear seal coating (reference Photographs 25 through 27 in Appendix B).

Interior view of the men's restroom dressing area.

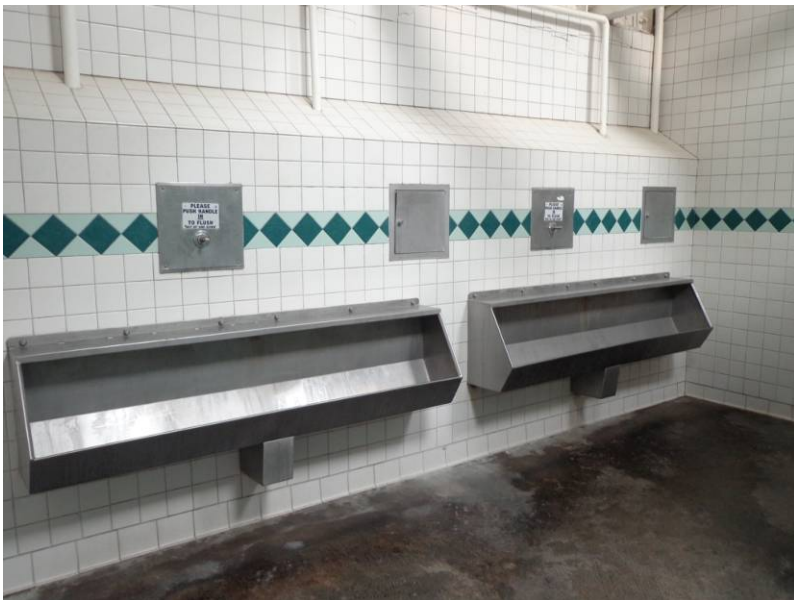
Photograph No. 26

The men's restroom contains two stainless steel trough-type wall-hung urinals with manual flush controls (reference Photograph 26 in Appendix B).

Interior view of the men's restroom urinals.

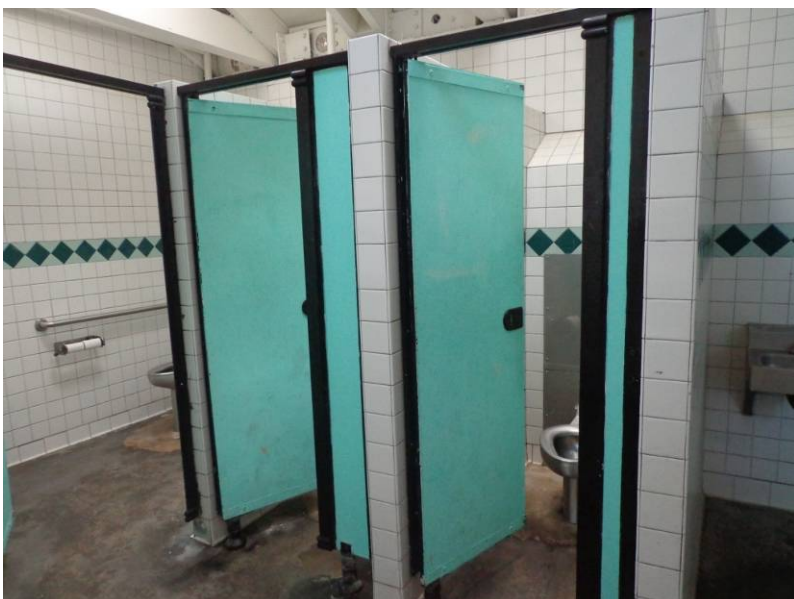
Photograph No. 27

The building contains nine wall-mounted stainless steel tankless water closets with automatic flush controls (reference Photograph 27 in Appendix B).

The building contains six wall-mounted stainless steel lavatories (reference Photograph 27 in Appendix B). The lavatories have single-handle, push-type, metering faucets. Water is supplied via copper pipe work and assumed to be drained through cast iron pipe work and fittings.

Interior view of the men's restroom water closet stall.

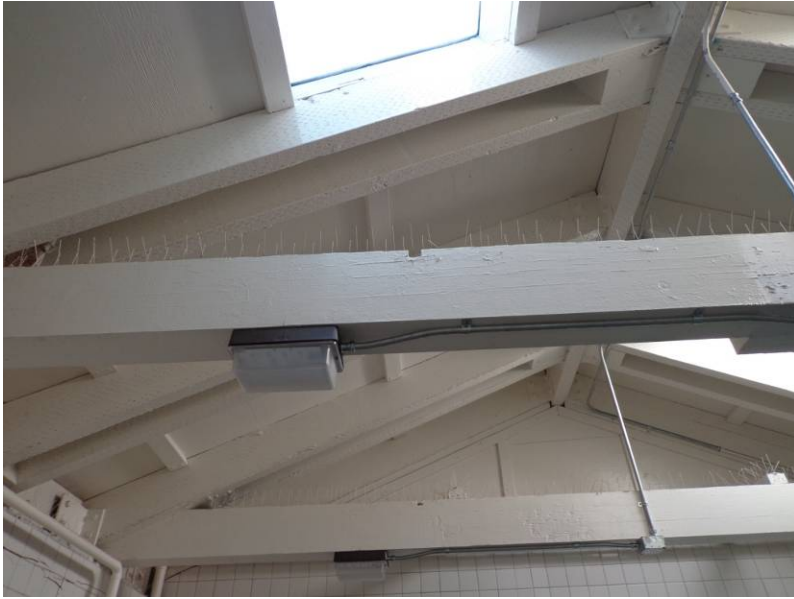
Photograph No. 28

The building does not have ceiling systems, with the painted roof structural systems exposed (reference Photograph 28 in Appendix B).

The interior lighting within the building is provided by roof-structure-mounted LED fixtures (reference Photograph 28 in Appendix B). The lighting is typically photo-cell controlled, with skylights typically providing natural light when the building is in use.

Interior view of the exposed roof framing and skylight in the men's restroom.

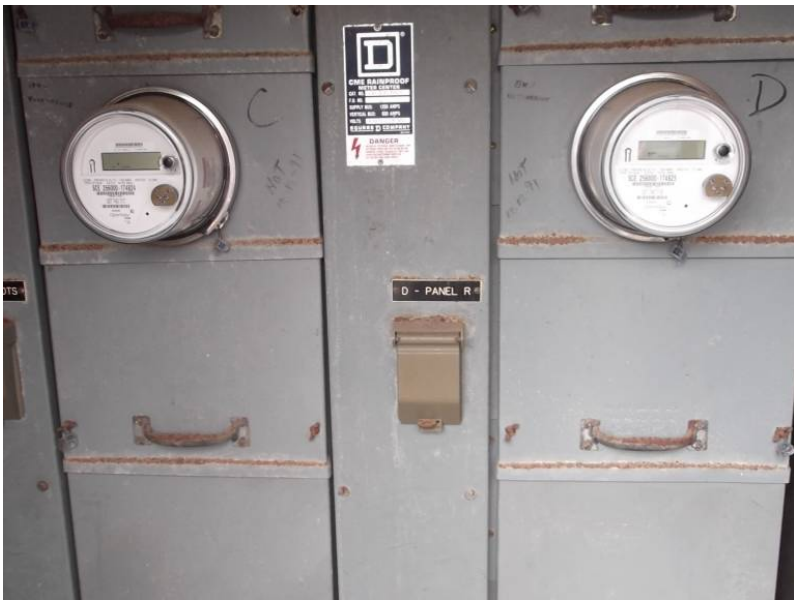
Photograph No. 29

View of the building's electrical main distribution panels and meters.

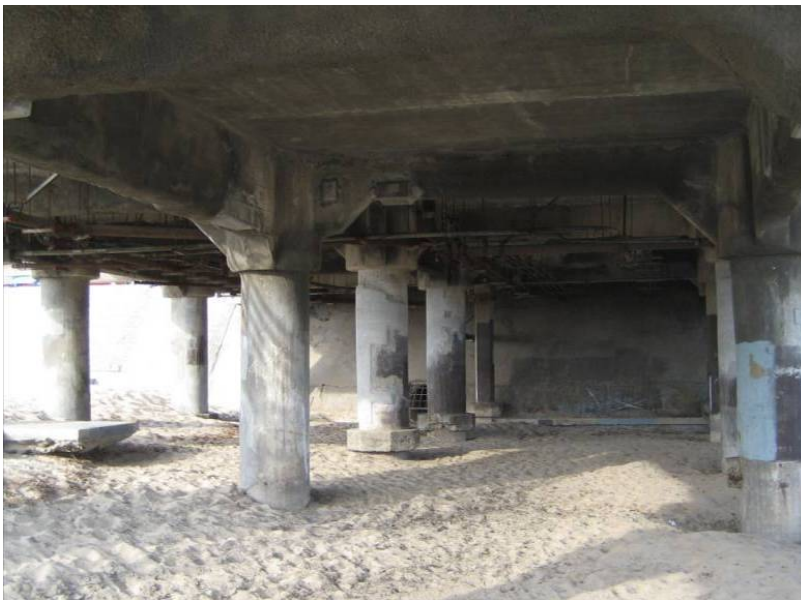
Photograph No. 35

View under the pier, looking east toward its connection with The Strand and Manhattan Beach Boulevard.

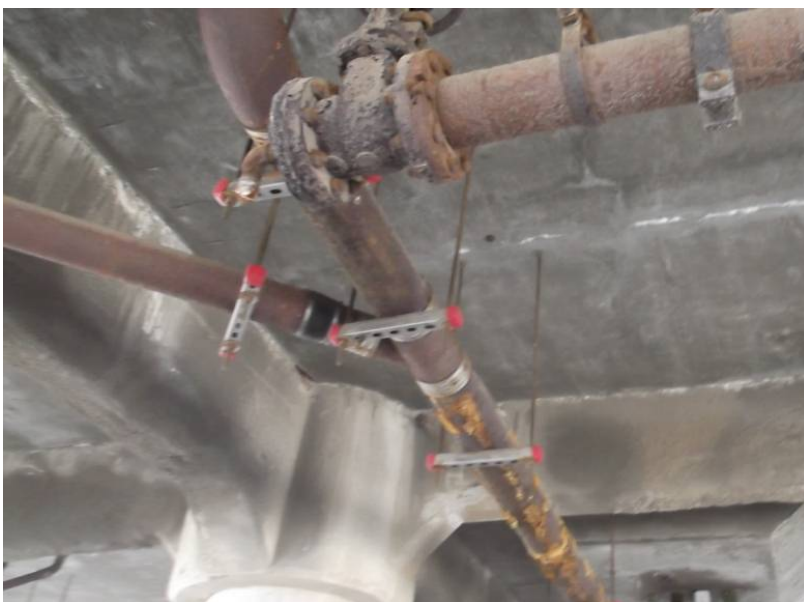
Photograph No. 39

Overhead view of suspended utility line under the pier deck.

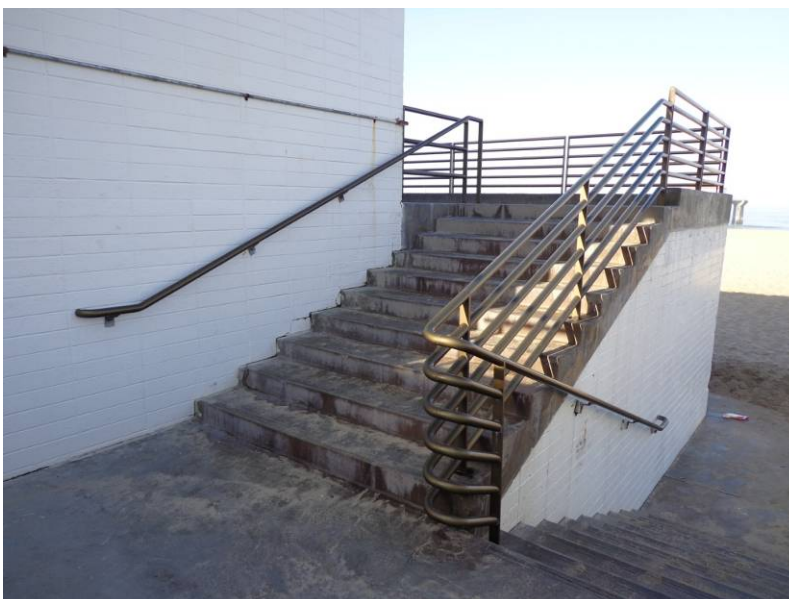
Photograph No. 42

Reinforced concrete stairs with anodized metal railings, providing access from the Pier Comfort Station to the municipal beach, are located at the north and south ends of the comfort station. Wood-framed stairs with painted metal railings are located near the east end of the pier near the lifeguard station, providing access from the pier to the beach (reference Photographs 42 and 45 in Appendix B).

View of the concrete stairs and anodized metal railings at the north end of the Pier Comfort Station.

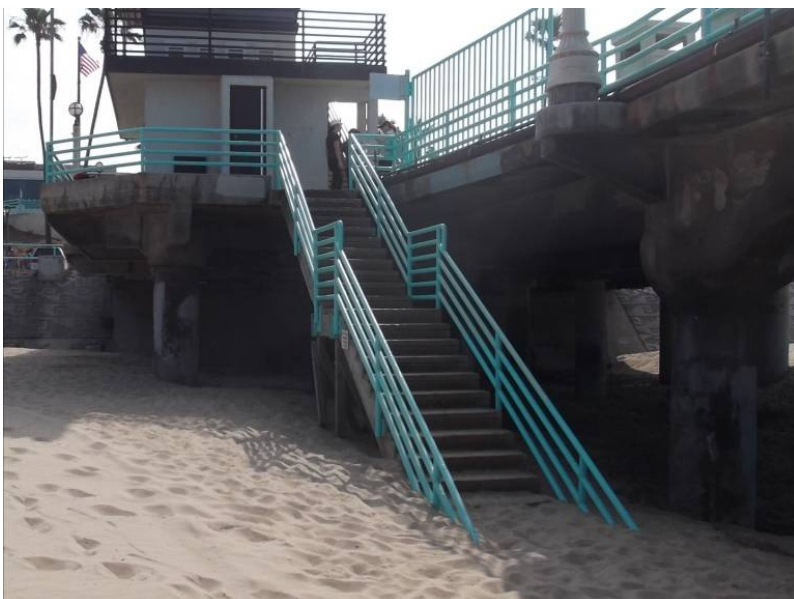
Photograph No. 45

The east end of the pier contains gates at the lifeguard station (reference Photographs 40 and 45 in Appendix B). The gates are made of painted steel railings to match the pier's railings and are utilized to restrict access to the pier. Anodized metal railings topping retaining walls are provided along the walkway along The Strand to the north and south of the pier, and precast concrete bollards are placed at pier entrance to prevent vehicular access.

View of one of the wood framed stairs at the east end of the pier.

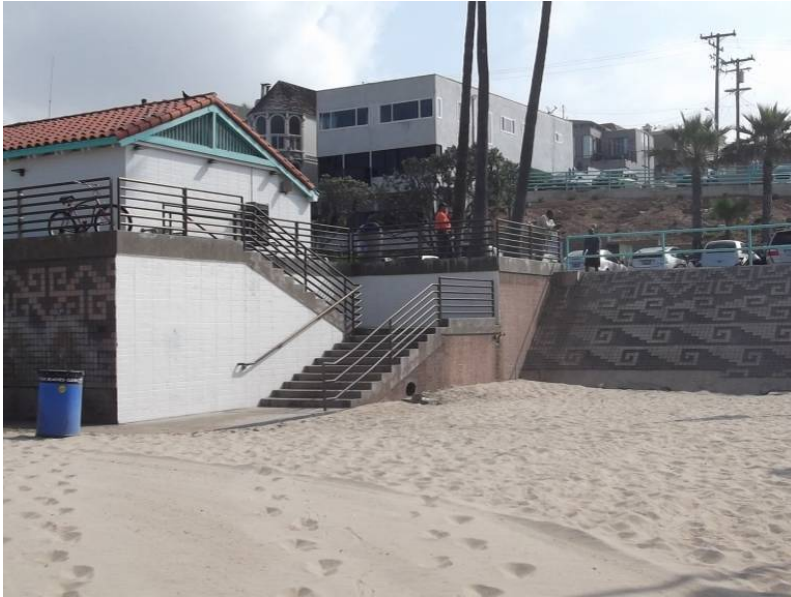
Photograph No. 46

There are concrete retaining walls located along the north, south and west sides of the Pier Comfort Station and to the north and south sides of the pier entrance along The Strand (reference Photographs 46 through 48 in Appendix B). The surfaces of the walls are covered with patterns of decorative tile, are typically 8' to 10' in height and are topped by painted or anodized metal railings.

View of concrete retaining walls at the Pier Comfort Station and along The Strand.

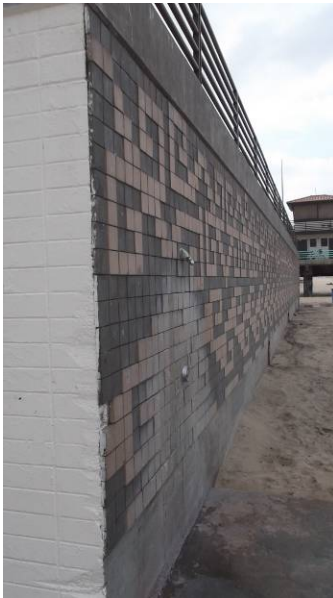
Photograph No. 47

View of retaining wall, with shower stations, at the west side of the Pier Comfort Station.

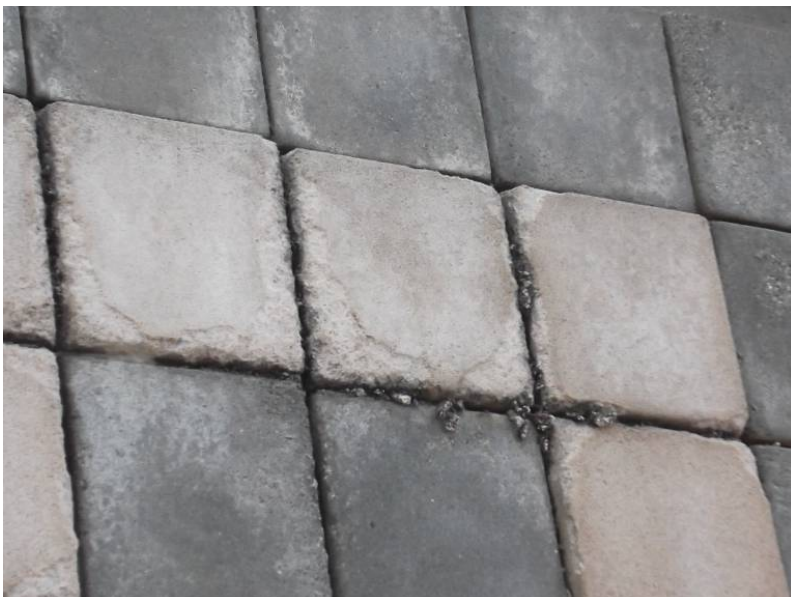
Photograph No. 48

Detail view of the decorative tiles applied to the retaining walls at the east side of the site.
