Citywide  
Facility Condition Assessment

Report of  
Facility Condition Assessment

For  
Premier Baseball Field  
18<sup>th</sup> Street and North Herrin Avenue, Manhattan Beach, CA

*August 23, 2013  
(Rev A)*

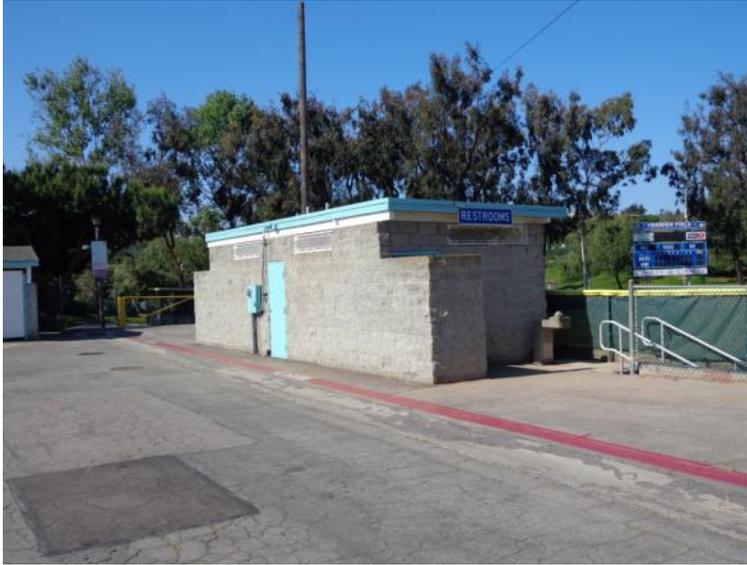
**Photograph No. 1**

The building is enclosed with split-faced concrete masonry units and wood trim (reference Photographs 1 and 5 in Appendix B). The wood trim contained a painted finish. There are CMU privacy walls at each end of the building at the restroom entrances (reference Photograph 1 in Appendix B).

The buildings contained single and double hollow metal doors and frames at the mechanical room entrances and the entrance to the storage building (reference Photographs 1, 2 and 5 in Appendix B). Door hardware consisted of push / pull or knob handles.

View of the front elevation of the building.

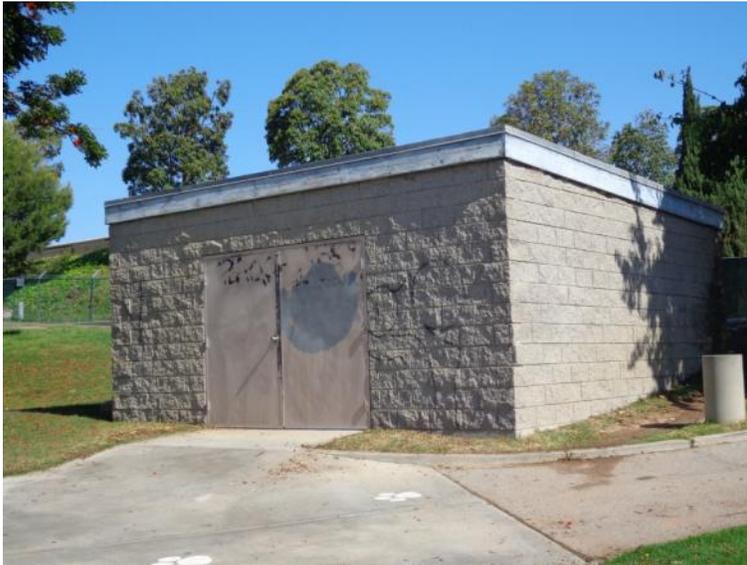
**Photograph No. 2**

The building is enclosed with split-faced concrete masonry units and wood trim (reference Photograph 2 in Appendix B). The wood trim contained a painted finish.

View of the side elevation.

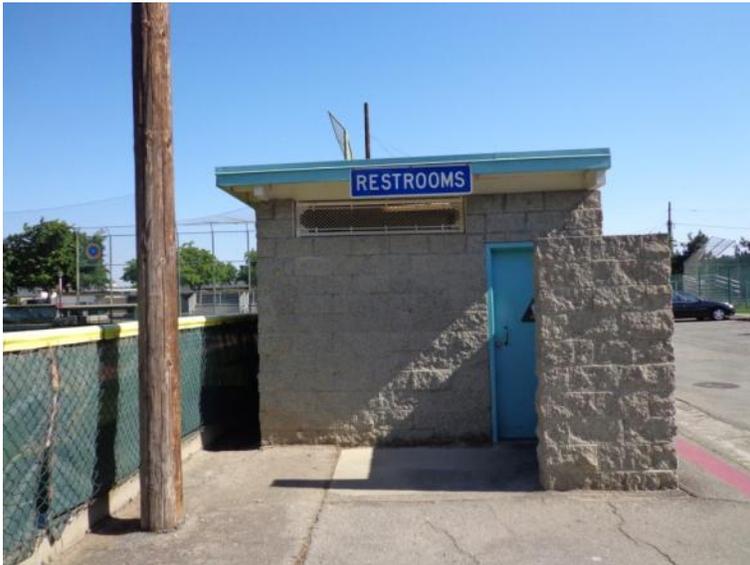
**Photograph No. 5**

View of the exterior finishes of the restrooms.

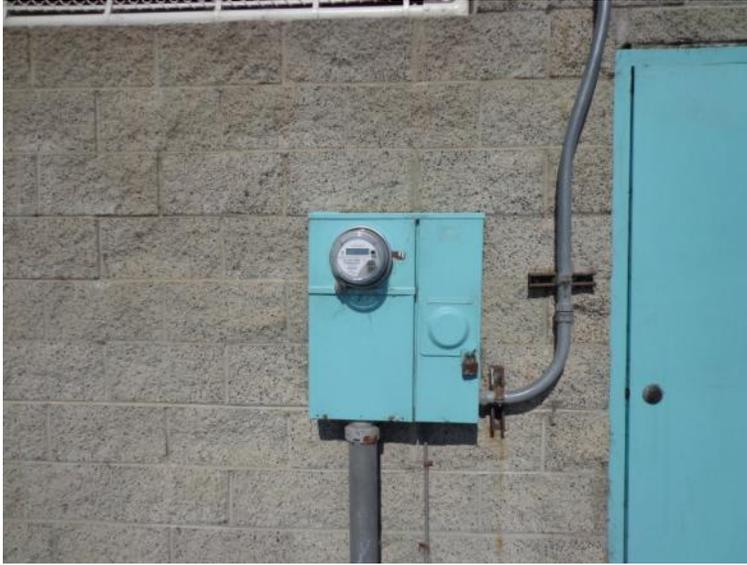
**Photograph No. 13**

The restroom building is serviced by a 60-amp, 120/240-Volt, single-phase, 3-wire metered panel which is located in the central plumbing chase with the meter located along the rear exterior elevation (reference Photograph 13 in Appendix B).

View of the typical interior finishes.

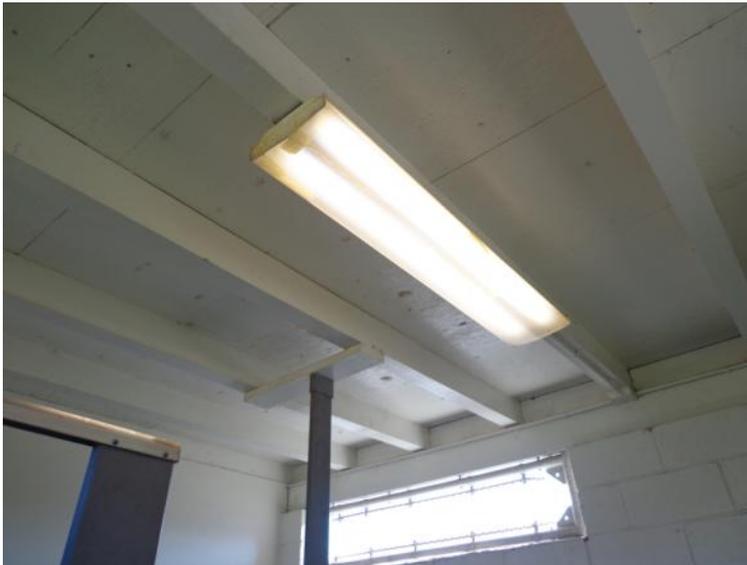
**Photograph No. 14**

The interior lighting within the building is provided by surface mounted 4' fluorescent fixtures (reference Photograph 14 in Appendix B). The florescent fixtures all contained T8 lamps and electronic ballasts. All of the in-room lighting is controlled via local switching in the respective rooms.

View of the typical interior lighting at the restrooms.

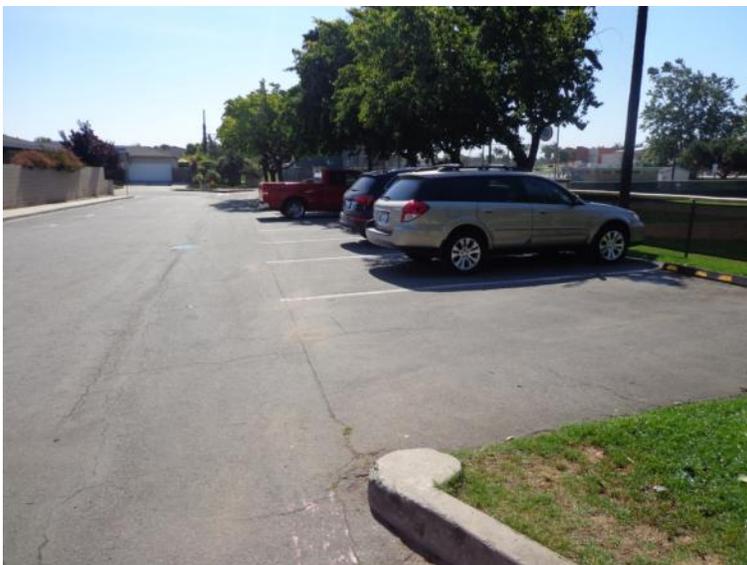
**Photograph No. 15**

The main facility parking lot is located at the northern end of the site and can be accessed from North Herrin Avenue to the east (reference Photographs 15 in Appendix B). The parking lot and paving around the site has an asphalt surface with white line striping denoting areas of parking stalls. We were not provided with the original specification details of the paving and therefore cannot comment on the specific asphalt mix type, classification or its suitability for its existing use. Table G20-1 provides a summary of the site systems.

View of the parking area.

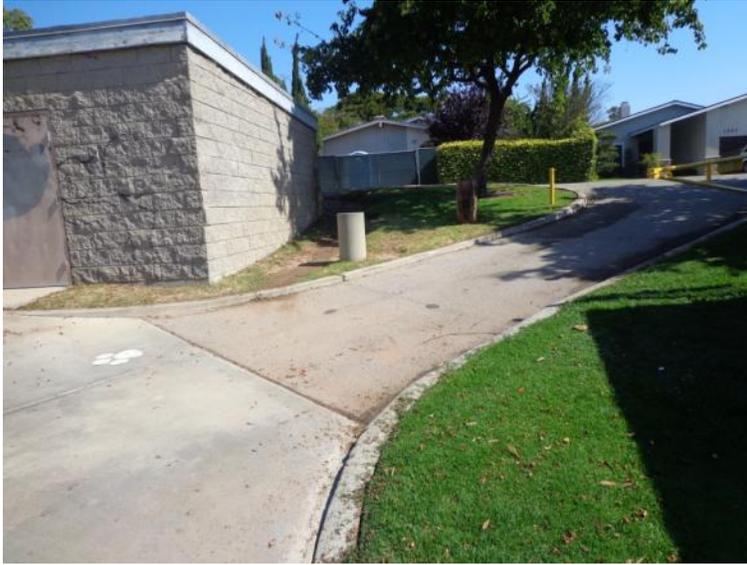
Photograph No. 16

The rear drive aisle leading to the Storage Building is comprised of concrete pavement (reference Photograph 16 in Appendix B). We were not provided with the original specification details of the paving and therefore cannot comment on the specific concrete mix type, classification or its suitability for its existing use.

View of the concrete pavement.

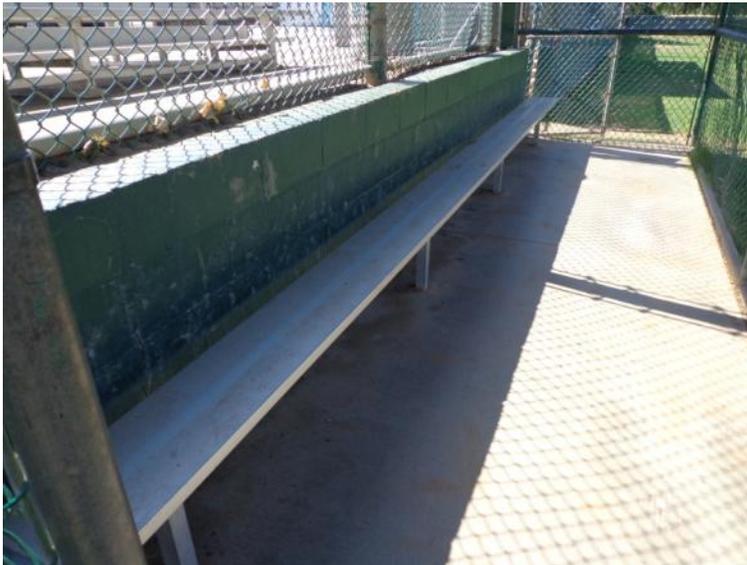
Photograph No. 17

The site contained cast-in-place concrete walkways throughout including at the perimeter of the restroom building and along the baseball field sidelines (reference Photograph 17 in Appendix B).

There are metal benches at each dugout area and metal bleachers are located behind the dugouts (reference Photographs 17 and 22 in Appendix B).

View of a concrete walkway and dugout bench.

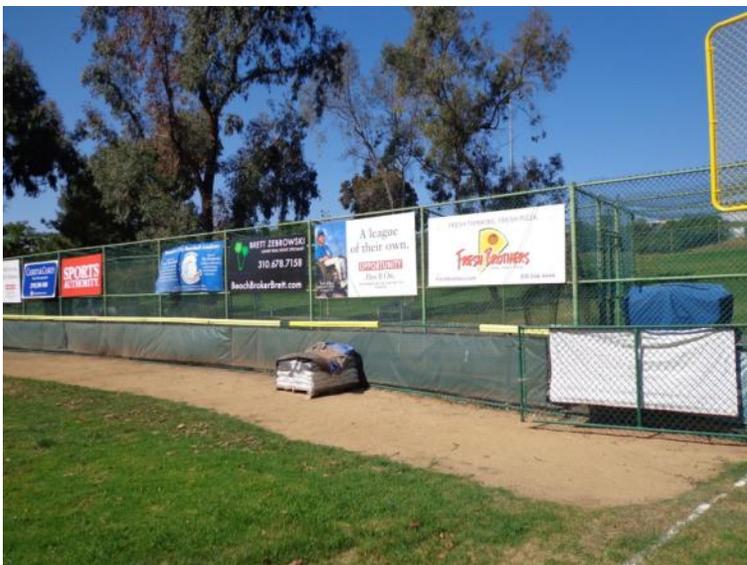
Photograph No. 18

The baseball field was surrounded by 12' in height chain link fence at the north east and west perimeter with 10' high chain link fencing at the southern end of the field (reference Photograph 18 in Appendix B). The perimeter of the restroom area was enclosed by 4' to 10' high chain link fencing. There is a batting cage at the right field area that is constructed of 10' high chain link fencing and the backstop is comprised of chain link fence approximately 25' high (reference Photograph 19 in Appendix B).

View of the chain link fencing.

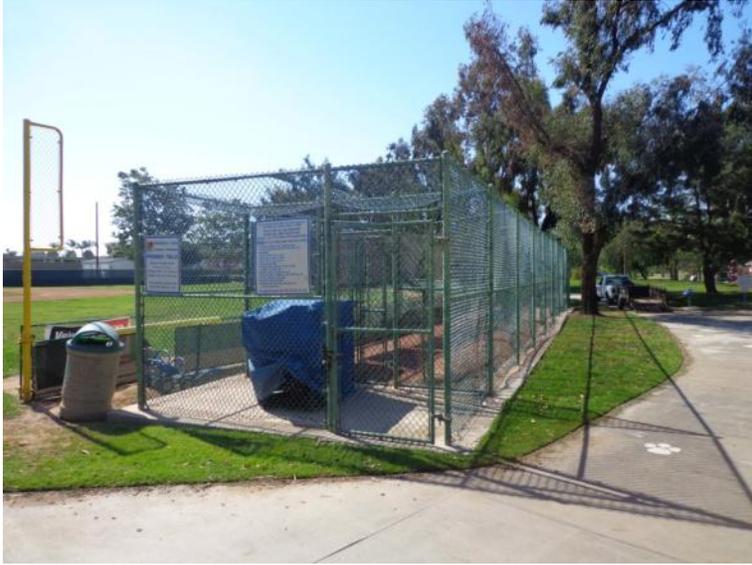
Photograph No. 19  
View of the batting cage.

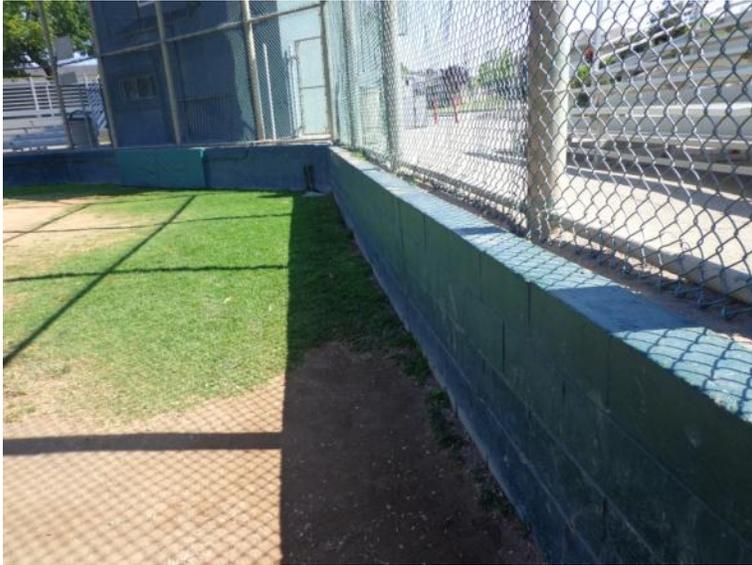
The wall is 33" in height concrete masonry unit along the right and left field perimeters (reference Photographs 20 in Appendix B). The walls have a painted finish.

Photograph No. 20  
View of the CMU wall.

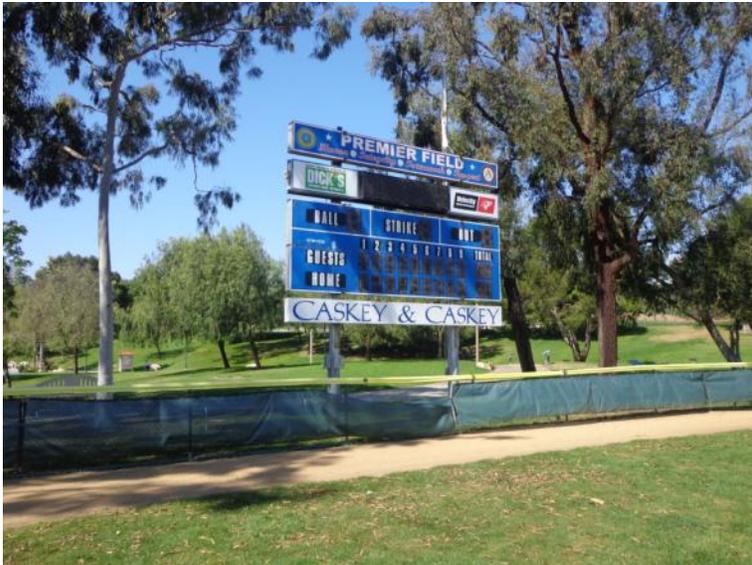
There is an electronic scoreboard beyond center field fence (reference Photograph 21 in Appendix B).

Photograph No. 21  
View of the scoreboard

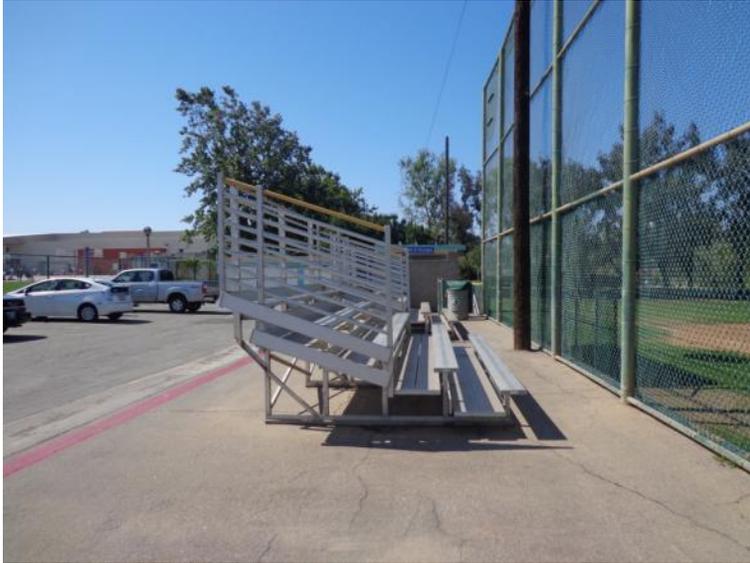
**Photograph No. 22**

View of one of the aluminum bleachers.
