**EXISTING FACILITIES** FACILITIES STRATEGIC PLAN - Final Report  
*Manhattan Beach, CA*

**The Scout House**

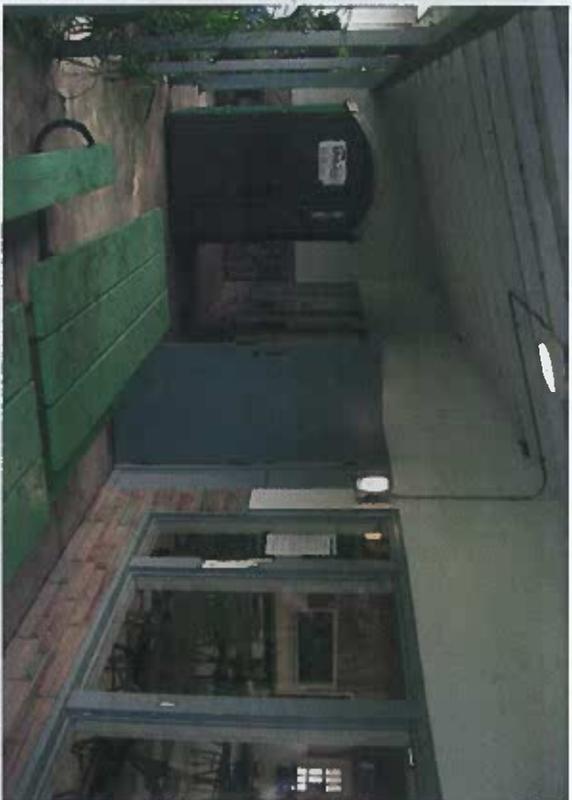
*The Front Porch of the Scout House. This building was built by volunteer labor in 1948. The Port-a-Potty is placed at the entrance in the building in order to bring the facility into ADA accessibility compliance.*

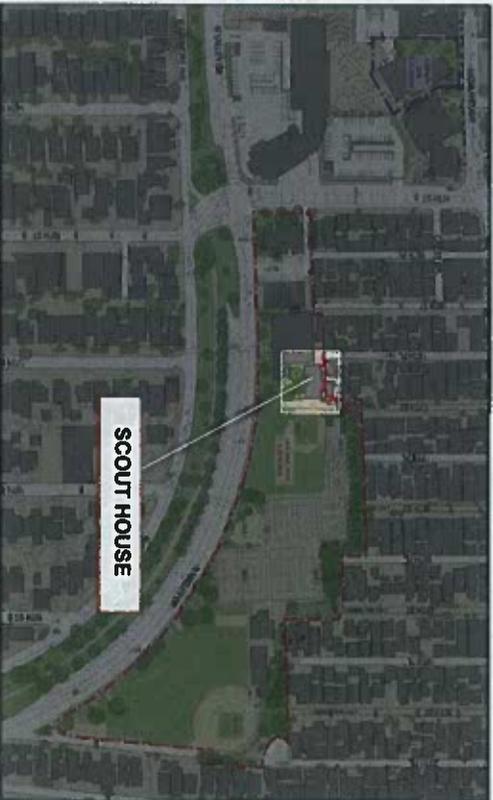
*The Scout House in Situ. This 3,000 SF building is jammed between the Joslyn Center and the Little League field. Before the Joslyn Center, the little league field and the basketball courts were built the Scout House was surrounded by lots of open space.*
