CAPITAL IMPROVEMENT AND  
PROTECTION PROGRAM

CITY OF MANHATTAN  
BEACH PARKING  
STRUCTURES  
LOTS 2, 3 & 4

Prepared for:  
CITY OF MANHATTAN BEACH  
PROJECT NO. 37-8377.00

SEPTEMBER 2013

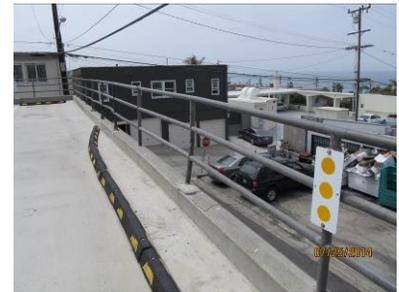
Photo 38: Vehicular Barriers on Upper Level

While the existing vehicular barriers in this structure have been in place since the original construction and may be grandfathered in under the current code, we recommend

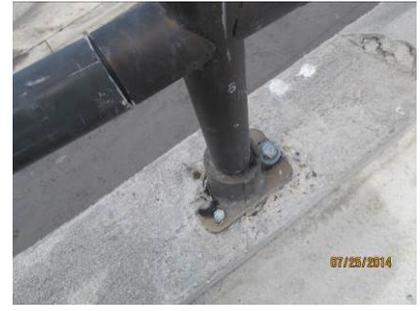
Photo 44: Deteriorating vehicular rail base plate

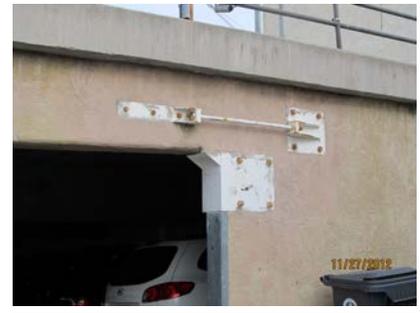
Photo 54: Evidence of a past seismic retrofit.

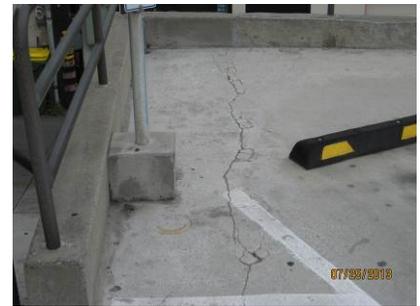
- Prior concrete patchwork was noted on the top surface of the supported slab. A large number of these patches were located along PT tendon runs. Many of the patches were noted to be failed and delaminated. In order to stop further deterioration to the concrete and the underlying PT, it is recommended that the delaminated patches be removed, underlying reinforcement and PT tendons cleaned and protected, and the areas re-patched with high quality repair mortar.
- Concrete spalls were visually observed and located by sounding at isolated locations on the floor and ceiling surfaces. The majority of the spalling was minor in size at less than 5 square feet. In order to stop further deterioration to the embedded reinforcing steel and PT from moisture intrusion, it is recommended that these spalled areas be removed, underlying reinforcement and PT strands cleaned and

Photo 26: Typical cracking and previous patchwork in elevated slab.

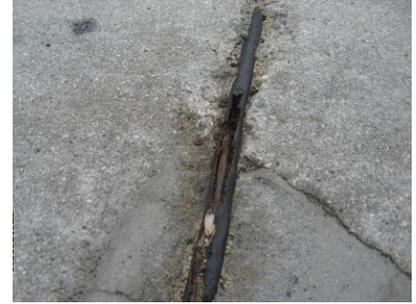
Photo 30: Exposed PT tendon

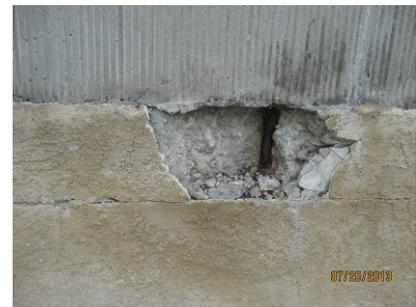
- Spalled areas were noted at select locations in the concrete walls. We recommend these spalls be removed, underlying reinforcement cleaned, and area patched with a high quality repair mortar.
- The concrete at the end of the beams on the west face of the structure was noted to be damaged due to impact, possibly from tall trucks passing by. This has exposed the PT anchor pockets at one location allowing for the intrusion of moisture and other environmental contaminants. In order to avoid an accelerated rate of deterioration of the PT anchors, we recommend removing the damaged concrete at the ends of the beams, cleaning the PT anchor pockets, and patching the area with a high quality mortar.
- Several small areas in the concrete curbs were noted to be damaged. We recommend these areas be removed and patched with a high quality mortar.

Photo 34: Concrete spall and corroded reinforcement in wall.

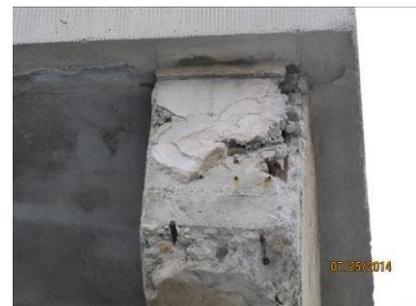
Photo 35: Spalling at the end of a beam exposing PT anchor pockets.

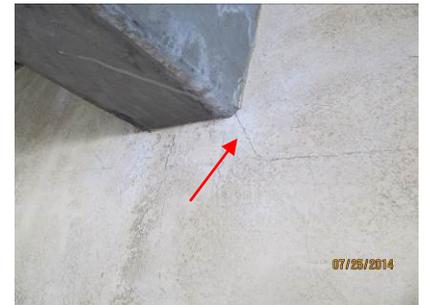
- Large cracks with signs of active leakage were noted in the concrete walls. The retaining wall on the east side of the structure exhibited cracks extending from beams that were framed into the wall. Moisture seeping in from the soil behind the wall can lead to deterioration of the concrete and embedded steel reinforcement. Cracks were also noted extending from the concrete drain enclosure in the north wall. Moisture from the nearby drain has the potential to infiltrate these cracks and accelerate deterioration of

Photo 13: Cracking in wall extending away from a beam.

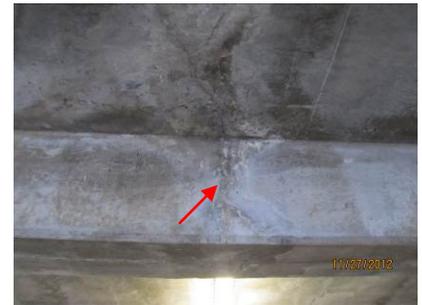
Photo 14: Signs of active leakage through beam crack.

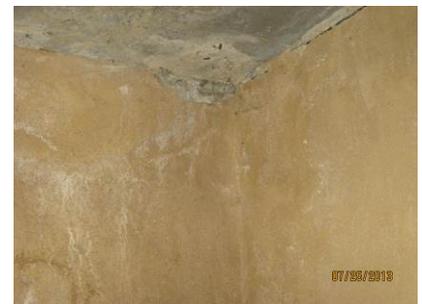
Photo 21: Active leakage noted along the joint between the walls and the ceiling.

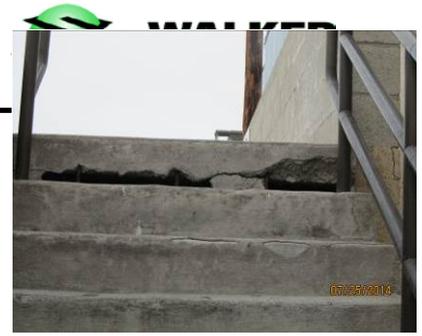
Photo 45: Large spall in the top tread of cast-in-place stairs.

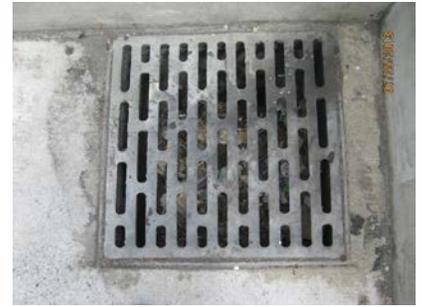
Photo 50: Upper level floor drain

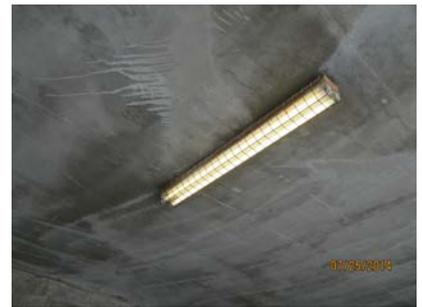
Photo 54: Typical T5 florescent light fixture.

Upgrading the lower level lighting to a more energy efficient LED system will reduce energy costs and contribute to further savings because of a longer bulb life. A lighting study is recommended to determine compliance of the existing lighting system with current lighting industry standards and provide a present value cost of replacing the existing florescent fixtures with efficient LED fixtures.

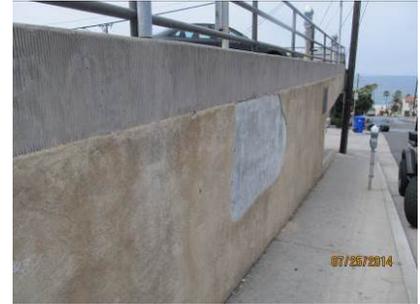
Photo 51: Large area of de-bonded stucco

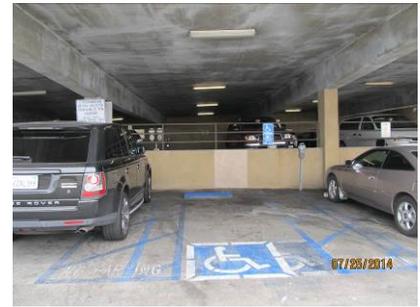
Photo 53: Typical ADA stall showing conflicting striping.

- Parking stall striping in this structure has reached the end of its useful service life. We recommend that all markings be removed and restriped, and done so routinely every five years, or as needed.

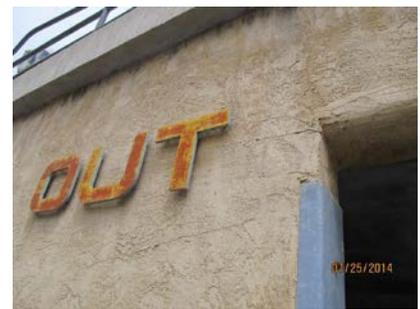
- Entry/Exit signage at the vehicular entry from the Center Place alleyway was noted to be faded. We recommend this signage to be replaced.
- We noted one fire hose cabinet in the structure. The cabinet component was heavily damaged and the water line feeding into it was noted to be non-functional. A fire cabinet assembly is not required by the California Building Code in this type of structure. We recommend removing the cabinet and water line

Photo 4: Faded signage outside of lower level entry.

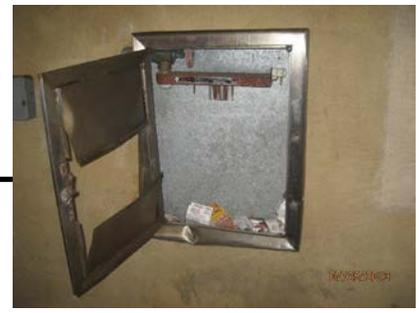
Photo 48: Trash collecting in fire cabinet.

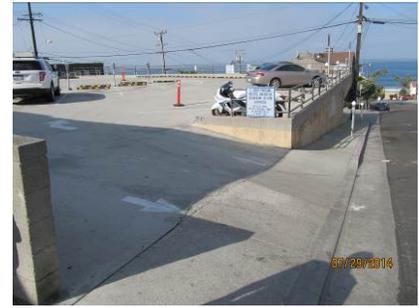
Additionally, no height restraint bar was noted at the entry to the upper level from 12<sup>th</sup> Street. This allows for over-sized vehicles to access the upper level and possibly overload the structure. This is of particular concern in this structure because several PT tendons in the elevated slab were noted to be broken. In addition to repairing the broken PT tendons,

Photo 53: Entry to upper level from 12<sup>th</sup> Street showing signs of vehicular scraping.

we recommend installing a height restraint bar at the entry to the upper level to avoid possible overloading.

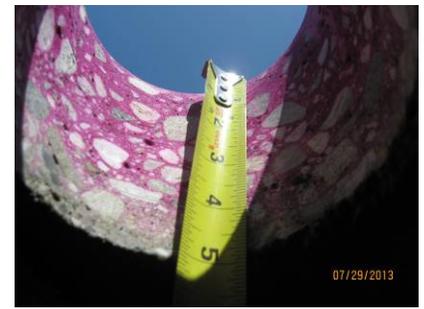
We measured the extent of carbonation in this structure on-site by spraying a freshly exposed surface of the concrete (where the cores were extracted) with a phenolphthalein solution. The calcium hydroxide is colored pink while the carbonated portion remains uncolored. In one of the two

Photo 55: Carbonation testing using a phenolphthalein solution. The pink region indicates no carbonation at the top of the slab.

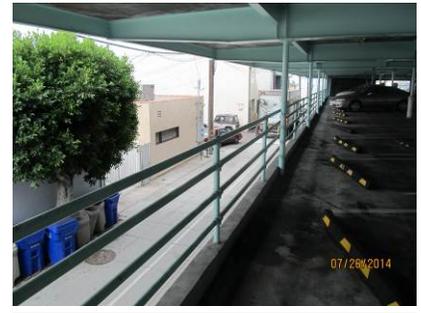
Photo 13: Vehicular Barriers on the Second Level

While the existing vehicular barriers in this structure have been in place since the original construction and may be grandfathered in under the current code, we recommend the City take a proactive approach by installing a new

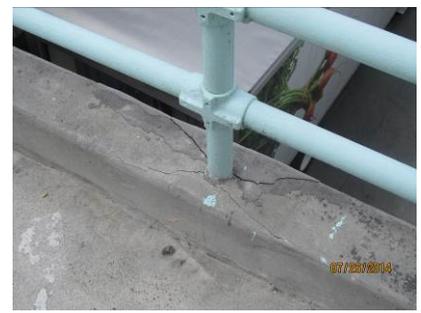
Photo 16: Cracked Curb at Perimeter Barrier Rail Mount

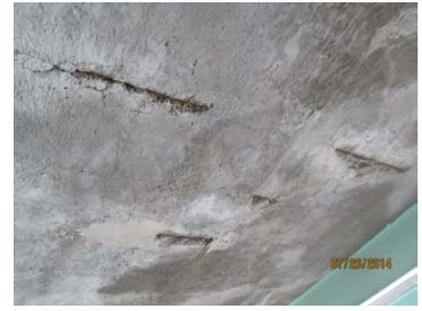
Photo 20: Typical spalling in the ceiling.

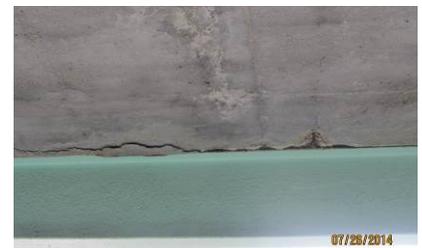
Photo 24: Typical spalling at interface of steel beam and deck.

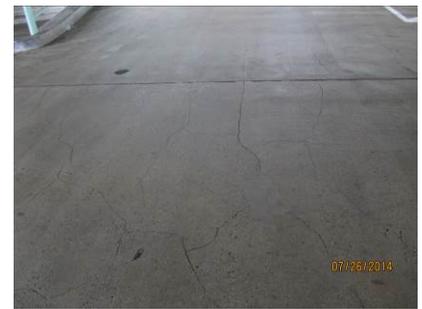
Photo 29: Typical cracking on top of elevated slab.

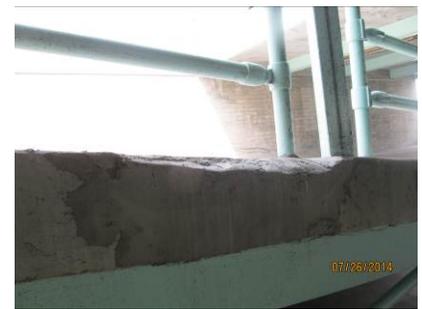
- A pattern of concrete spalling and previous patchwork was noted in the curbs at each location where pedestrian handrails are anchored. This

Photo 36: Previously patched curb at rail anchorage.

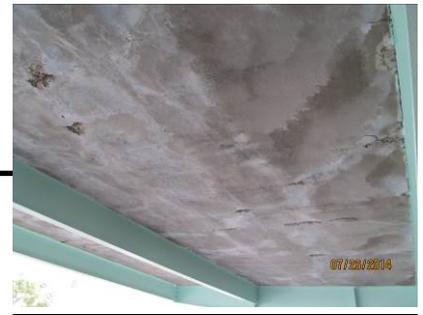
Photo 48: Efflorescence seen in the ceiling.

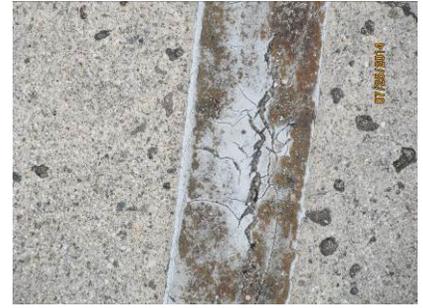
Photo 46: Deteriorated control joint sealant.

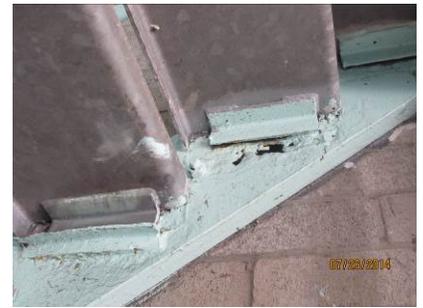
Photo 55: Deteriorated steel stair components.

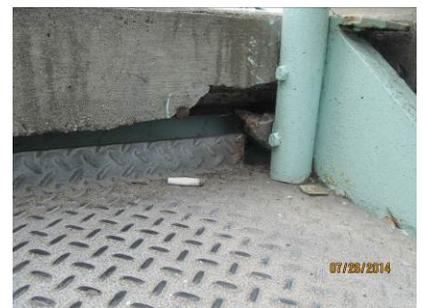
Concrete spalling was noted at the edge of the third level slab near the top tread of the east stairs. The corrosion of

Photo 56: Damaged concrete at stair connection.

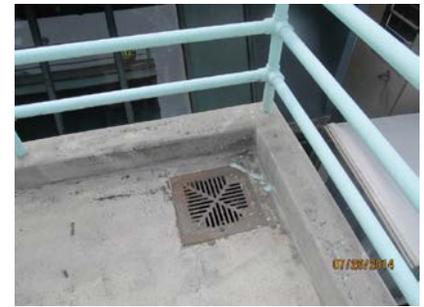
Photo 64: Typical floor drain.

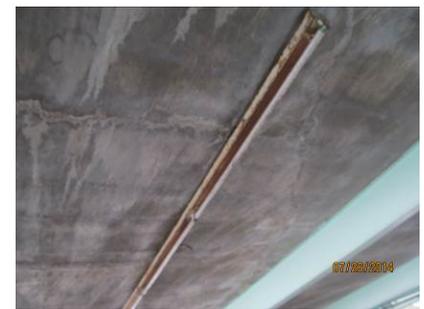
Lighting on the ground level has been recently upgraded to LED fixtures. Lighting on the second level is provided by fluorescent T5 light fixtures, with embedded conduit. Light level measurements were not part of the scope of this project; however the overall lighting appeared to be low on the second level. A number of light bulbs at select locations appeared non-functional and were missing in some cases. Extensive corrosion damage was noted on the lighting fixtures at select locations. The roof level lights are mounted on poles. The poles are generally in good condition. The lights at the roof level were turned off during the day to conserve energy.

Photo 60: Corroded light fixture.

We recommend an electrical allowance to address necessary repairs of the existing fluorescent fixtures; however we recommend as an enhancement initiating a lighting study to determine the cost feasibility of replacing the existing florescent fixtures with efficient LED fixtures (see Enhancements).

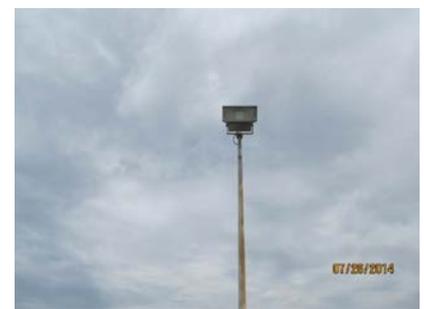
Photo 60: Typical roof level light post.

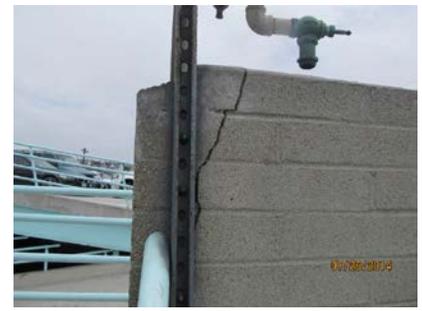
- Several CMU blocks were noted to be cracked in a number of the masonry shear walls. The cracks serve as avenues of moisture intrusion, which can lead to deterioration of the embedded steel reinforcement in the shear walls. We recommend all damaged masonry blocks be repaired to stop infiltration of moisture and other environmental contaminants.

Photo 34: Large crack in masonry wall.

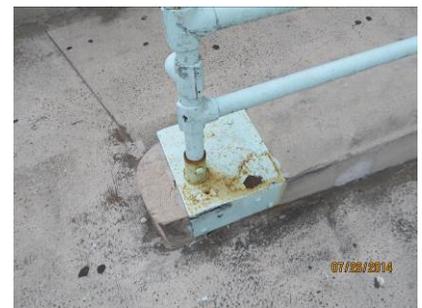
- All exposed steel elements were noted to be painted with an epoxy coating to protect against corrosion. It was observed in some areas that the coating has deteriorated and no longer protects the steel. This was particularly evident at the rail anchor plates in addition to isolated areas on the steel beams and

Photo 67: Corroded anchor plate at base of railing.

columns. To stop further deterioration and the potential for structural issues, we recommend these corroded areas be cleaned and recoated with high quality epoxy coating.

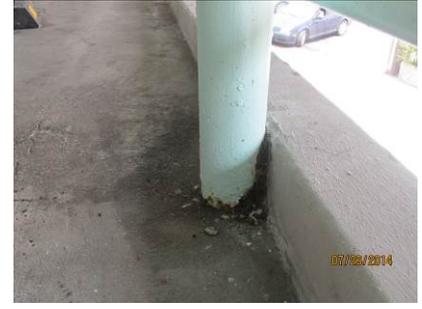
- Two of the steel pipe columns along the south perimeter of the second level were noted to have undergone a considerable amount of deterioration at their base. This has led to a loss of section and is compromising their strength. It was noted that this issue was previously addressed in other perimeter columns by installing a 5" long steel jacket at the base. We recommend steel jackets be installed at the base of the corroded columns to restore the loss of section. In order to protect against this deterioration occurring in the future, we recommend adding a concrete enclosure at the base of the perimeter columns.

Photo 69: Base of perimeter column showing signs of corrosion.

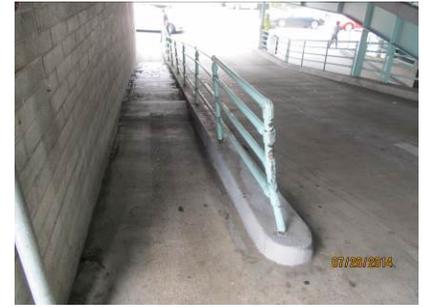
- The pedestrian handrails were noted to be in poor condition throughout the garage. A number of the posts were noted to be bent from vehicular impact and many of the embedded connections to the curbs were loose. This has caused water to enter and corrode the embedded steel, which has spalled the concrete at many of these locations. We recommend all spalled concrete in the curbs at these locations be removed, the embedded steel connections cleaned, and the handrails be reshaped and repainted to extend their useful service life.

Photo 79: Pedestrian handrails damaged from vehicle impact.

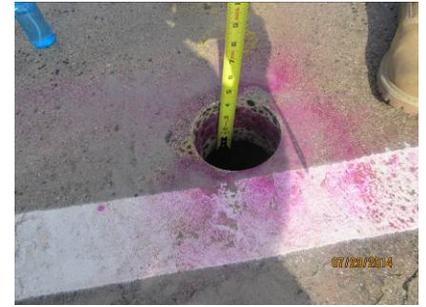
Results for this structure revealed a moderately high water-to-cement ratio of approximately 0.50. The water-to-cement ration of the concrete currently specified for use in parking facilities by the ACI Building code is 0.40 to 0.45. The petrographic analysis also revealed moderately tight paste-aggregate bond. This indicates that the concrete has moderate durability characteristics and is susceptible to chloride or carbonation-induced concrete deterioration.

Photo 53: Carbonation testing using a phenolphthalein solution. The colorless region indicates carbonation on top and bottom of the slab.

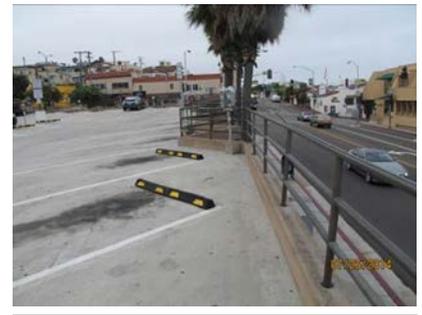
In general, the existing barrier rail system is in poor condition. A number of the posts were noted to be bent from vehicular

Photo 8: Vehicular Barriers on east side of the upper level

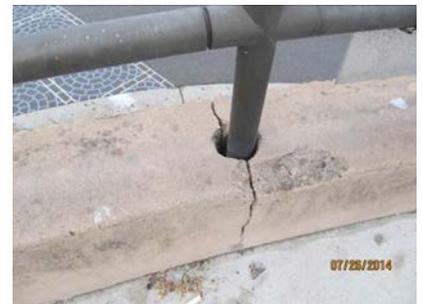
Photo 13: Cracking in concrete curb at rail mount location.

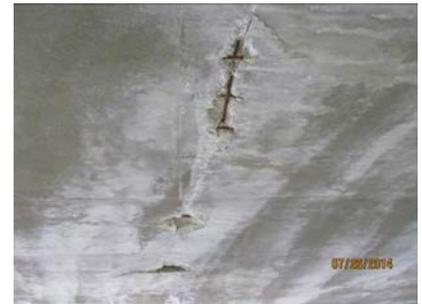
Photo 15: Typical spalling and exposed reinforcement seen in the ceiling

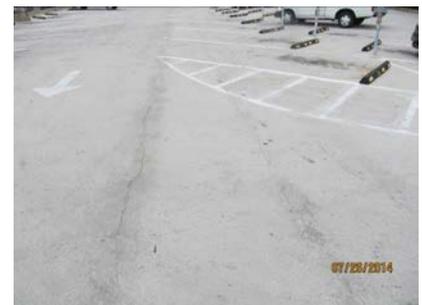
- Above average floor cracks were noted throughout the upper level. The cracks were most often aligned with the wide-shallow post-tensioned beams below. We recommend these cracks be routed and sealed

Photo 20: Large floor cracks running parallel to drop panels below.

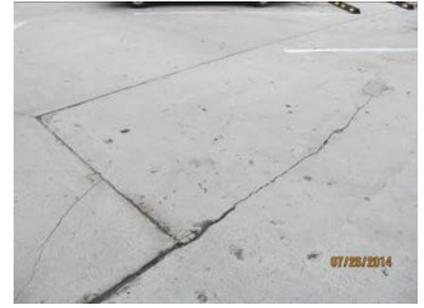
Photo 21: Large crack seen extending from the control joint.

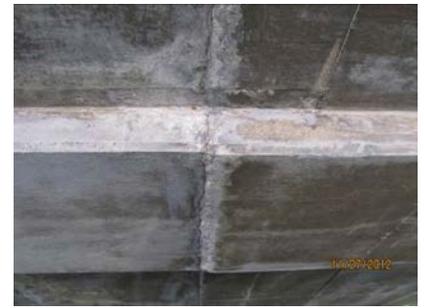
Photo 24: Large crack seen in a drop panel.

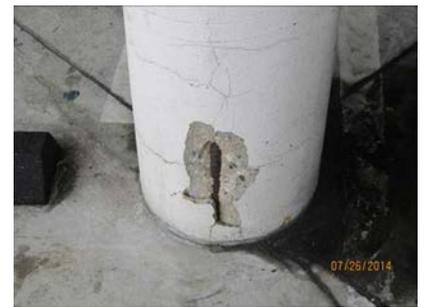
- Cracking and spalling was identified near the base of a number of columns, exposing the underlying reinforcement in some cases. The shortening of the slab and beams in one direction due to post-tensioning cause these cracks in the columns. This phenomenon is common in structures of this type. We recommend the spalled concrete in the columns be removed, underlying reinforcement cleaned, and area patched with a high quality repair mortar. The cracks in the columns should be repaired with epoxy injection.

Photo 25: Spall and cracking in a column.

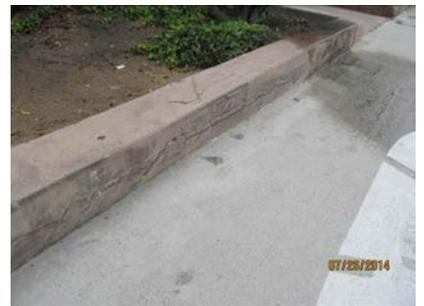
- Significant cracking and spalling was noted in the concrete curb adjacent to the upper level planter on the east side of the structure. This provides avenues for water and other contaminants to get into the

Photo 28: Cracked curb on the upper level

retaining wall below, which can lead to deterioration of the embedded reinforcing steel. We recommend all damaged curbs be removed and repaired with a high quality mortar to eliminate avenues of water infiltration into the structure.

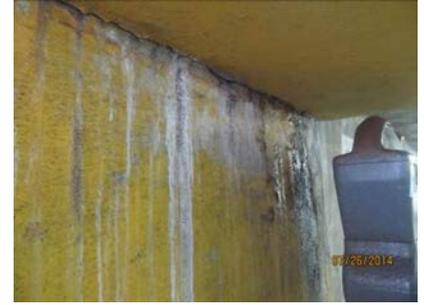
- Extensive cracking and signs of active leakage were identified on the concrete drain enclosure located on the north side of the lower level. The leaking material has the potential to infiltrate the surrounding cracks in the adjacent concrete walls and deteriorate the embedded steel reinforcement. We believe the drain enclosure does not serve its purpose and recommend it be reconstructed to stop further deterioration to the adjacent concrete retaining wall.

Photo 32: Concrete drain enclosure exhibiting signs of active leakage.

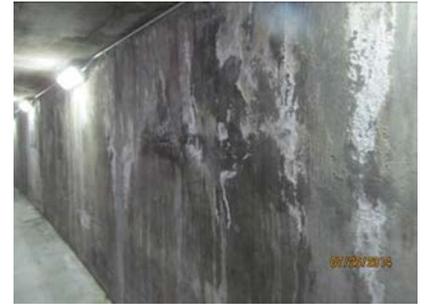
Photo 38: High amounts of efflorescence seen on the wall adjacent to the planter.

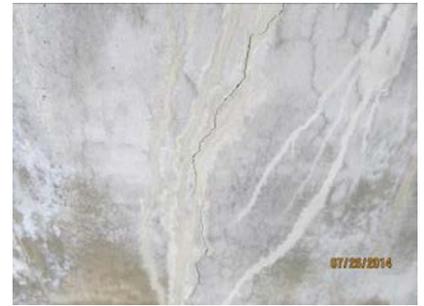
Photo 43: Signs of active leakage through a crack in the ceiling.

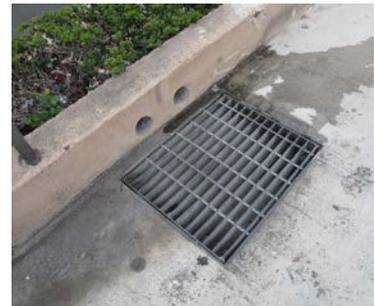
Photo 45: Upper level drain.

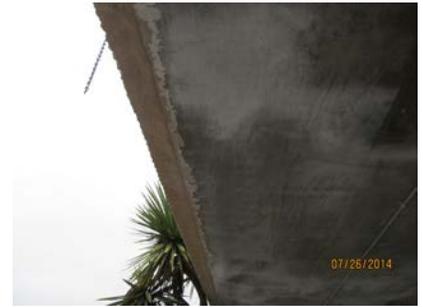
Photo 49: Staining around the perimeter of the ceiling.

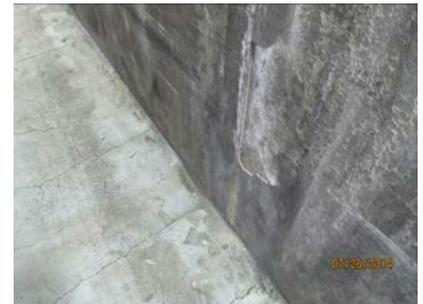
Photo 39: Damaged wall.

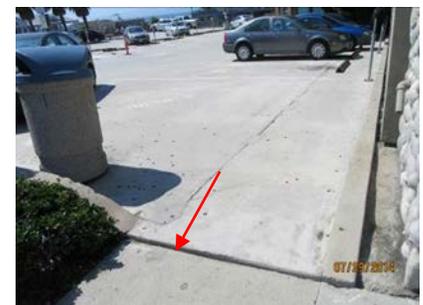
Photo 59: Trip hazard at pedestrian entry.

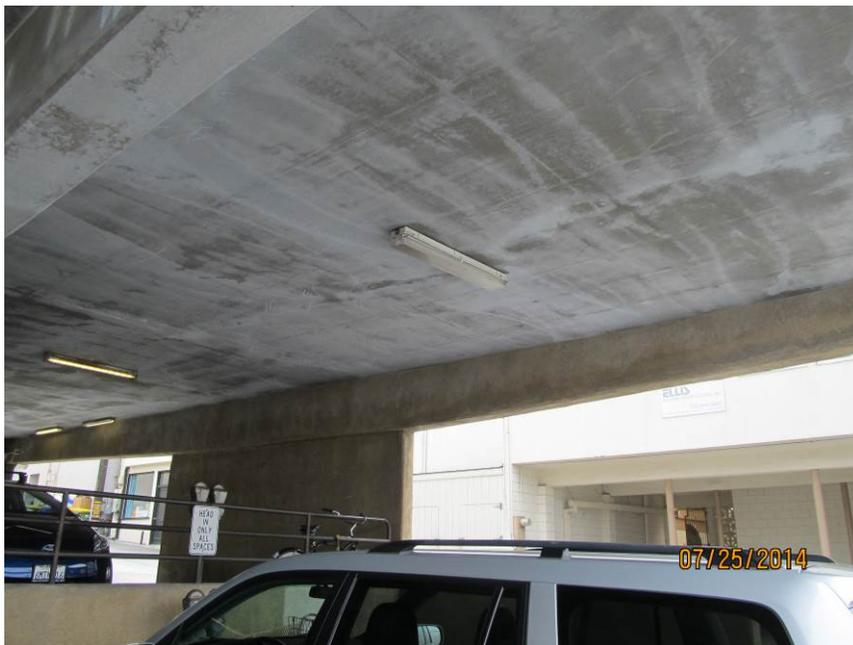
Photo 10

Extensive efflorescence seen in the ceiling.

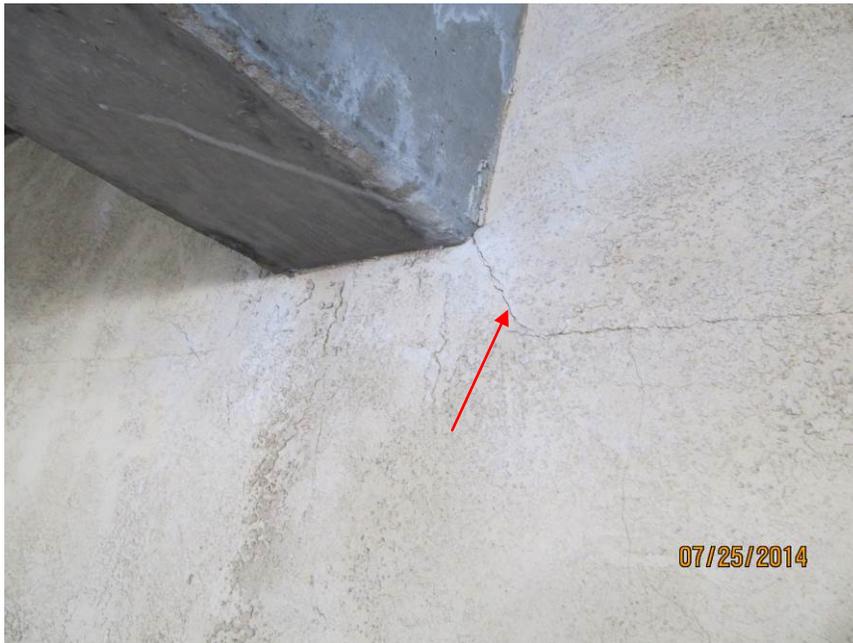
Photo 13

Cracking in the stucco skim coat extending from the beam-to-wall connection.

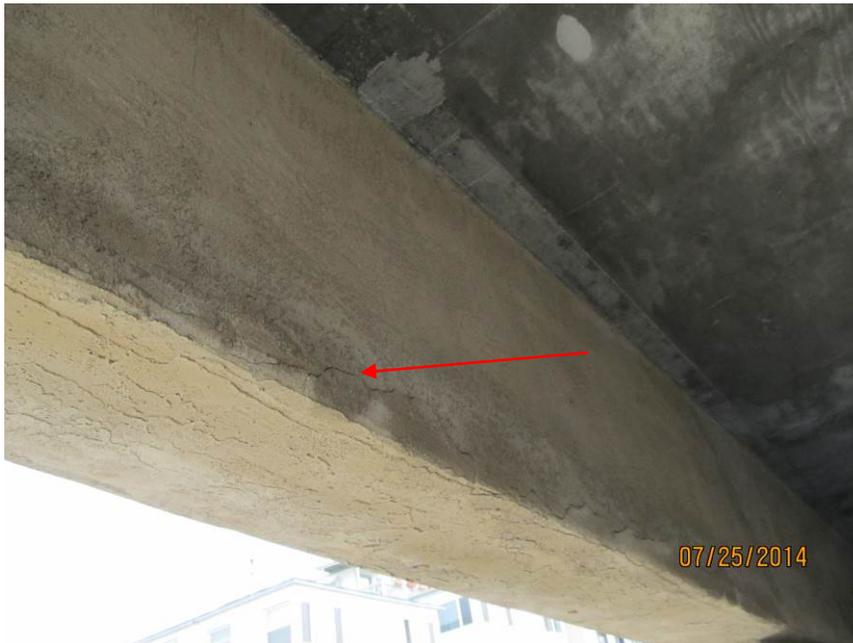
Photo 15

Cracking in the skim coat above the south entry into the lower level.

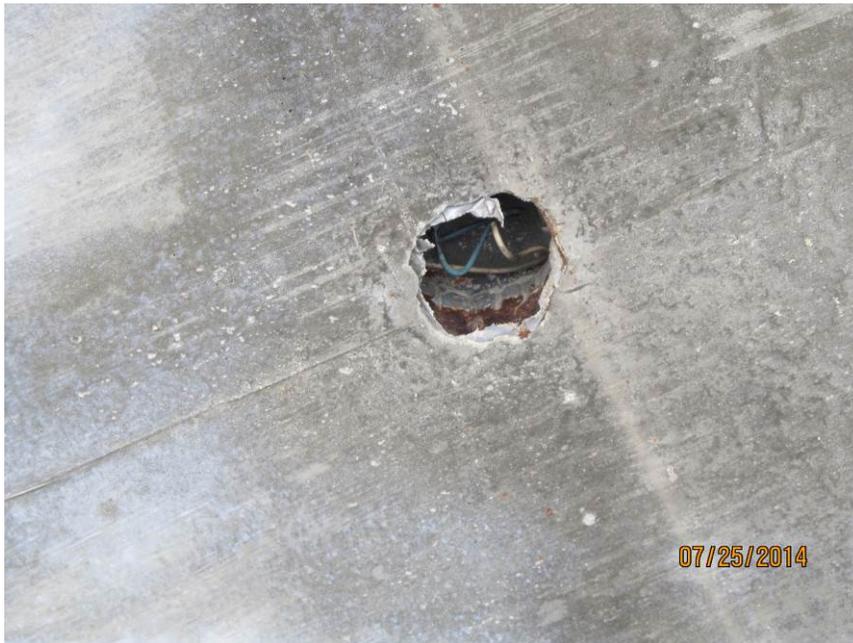
Photo 17

Exposed junction box in the ceiling.

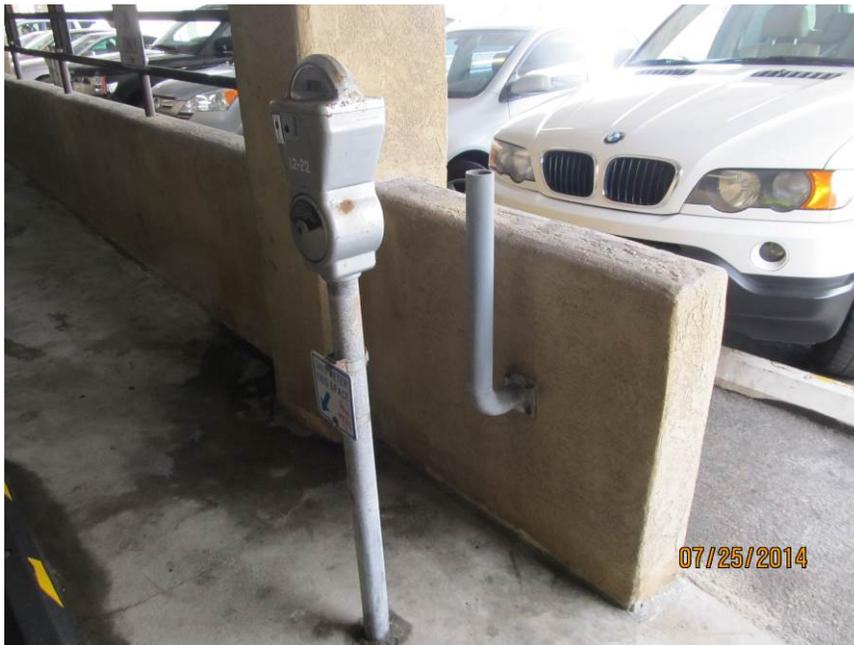
Photo 19

Unused meter mount in the lower level.

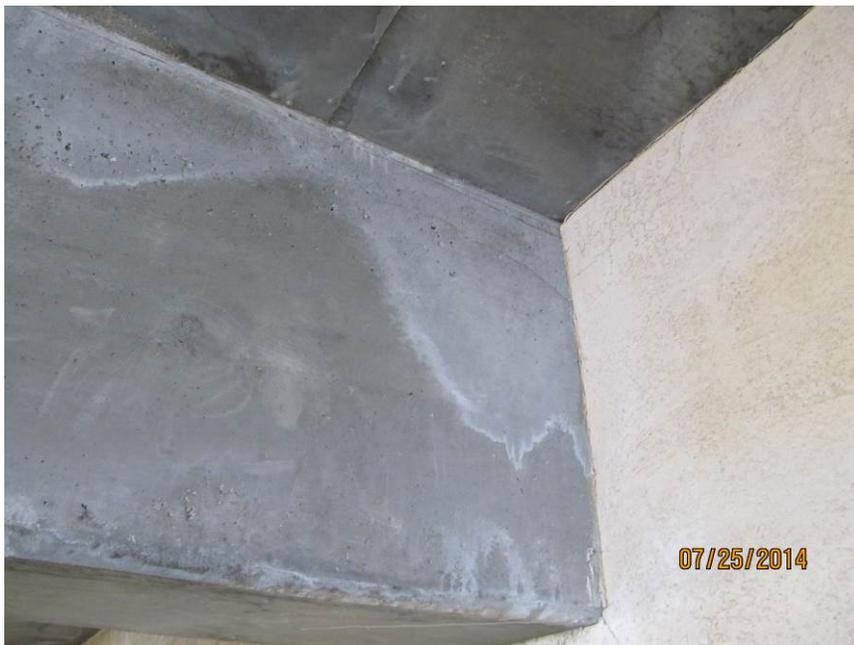
Photo 20

Efflorescence seen on a beam.

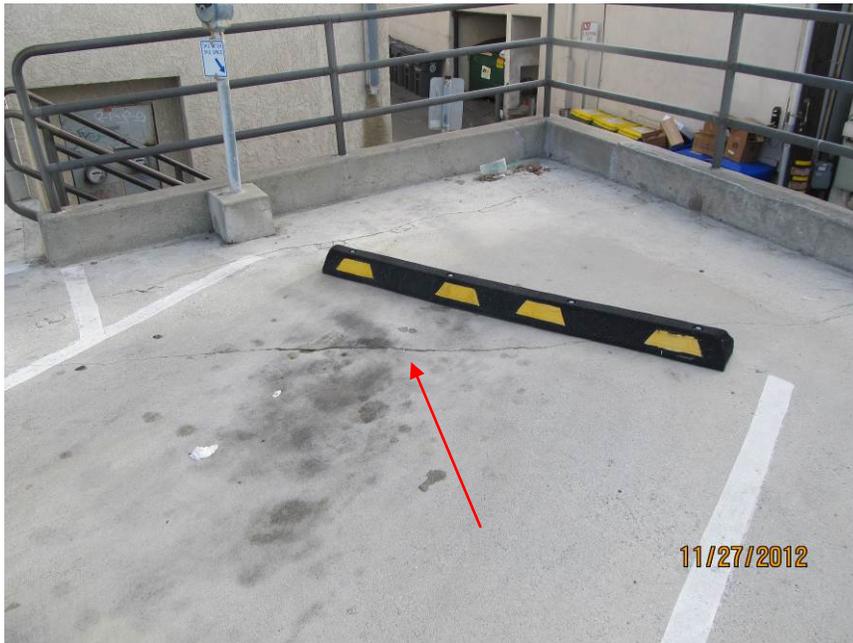
Photo 23

Cracking on the upper level.

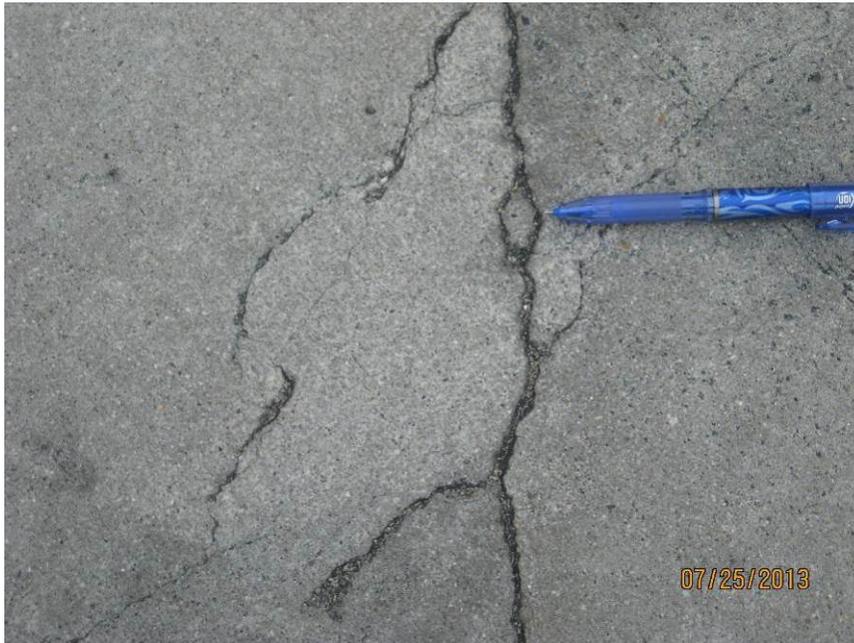
Photo 27

Large cracks seen in the elevated deck.

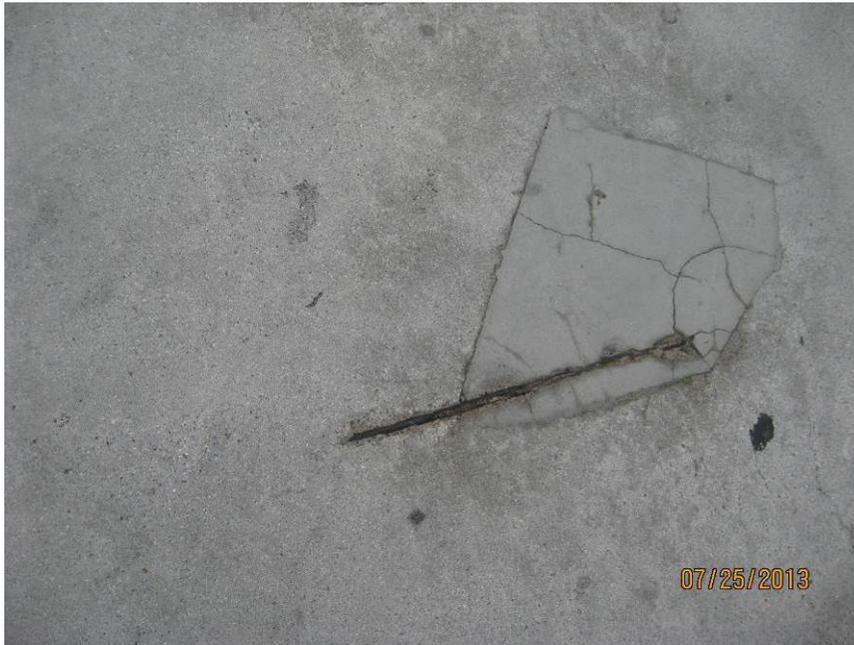
Photo 29

Exposed PT strand seen through a previously patched area.

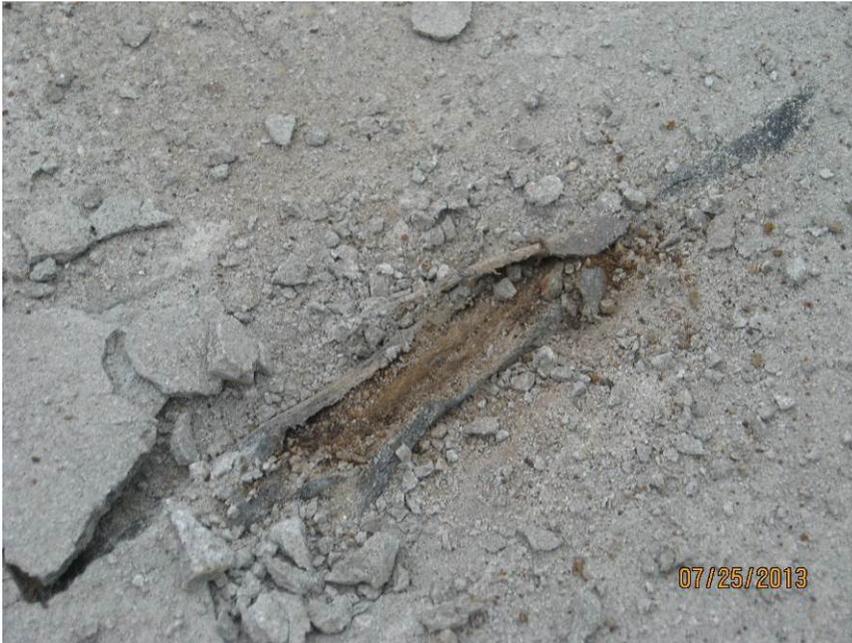
Photo 31

An exposed and deteriorated PT strand in the elevated deck.

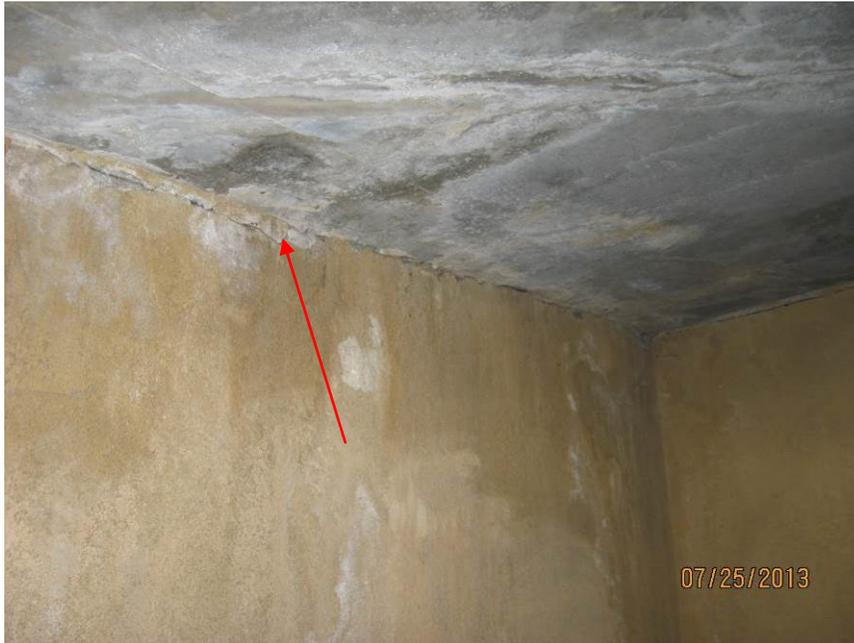
Photo 33

Signs of active leakage through the joint between wall and ceiling.

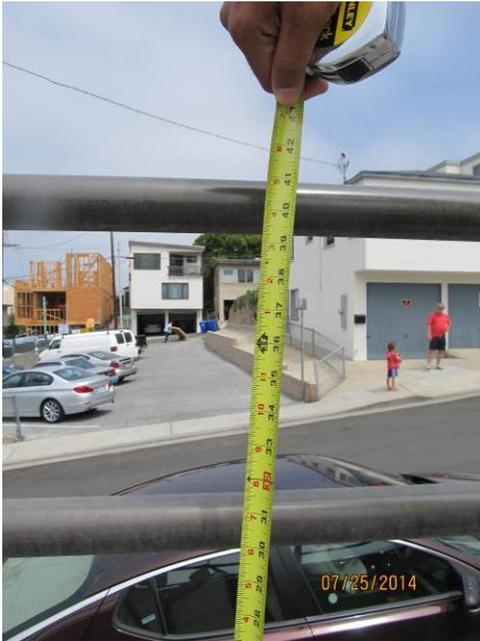
Photo 39

Spacing between the horizontal members was noted at 9" ..

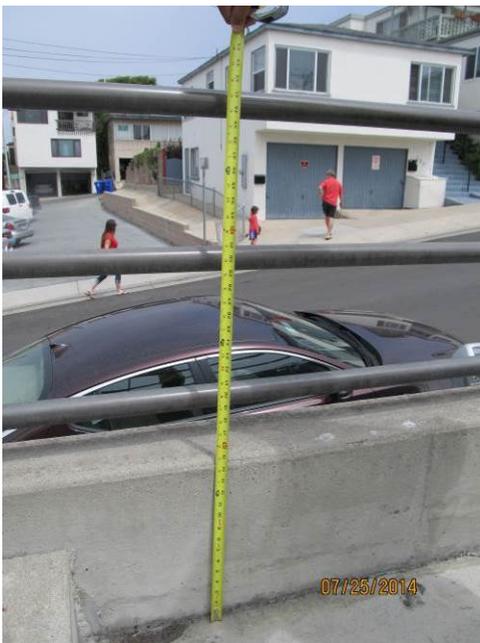
Photo 40

Total height of the existing barrier rail measured to be 41" .

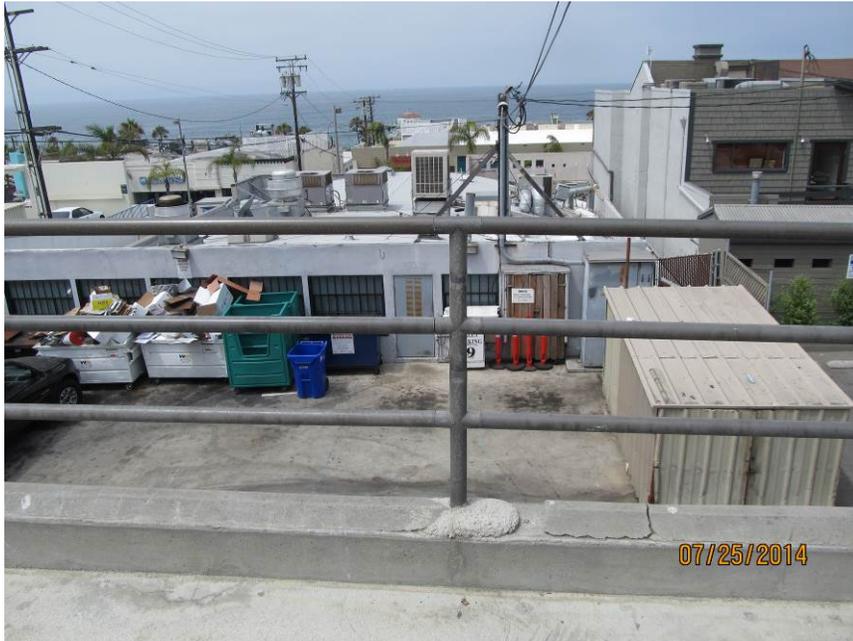
Photo 41

Previous repair work on barrier railing showing signs of deterioration.

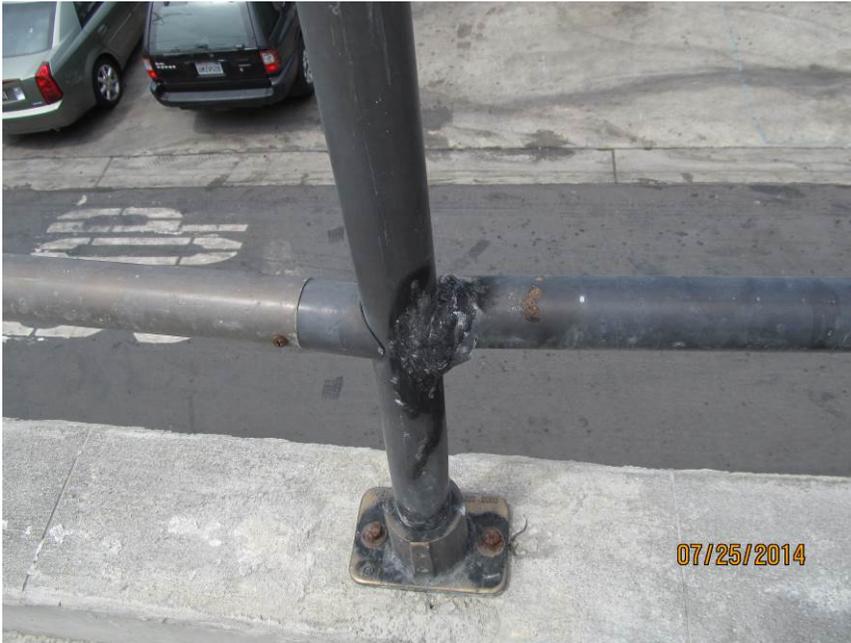
Photo 43

Previous repair work on barrier railing showing signs of deterioration.

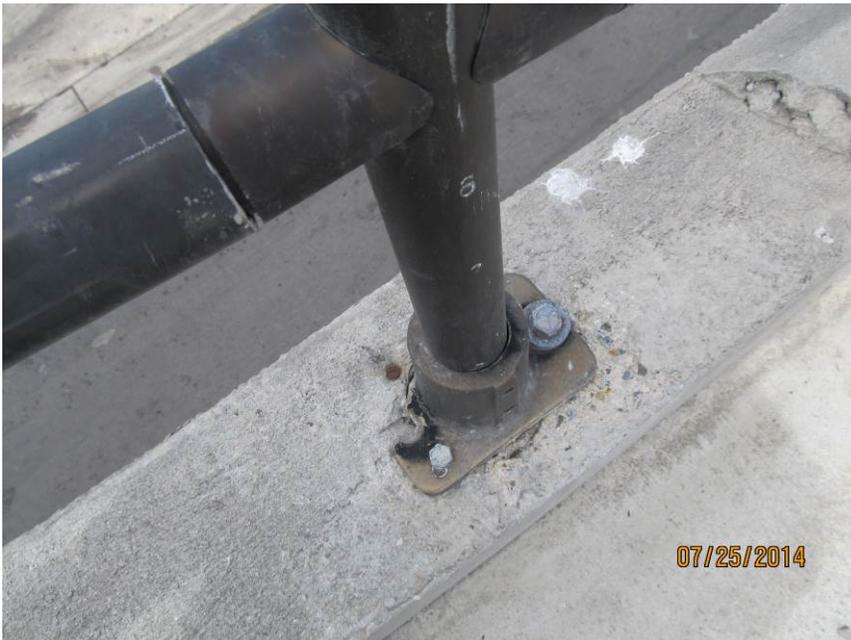
Photo 44

Deteriorated anchor plate at the base of barrier rail.

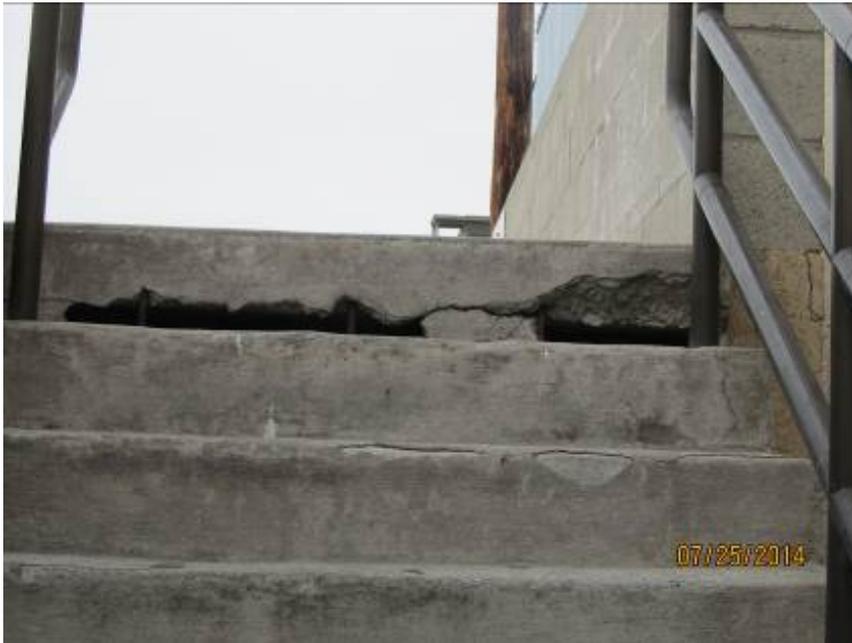
Photo 45

Spalled concrete at top tread of cast-in-place stairs.

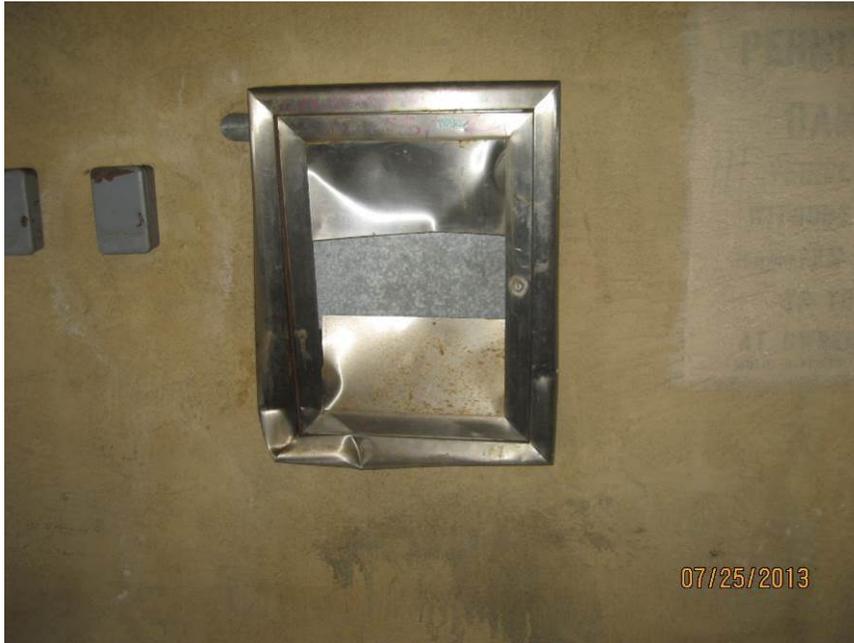
Photo 47

Previous repair work on barrier railing showing signs of deterioration.

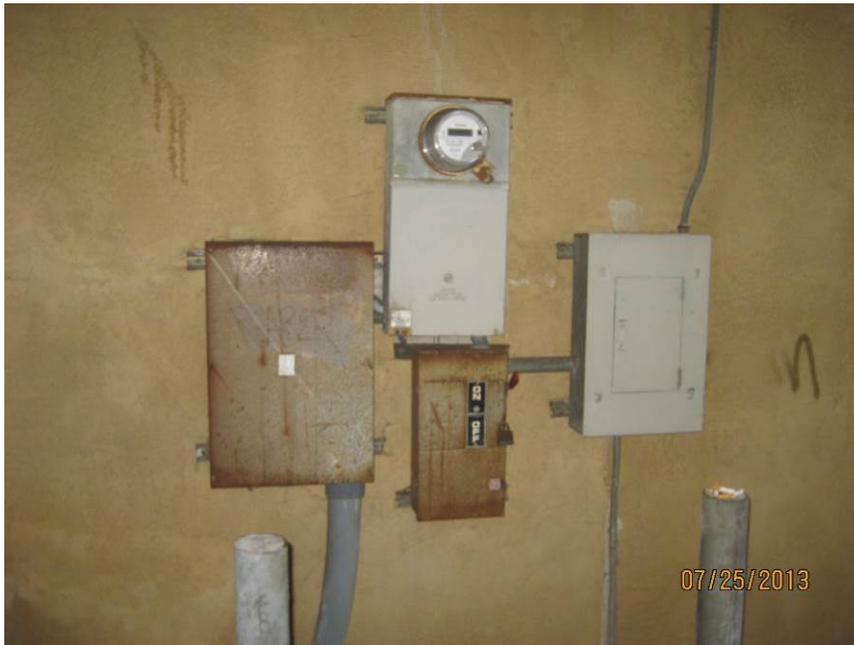
Photo 49

Electrical panels on lower level.

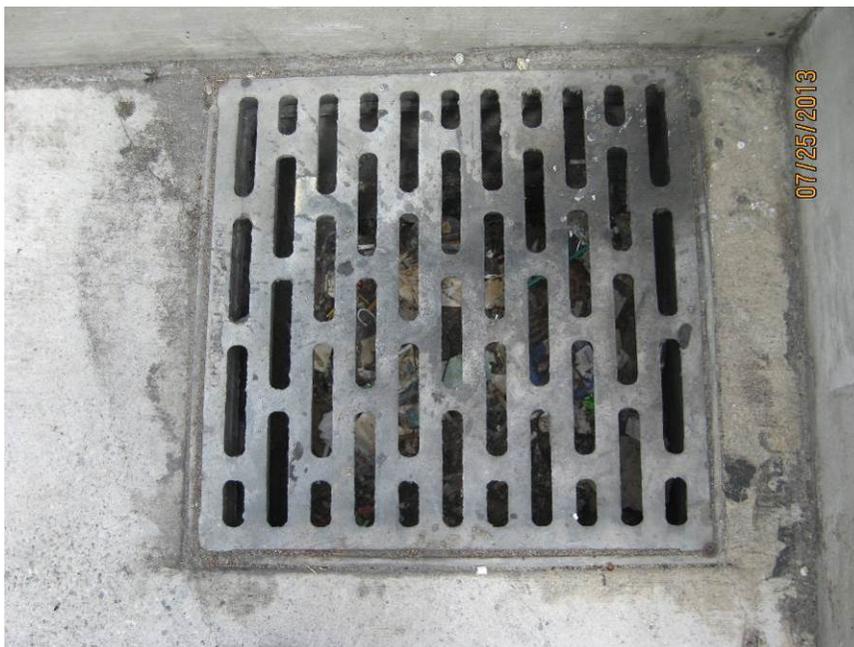
Photo 50

Floor drain located on upper level.

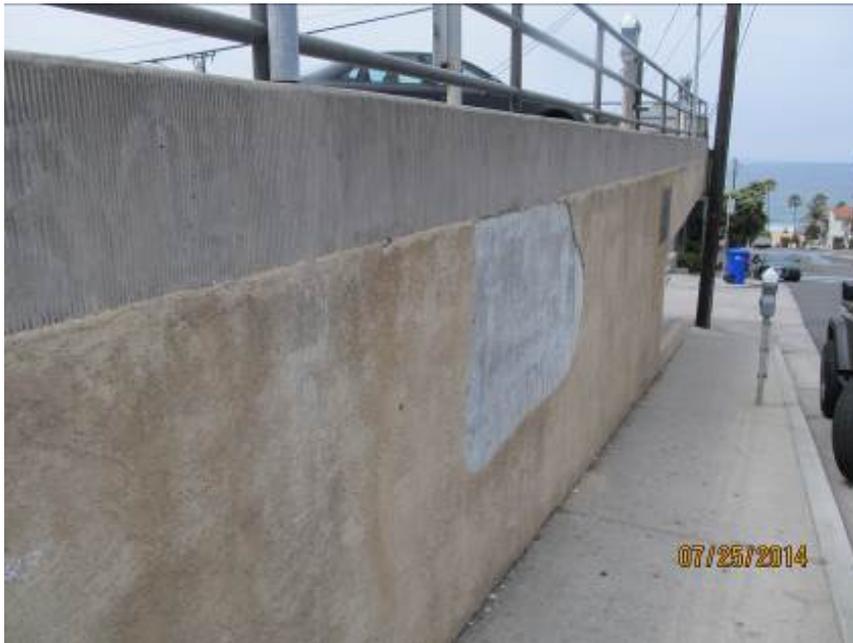
Photo 51

Large area of debonded stucco on exterior of building.

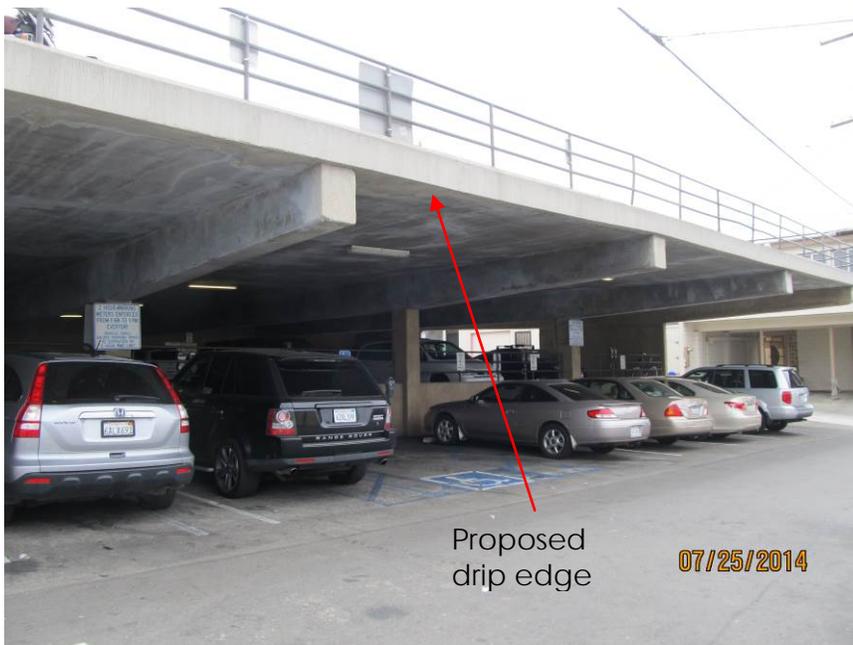
Photo 52

West elevation of the structure showing proposed area for new drip edge.

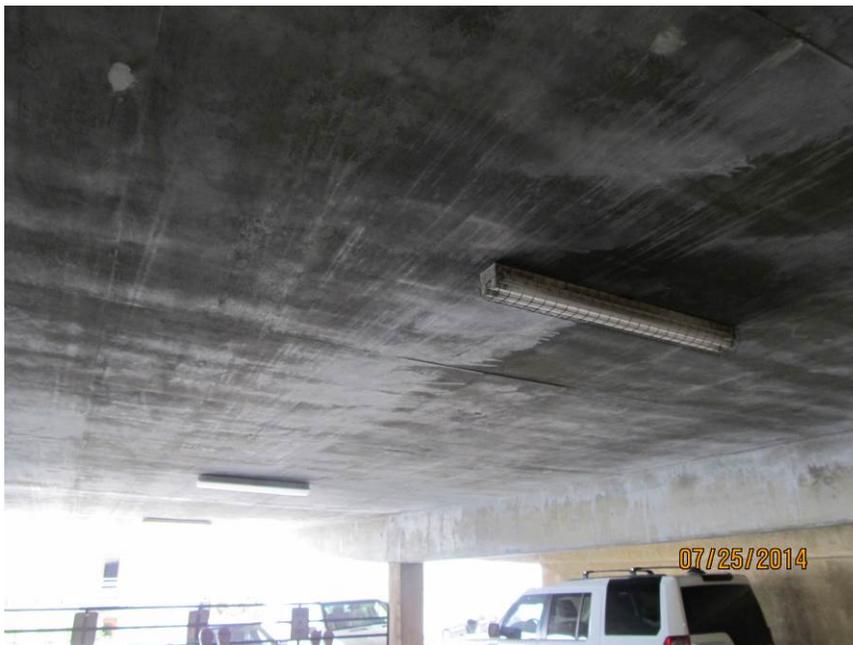
Photo 54

Non-functioning light fixtures on the lower level.
