CAPITAL IMPROVEMENT AND  
PROTECTION PROGRAM

CITY OF MANHATTAN  
BEACH PARKING  
STRUCTURES  
LOTS 2, 3 & 4

Prepared for:  
CITY OF MANHATTAN BEACH  
PROJECT NO. 37-8377.00

SEPTEMBER 2013

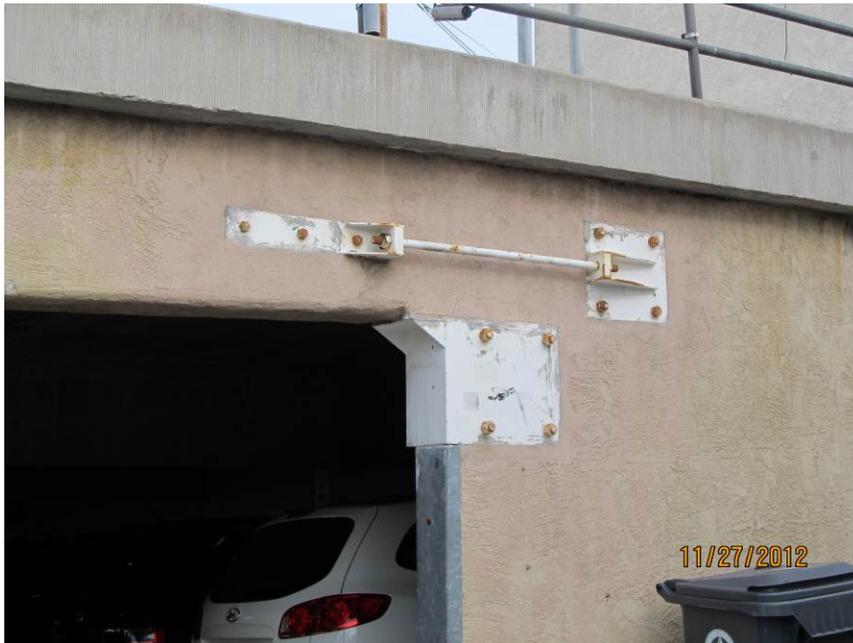
Photo 56

Bracing installed as a part of a previous seismic retrofit.

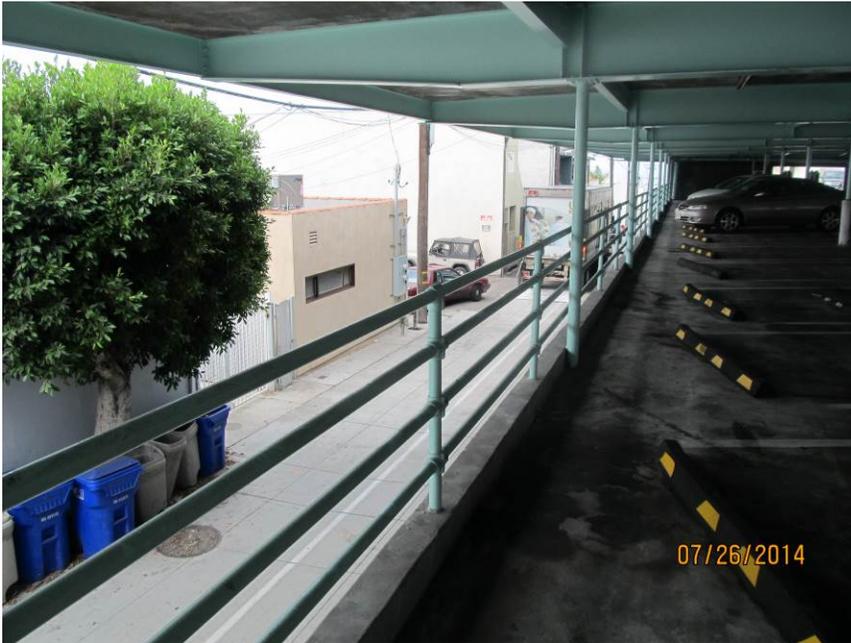
Photo 13

Vehicular barriers on the second level.

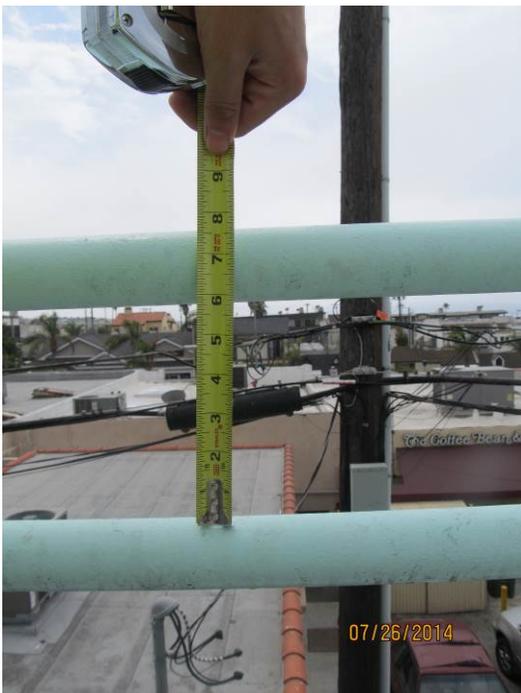
Photo 14

Spacing between the horizontal members was measured to be 6". Current code restricts this spacing to 4".

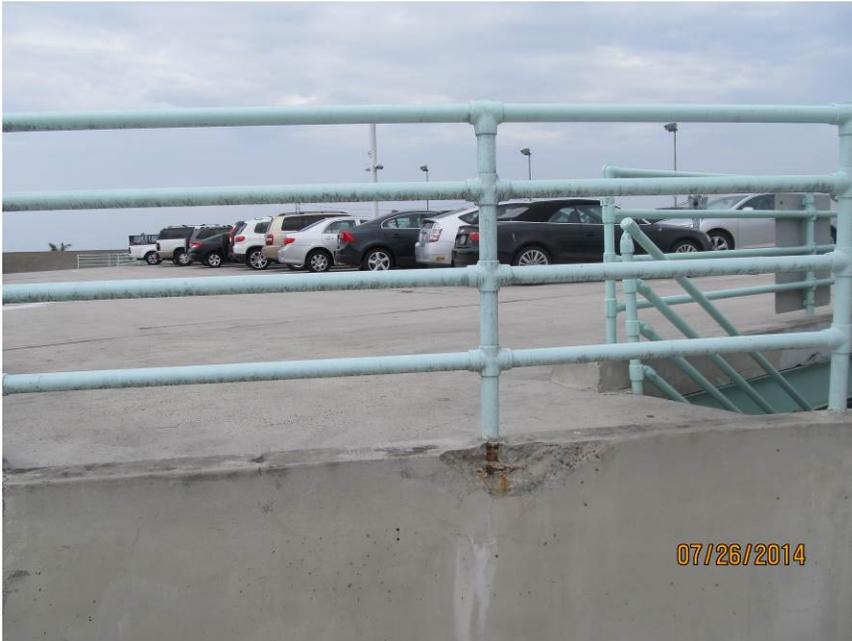
Photo 15

Typical spalled concrete at the anchor of a barrier rail.

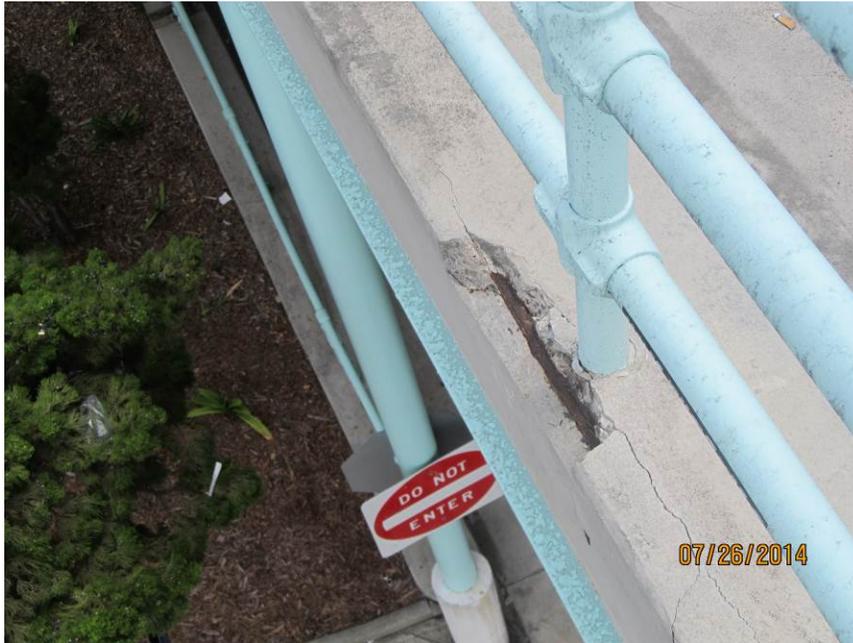
Photo 17

Typical spalled concrete at the anchor of a barrier rail, like a result of a failed sealant at the anchoring point.

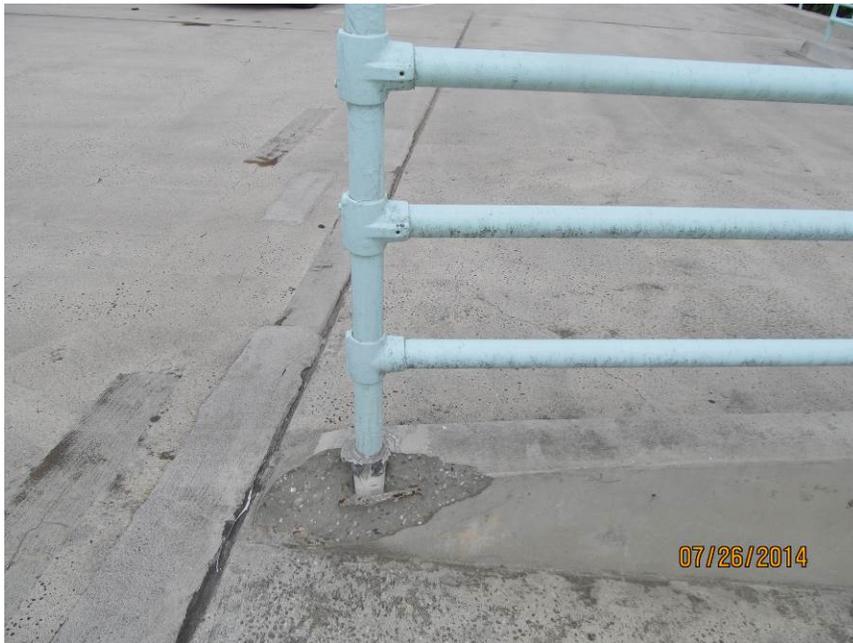
Photo 18

Typical spalled concrete at the anchor of a barrier rail.

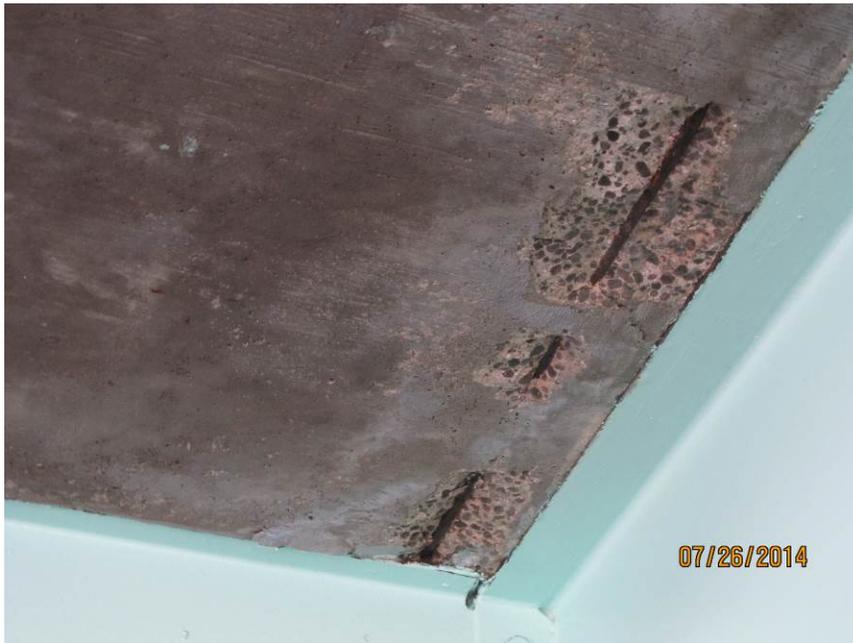
Photo 21

Typical spalling with exposed reinforcement seen in the ceiling.

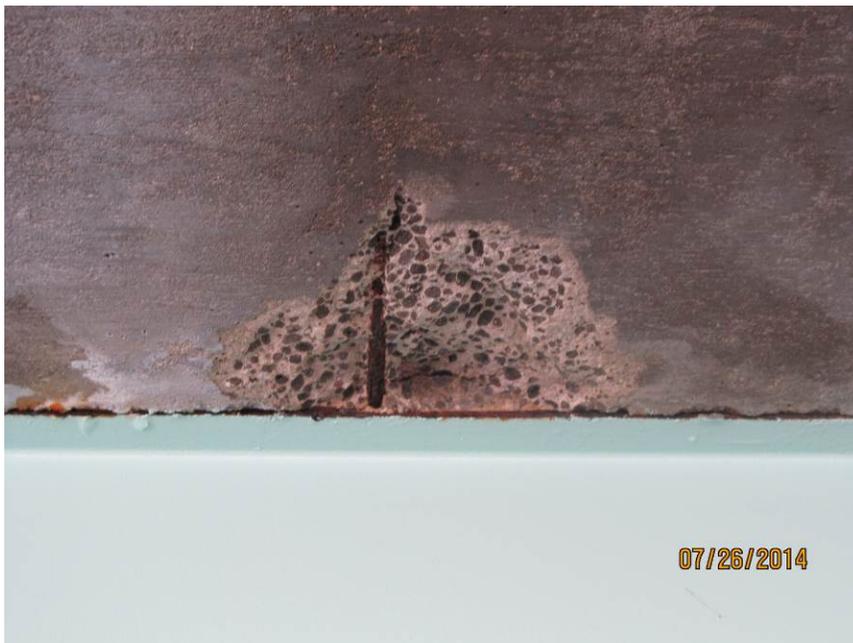
Photo 22

Typical spalling with exposed reinforcement seen in the ceiling.

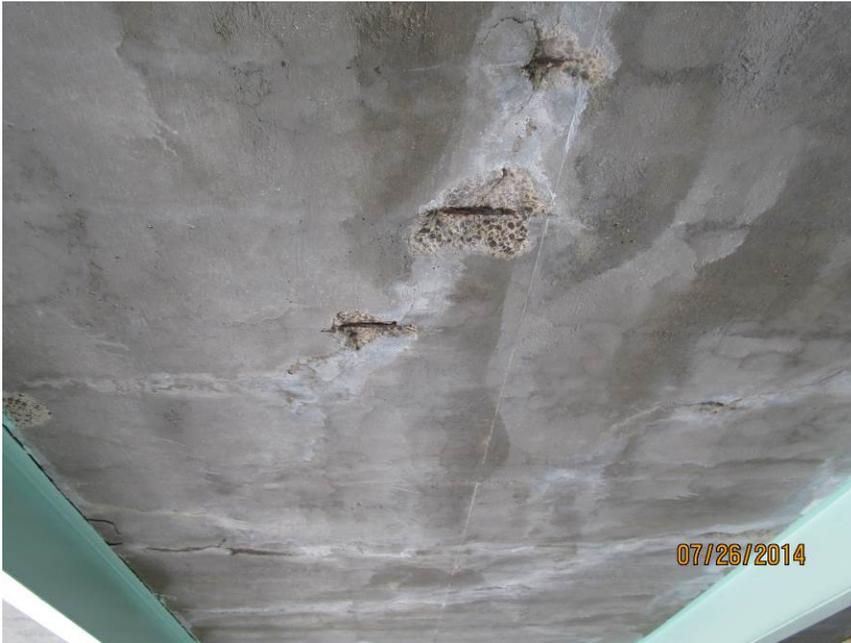
Photo 23

Typical spalling with exposed reinforcement seen in the ceiling. High amounts of efflorescence can also be seen. This is an indication of active leakage through the slab.

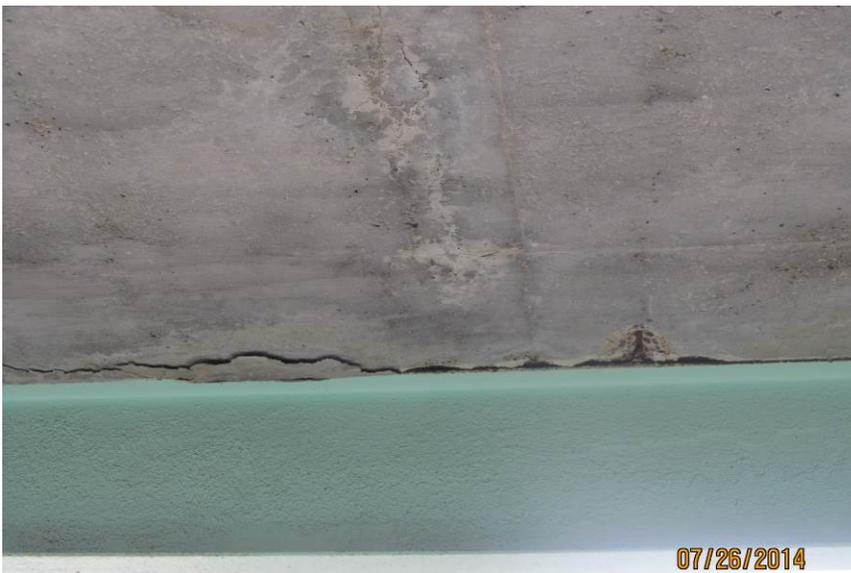
Photo 24

Delaminated and spalled concrete seen initiating from the interface between the slab and the top of beam.

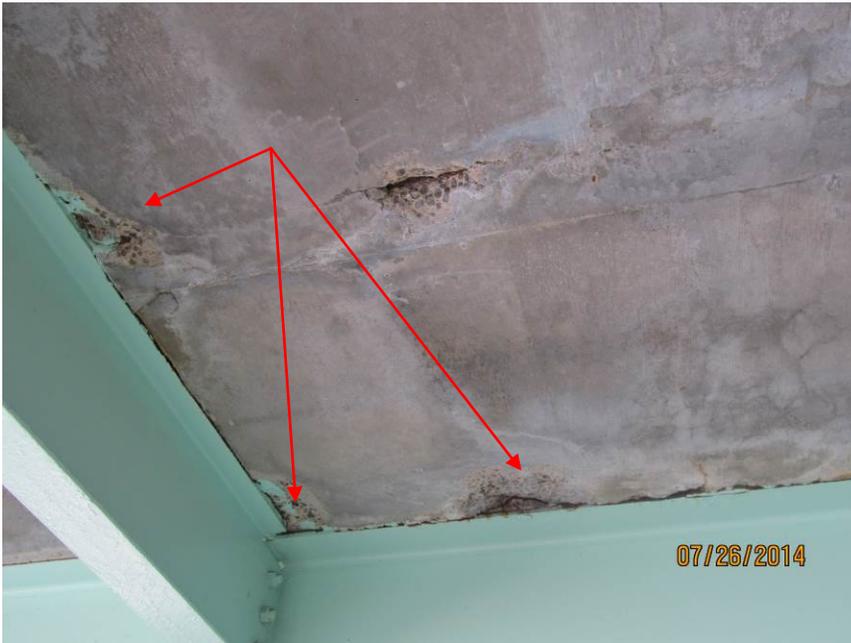
Photo 25

Delaminated and spalled concrete seen initiating from the interface between the slab and the top of beam, particularly at the location of shear studs.

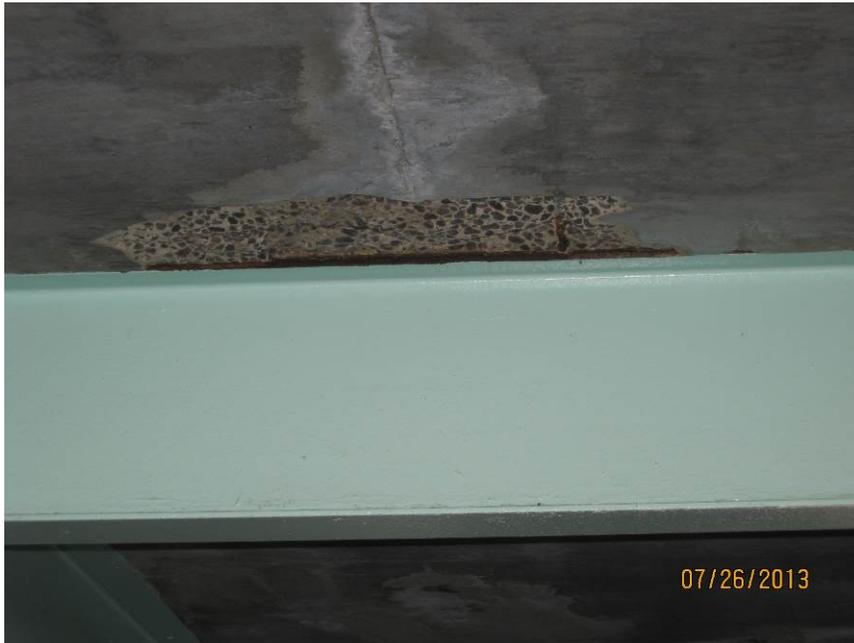
Photo 27

Delaminated and spalled concrete seen initiating from the interface between the slab and the top of beam.

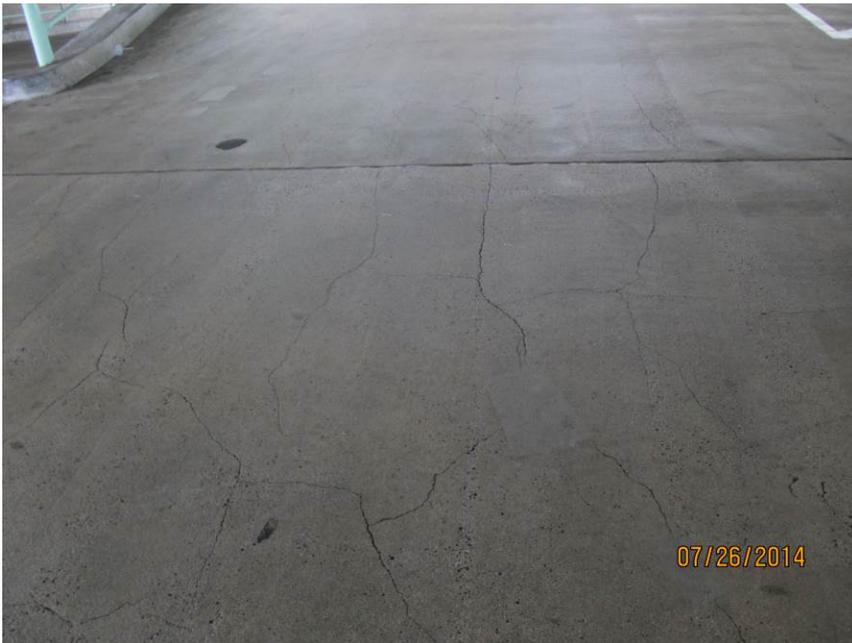
Photo 29

Typical floor cracks on second level.

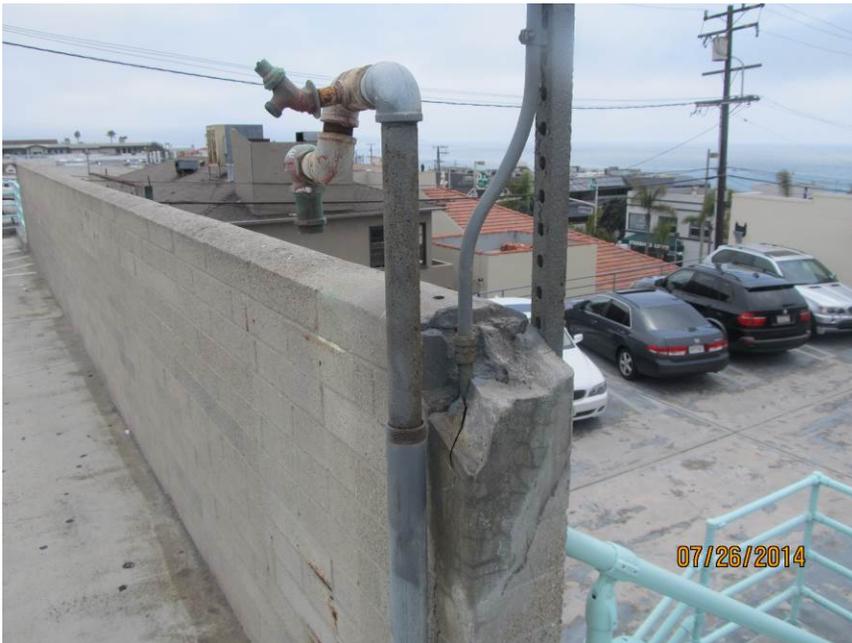
Photo 33

Damaged masonry wall on the west side of the structure.

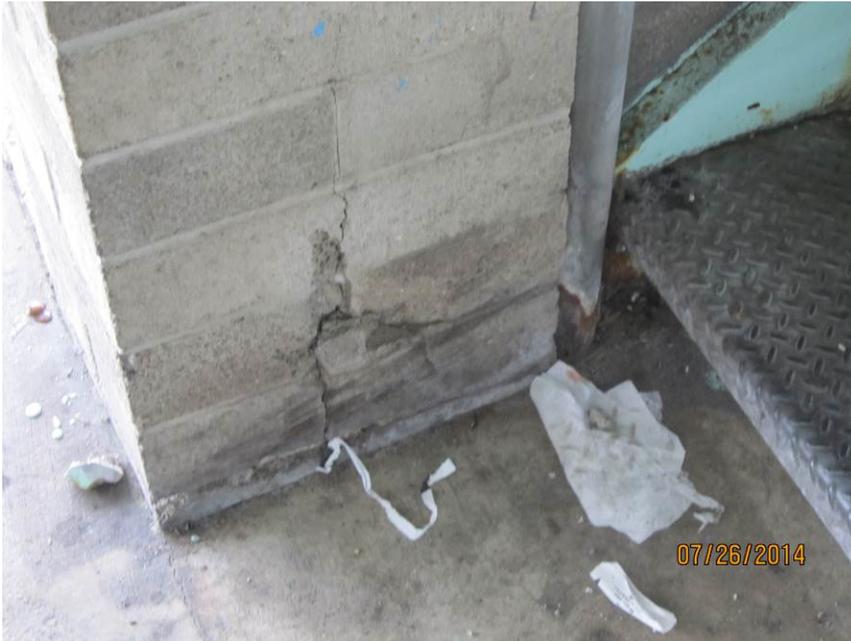
Photo 35

Large crack in a masonry wall.

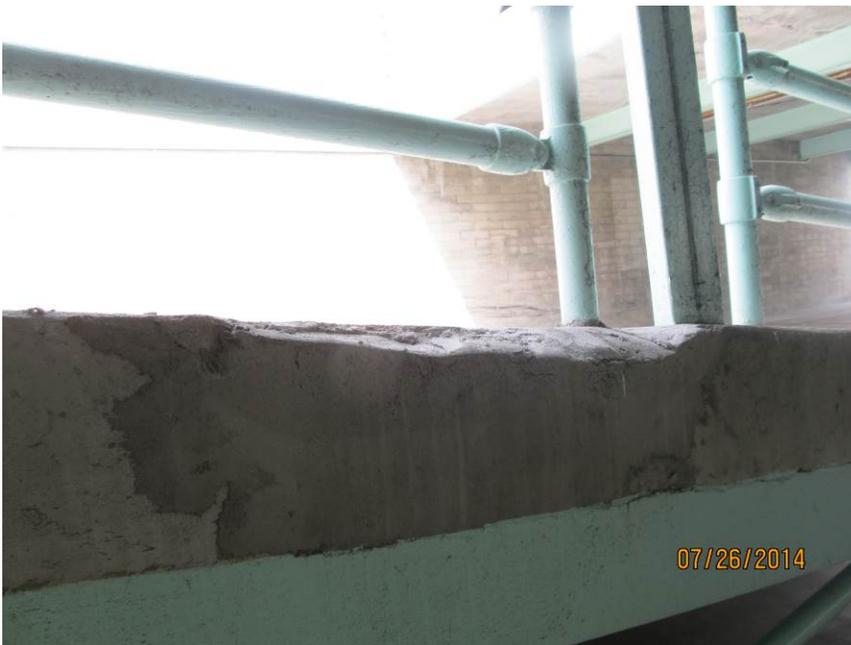
Photo 36

Photo 36: Previously patched curb at rail anchorage.

Previous curb patchwork at barrier rail connection.

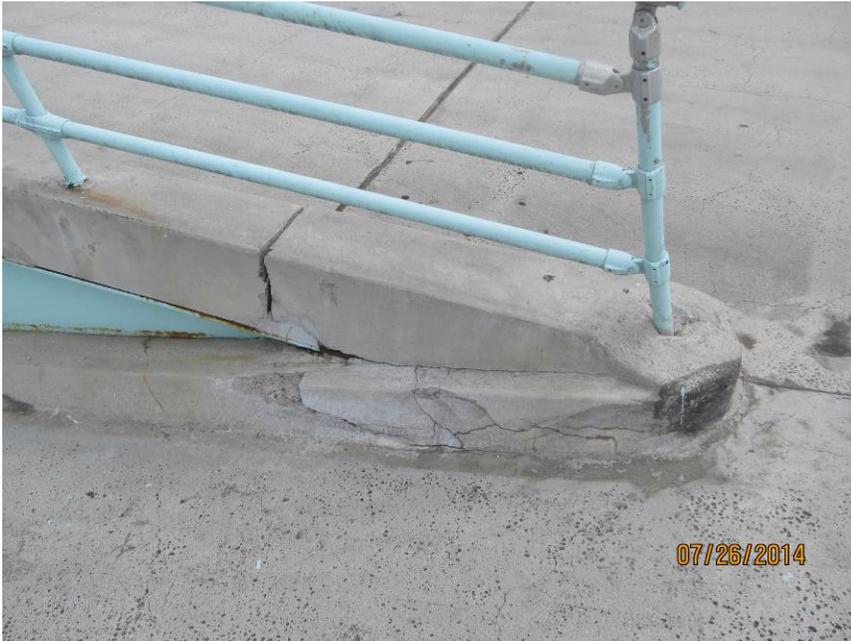
Photo 37

Previous patchwork and spalls seen in curb.

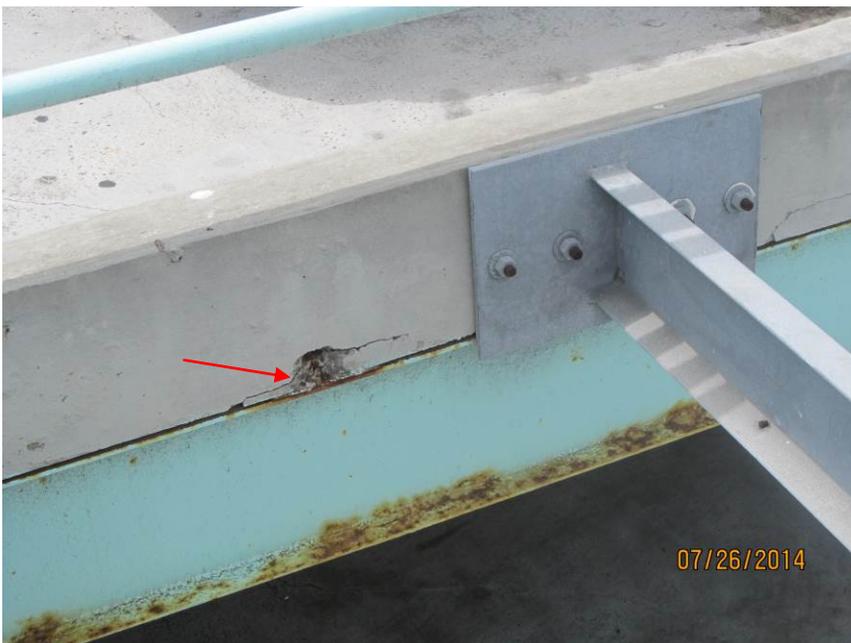
Photo 38

Spall in curb at shear stud location. Corrosion can also be seen in the supporting steel beam.

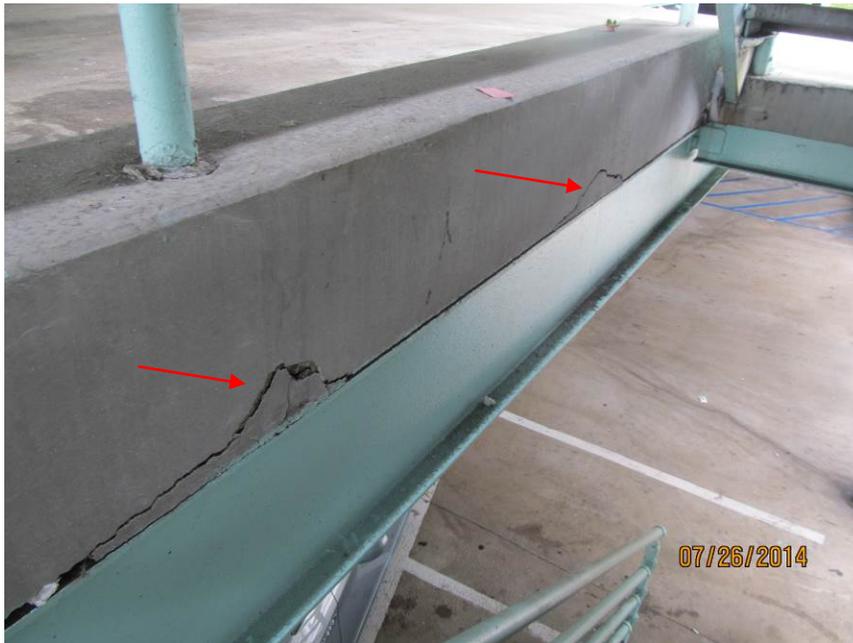
Photo 39

Spalls in curb at shear stud locations.

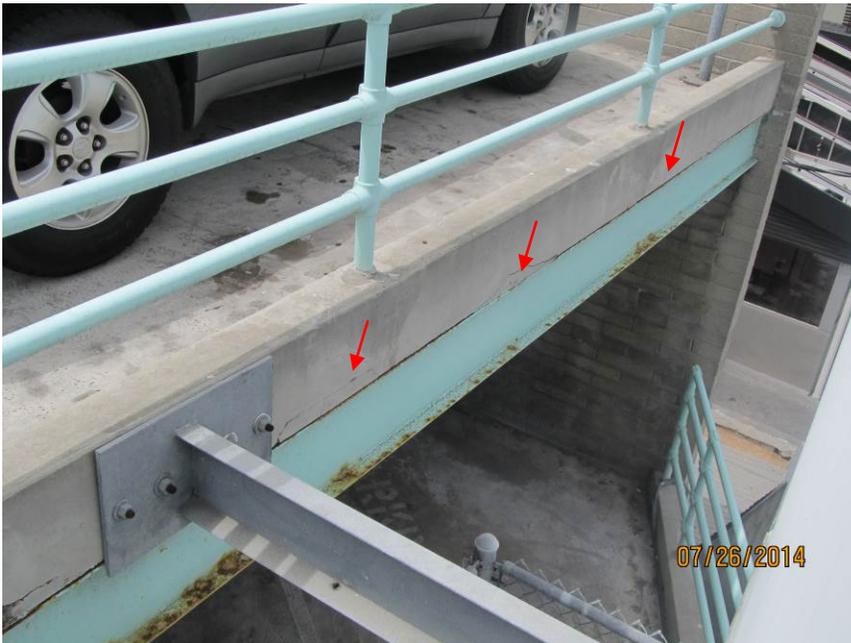
Photo 41

Spalls in curb at shear stud locations.

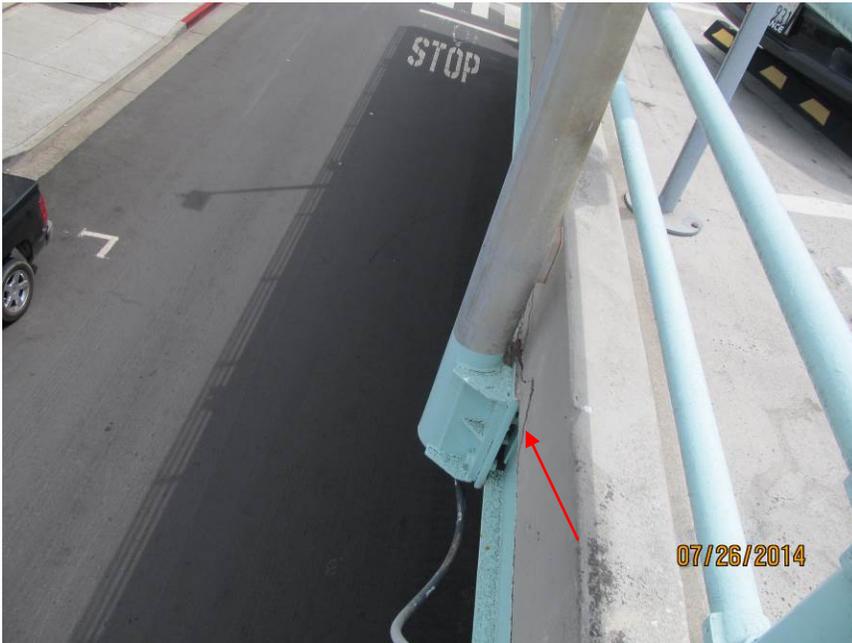
Photo 43

Spalling in the curb at the anchoring point of a roof level light post.

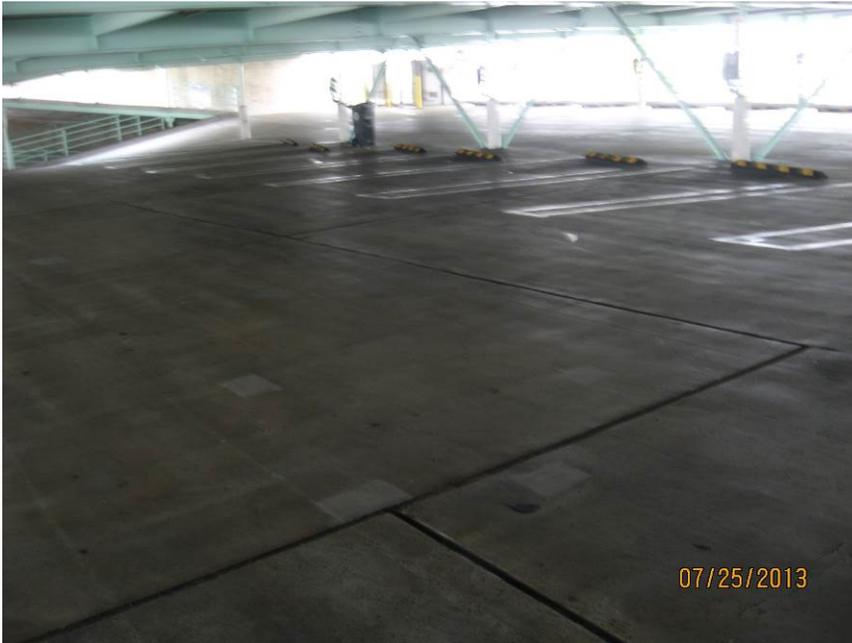
Photo 45

Typical control joints on the second level.

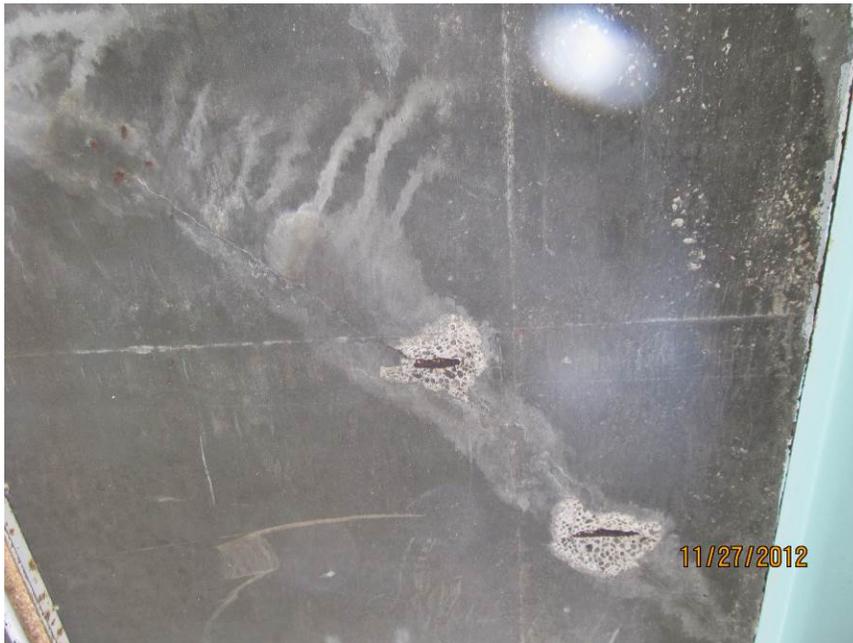
Photo 49

Efflorescence in the second level ceiling, a sign of active leakage through the slab.

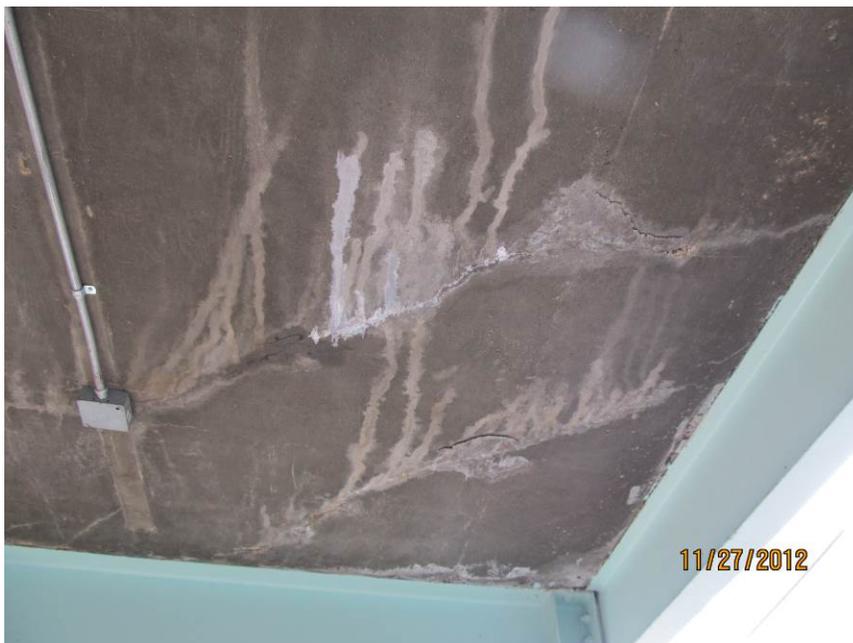
Photo 50

Efflorescence in the second level ceiling, a sign of active leakage through the slab.

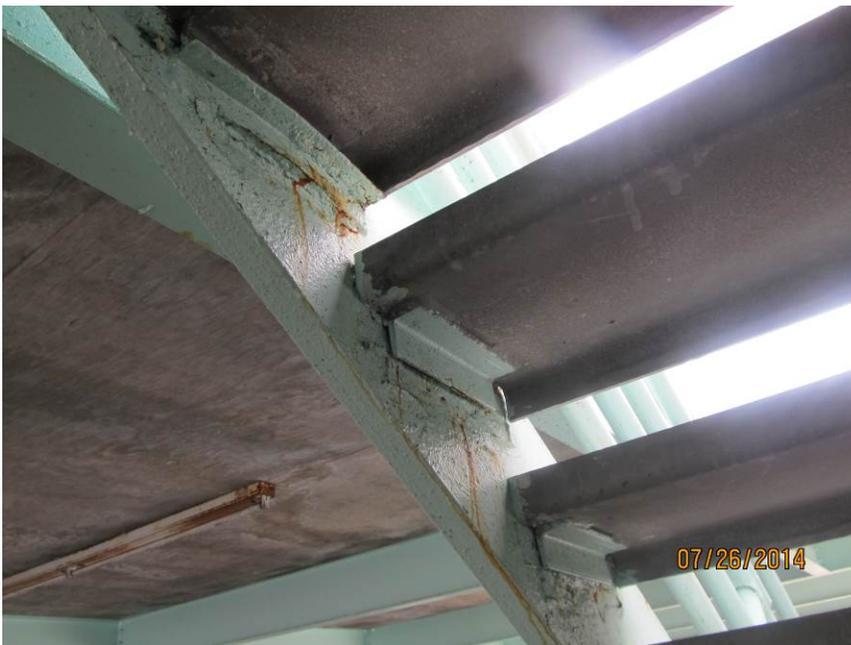
Photo 54

Steel connectors at the underside of the metal tread stairs showing signs of corrosion.

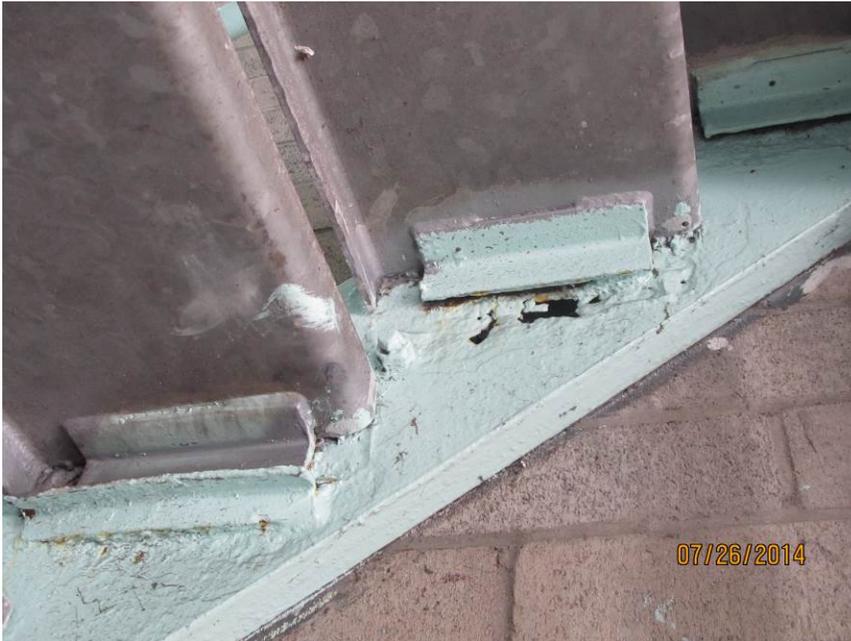
Photo 55

Photo 55: Deteriorated steel stair components.

Steel connectors at the underside of the metal tread stairs showing signs of deterioration.

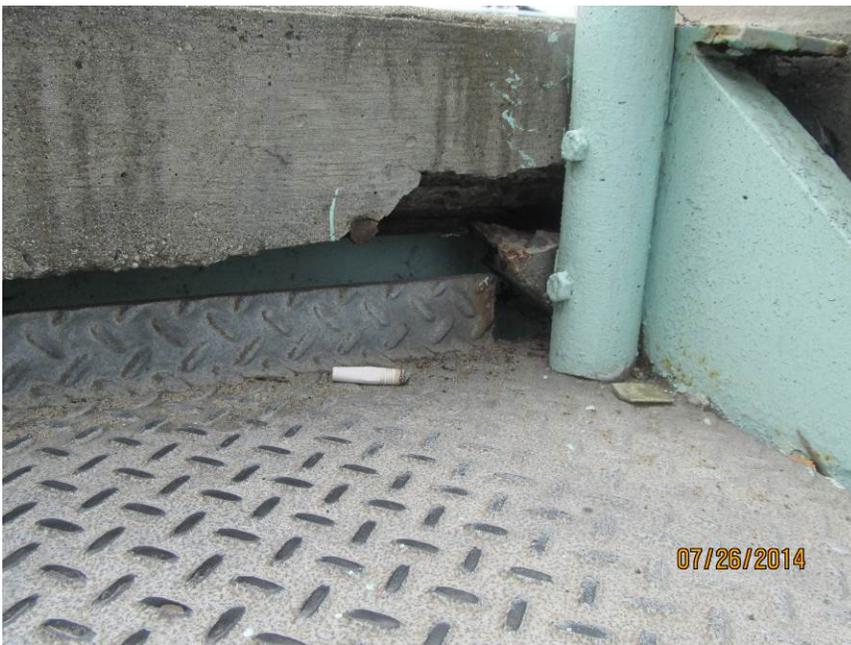
Photo 56

Photo 56: Damaged concrete at stair connection.

Damaged concrete at to stair connection to roof level slab.

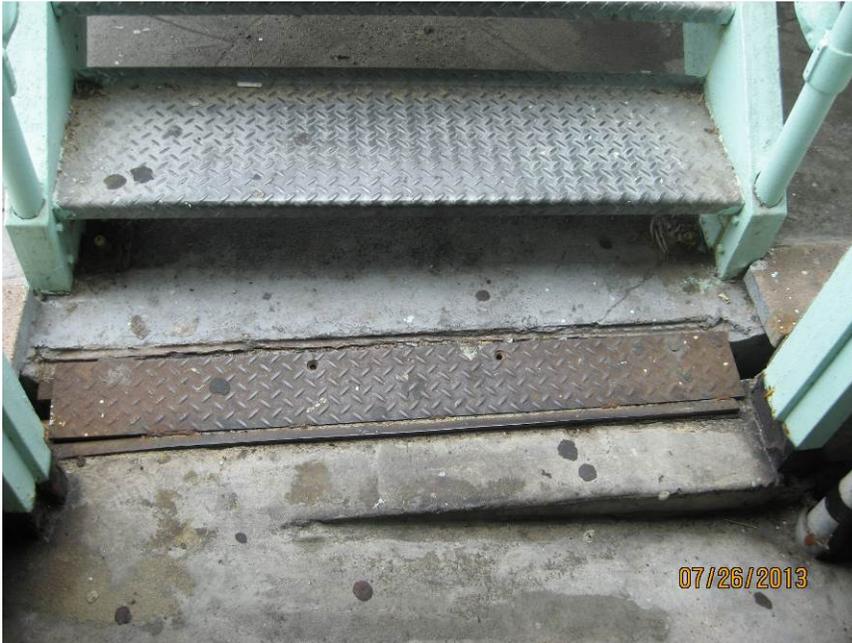
Photo 57

Deteriorated expansion joint at second level entry to west stairs.

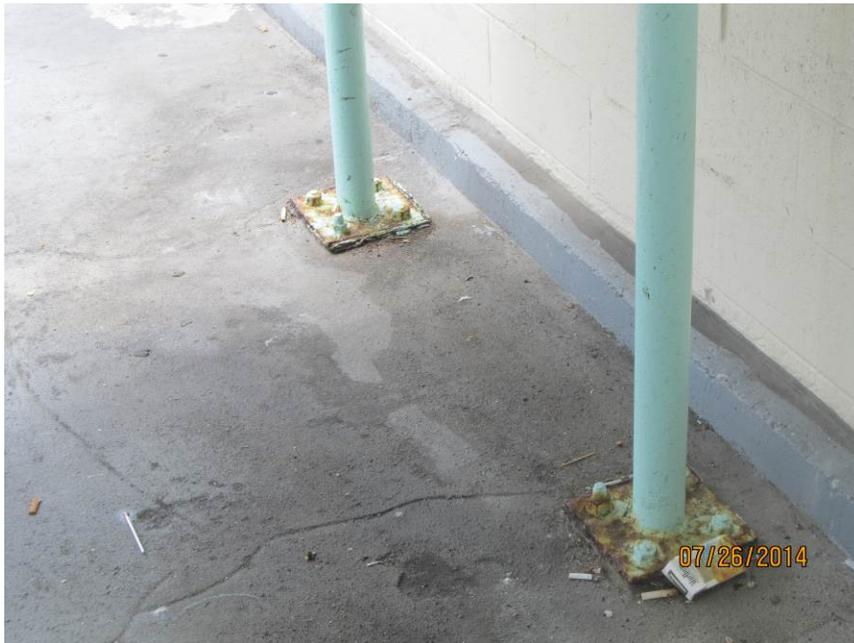
Photo 59

Deteriorating base plates (at posts supporting west stairs).

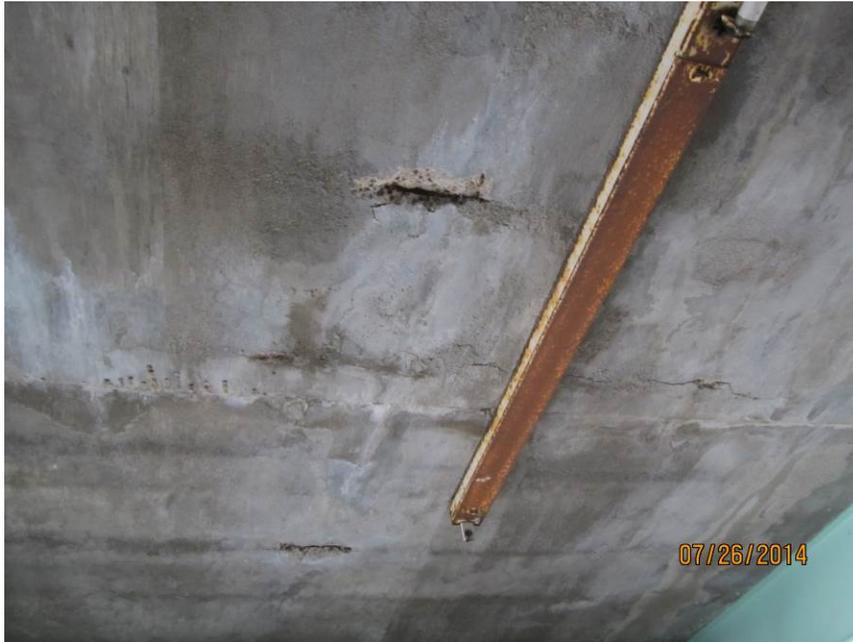
Photo 61

Corroded lighting fixture missing bulb.

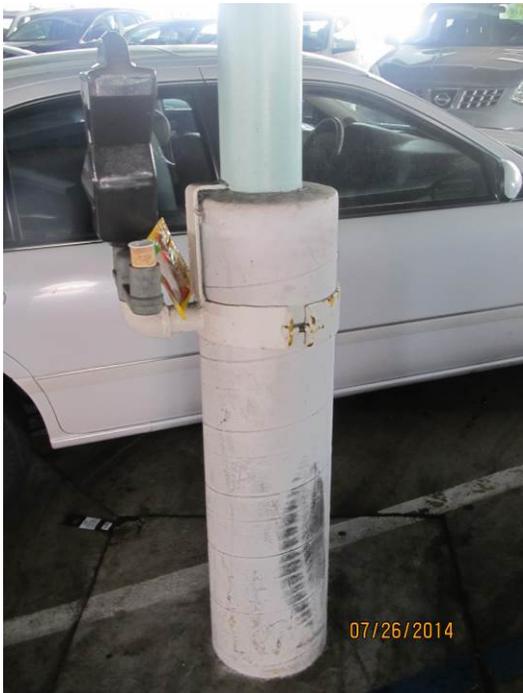
Photo 71

Typical steel column concrete enclosure that requires new paint.

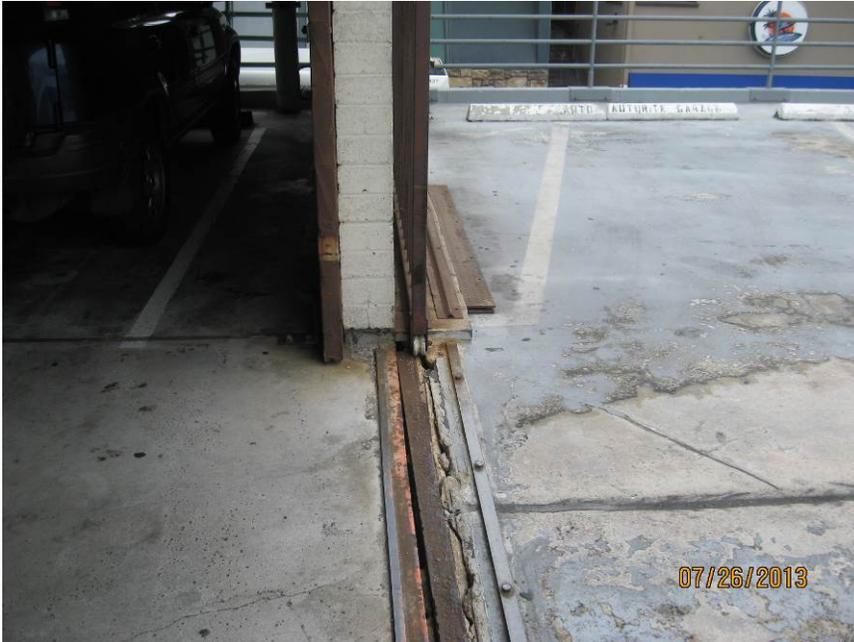
Photo 73

Deteriorated expansion joint at opening to adjacent property.

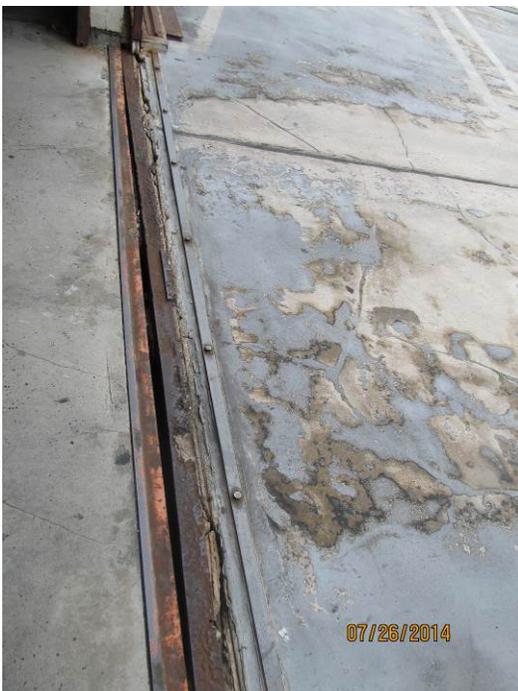
Photo 74

Photo 74: Deteriorated expansion joint.

Deteriorated expansion joint at opening to adjacent property.

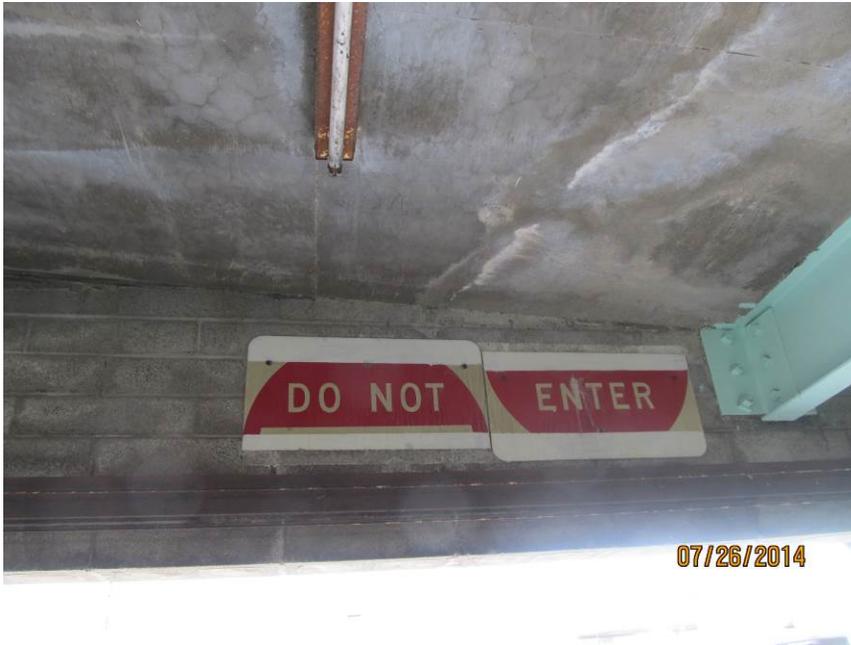
Photo 77

Makeshift signage above opening to adjacent property.

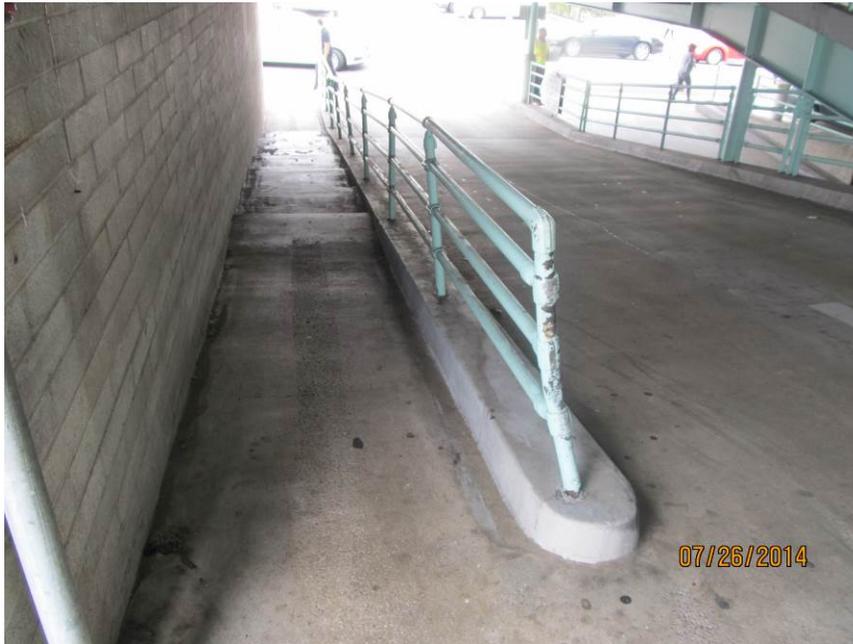
Photo 79

Pedestrian handrail  
damaged from vehicle  
impact.

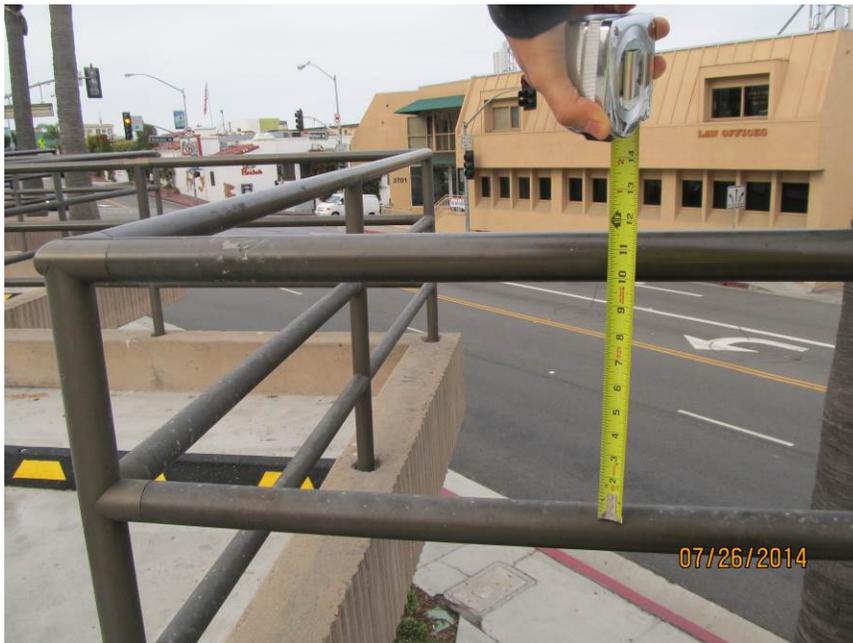
Photo 9

The spacing between horizontal members of barrier rails was measured to be 10". Current code limits this spacing to 4".

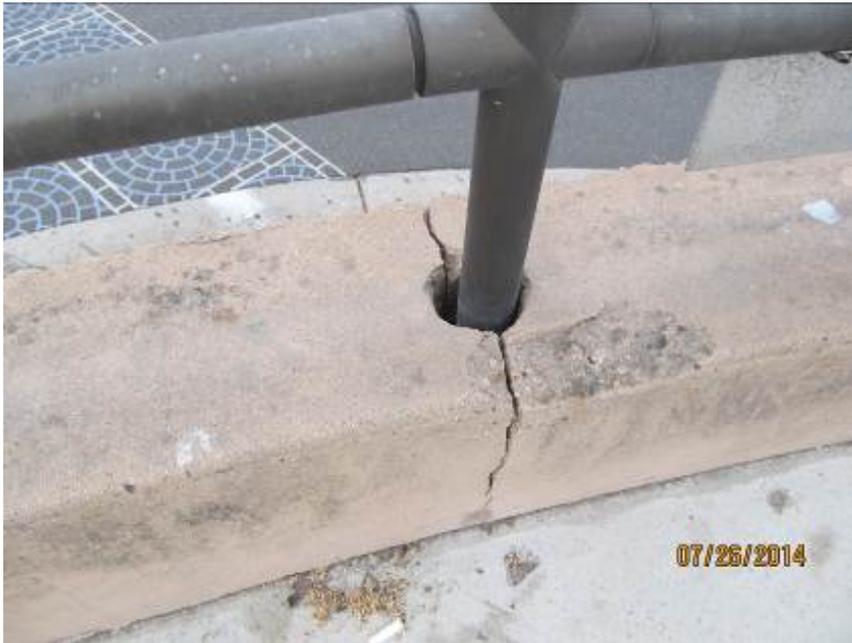
Photo 13

Cracking in concrete curb at rail mount location.

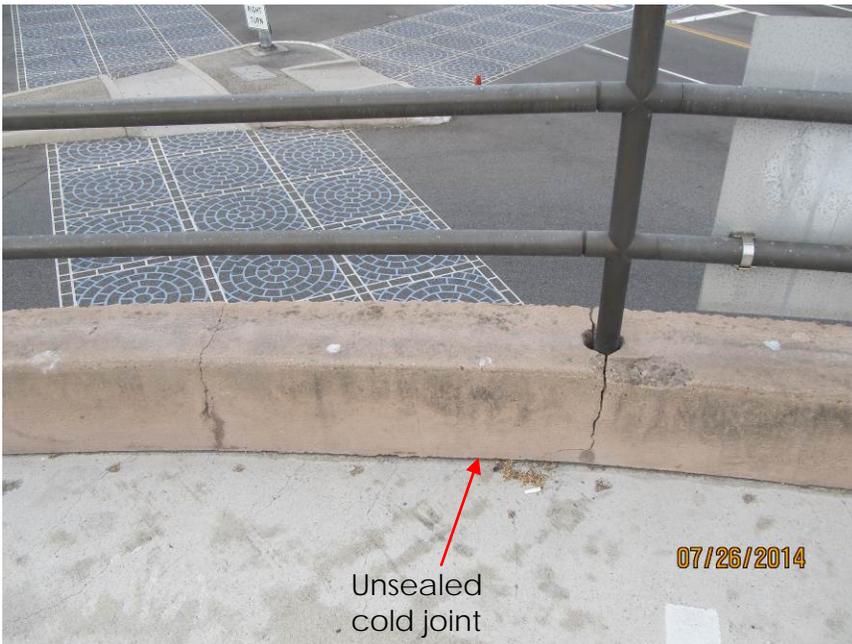
Photo 14

Cracking in perimeter concrete curb seen at various locations. The curb can also be seen unsealed and separating from the elevated slab.

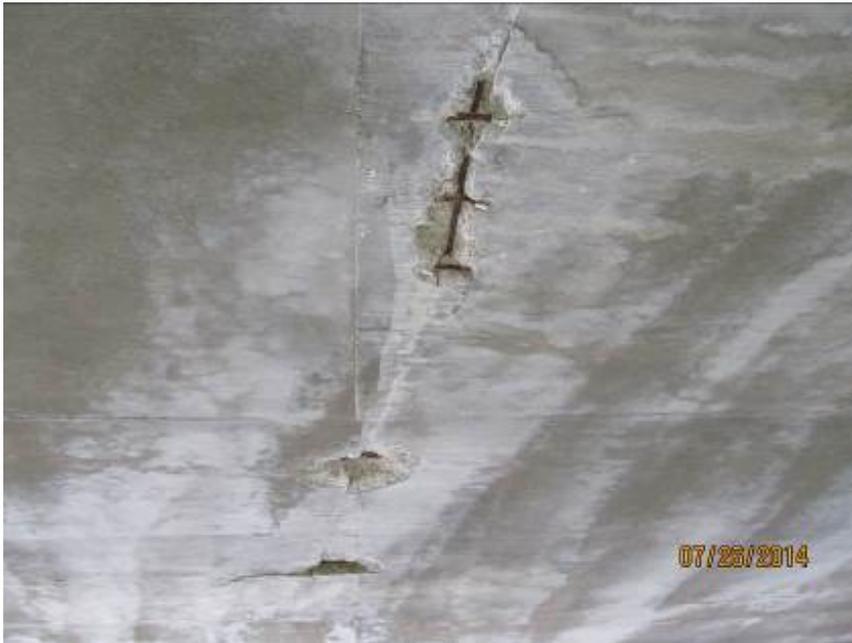
Photo 15

Spalled concrete in ceiling, which has exposed embedded reinforcement.

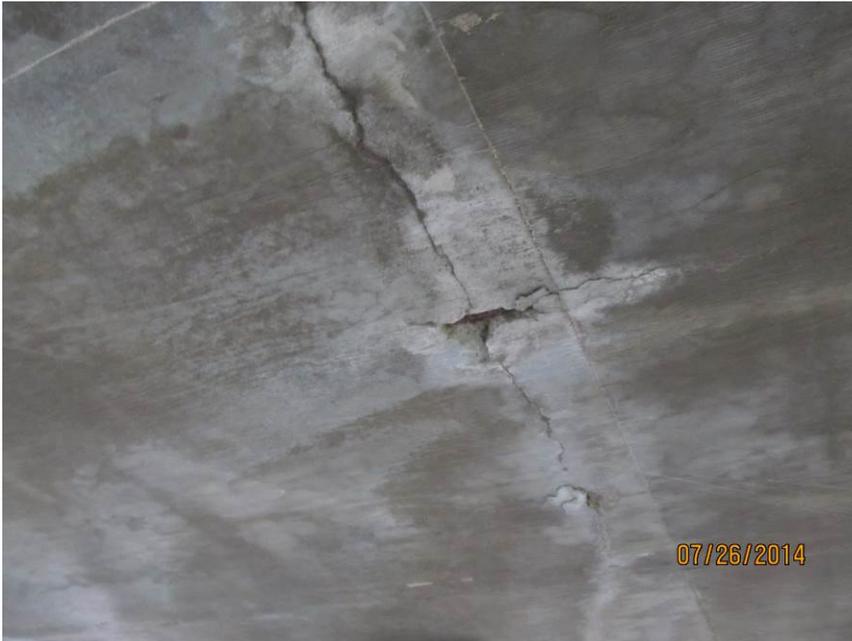
Photo 17

Spalled concrete and cracking in the ceiling.

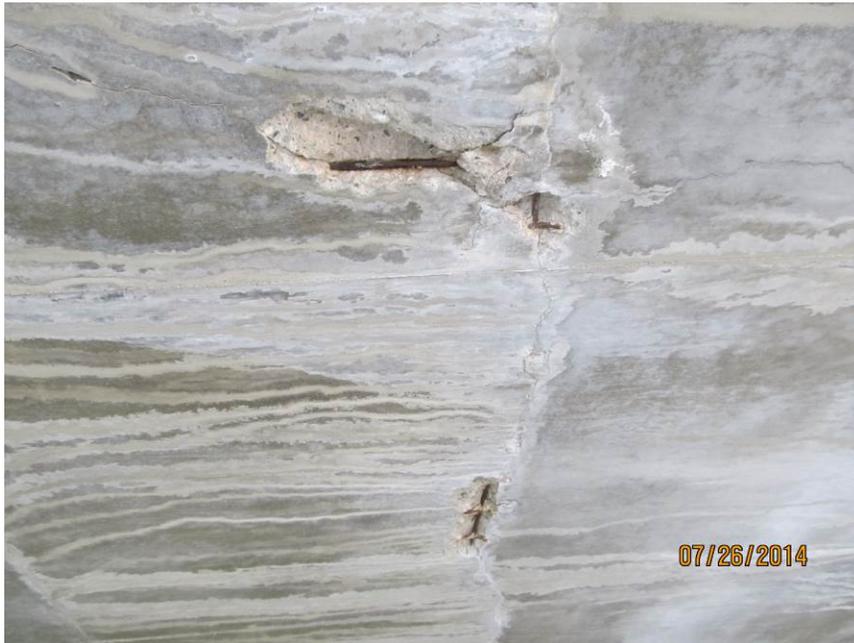
Photo 19

Spalled concrete and extensive efflorescence in the ceiling.
