CAPITAL IMPROVEMENT AND  
PROTECTION PROGRAM

CITY OF MANHATTAN  
BEACH PARKING  
STRUCTURES  
LOTS 2, 3 & 4

Prepared for:  
CITY OF MANHATTAN BEACH  
PROJECT NO. 37-8377.00

SEPTEMBER 2013

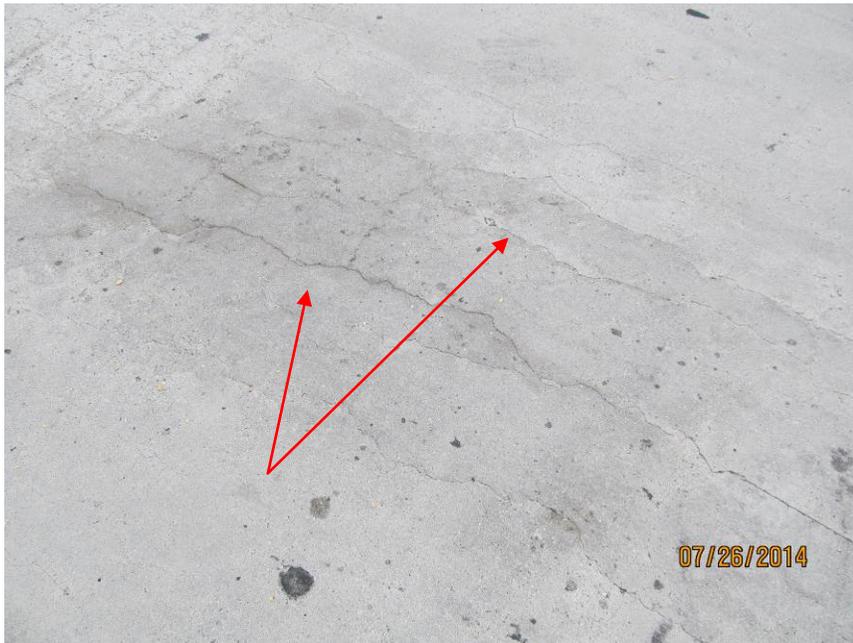
Photo 23

Typical floor cracks on the upper level.

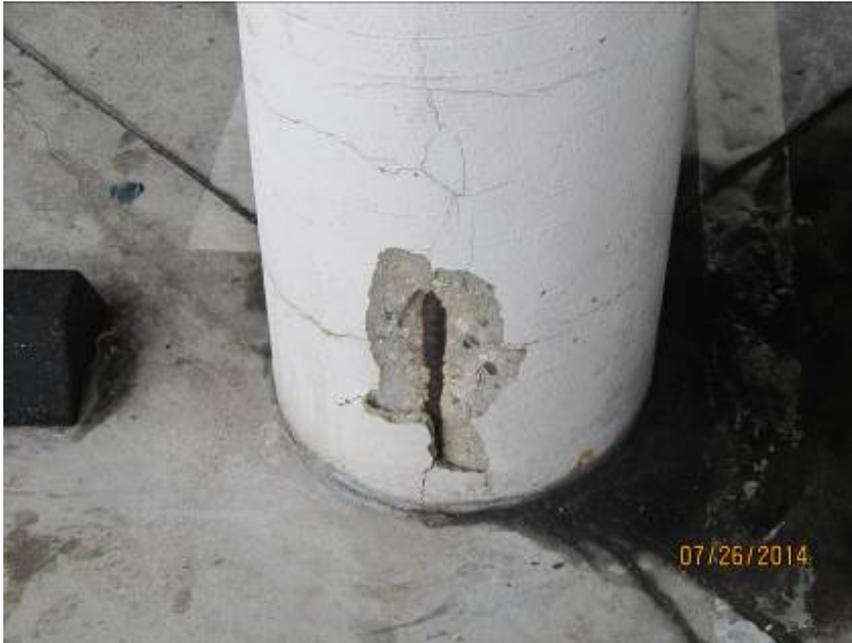
Photo 25

Spalling and cracking at the base of a column.

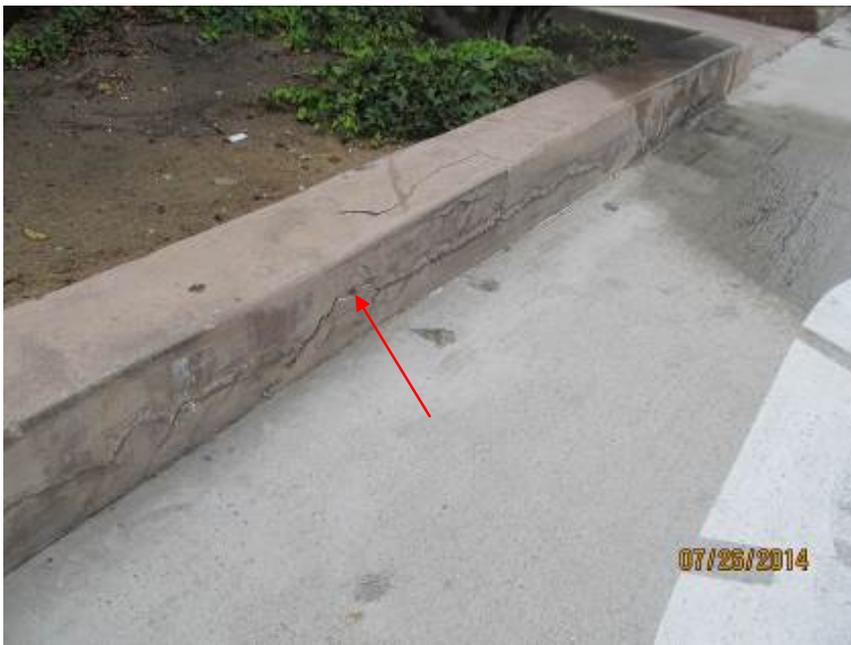
Photo 28

Extensive cracking in the curb adjacent to a planter.

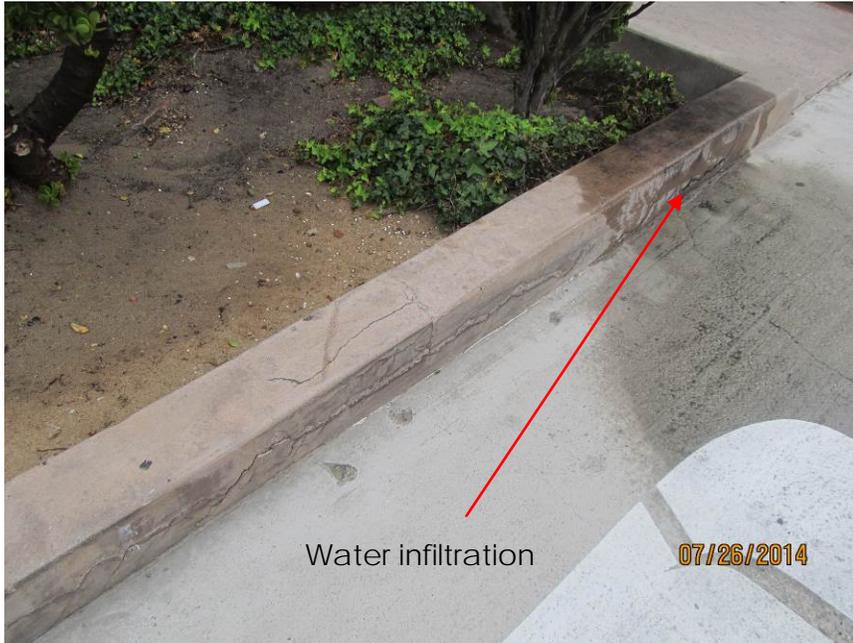
Photo 29

Extensive cracking in the curb adjacent to a planter.

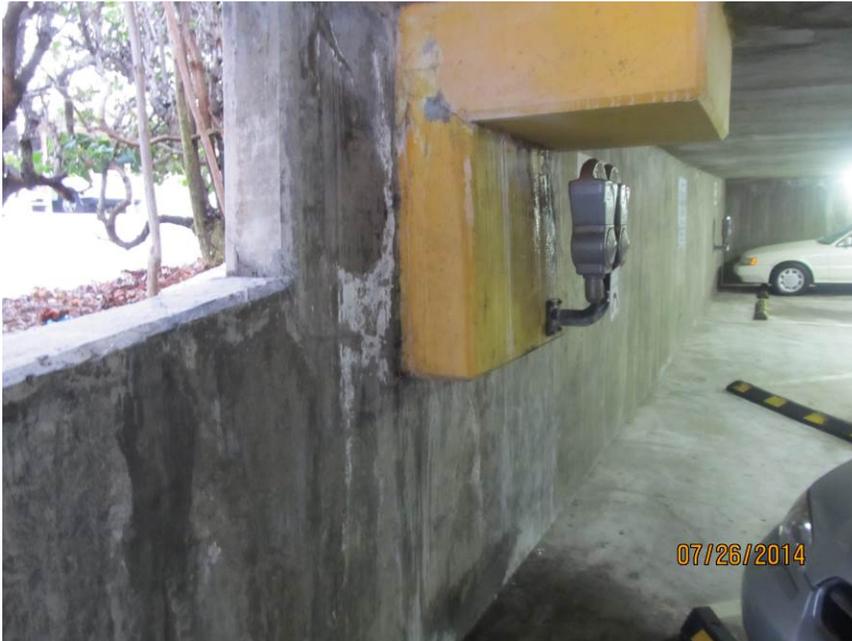
Photo 31

Signs of active leakage surrounding concrete drain enclosure (yellow).

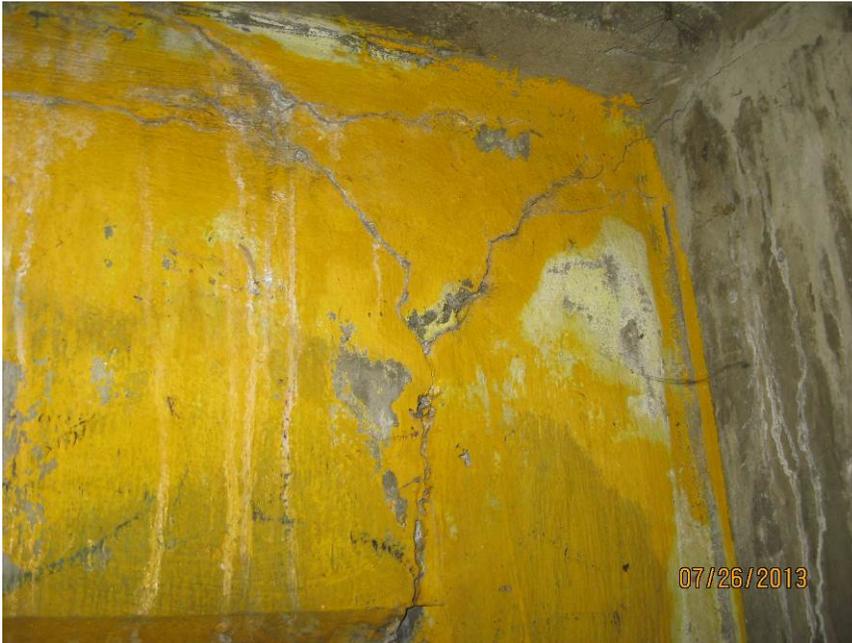
Photo 33

Extensive cracking in the concrete drain enclosure.

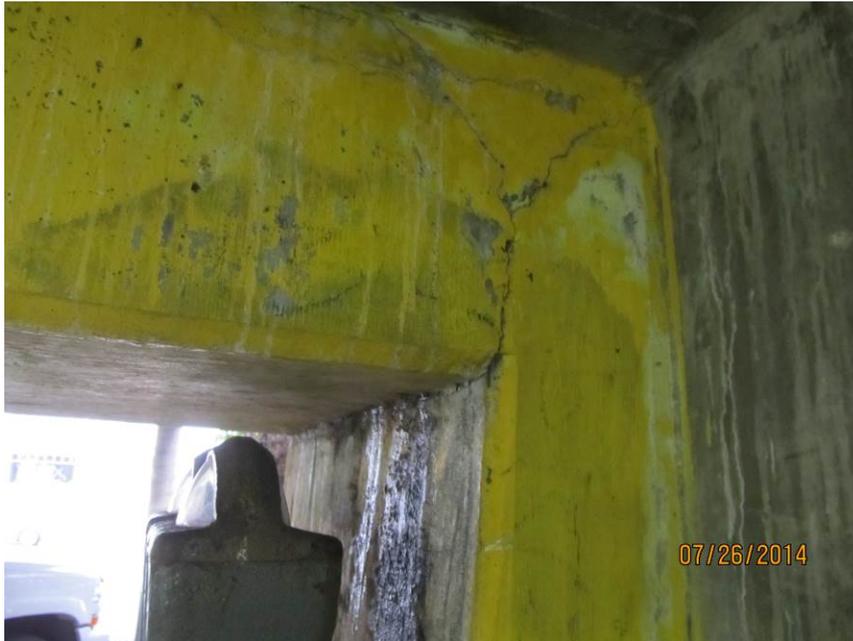
Photo 35

Extensive cracking and active leakage in the concrete drain enclosure.

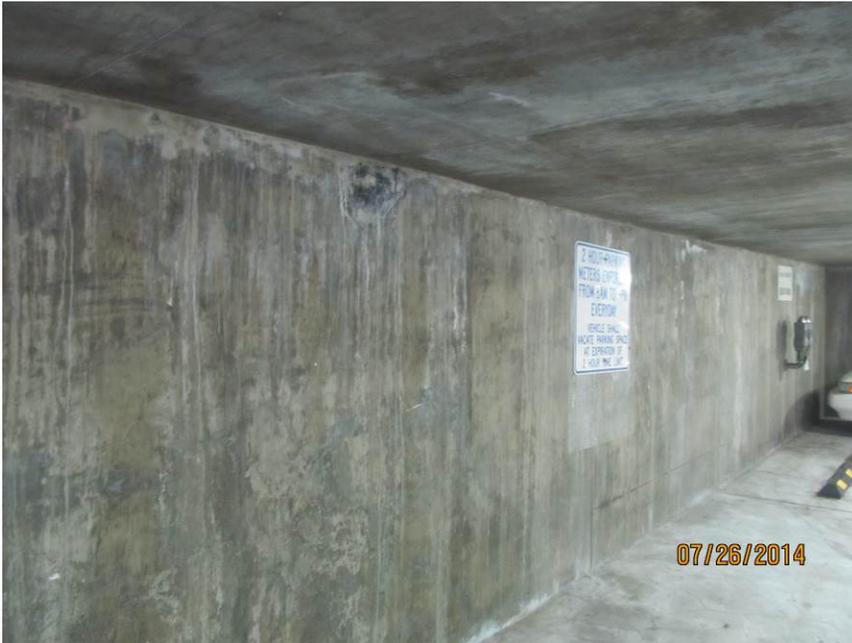
Photo 37

Staining showing active water infiltration through a concrete retaining wall.

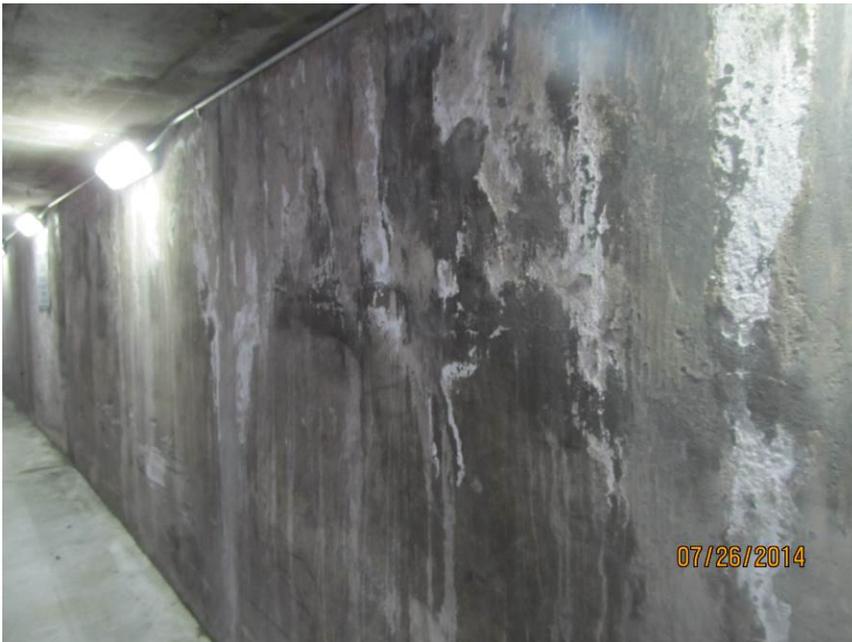
Photo 38

Staining showing active water infiltration through a concrete retaining wall.

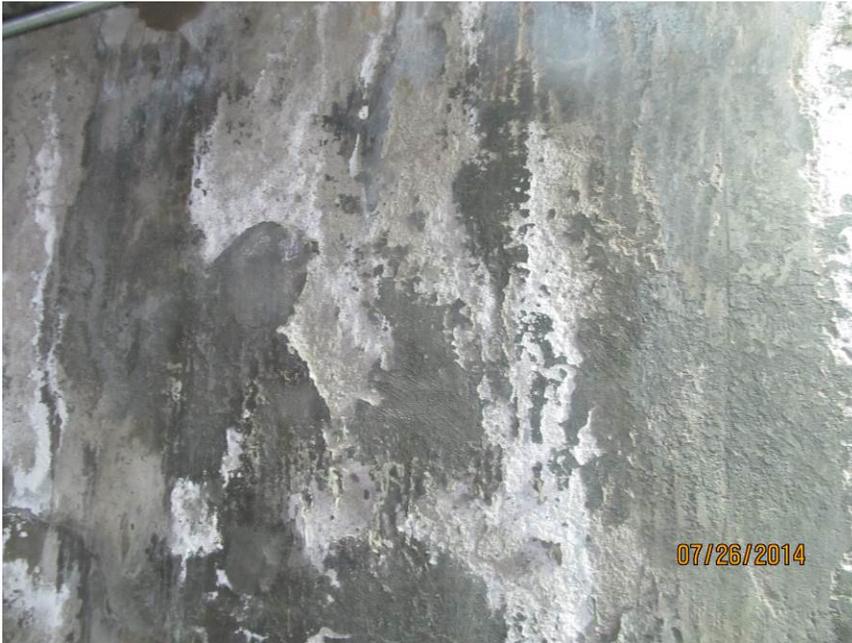
Photo 39

Damaged concrete due to moisture infiltration through the retaining wall.

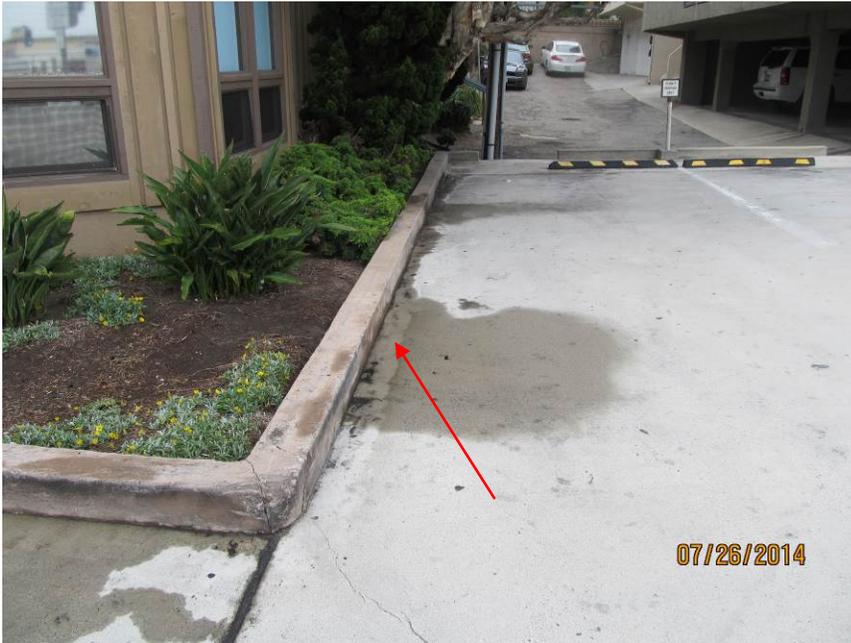
Photo 47

Water from sprinklers collecting near the unsealed joint between the curb and the slab.

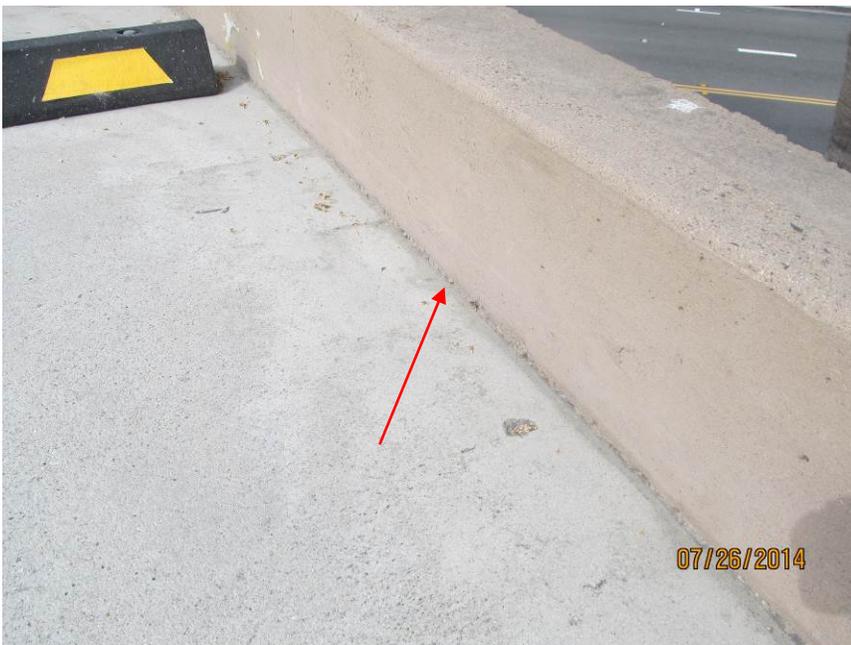
Photo 48

Deteriorated sealant at cold joint between curb and floor slab.

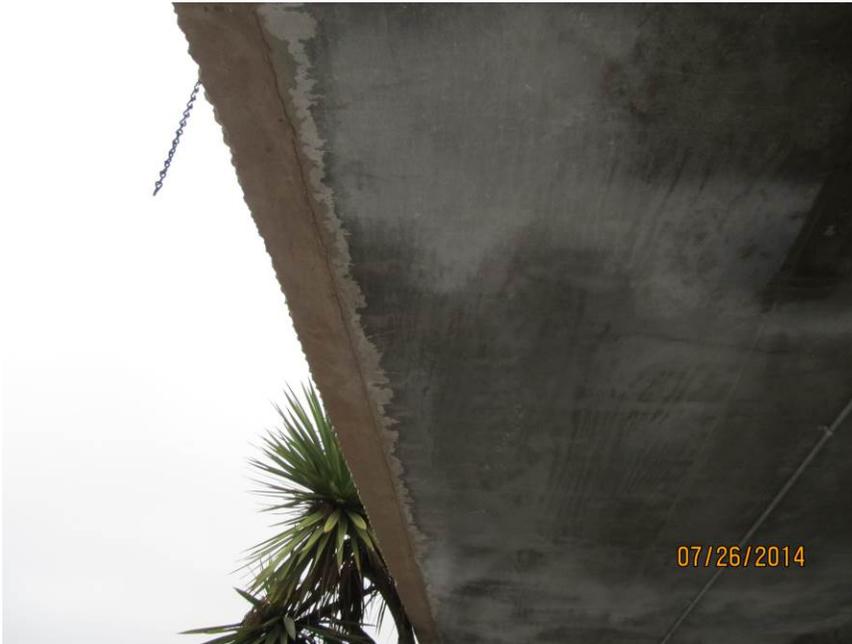
Photo 49

Staining around the perimeter of the ceiling.

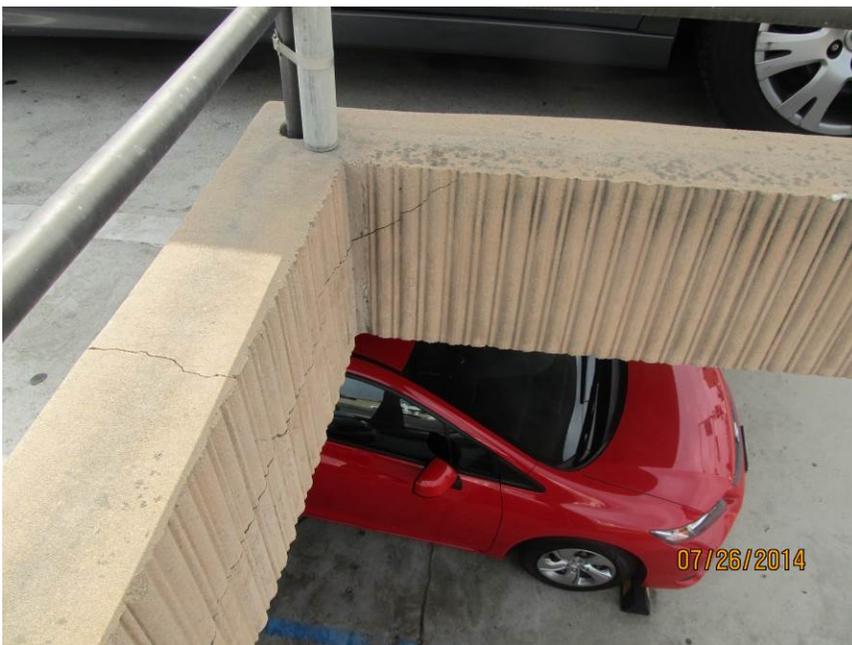
Photo 50

Cracking seen in perimeter curb/façade.

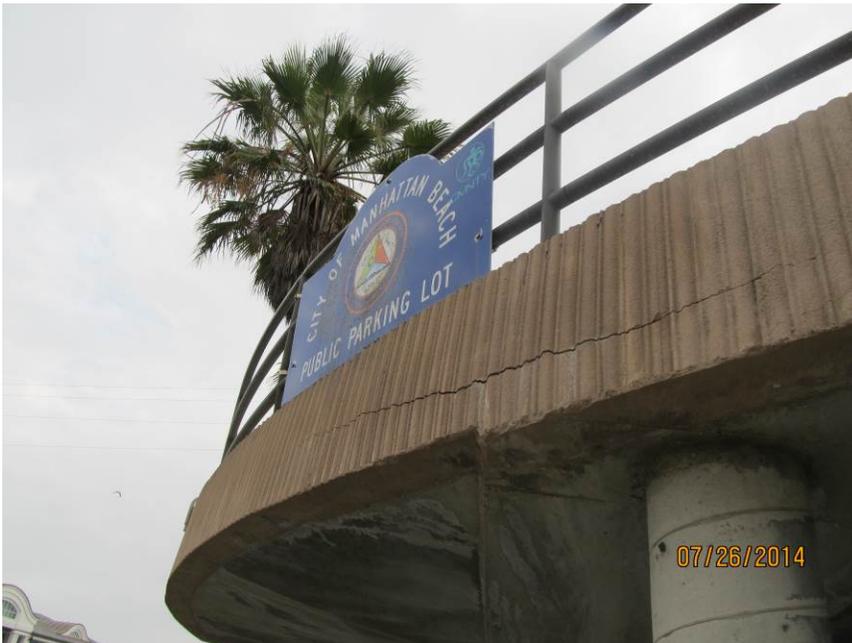
Photo 51

Cracking seen in perimeter curb/façade.

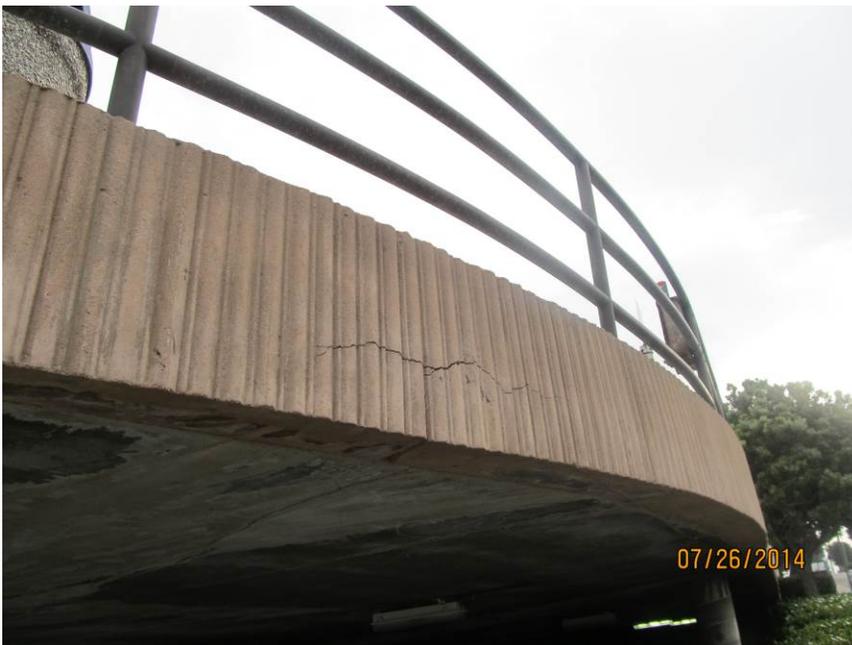
Photo 52

Cracking seen in perimeter curb/façade.

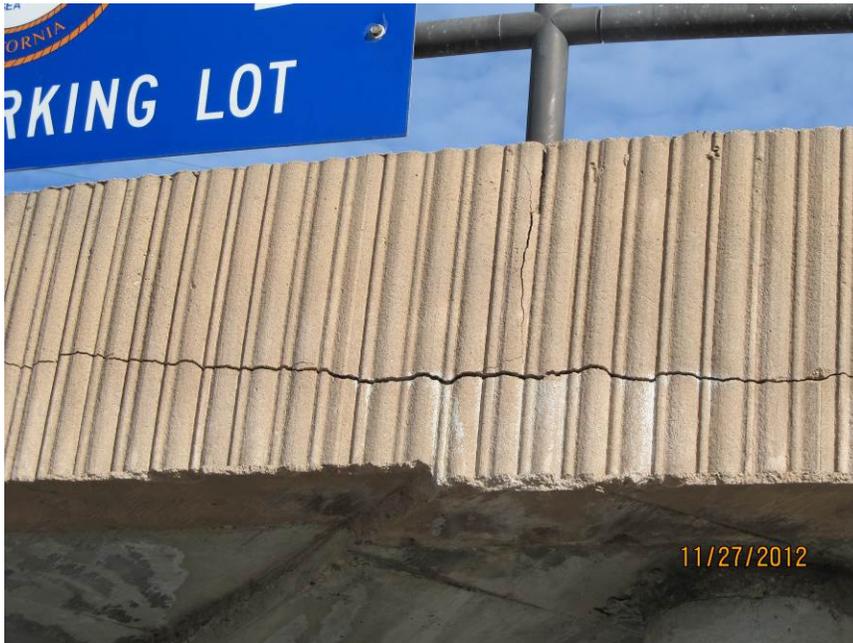
Photo 53

Cracking seen in perimeter curb/façade.

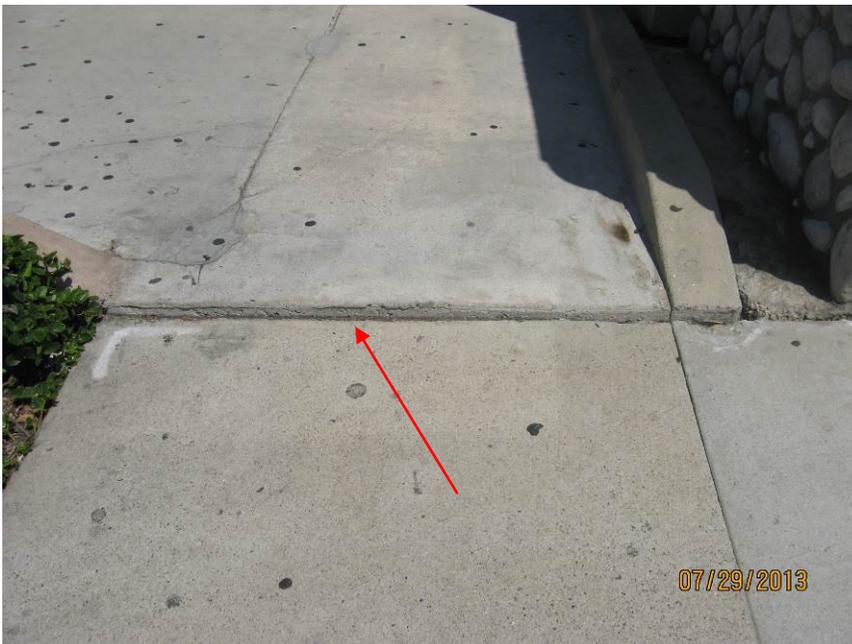
Photo 59

Trip hazard at pedestrian entry to upper level from Rosecrans Ave.
