Citywide
Facility Condition Assessment

Report of
Facility Condition Assessment

For
City of Manhattan Beach
Public Safety Building and Fire Station No. 1
400-420 15th Street, Manhattan Beach, CA

*September 4, 2013
(Rev A)*

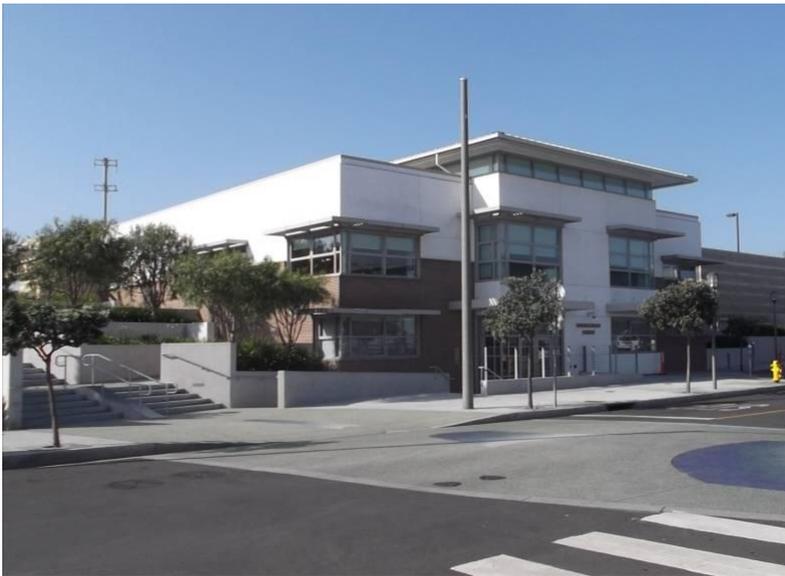
Photograph 1

View of the south façade, facing 13th Street

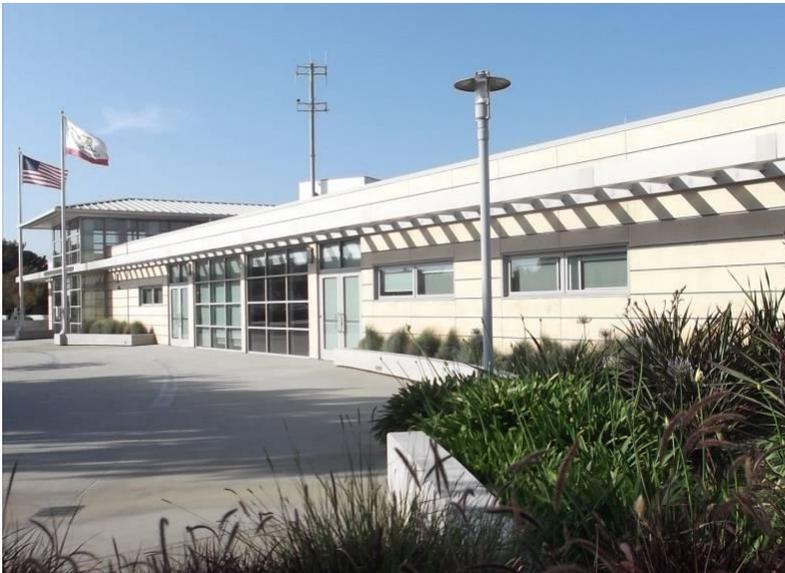
Photograph 2

View of the west façade, facing the public plaza

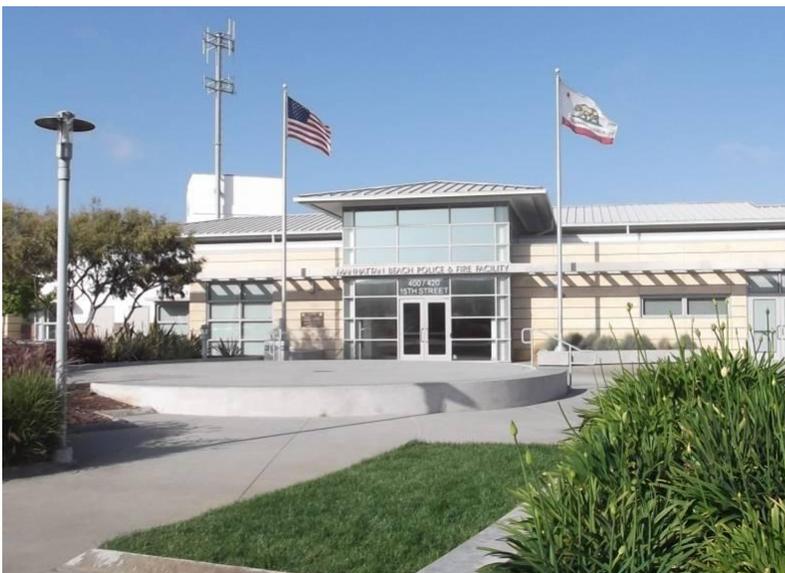
The site contains concrete sidewalks along the public roadways along its north, east and south boundaries, with the pavement at the north end of the site having memorial sculpture and precast concrete benches and the south end having concrete steps and ramp for access to the building's basement level (reference Photographs 4 and 9 in Appendix B). The steps and ramp have painted metal railings placed on bordering concrete walls. At the west side of the building, the entrance to the building is from a concrete-paved municipal plaza shared with the adjacent City Hall (reference Photograph 3 in Appendix B).

View of the main entrance at the west side of the building, from the public plaza

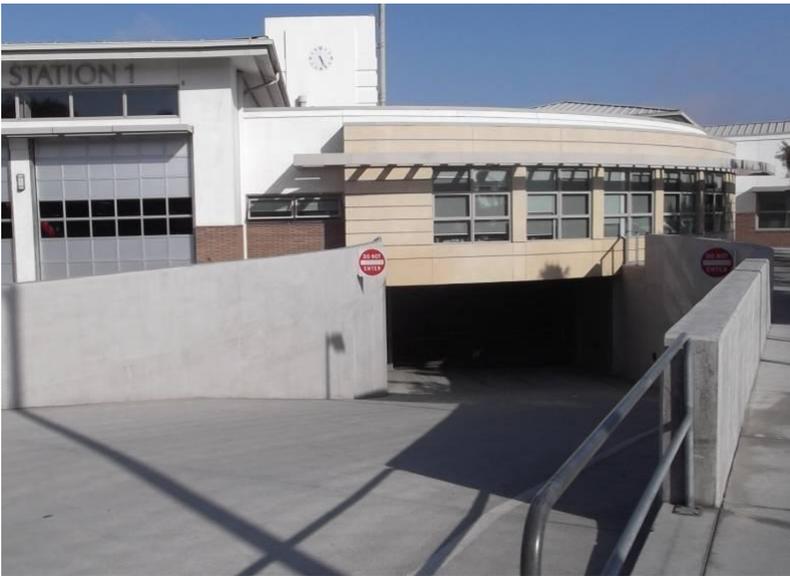
Retaining walls, steel-reinforced concrete of varying height and approximately 10" wide, are provided at each side of the ramped garage entrance/exit driveways at the northwest corner and along the east side of the building (reference Photograph 4 in Appendix B). Planters with steel-reinforced concrete walls are integrated into retaining walls along steps and walkways leading to the public plaza at the west side of the building.

View of the basement parking garage exit at the northwest corner of the building

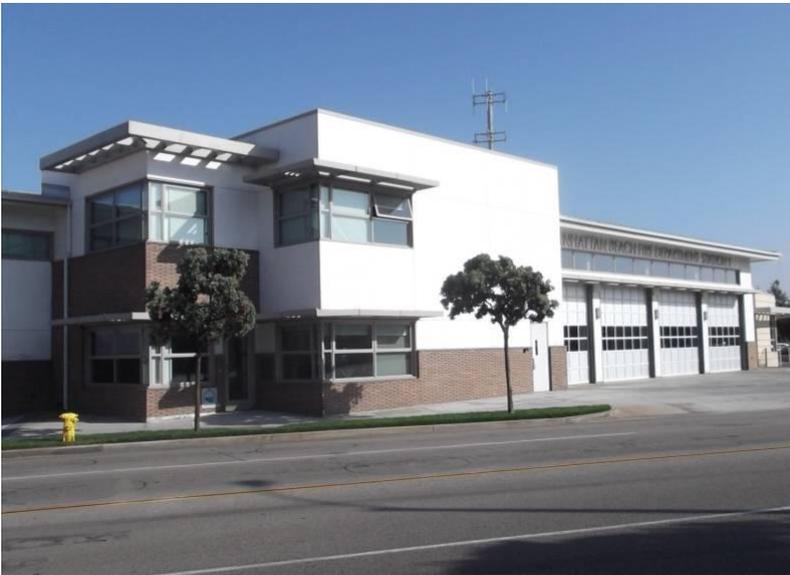
Photograph 5

View of the north façade of the building, facing 15th Street

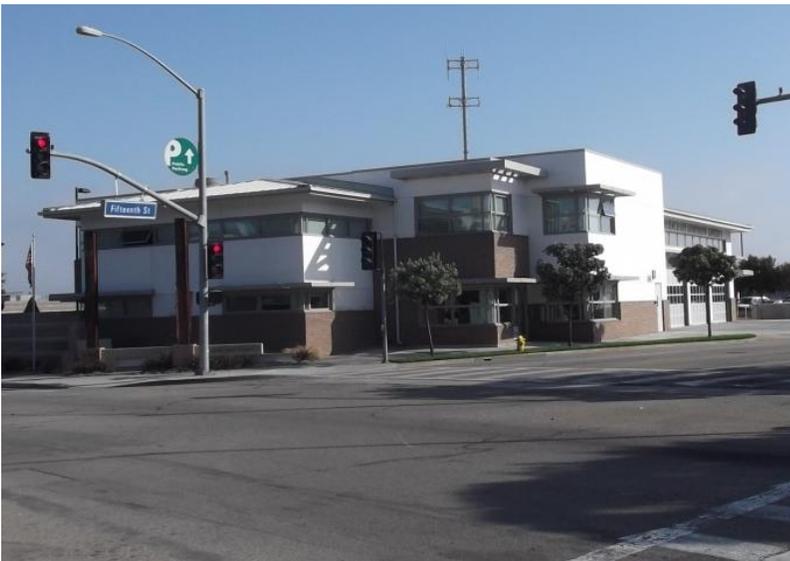
Photograph 6

View of the north and east facades, facing the intersection of 15th Street and North Valley Drive

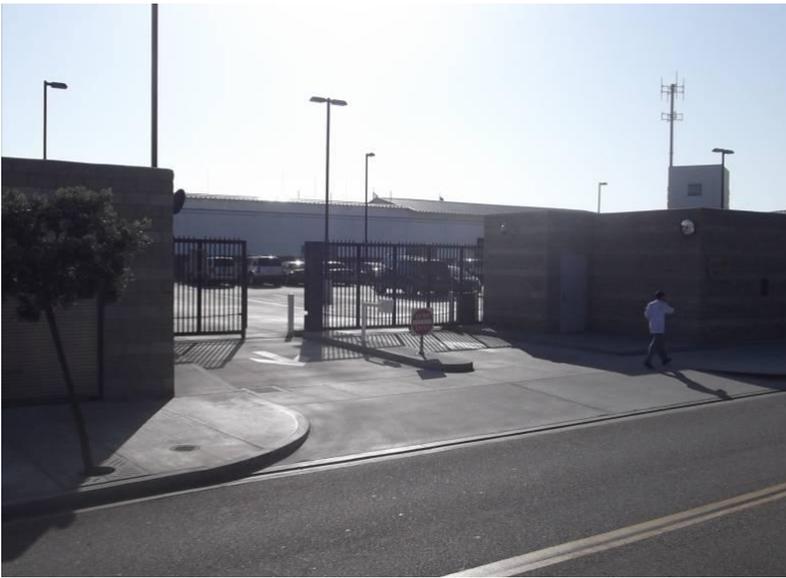
The parking deck entrances are secured by rolling steel gates with motorized chain-drive operators that are controlled by proximity readers and card keys (reference Photograph 7 in Appendix B). The gates are located at the southeast and northeast corners of the parking deck, along North Valley Drive.

View of the secured parking entrance from North Valley Drive

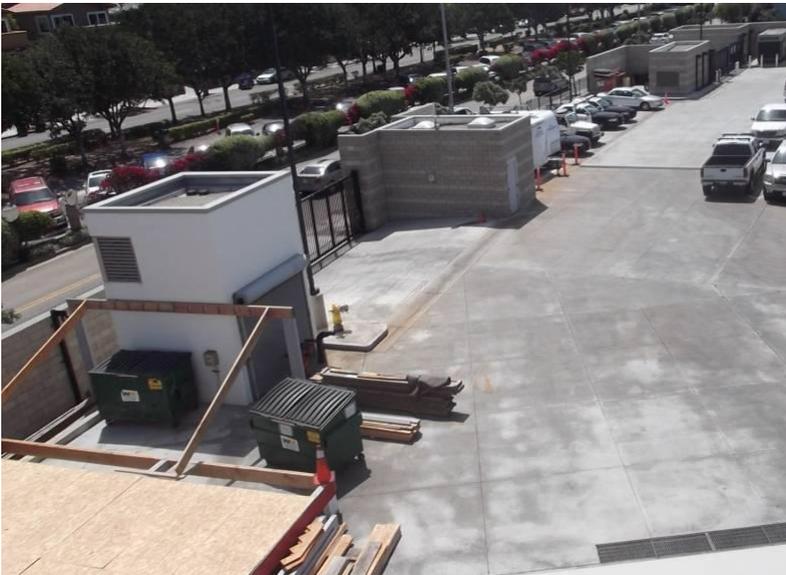
Photograph 8

Overview of the surface parking deck, looking southeast

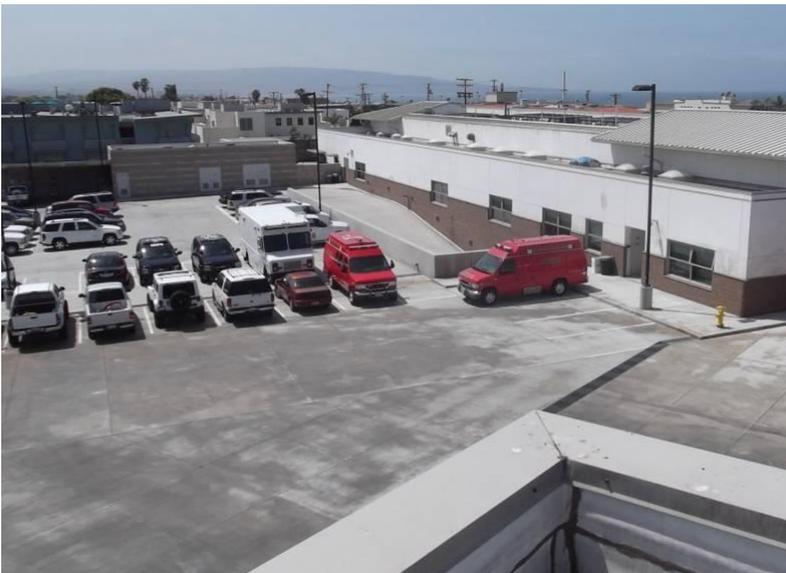
Photograph 9

Overview of the surface parking deck, looking southwest

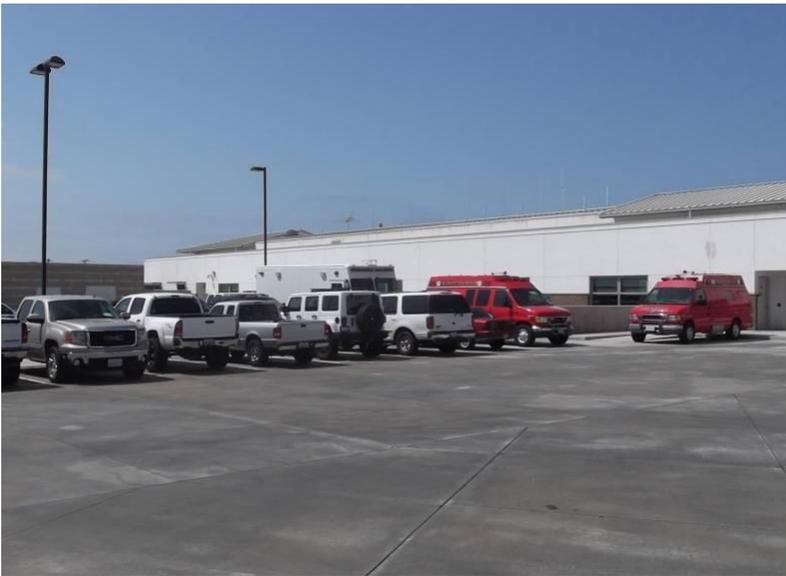
Photograph 10

View of the concrete surface parking deck

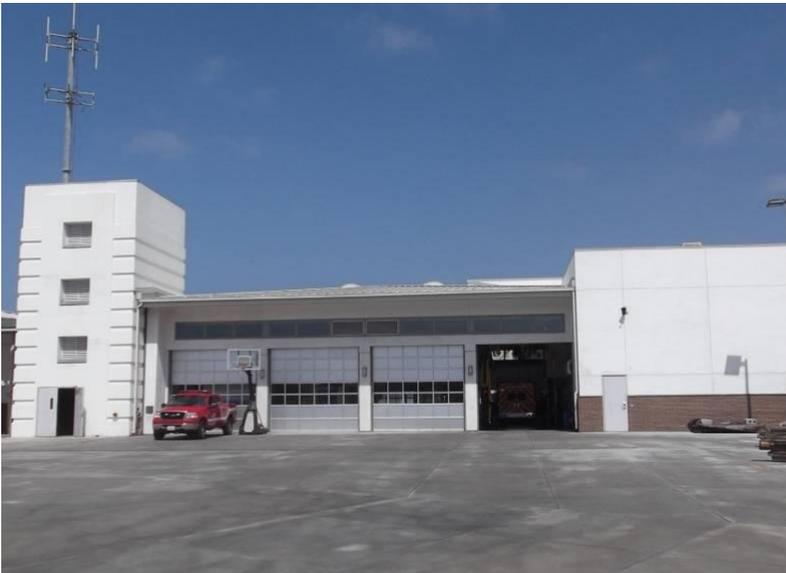
Photograph 11

View of the south façade of Fire Station No. 1 and the apparatus bays' entrances

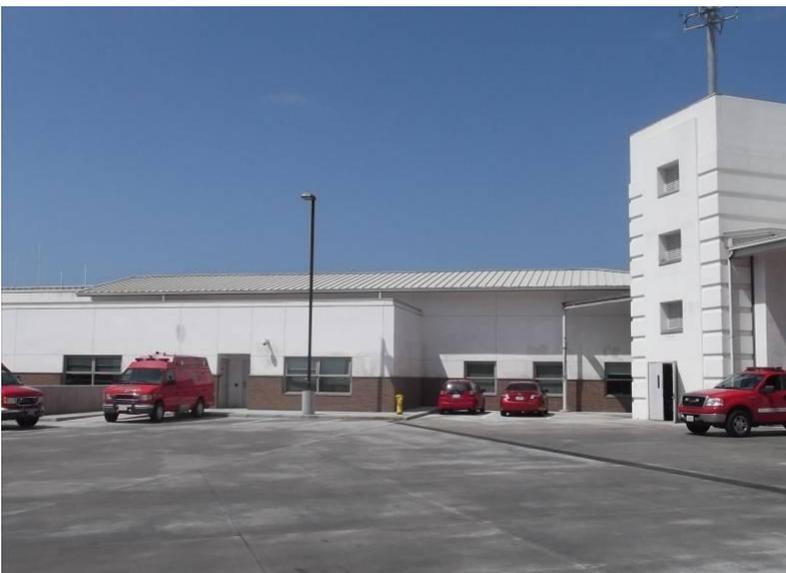
Photograph 12

View of the east façade of the Public Safety Building

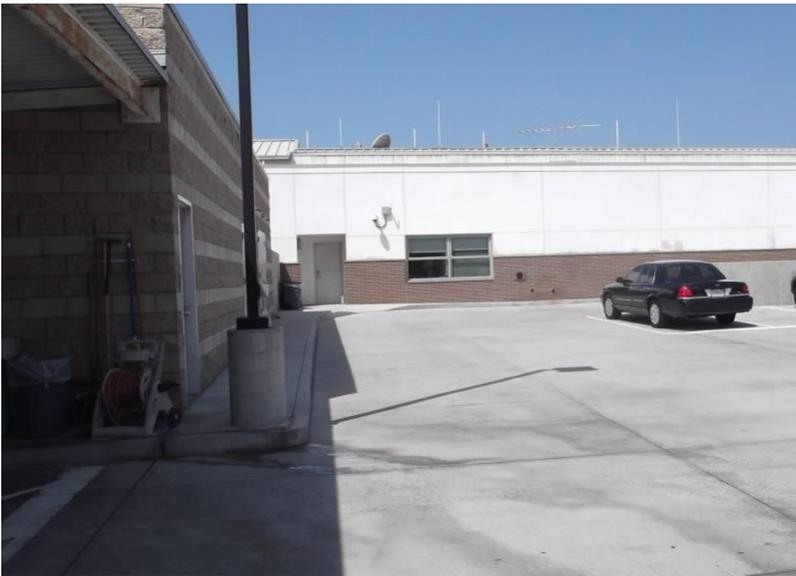
Photograph 13

View of the east façade of the Public Safety Building and the mechanical equipment structure

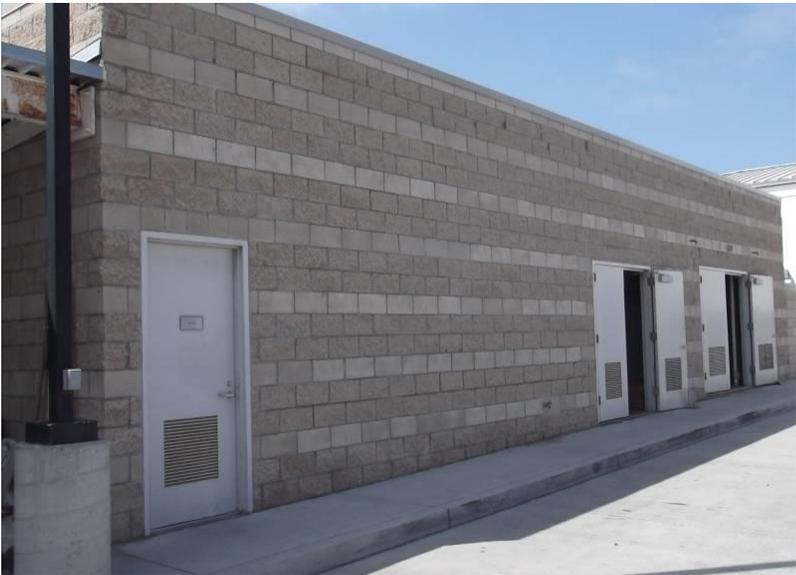
Photograph 14

View of the freestanding mechanical equipment structure at the south end of the surface parking deck

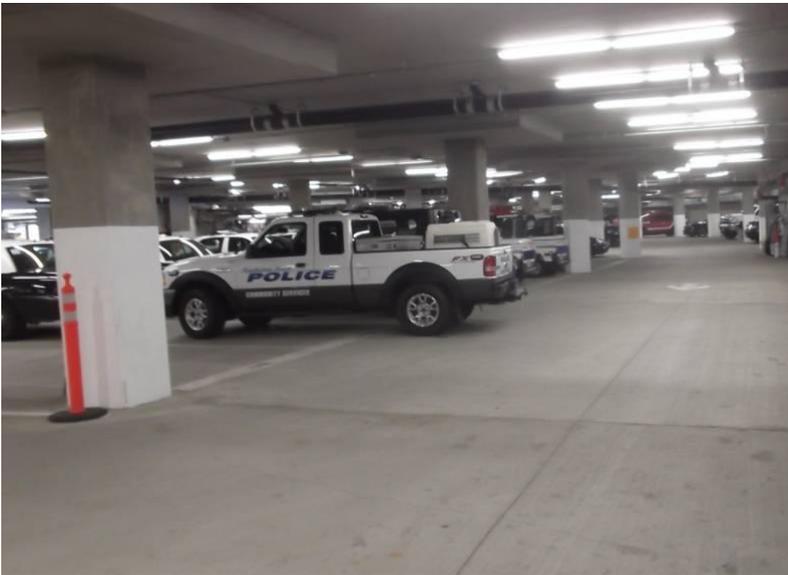
Most of the first floor is of two-way steel-reinforced concrete deck construction, supported on the concrete foundation walls and interior concrete columns (reference Photograph 17 in Appendix B). The construction consists of 12" to 14" concrete decks, with 4" thick sloped concrete topping slabs installed in the surface parking area to promote stormwater drainage. This concrete deck is sandwich-type construction that includes the structural first-floor-level deck covered by a waterproofing membrane, with the second topping layer of concrete poured over the membrane. The deck has expansion joint material installed at regular intervals. Structural drawings available for reference for the building indicate that the concrete decks were designed with a compressive strength of 4,000 psi.

View of the basement level parking garage

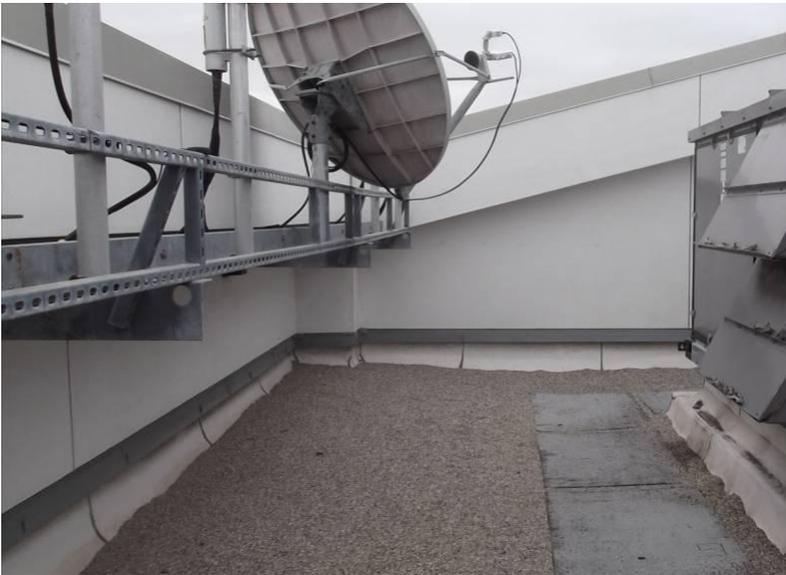
Photograph 20

The building contains nine low-sloped roof areas covered with a white asphaltic built-up 3-ply membrane, with stone ballast (reference Photographs 20 through 22 and 25 through 27 in Appendix B). The roof covering is original to construction of the building, installed in 2006. Roof drainage is to surface mounted drains with internal leaders and by perimeter scuppers.

View of the upper roof over the Public Safety Building (Roof Area 2)

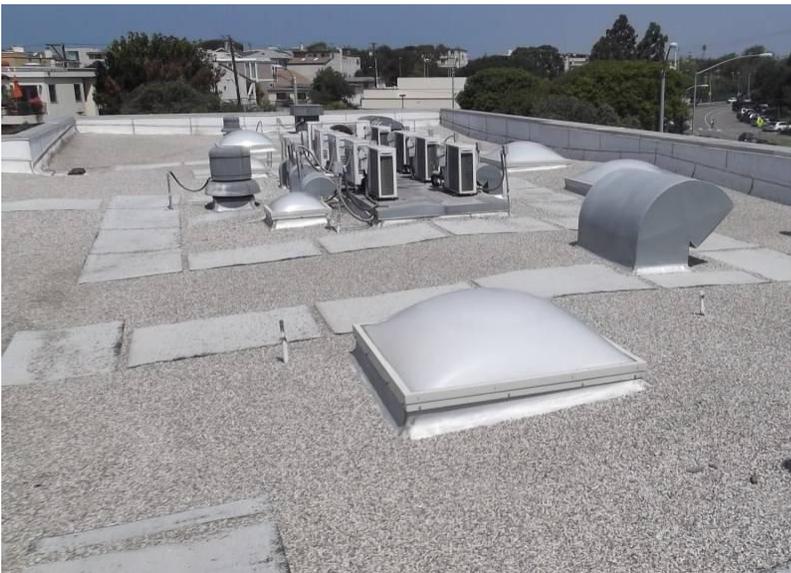
Photograph 21

View of the roof of the fire station (Roof Area 8)

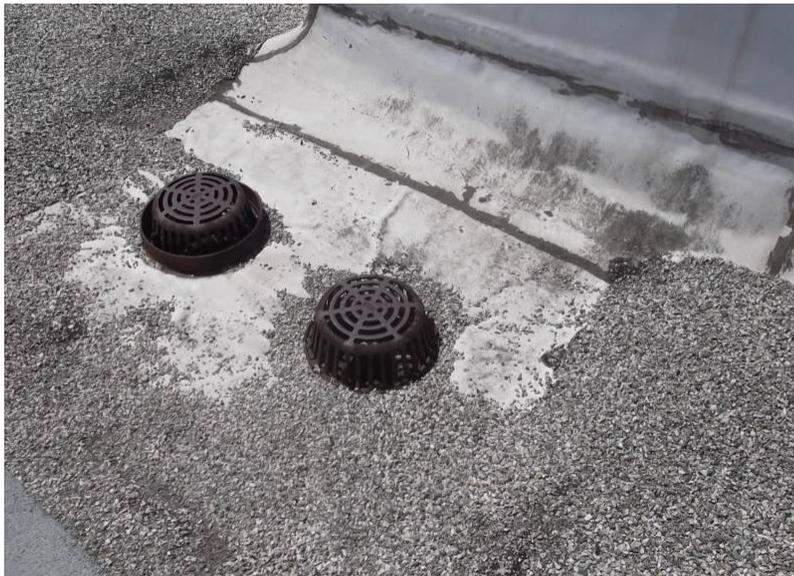
Photograph 22

View of typical roof drain and overflow drain

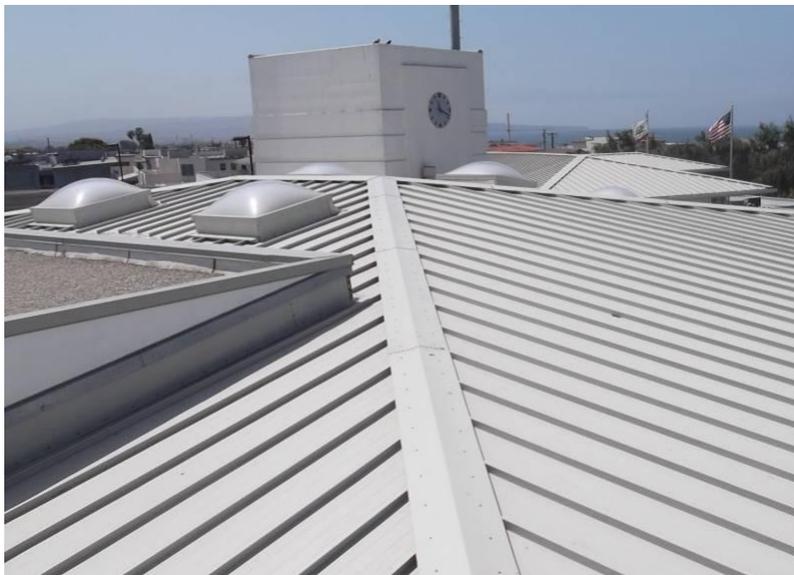
Photograph 23

The building also has three pitched roof areas with standing seam metal roofing with a factory-applied painted finish (reference Photographs 23 and 24 in Appendix B). The metal roofing is also original to construction of the building, installed in 2006. Roof drainage is to perimeter gutters and downspouts, draining to the surrounding low-slope roofs or to grade. Table B30-1 provides a summary of the roof coverings:

View of the metal roofing over the fire station (Roof Area 7)

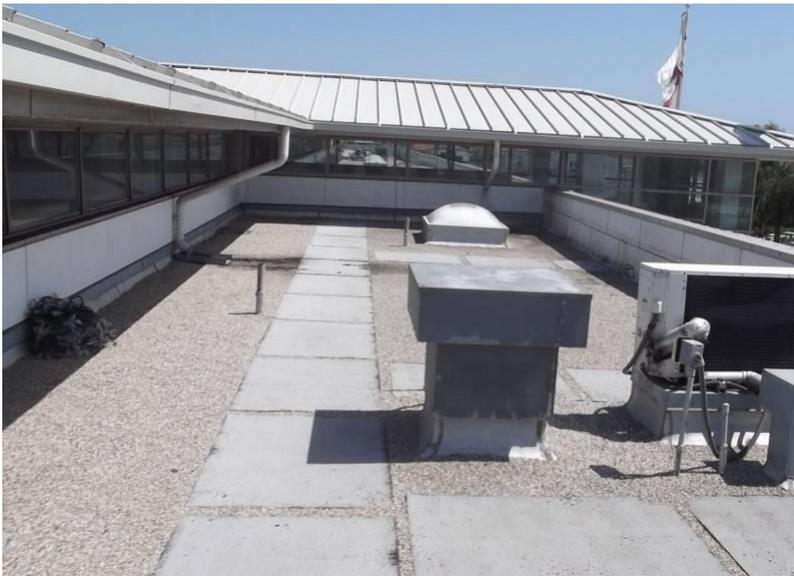
Photograph 25

View of one of the lower roofs of the Public Safety Building (Roof Area 6)

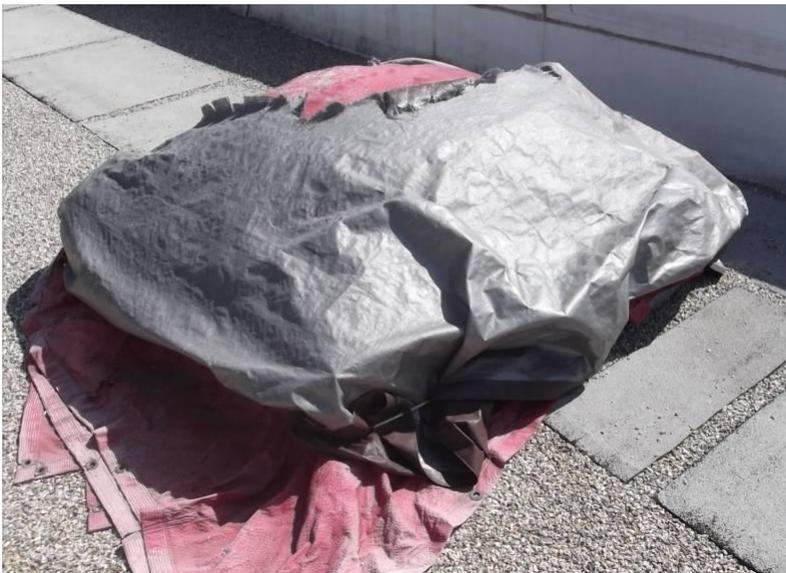
Photograph 27

View of one of the covered skylights

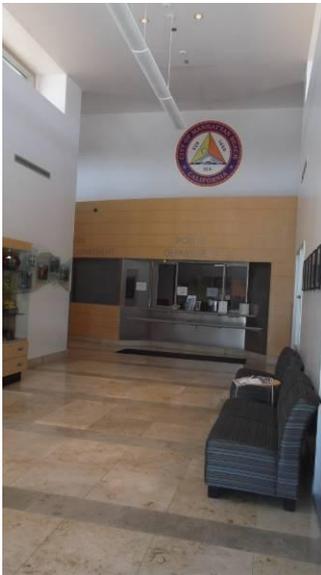
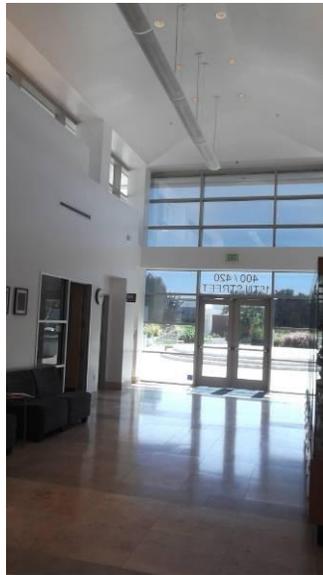
Photographs 32A and 32B

View of the main entrance lobby

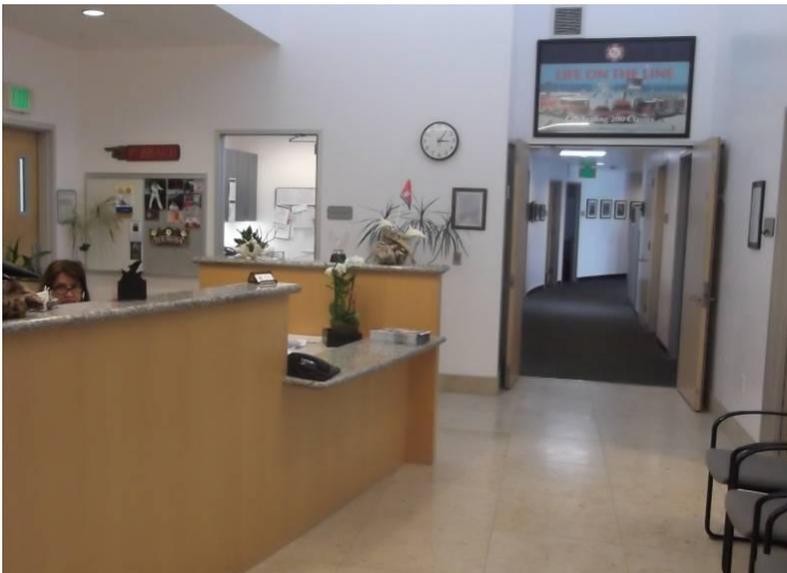
Photograph 33

View of the fire department reception area
