Citywide
Facility Condition Assessment

Report of
Facility Condition Assessment

For
City of Manhattan Beach
Manhattan Heights Park
1600 Manhattan Beach Boulevard, Manhattan Beach, CA

*September 4, 2013
(Rev A)*

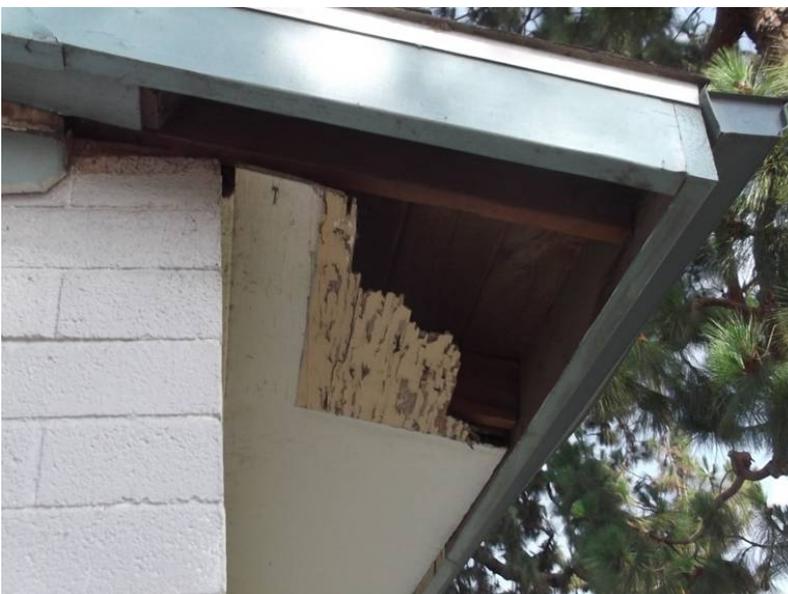
Photograph 9

View of the deteriorated soffit of Building 6 and Restrooms

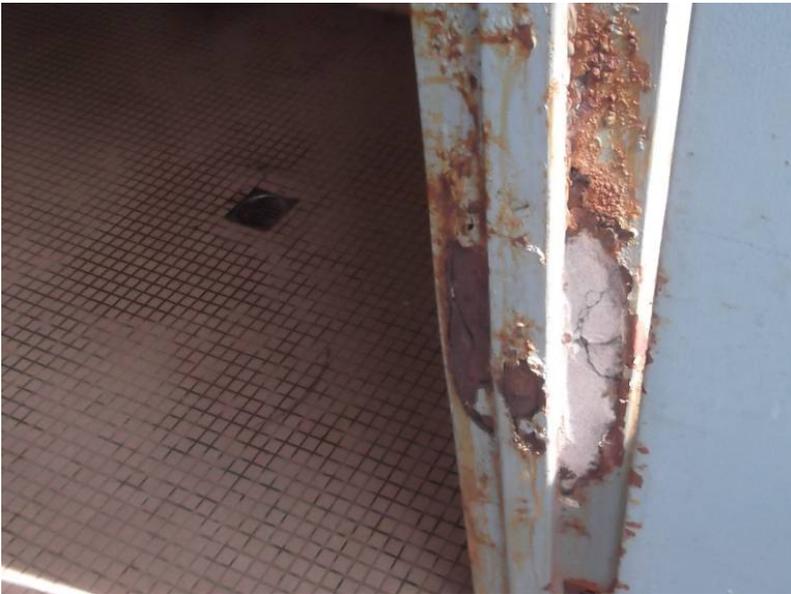
Photograph 14

View of deteriorated door and frame at the restroom in Building 6 and Restrooms

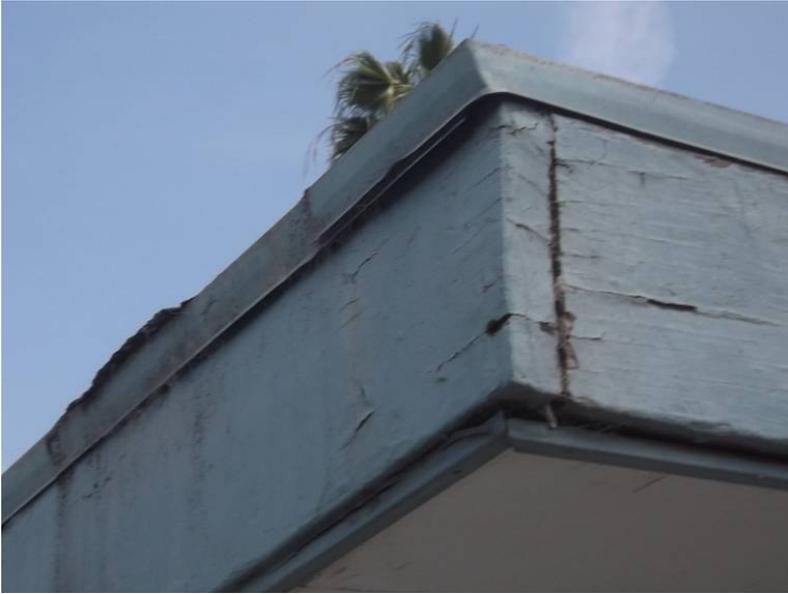
Photograph 16

View of deterioration in the fascia of Building 7

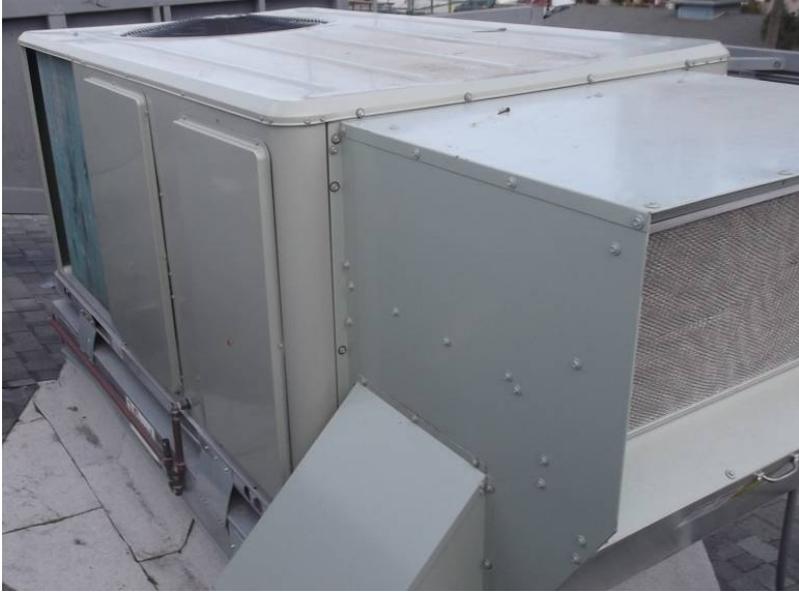
Photograph 31

The building is heated and cooled by three rooftop package units. The units provide direct exchange cooling, with natural gas fired heating sections, installed in 2013 (reference Photographs 31 and 32 in Appendix B). The units, manufactured by Trane, are curb-mounted and located within a painted plywood siding rooftop enclosure. Refer to the following Table D30-1 for further details of the equipment.

View of the rooftop package HVAC units on the roof of the Community Center

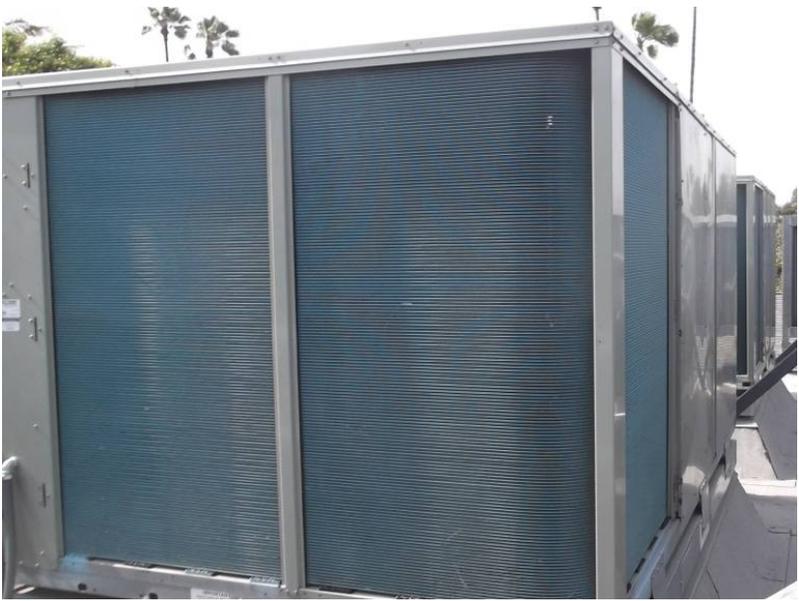
Photograph 32

View of the rooftop package HVAC units on the roof of the Community Center

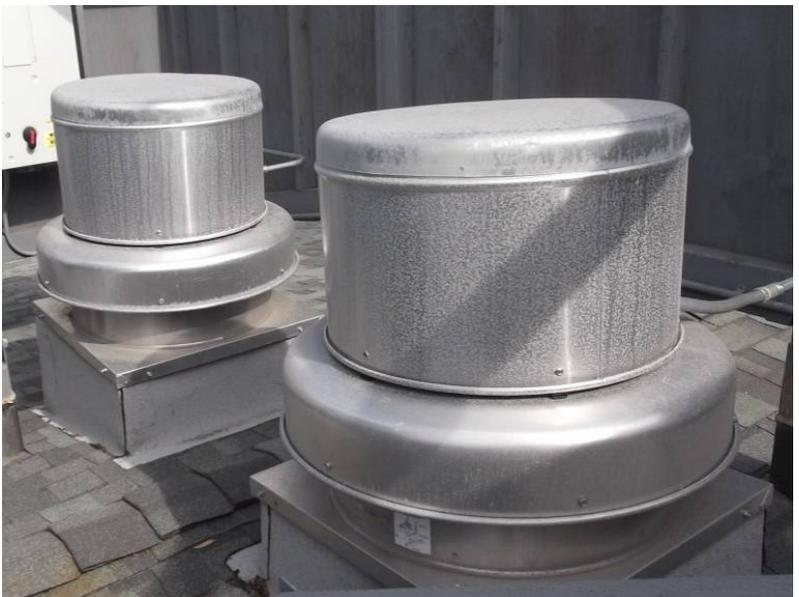
Ventilation of the restrooms, kitchen and auditorium is provided by rooftop exhaust fans, manufactured by Greenheck and installed in 2013. Ventilation of the kitchen range is provided by a stainless steel hood, with Ansul fire protection system and rooftop exhaust fan (reference Photograph 33 in Appendix B). Refer to Table D30-1 for a summary of the exhaust ventilation equipment.

View of the exhaust fans on the roof of the Community Center

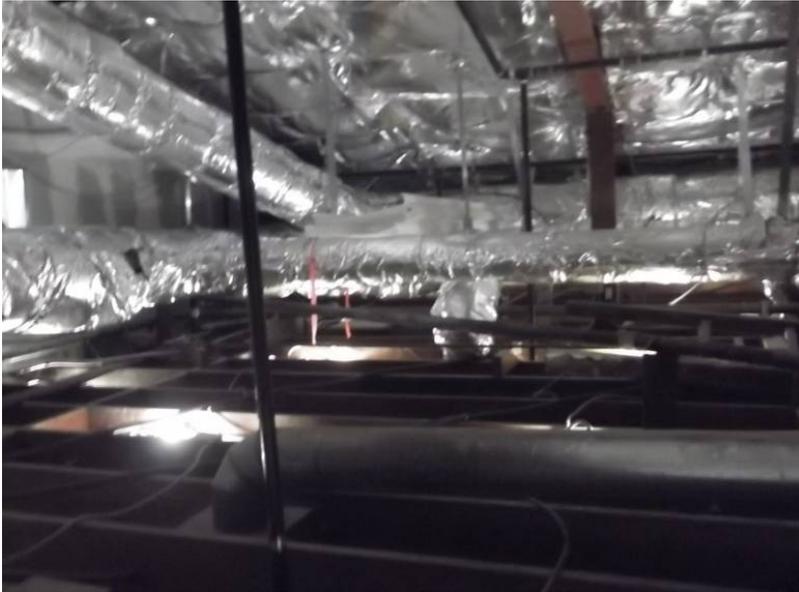
The conditioned air is distributed throughout the building by rigid interior metal ducts located above the ceilings, within attic space and in walls, and through flexible duct connections to diffusers/grilles in the ceilings and walls (reference Photograph 34 in Appendix B).

View of the attic space ductwork in the Community Center

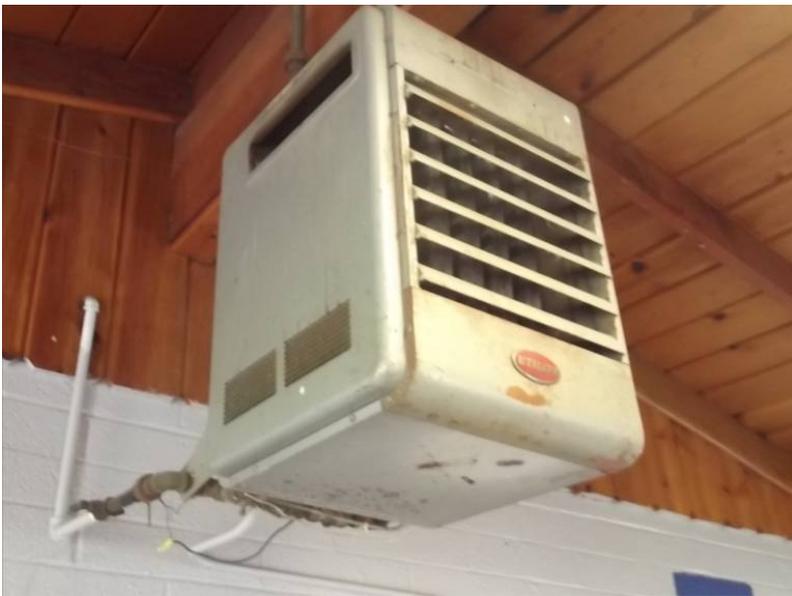
The building contains a gas-fired unit heater suspended from the roof framing within the central activity room (reference Photograph 35 in Appendix B). The unit, manufactured by Utility, is a heating only unit. Refer to the following Table D30-2 for further details of the terminal unit.

View of the unit heater in Building 6 and Restrooms

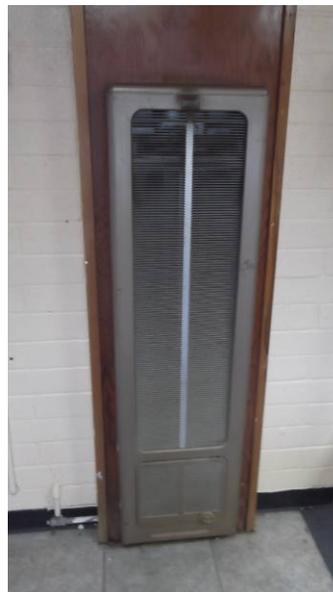
The building contains a gas-fired unit heater wall mounted within the central activity room (reference Photograph 36 in Appendix B). The unit, manufactured by Mission Appliance Corp., is a heating only unit. Refer to the following Table D30-3 for further details of the terminal unit.

View of the unit heater in Building 7

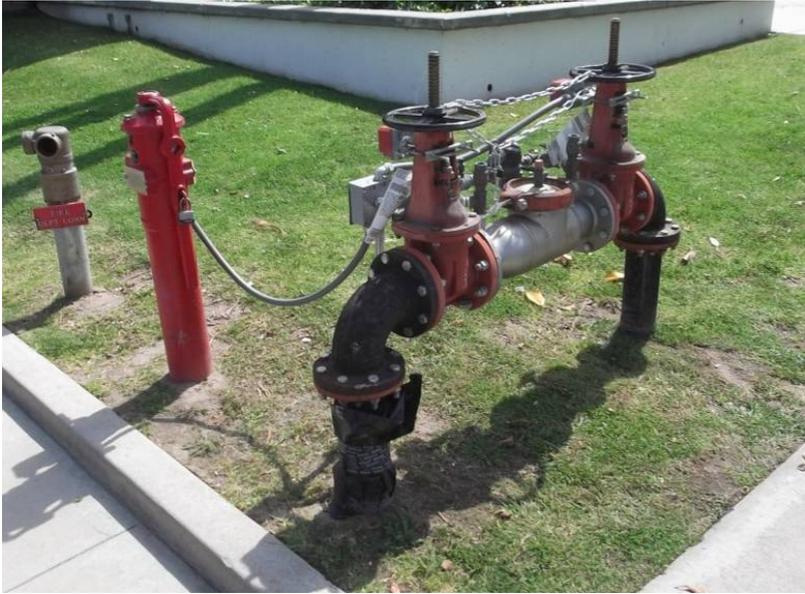
The building contains a wet-pipe fire sprinkler system, with ceiling pendant heads supplied from an exterior riser at the northeast corner of the building (reference Photograph 38B in Appendix B). System water supply is provided by municipal main pressure, without the use of a fire pump, and water flow is monitored by a local fire system. The service main, with check valve assembly, post valve indicator and Siamese hose connections, is located at the northeast corner of the building (reference Photograph 37 in Appendix B).

View of the fire water line valves, post indicator valve and Siamese hose connection

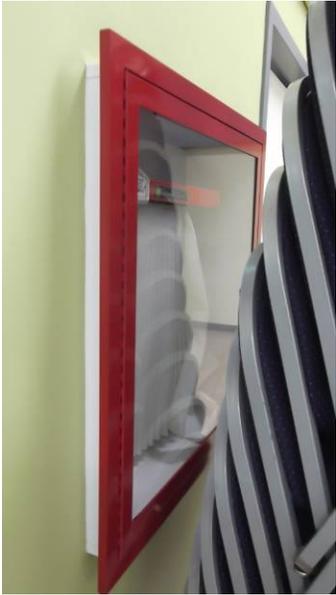
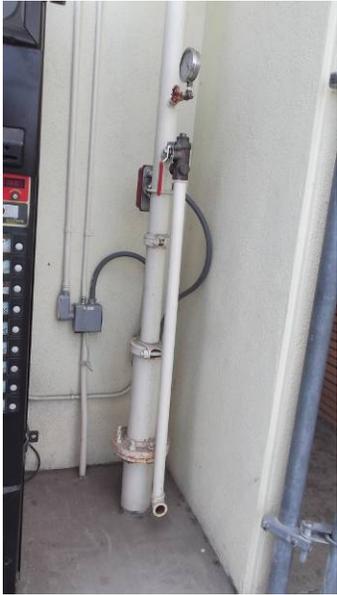
Photographs 38A and 38B

Views of the fire sprinkler riser (right) and fire hose cabinet in the Community Center

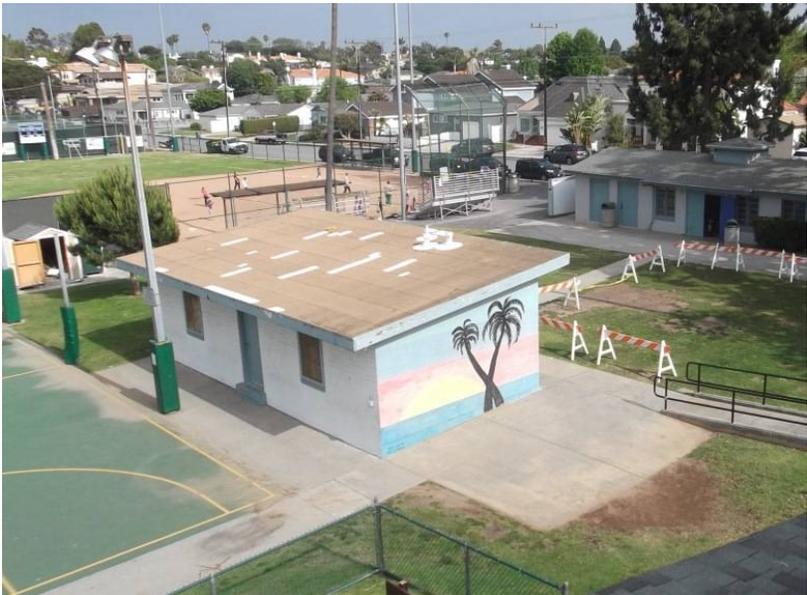
Photograph 42

Overview of site, looking southeast toward Building 7, the baseball field and tennis courts

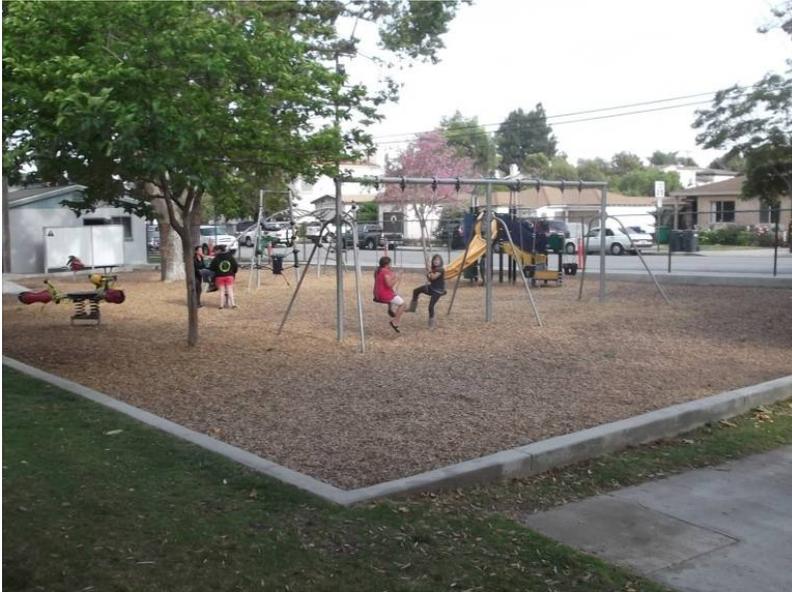
Additional surfacing, using wood mulch, is provided at the children's playground area and at the climbing wall at the park's southwest corner (reference Photograph 43 in Appendix B). Asphalt surfacing is used between the Building 6 and Restrooms structure and the baseball field, to provide maintenance vehicle access to the property (reference Photographs 47 and 49 in Appendix B).

View of the playground

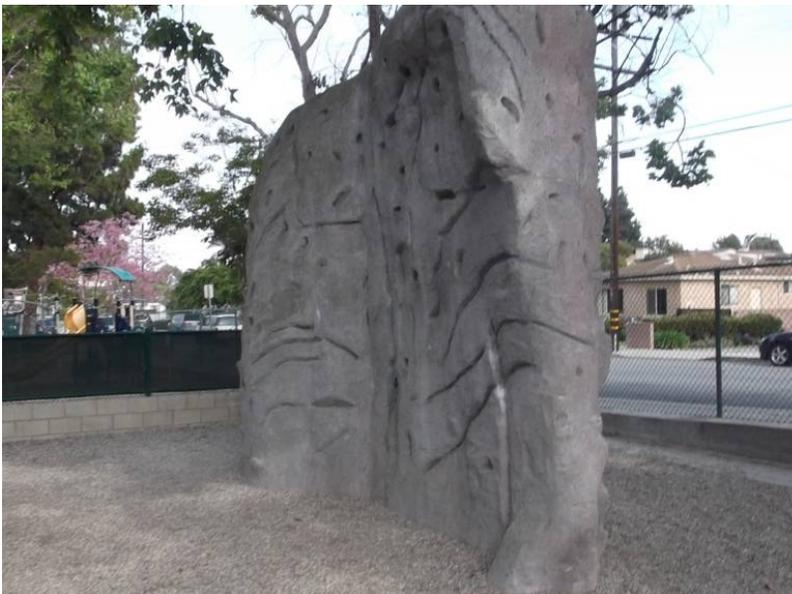
Photograph 44

View of the climbing wall

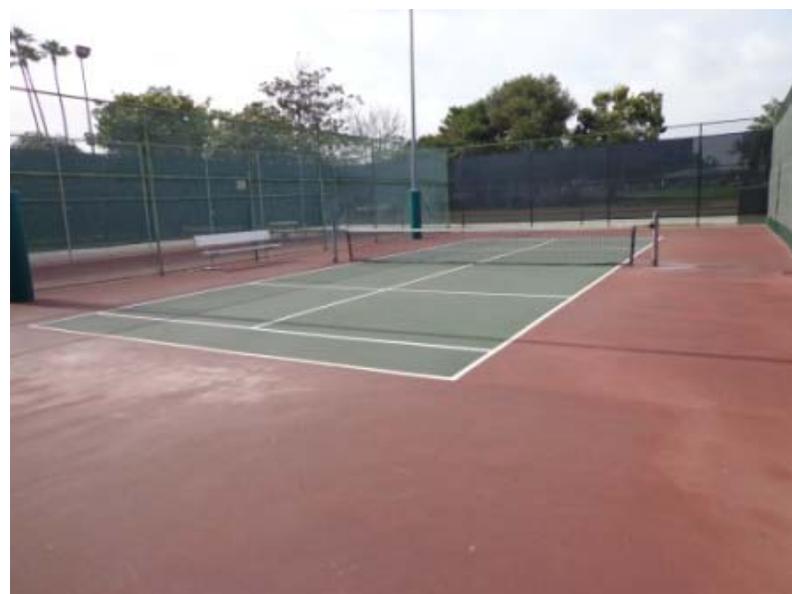
Photograph 45

View of one of the paddle ball courts

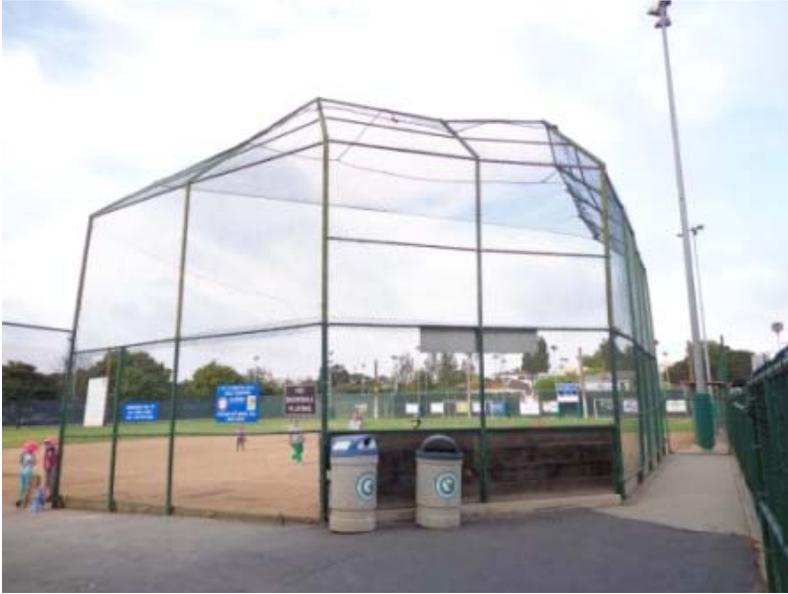
Photograph 46

View of the baseball field

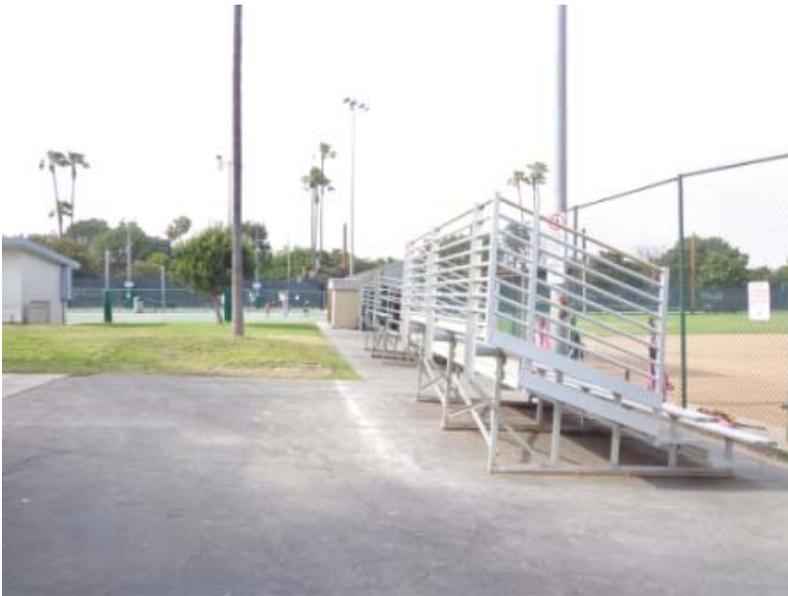
Photograph 47

View of the bleachers at the baseball field

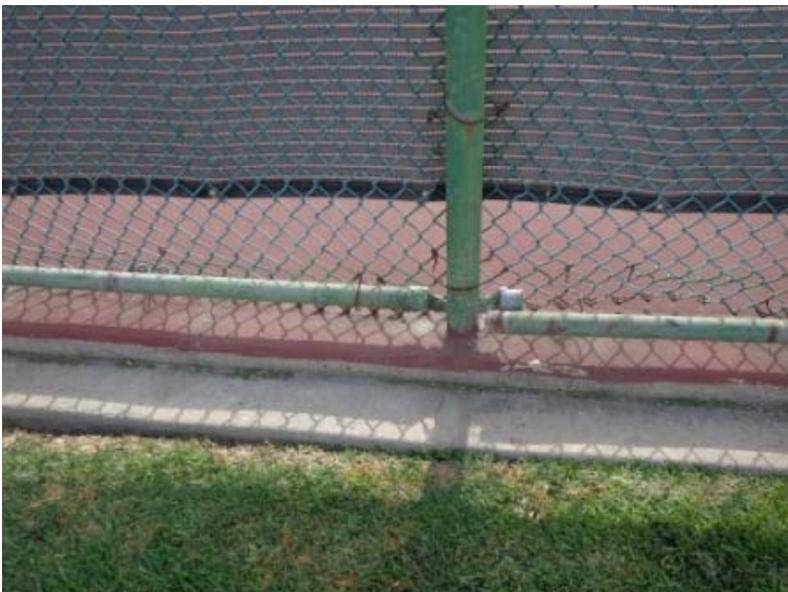
Photograph 48

View of chain link fencing deterioration

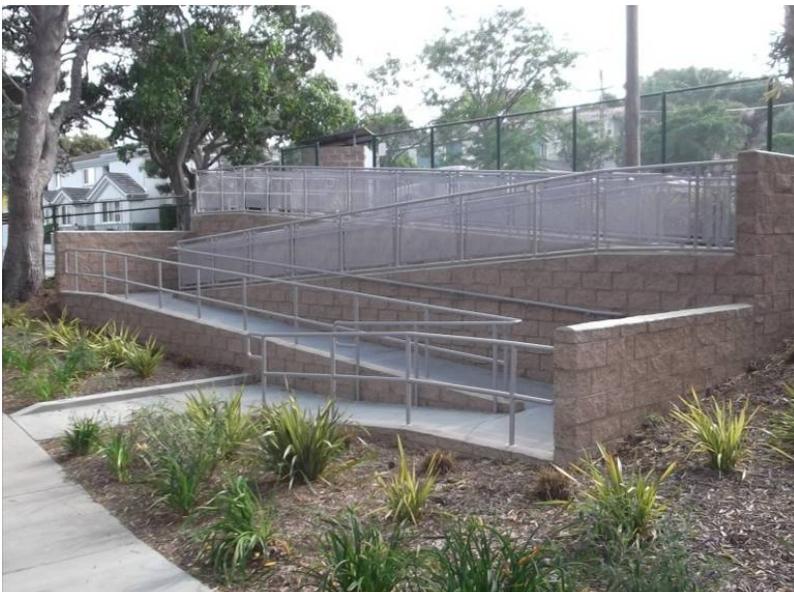
Photograph 51

Reinforced concrete ramps and stairs are located within the park to provide access for an adjoining parking area to the west and from sidewalks to the east entrances of the Community Center (reference Photographs 51 and 52 in Appendix B). The steps and ramps typically have galvanized or painted metal handrails at the center and along each side.

View of one ramp with railings at the west side of the site

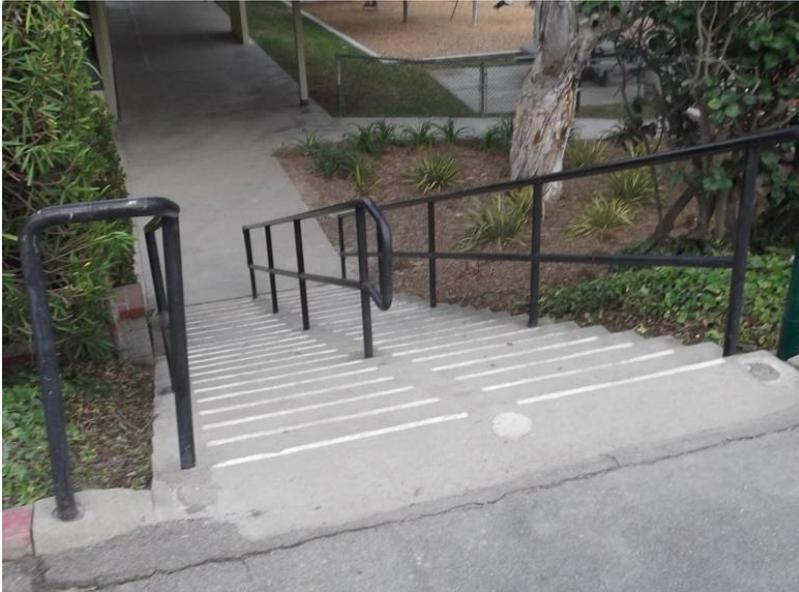
Photograph 52

View of stairs at the west side of the site

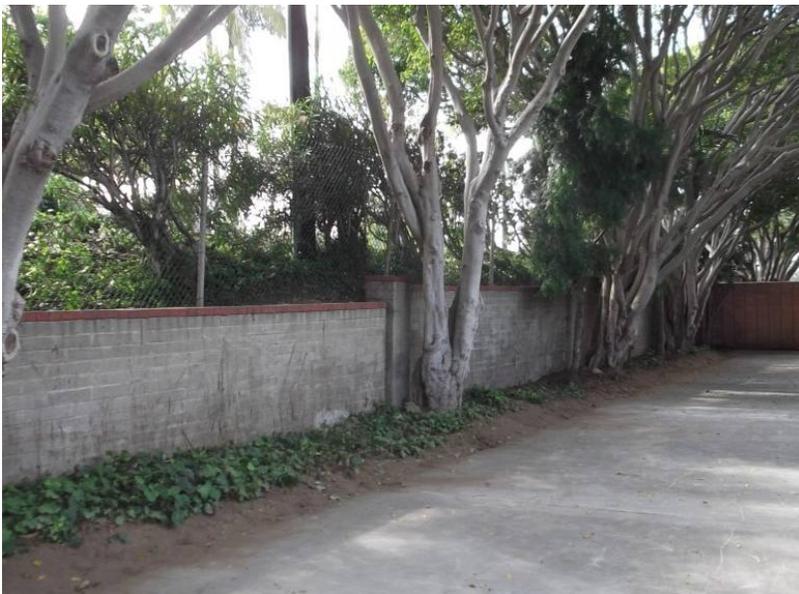
Photograph 53

View of the retaining wall at the west side of the site

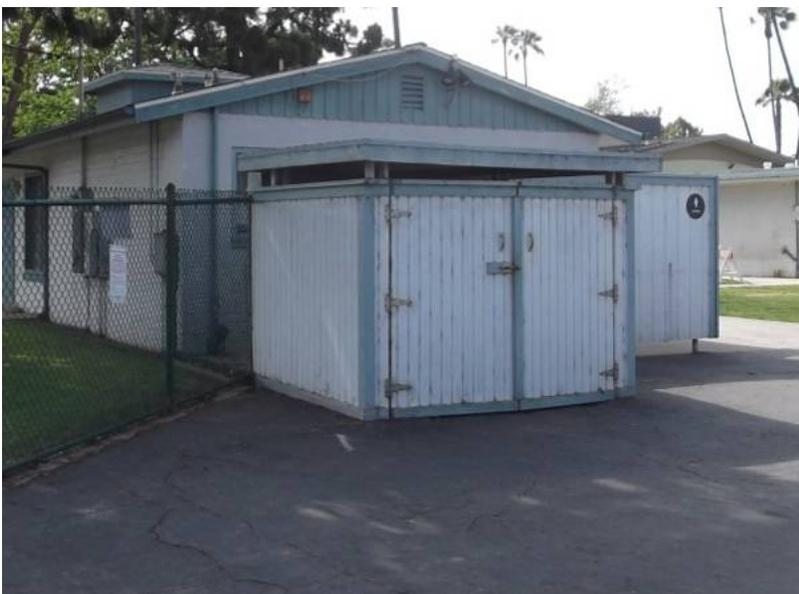
Photograph 54

View of the dumpster enclosure adjacent to Building 6 and Restrooms

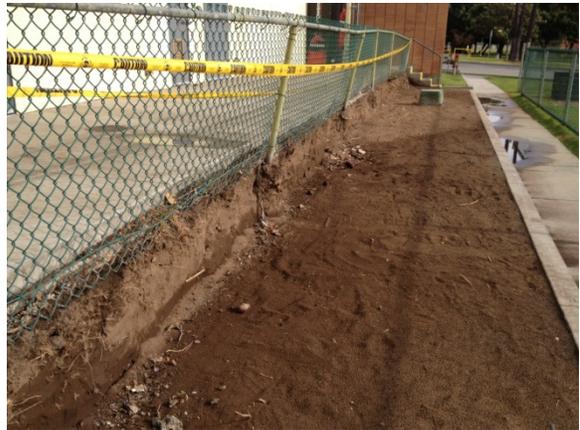
Figure 11: Temporary Excavation

Currently, there are no outstanding structural issues within the Manhattan Heights Community Center that require immediate repair or mitigation again except for the temporary excavation and a further investigation into the possible water damage. The minor cracking in the slabs on grade noted in the present structural inventory poses no immediate concerns about the building's structural performance or safety, and can be repaired with patching with cement based mortar or epoxy materials. Depending on the City's capital improvement budgets, such minor repair can be included in the City's mid-term (4-6 years) or short term (1-3 years) capital improvement programs. The estimated cost for such repair is summarized in the following table:

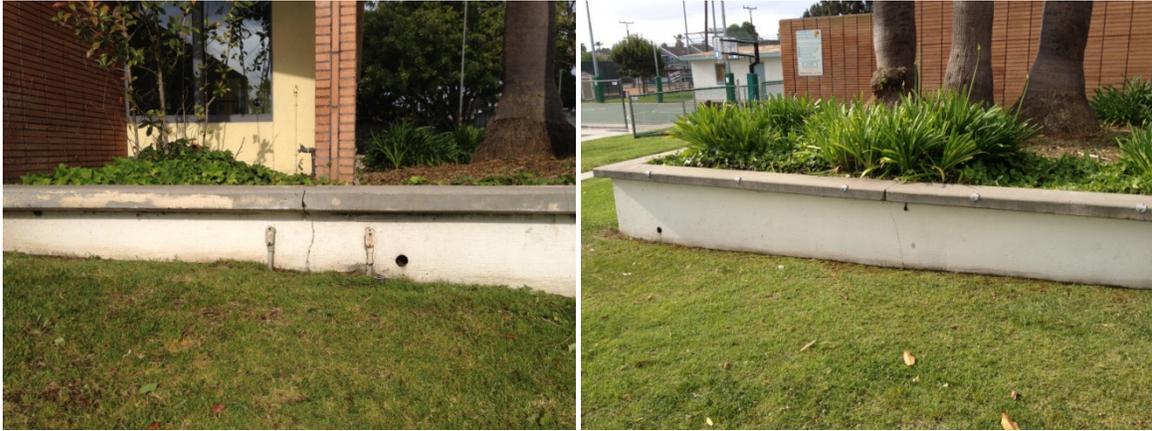
Figure 12: Crack in Low Retaining Walls

Item	Unit Cost	Quantity	Estimate Cost
Crack Repair in Planter Retaining Wall	\$30	30 feet	\$900
Crack Repair in Slab	\$20	30 feet	\$600
