Citywide
Facility Condition Assessment

Report of
Facility Condition Assessment

For
City of Manhattan Beach
Public Works Yard
3621 Bell Avenue, Manhattan Beach, CA

*September 4, 2013
(Rev A)*

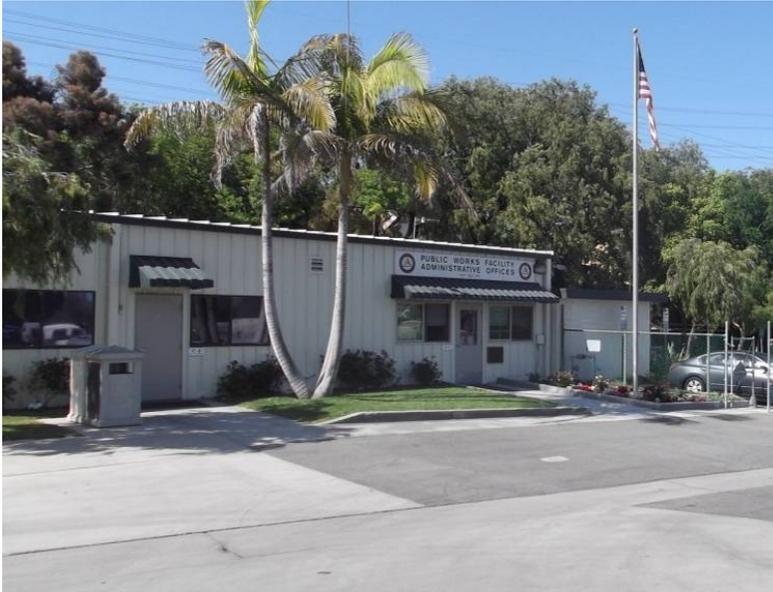
Photograph 1

The building has exterior walls of prefinished ribbed metal siding, painted cementitious stucco and painted T1-11 plywood siding, which are typically placed over plywood or solid sheathing, some locations with painted wood trim (reference Photographs 1 through 4 in Appendix B). The drawings available for reference did not indicate insulation within the exterior walls.

The building's windows are typically aluminum-framed with fixed and sliding single- or double-pane-glazed units (reference Photographs 1, 45 and 60 in Appendix B).

The buildings contain swinging single-leaf flush metal doors in steel frames, some with glazing, with painted finishes (reference Photographs 1 and 30 in Appendix B). Door hardware consisted of lever handles and closers.

View of the front of Building A

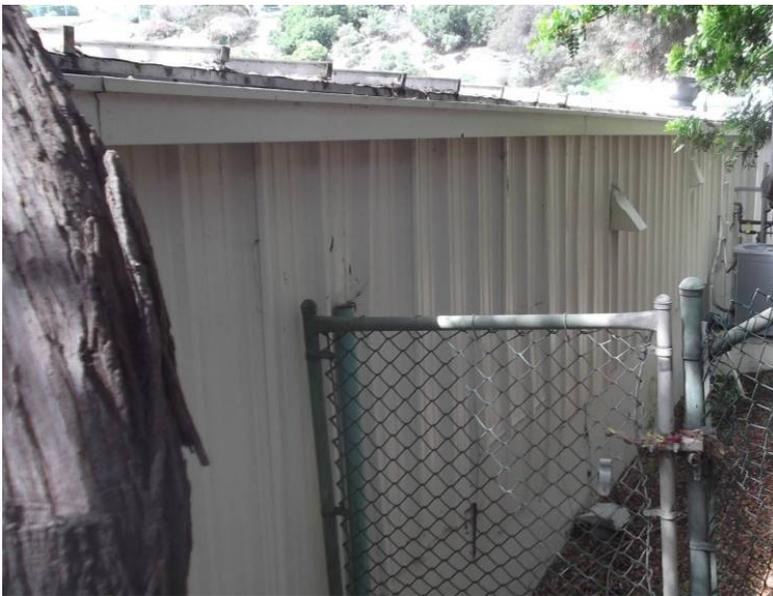
Photograph 2

View of rear of Building A

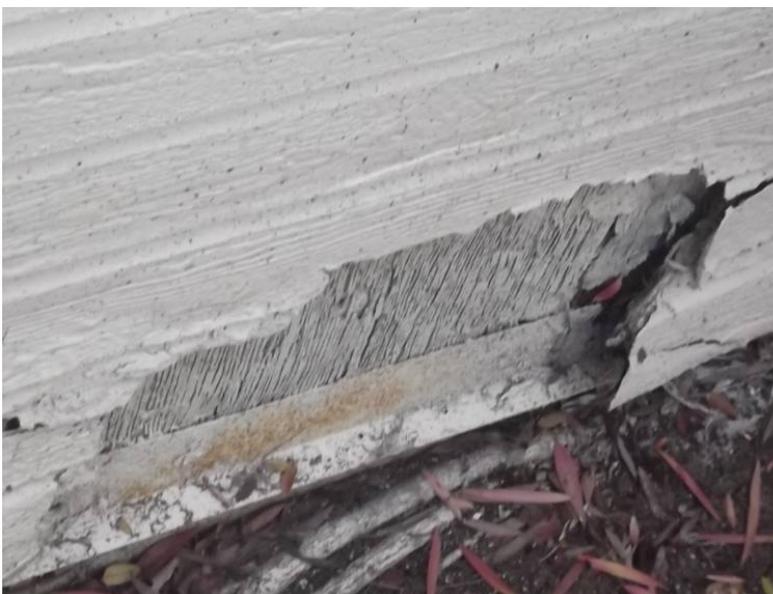
Photograph 3

View of deteriorated wood siding at Building A

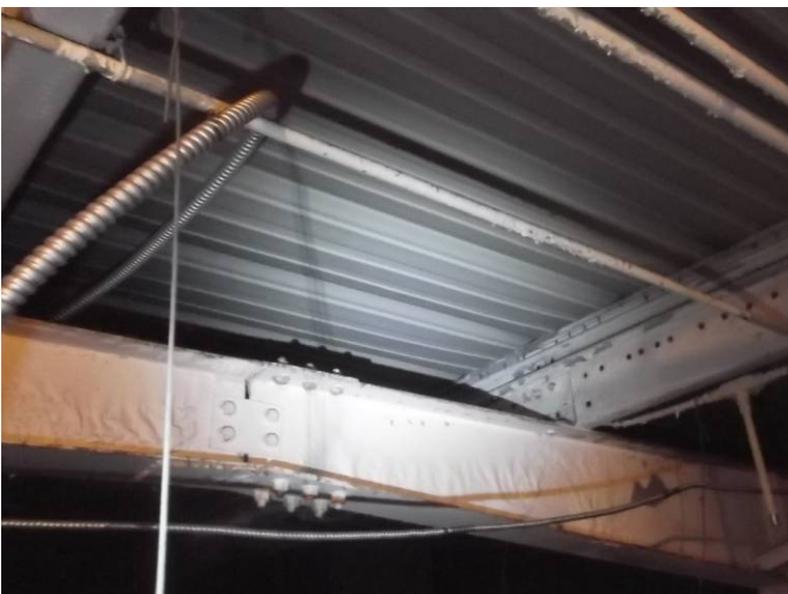
Photograph 6

View of roof framing of Building A

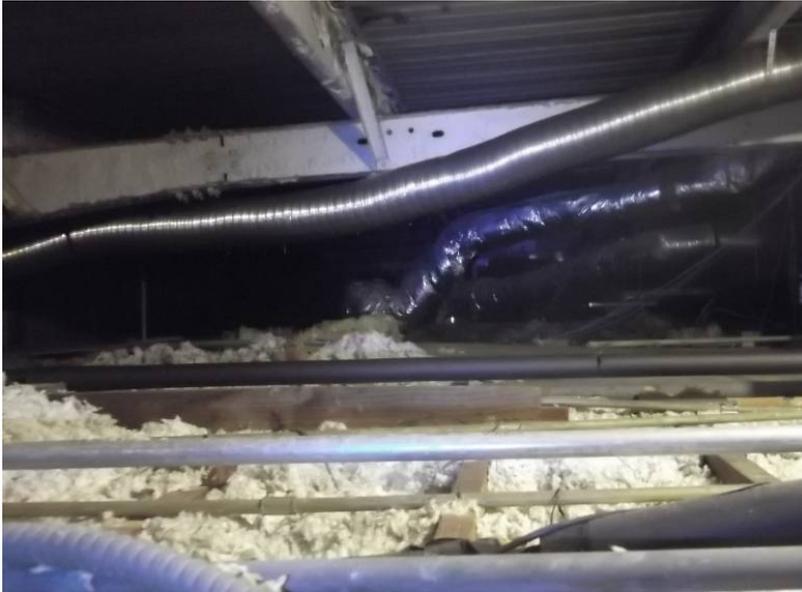
Photograph 7

View of the "attic" space in Building A, containing HVAC ductwork

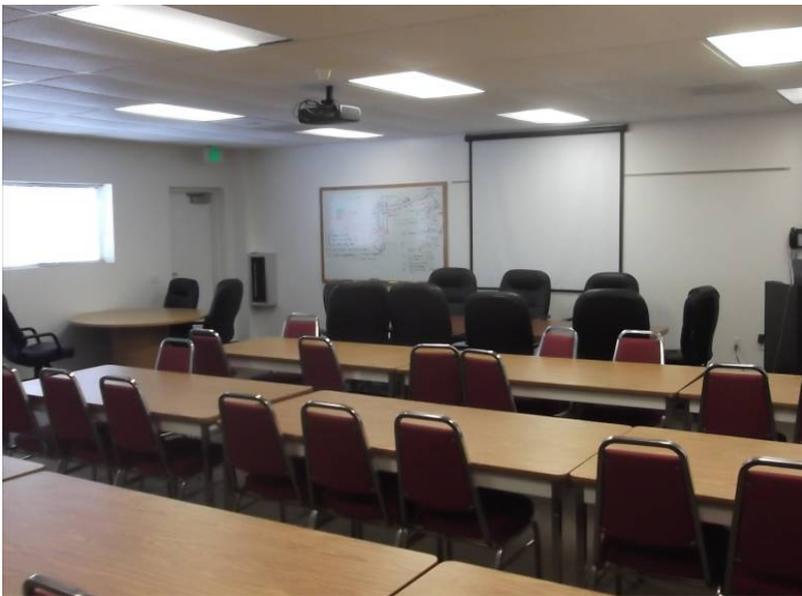
Photograph 8

Interior walls at the building typically have painted gypsum wallboard finishes, with locations of vinyl-clad gypsum board and ceramic tile (reference Photographs 8 through 14 in Appendix B).

The ceiling finishes throughout the building predominantly consist of acoustical tile, with locations of painted gypsum board (reference Photographs 8 through 11 in Appendix B).

View of the interior of Building A

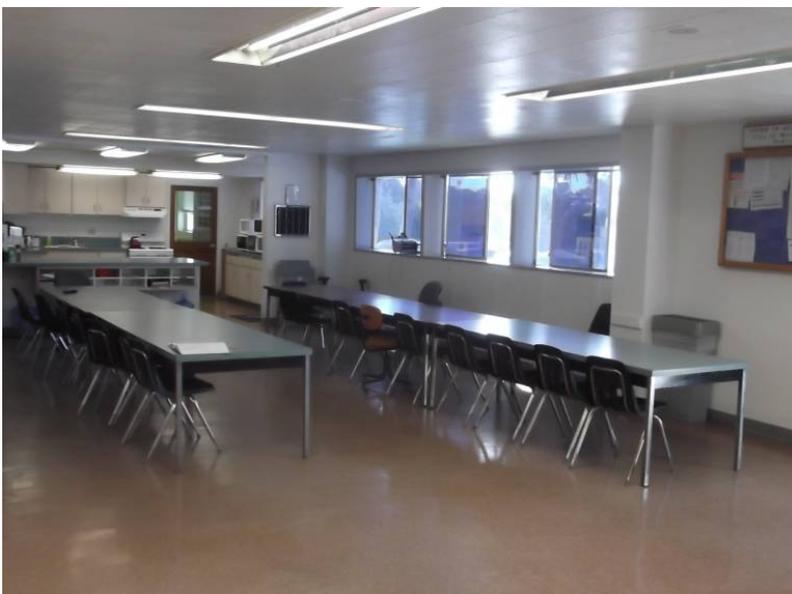
Photograph 9

The flooring in the building is a combination of vinyl tile in the lunch room, kitchen and locker room, carpeting in office areas and ceramic tile in office areas, the restrooms and shower room (reference Photographs 9 through 14 in Appendix B).

The buildings contain wood-constructed fixed base and wall cabinet casework (reference Photograph 9, 52 and 62 in Appendix B). The cabinets consist of hardwood frames with plastic-laminate-faced plywood interior panels, doors and drawers, with hinges, pulls and locking hasps.

View of the interior of Building A

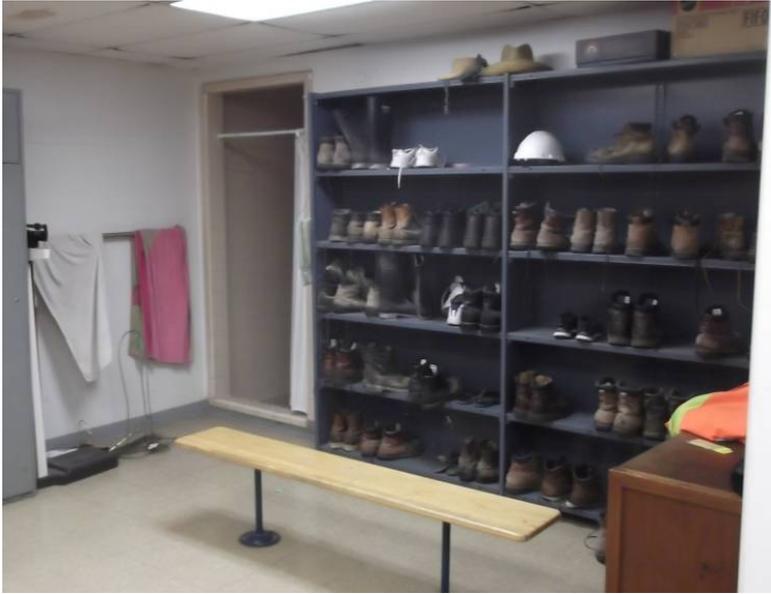
Photograph 10

View of the interior of Building A – men's locker / shower room

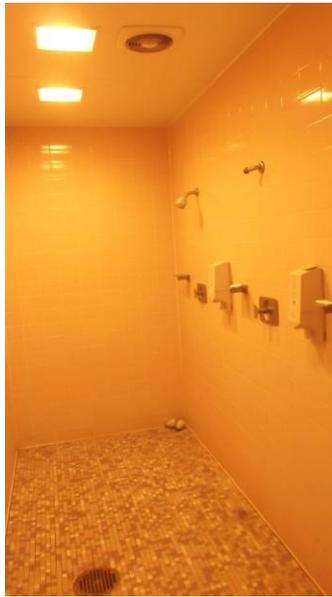
The men's locker room has a gang-type shower stall with three separate shower heads, knob-type controls and a single floor drain (reference Photograph 11 in Appendix B). The floor and walls are finished with ceramic tile, the ceiling is painted sheathing and the entry has a raised curb with plastic curtain.

View of the interior of Building A – men's shower

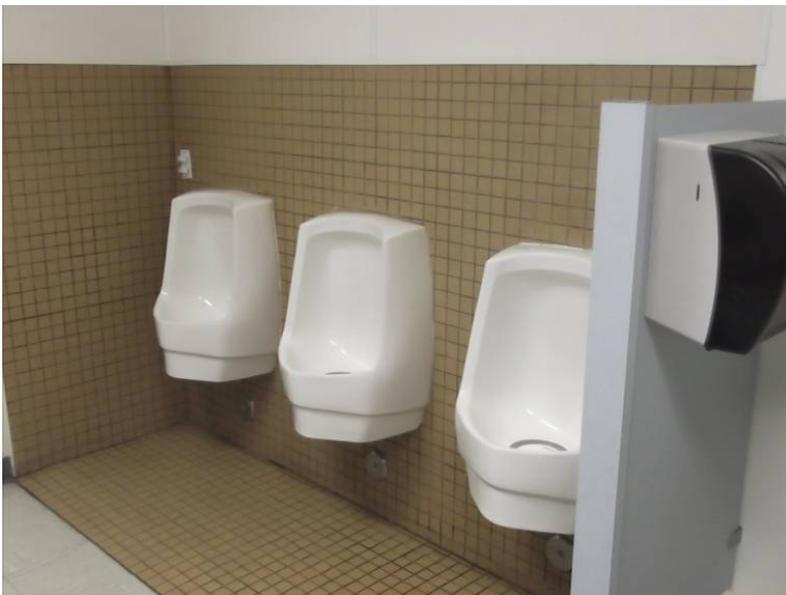
The men's restroom contains three vitreous china wall-mounted waterless urinals (reference Photograph 12 in Appendix B).

View of the interior of Building A – men's restroom

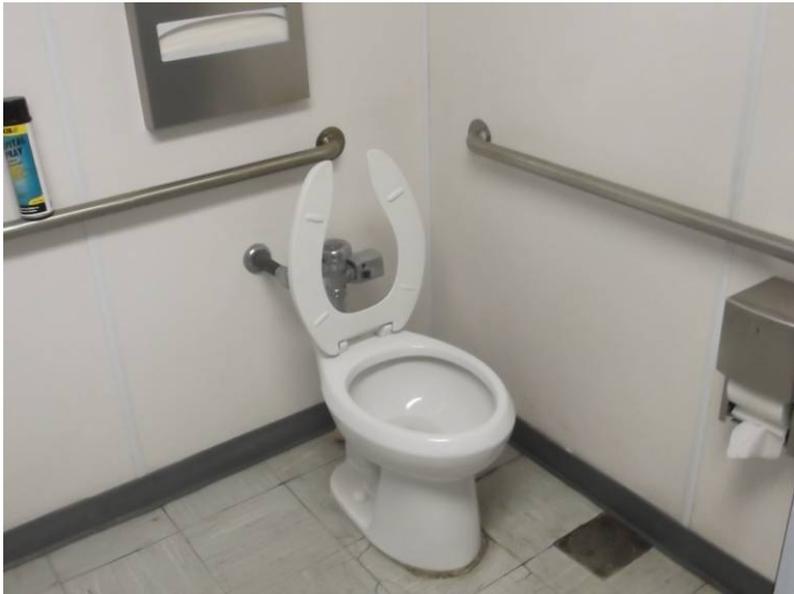
The building contains five floor-mounted vitreous china tank-less water closets with manual flush valve controls (reference Photograph 13 in Appendix B).

View of the interior of Building A – men's restroom

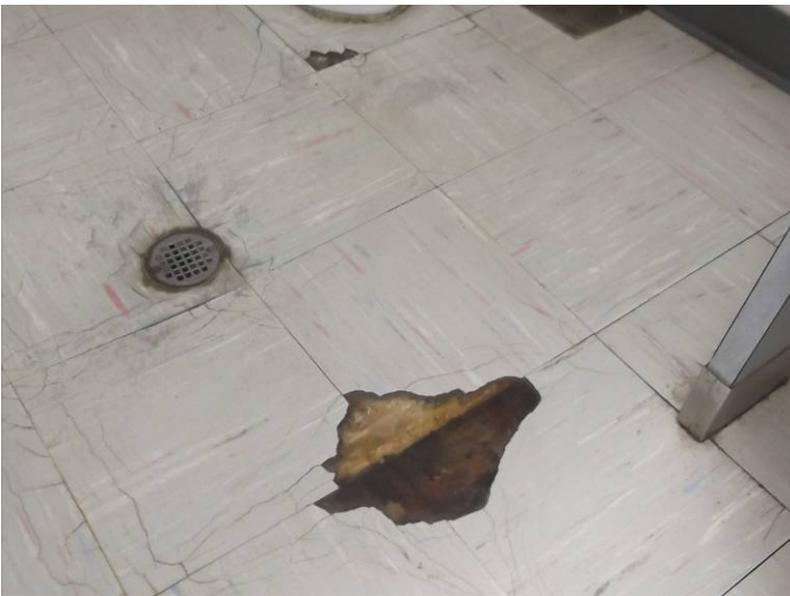
Photograph 14

View of deteriorated vinyl flooring in the men's restroom in Building A

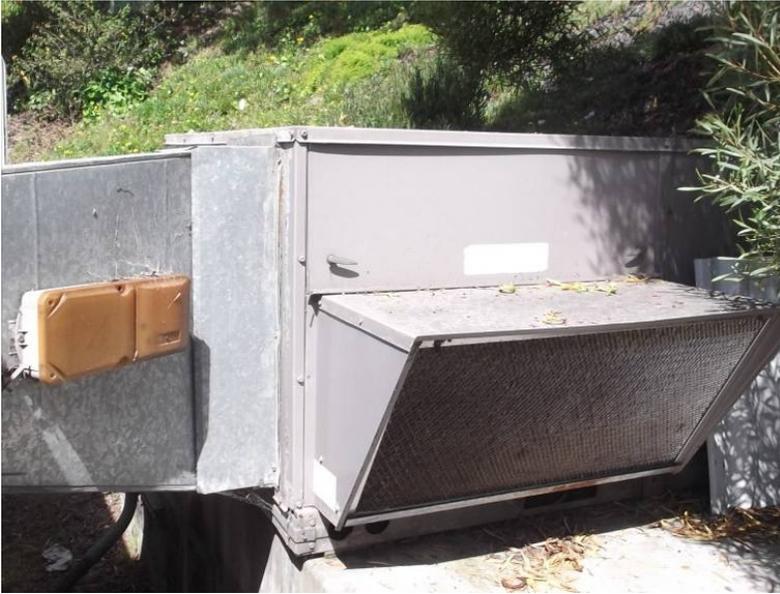
Photograph 16

View of the package unit serving Building A

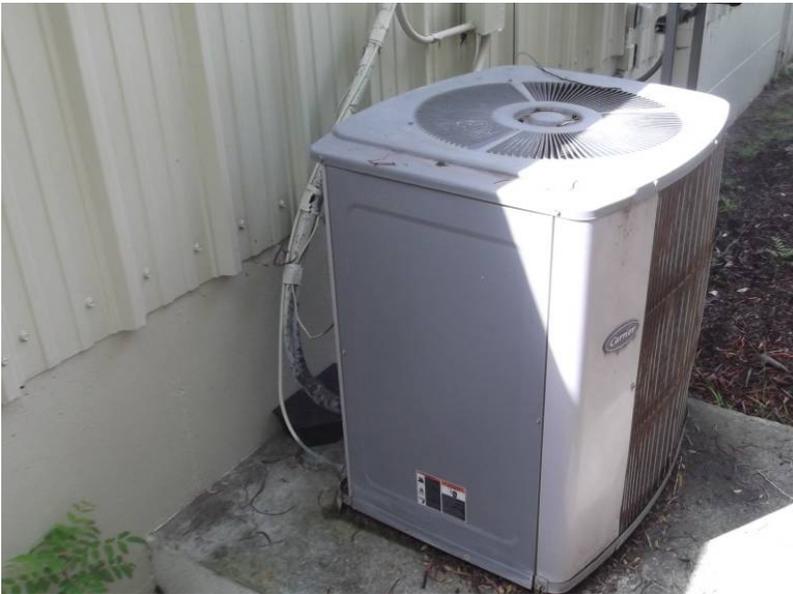
Photograph 17

View of the split system condenser serving Building A

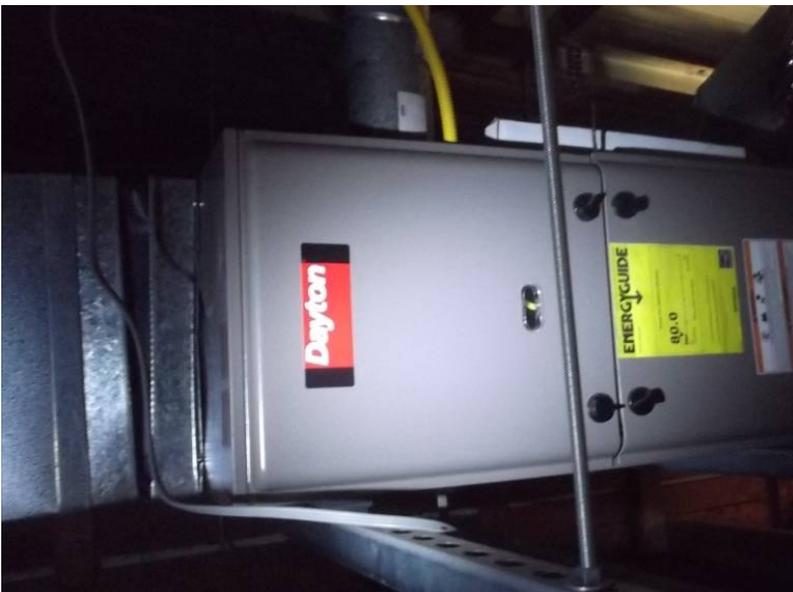
Photograph 18

View of the split system air handling unit in the "attic" space of Building A

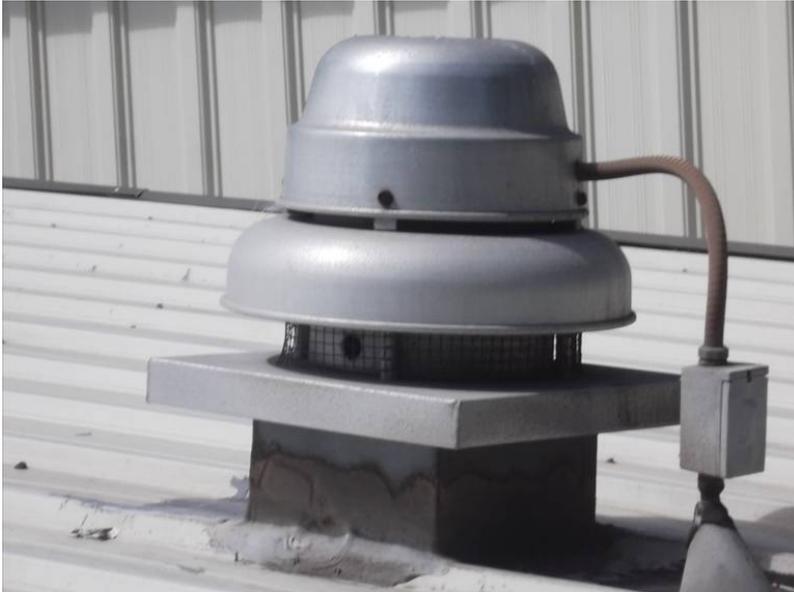
Photograph 19

View of the rooftop fan on Building A

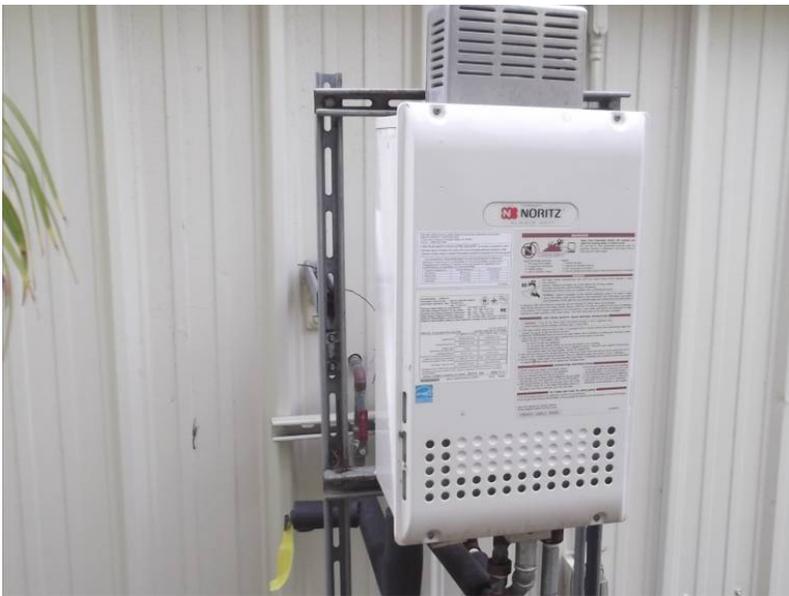
Domestic hot water is provided in the kitchen, restrooms and shower rooms, generated via two natural-gas-fueled instant water heating units mounted on the exterior wall at the north side of the building (reference Photograph 20 in Appendix B).

View of the one of the domestic water heaters at Building A

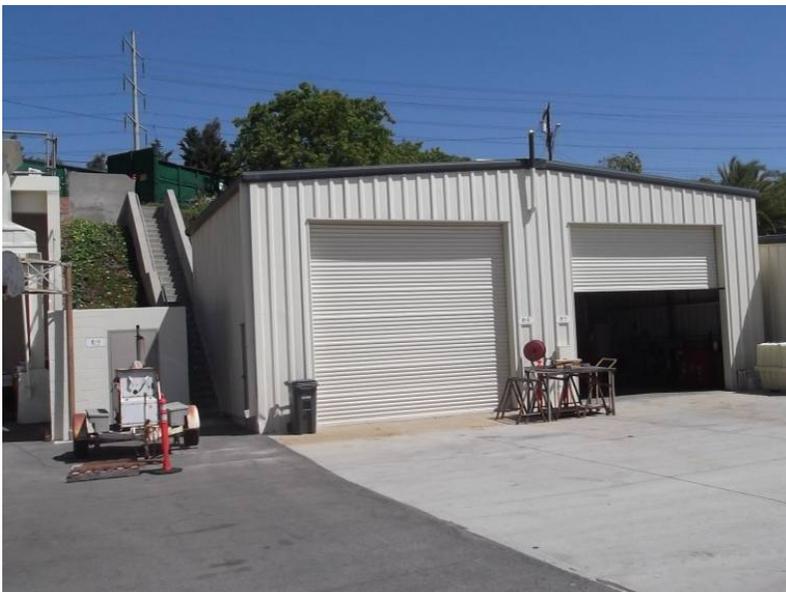
Photograph 21

The buildings have exterior walls of prefinished ribbed metal siding, typically placed over the superstructure without thermal insulation (reference Photographs 21, 23, 44 through 46, 60, 61, 67 and 72 in Appendix B).

The buildings have overhead service doors, of coiling, sectional or pivoting metal types and sliding overhead track types. The doors are typically manually operated on interior or exterior metal tracks (reference Photographs 21, 45, 46 and 60 in Appendix B).

View of the front of Building B

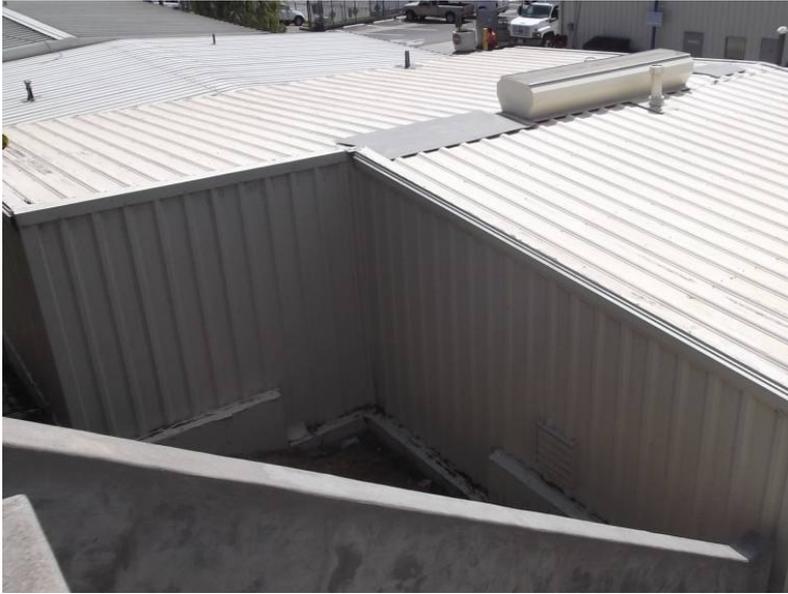
Photograph 22

The sloped, gabled roofs of the buildings contain prefinished ribbed metal roofing panels (reference Photographs 22, 44, and 69 in Appendix B). We understand that the roofing was installed at the time of construction, in 1967 or 2000.

View of the rear and roof of Building B

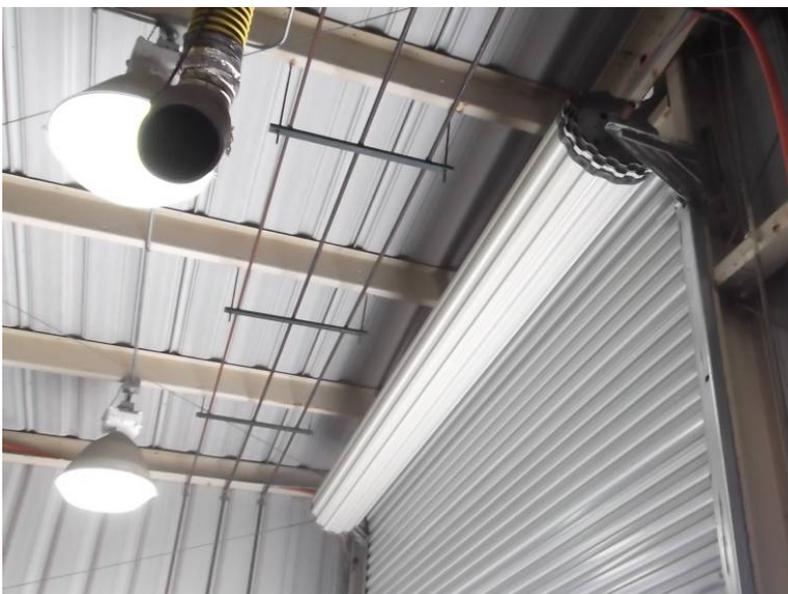
Photograph 24

View of the roof framing and overhead coiling door at Building B

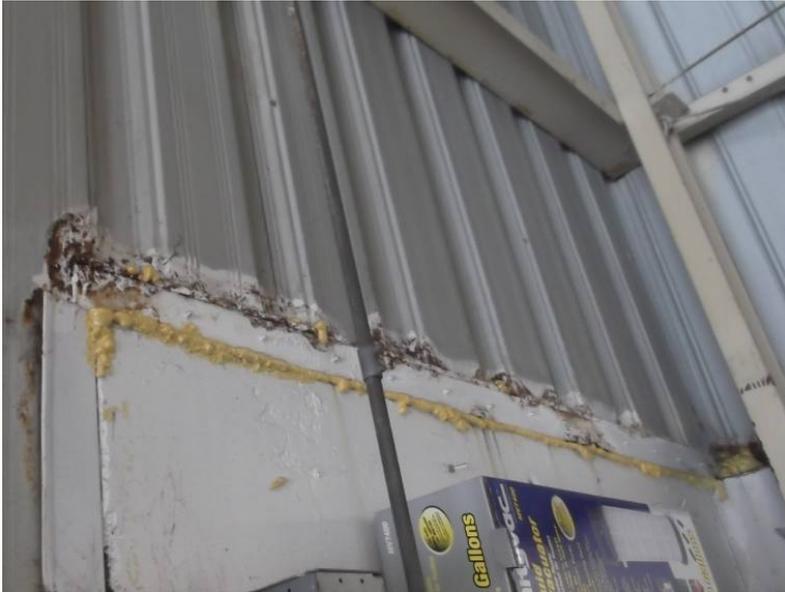
Photograph 25

View of exterior wall metal siding deterioration in Building B

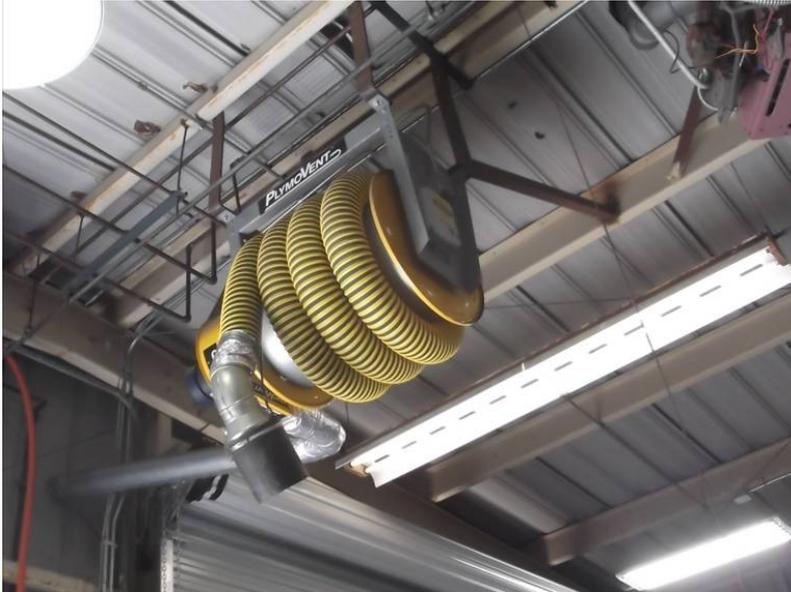
Photograph 28

View of vehicle exhaust extraction equipment in Building B

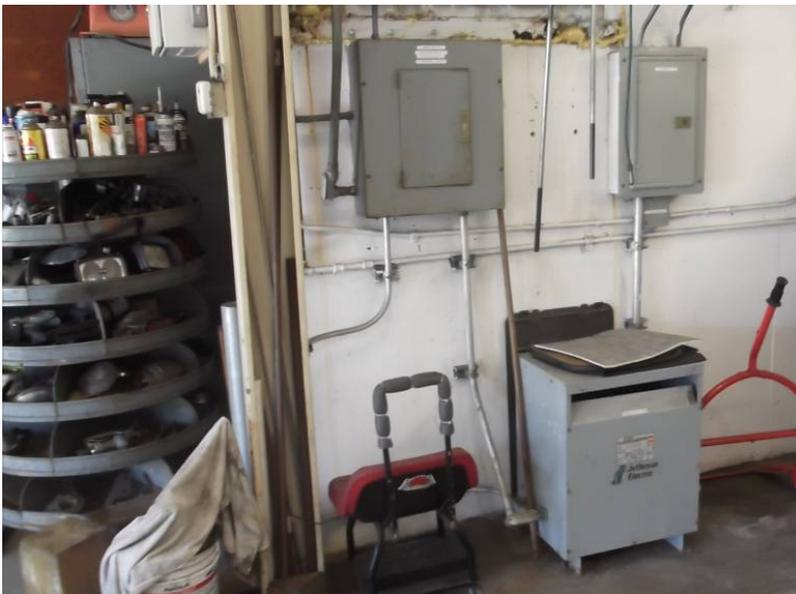
Photograph 29

View of the electrical panel and transformer in Building B

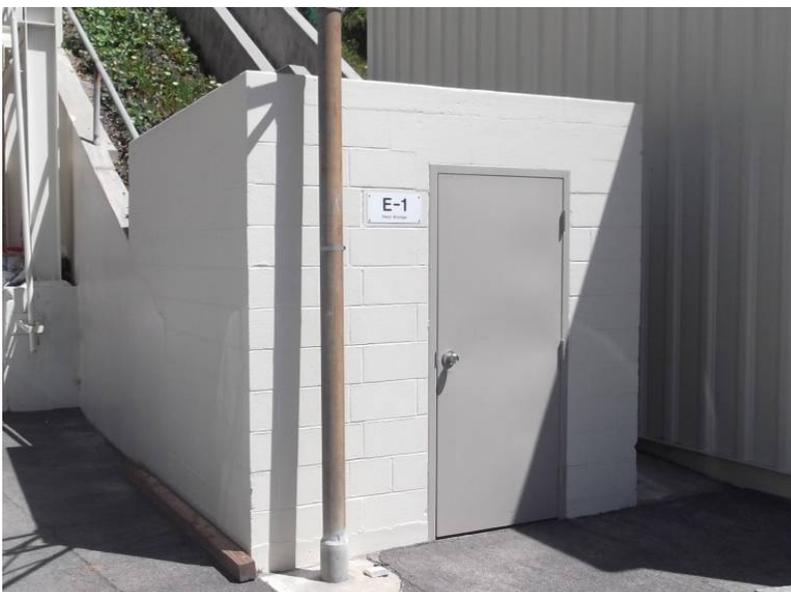
The building has exterior walls of painted concrete masonry, supporting the roof's structural framing (reference Photograph 30 in Appendix B). The walls are uninsulated.

View of building typical of Building C

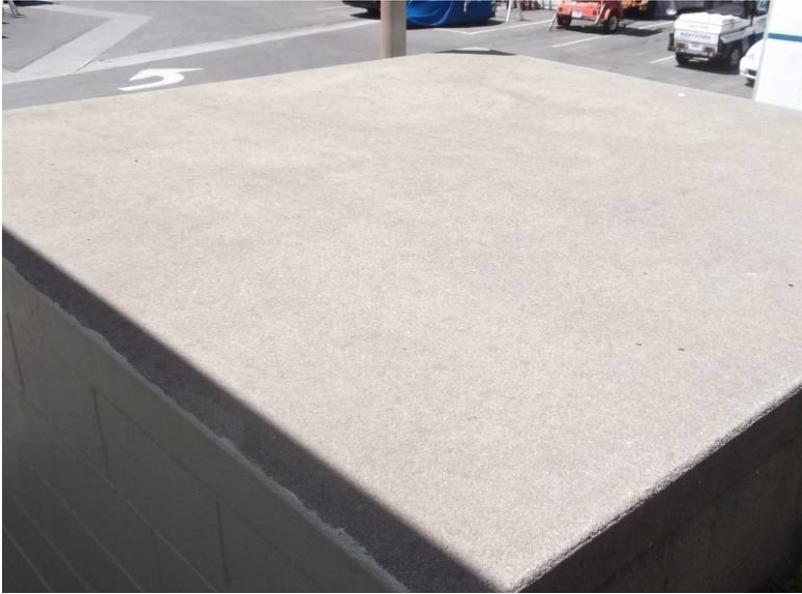
Photograph 31

View of the roof of Building C

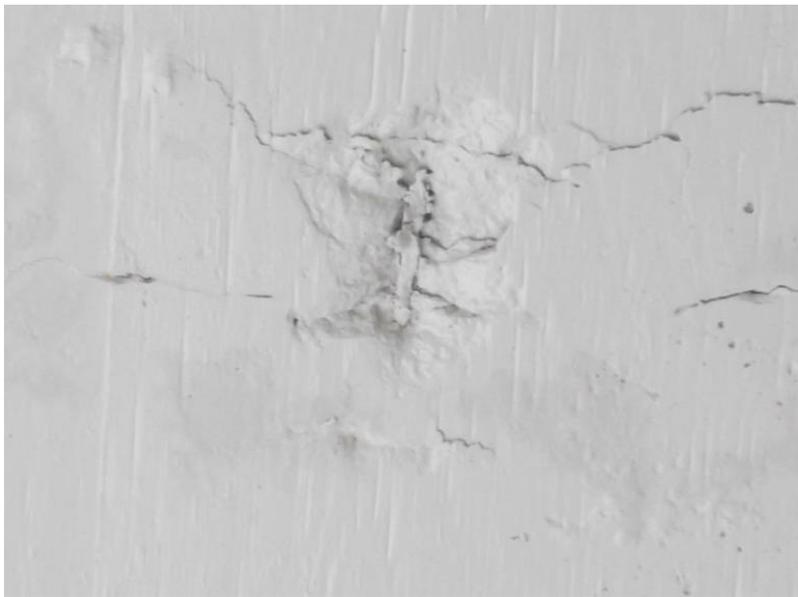
Photograph 35

View of concrete deterioration in the Sand/Gravel Hoppers

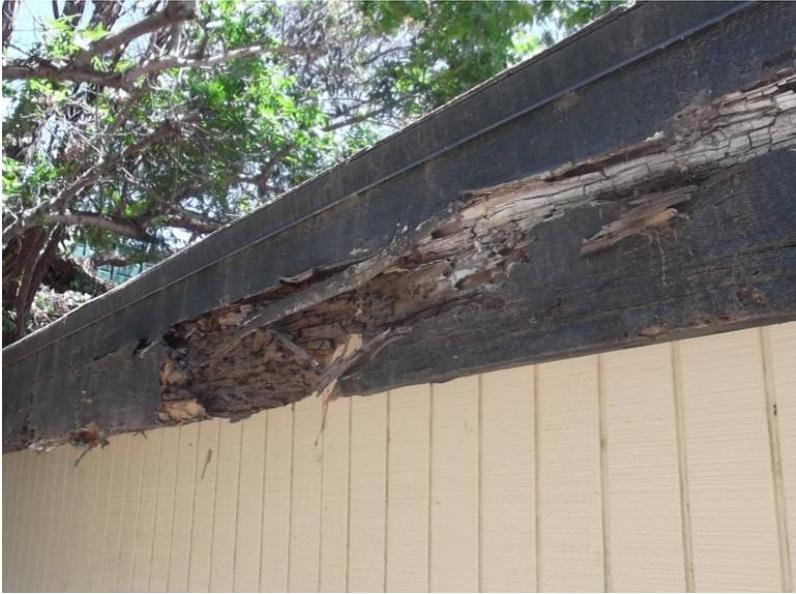
Photograph 40

View of the deteriorated wood fascia of the Storage Building (Oil Tanks) 7

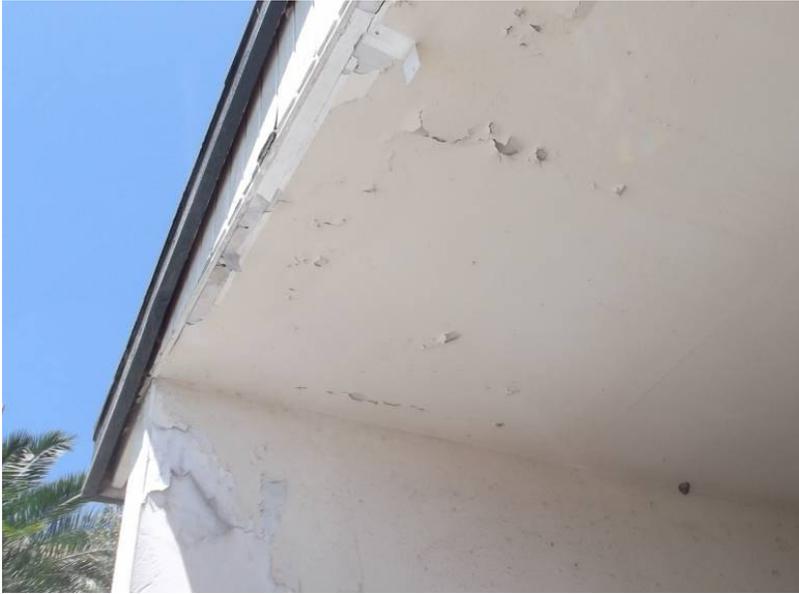
Photograph 43

Interior walls at the building have painted gypsum wallboard finishes (reference Photographs 42 and 43 in Appendix B).

The ceiling finishes of the building consist of painted gypsum board (reference Photographs 42 and 43 in Appendix B).

View of the wall and ceiling deterioration in the Storage Building (Oil Tanks)

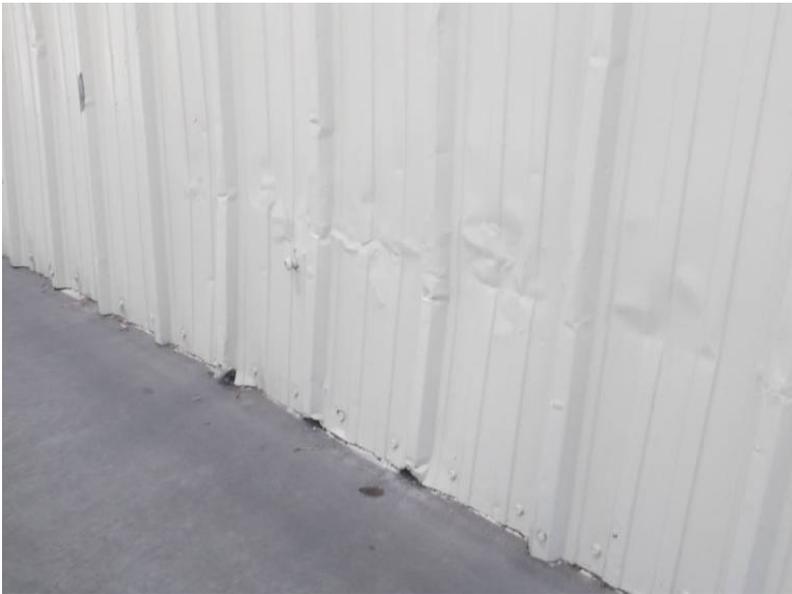
Photograph 47

View of metal siding damage at Building D

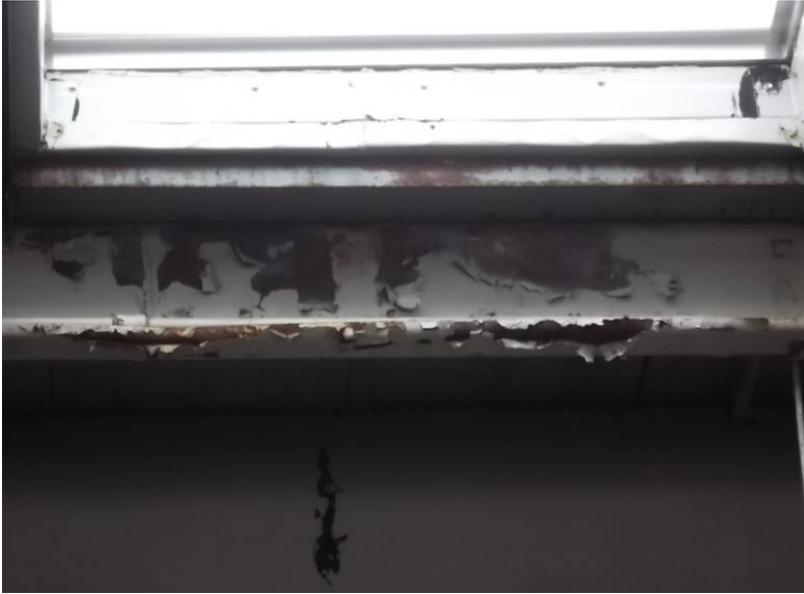
Photograph 49

View of deterioration under the skylight in Building D

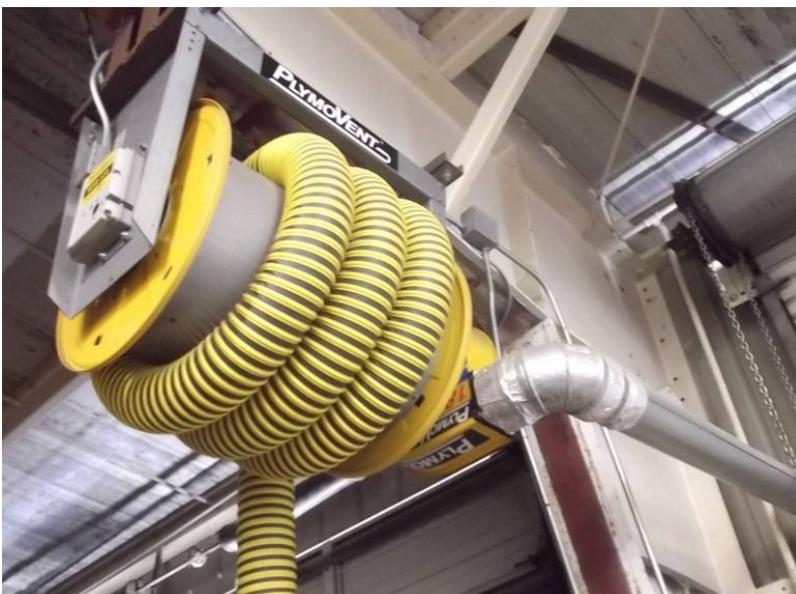
Photograph 54

View of the vehicle exhaust extraction equipment in Building D

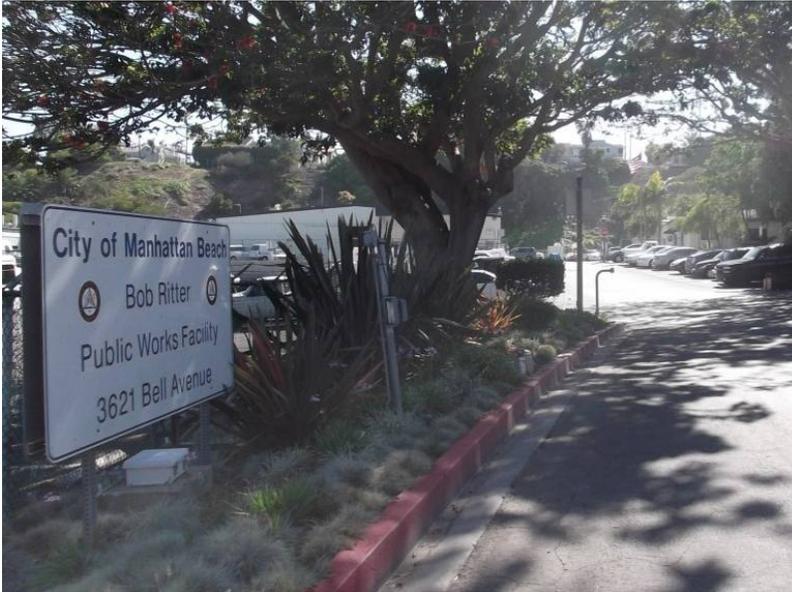
Photograph 75

Overview of the site, looking northeast

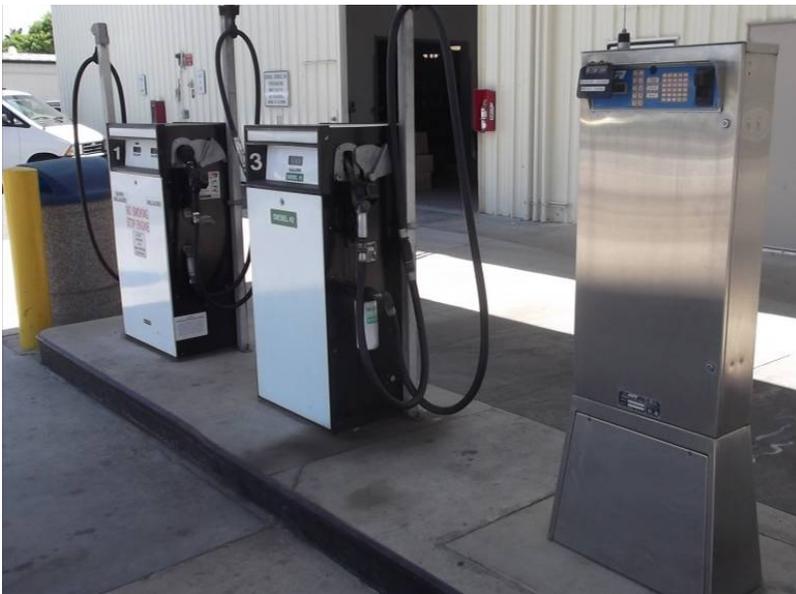
Photograph 79

A canopy-covered vehicle fuel dispensing station is located at the northeast corner of Building D. The canopy is steel framed, with prefinished metal fascia, soffit and roof. There are gasoline and diesel fueling pumps, as well as a natural gas fueling pump, located on a raised island (reference Photographs 79 through 81 in Appendix B). Two additional natural gas fueling stations are located along the sidewalk to the east side of the site. The 1997 construction drawings indicate installation of two 10,000-gallon and one 4,000-gallon underground diesel and gasoline fuel tanks.

View of fuel dispensing station adjacent to Building D

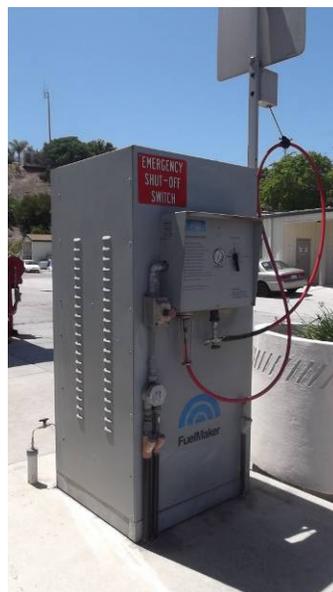
Photograph 80

View of the fuel dispensing equipment adjacent to Building D

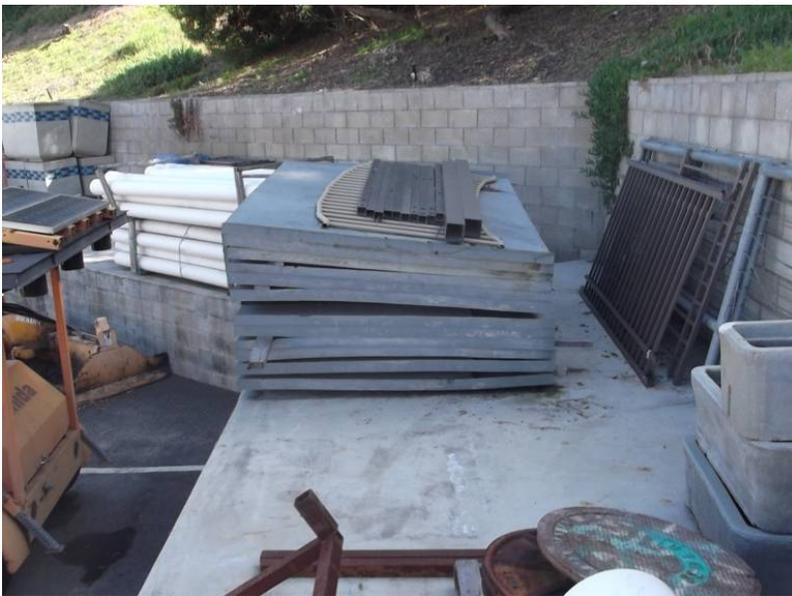
Photograph 85

The site includes raised loading docks and storage platforms along its west side, west of Buildings D and F. The docks are typically constructed with concrete masonry front walls and reinforced concrete decks, with concrete and wood-framed access stairs. The dock heights are typically 3'-6" to 4' in height (reference Photographs 85 and 86 in Appendix B).

View of loading platforms at the west side of the site

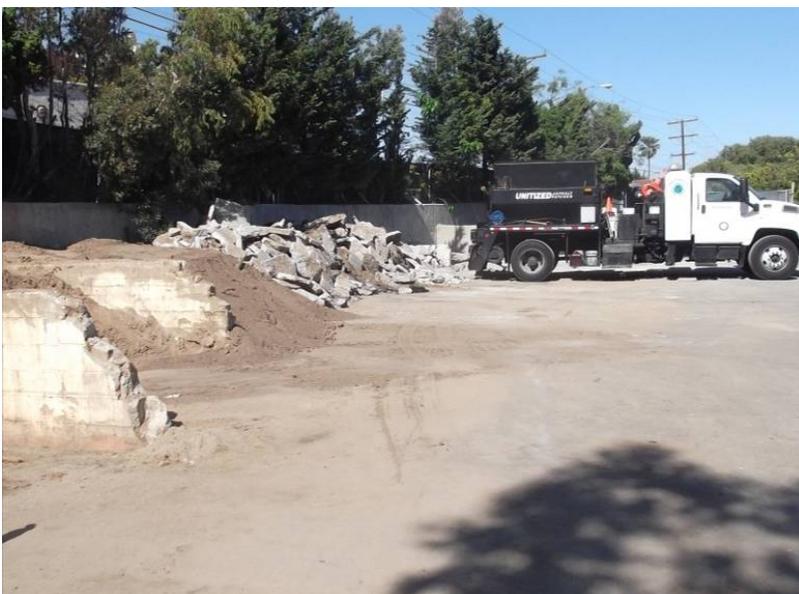
Photograph 89

View of entrance to the upper bulk loading area, accessed from 36th Place

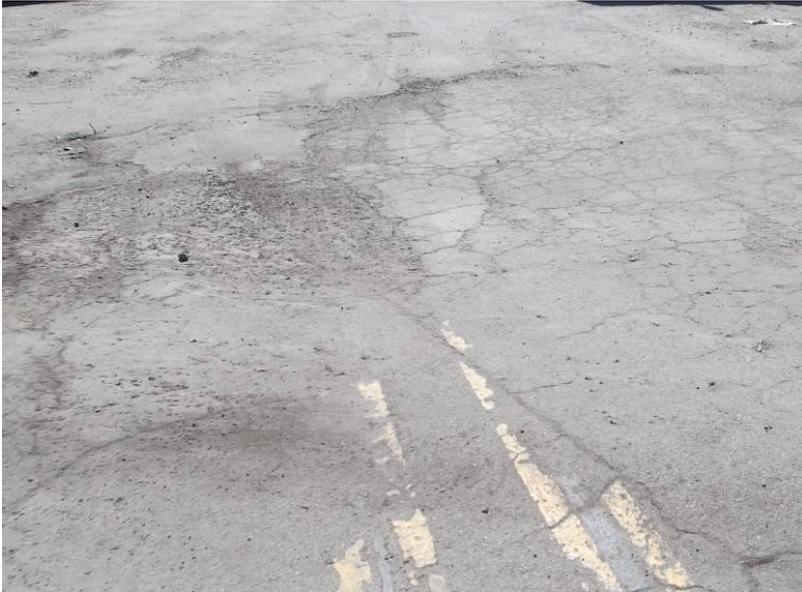
Photograph 90

View of the upper bulk loading area
